**Dune erosion during storm surges**  
**The realdune/reflex experiment at the sand engine**

## Dune erosion during storm surges: The realdune/reflex experiment at the sand engine

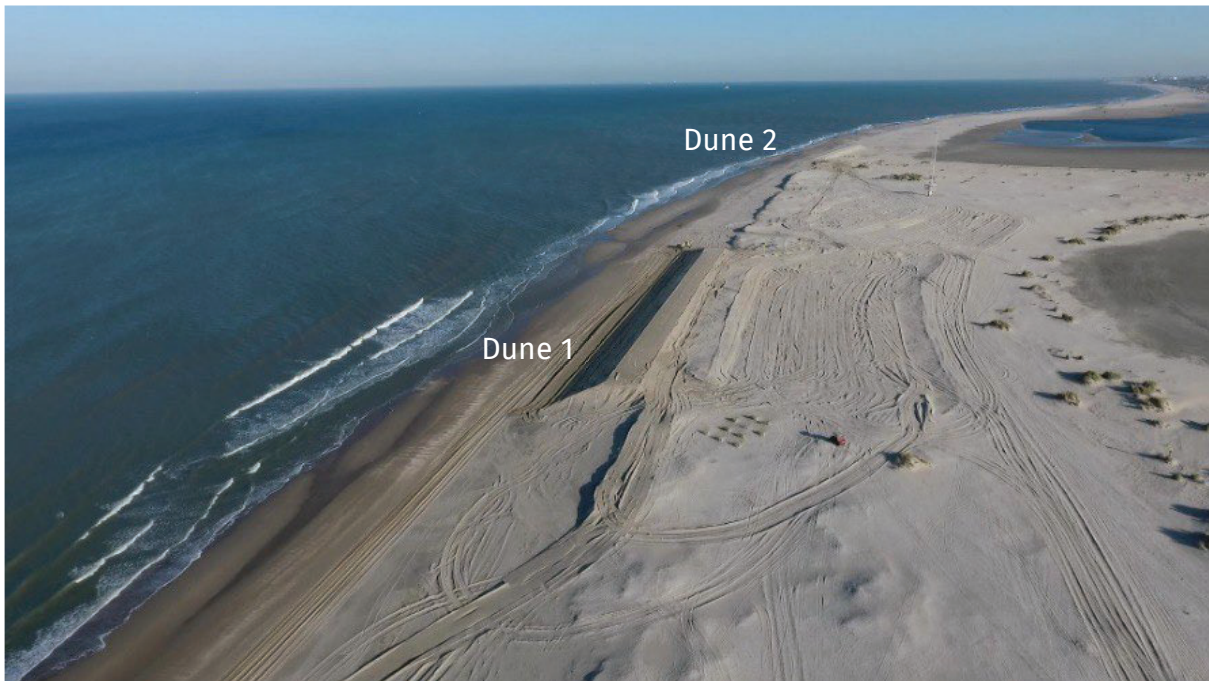
Figure 1: Aerial impression of the field site at the Sand Engine, Kijkduin, the Netherlands

An international field experiment was conducted to study dune erosion during storm surges from November 6 2021 until January 6 2022. on the Sand Engine. During the *Realdune/Reflex* experiment, two prototype un-vegetated dunes of 5.5 m high and 150 m long were built just above the high waterline. Due to a different shoreline orientation and nearshore bathymetry, these dunes eroded differently during moderate storm conditions. 3 storms were captured during the campaign.
