## Seismic assessment of a lab-tested two-storey unreinforced masonry Dutch terraced house

Bulletin of Earthquake Engineering

### Abstract

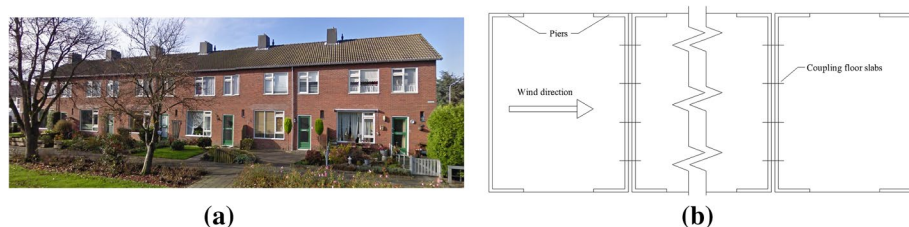
**Fig. 1** **a** Typical Dutch terraced houses; **b** prescriptive rules for the design against wind load (NEN 2012)

Being the area not prone to tectonic earthquakes, Dutch terraced houses were not designed accordingly to specific seismic-resistant criteria, while wind load is mainly considered. For optimal sunlight insight the houses, only narrow piers are used in the facades (Fig. 1). A prescriptive rule (NEN 2012), which gives a requirement to the summation of the pier lengths for the whole block, is generally adopted for wind design. To provide structural continuity, the floor slabs between the different houses are connected. The presence of slender piers and the limited connectivity between the structural elements make terraced houses vulnerable to seismic load in particular in the direction parallel to the façade piers.
