**Detection of Disaster-Prone Vernacular Heritage Sites at District Scale  
The Case of Fındıklı in Rize, Turkey**

International Journal of Disaster Risk Reduction

# Detection of disaster-prone vernacular heritage sites at district scale: The case of Fındıklı in Rize, Turkey

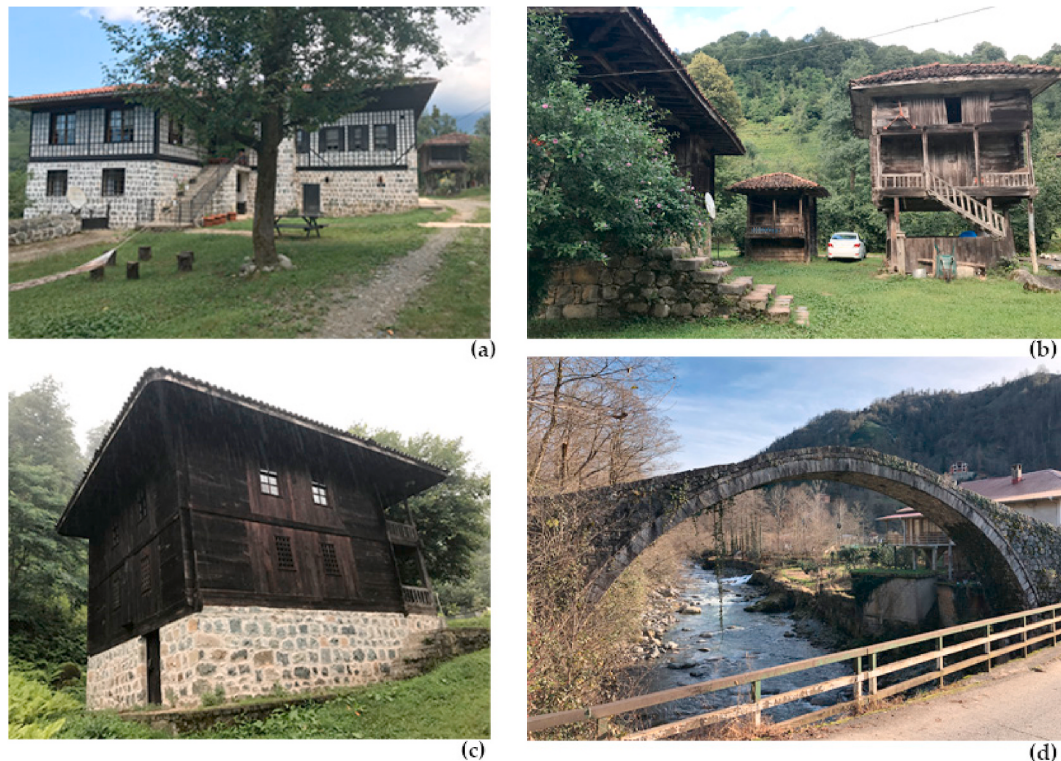
Fig. 2. Typical vernacular heritage in the region with (a) stone-infilled timber mansion, (b) timber house and storage houses, (c) timber mosque, and (d) stone bridge.

Fındıklı in Rize is rich with vernacular built heritage, such as mosques, stone bridges, traditional stone-infilled timber houses (Fig. 2), mills, barns, kilns, and archaeological sites; natural heritage, such as waterfalls, plateaus, and forests; and intangible heritage, such as timber artisanship, stone masonry, coppersmithing, basket making, weaving, hawk eagle raising, and corn bread making, in addition to other representations of the area's food culture [53]. The coastline settlements are more densely populated except during the summer months, especially July and August, when the population migrates toward higher plateaus for agricultural activities and animal breeding [54].

Although Beydere Village is highly affected by the floods and landslides, the flood map provided by DSI does not include flooding data beyond the coastal area. Flood defenses formerly focusing around Beydere Village were extended to Çağlayan Village due to increasing and intensifying effects of floods. The DSI 22nd Regional Directorate determined these extensions based on estimation of the construction cost and the material and on the height of the flood protection and control structures according to the slope and width of the streambed [74]. Vernacular houses near flood defenses in lowland villages such as Çağlayan reveal that grand mansions—such as the one in Fig. 2—are also in danger.

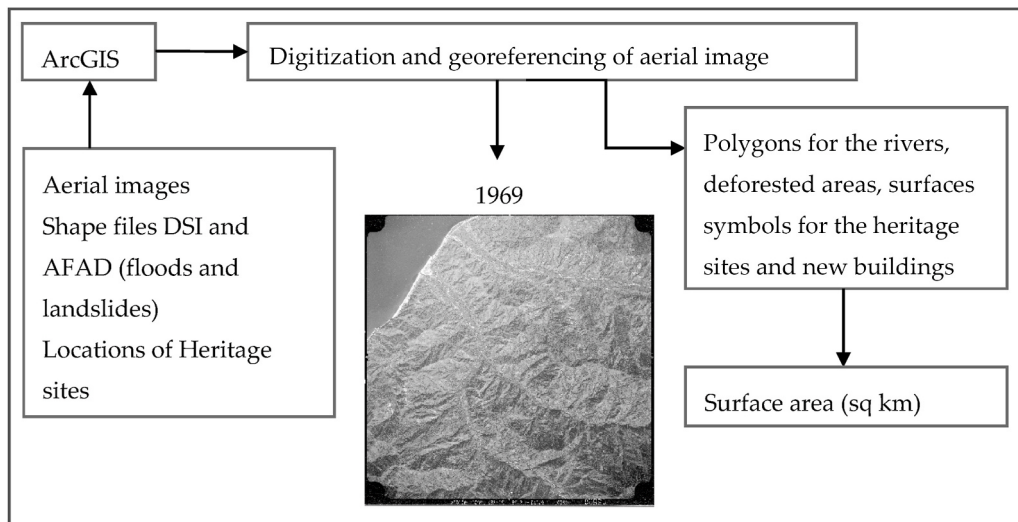
Fig. 3. Flow diagram of the methodology used in this study.

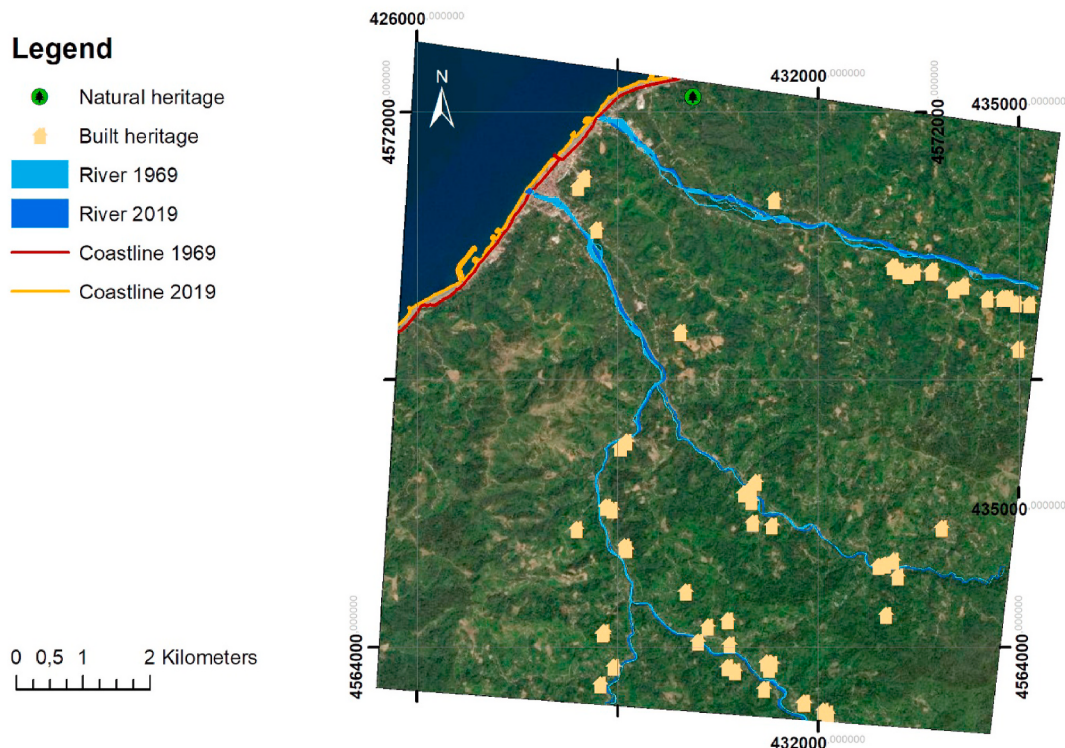
Fig. 4. An image of the coastline and major rivers of Fındıklı, Arılı, and Çağlayan, along with the locations of natural and built heritage sites in 1969 and 2019.

Since 1969, there have been major interventions to the rivers of Çağlayan and Arılı. In 1969, the riverbeds of Arılı and Çağlayan were wide enough to accommodate sudden fluctuations and changes in the natural flow of the rivers (Fig. 4). Later, both rivers expanded toward the sea to form estuaries. The river flow was levelled by the converging tributaries in 1969, and were merged and realigned with the downstream channel in 2019. However, the morphology of Arılı has been slightly modified on two diverging streams.

The river of Çağlayan used to have diverging tributaries—comprising a large watershed—that have been substantially realigned and corrected (Fig. 4). According to the map, the division of the streams was altered completely by keeping a straight channel, which increased the pressure of the water flow. One implication of this was a densification of flood plains, which eventually put the nearby newly built houses at risk of river flooding. Concrete buildings with many floors were constructed near the riverbeds where the urban densification increased. The major reason behind the river flooding, according to DSI reports, was the discarding of rubble into the riverbeds during the construction of the new houses. This led to the blocking of the water flow, particularly in curves and under bridges. Although this is also an important factor to consider, the influence of extreme shifts in channel shape cannot be overlooked.

The riverbeds of Çağlayan were branching out and widening to a larger area where only one vernacular house is located. Unlike its 1969 shape, today the river flows rather straight, allowing access to cars via bridges and roads along the river. The site selection of vernacular houses was not arbitrary, since they were built far from river flood plains. However, in 2019, the river was narrowed by concrete walls to allow the construction of new houses along the river. This increased the vulnerabilities of the vernacular houses along the river by changing the location of flood-prone areas—thus placing the previously safe structures in the path of flooding. Furthermore, the alteration led to the destruction of many newly built houses on both sides of the river where the river modification was major.

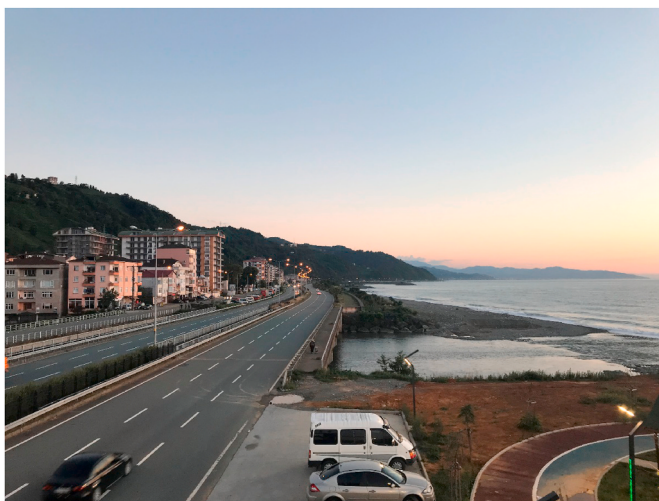
Fig. 5. The Karadeniz Sahil Yolu (Black Sea Seaside Highway) in Fındıklı of Rize. The photograph was taken by the first author, Gül Aktürk, on July 1, 2019.

The infilling project of the coastline of the Black Sea, known as Karadeniz Sahil Yolu (Black Sea Seaside Highway) (Fig. 5), connects the coastal cities of the Black Sea region in Turkey [73]. Although the highway officially opened in 2007, the foundation of this infrastructure was initiated by Russians after their invasion of the city of Rize in 1916 during the Ottoman Empire period, with the opening of a one-way road. The construction of the highway not only obstructed the sea access of local residents but also caused the destruction of historically important coastal settlements. As part of this project, the city grew toward the sea

and rocks were used to claim new lands. A new coastline was created to support the creation of additional public spaces [73].

On this new territory, the maps reveal the extension of harbor facilities with new seawalls along the coast. The erosion of rocks underneath the infrastructure has become an issue of land reclamation in the coastal area of Rize [43]. Coastal planning and developments along with river modifications increased the risks of flooding on coastal lowlands and riverine areas. Both coastal and inland flooding are affecting the surrounding settlements and infrastructure. Although the geographical location of the vernacular heritage in the hinterland seems to be far from these developments, the pressure of the coastal and central area are reflected on the hinterland, as a result of construction in the hinterland due to land scarcity on the coast and the drastic reduction of the riverbed to allow urbanization.

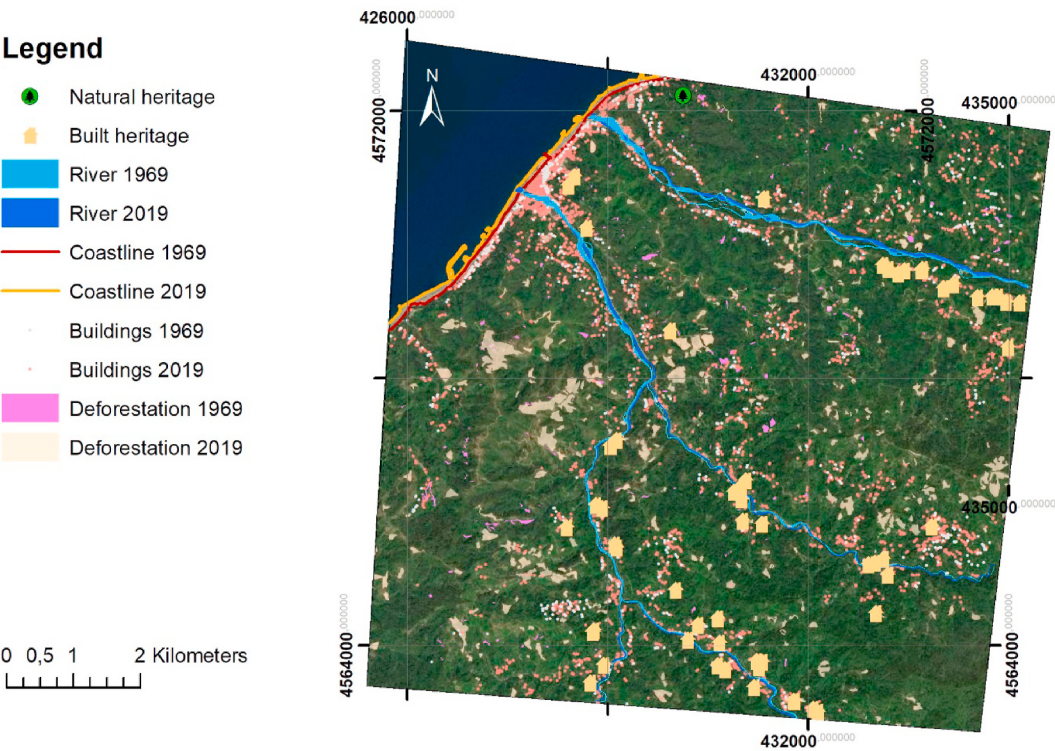
Fig. 6. Image of the coastline and major rivers of Fındıklı along with the locations of natural and built heritage sites, and buildings in 1969 and 2019. The map identifies areas of deforestation in 1969 and larger-scale deforestation in 2019.

The overlay of the maps revealed that most of the former deforested areas match with contemporary ones and are growing in scale at an alarming rate (Fig. 6). The distribution of these small patches was sparse in 1969, while in 2019 the deforested areas densified in the northwest direction. Many settlements located around these patches, including the vernacular houses, will likely be affected by landslides caused by this deforestation (see Fig. 7). There are already observable damages at the building scale, such as the complete destruction of undocumented vernacular houses and storage buildings. Snow cover on top of the mountains melts in the summer season, which also accelerates the flow of the rivers. Combined with the heavy rains of June and July, river flooding becomes more intense, forcing residents of historic buildings to abandon their houses, according to the interviews with locals [76].

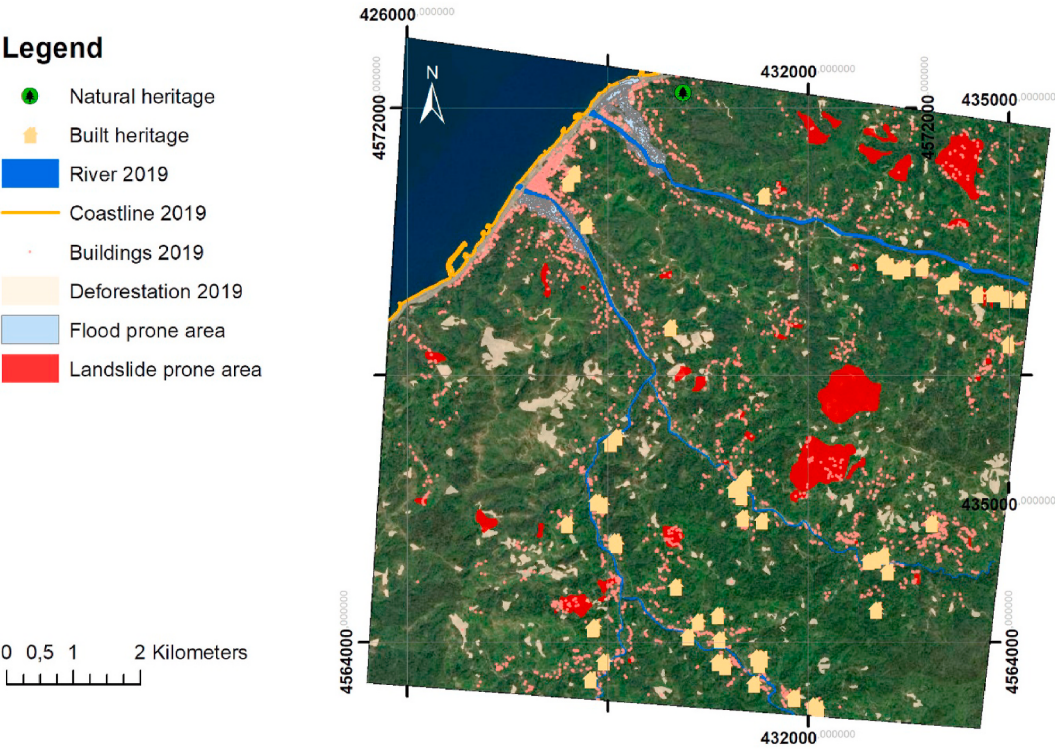
Fig. 7. The flood- and landslide-prone and deforested areas in the selected area of Fındıklı in 2019.

Results obtained from the maps indicated that not many vernacular and natural sites are under threat of floods and landslides, compared to the new buildings. The greatest disaster-prone surface is located between the valleys of Arılı and Çağlayan and the northeast part of the Çağlayan River.

According to the map, the deforested areas in some cases intersect or precisely overlap with the risk-prone areas, supporting the argument of being a multiplier risk through, for instance, landslides. One natural heritage site known as Sarıcam Forest, which has not been listed, is part of the deforested area. In addition, the clusters of newly built houses are located in landslide-prone areas shown as red patches (Fig. 8). It is especially visible in a zoomed-in view of the map that one historic building, namely Sevketybeyoglu House, is positioned at the intersection of the deforested and landslide-prone area (Fig. 8b), whereas a few houses, such as Sulak Village House (Fig. 8a) and Sevkety Atac House, remain in close proximity to landslide-prone areas (Fig. 8b). The two houses of Sevkety Atac and Sevketybeyoglu are located side by side in the deforested and landslide-prone area. As shown in the figure, the threatened sites are located in Çağlayan and Sulak villages. Three out of 58 vernacular built heritage were situated in the landslide-prone areas (Table 2).

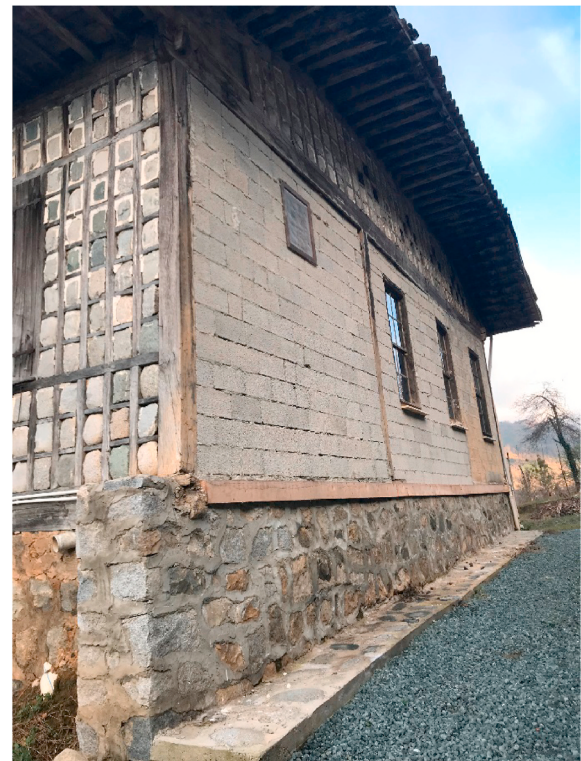
**Fig. 9.** The degradation of the rear façade of the Şevket Atac House due to landslides in Çağlayan Village in Fındıklı of Rize. The photograph was taken by the first author, Gül Aktürk, on January 12, 2019.

In interviews, locals mentioned damages on vernacular buildings, e.g., façade deterioration and loss (Fig. 9). The maps from the institutions
