## Factors favouring vegetation in quay masonry walls: A pilot field study

Building and Environment

# Factors favouring vegetation in quay masonry walls: A pilot field study

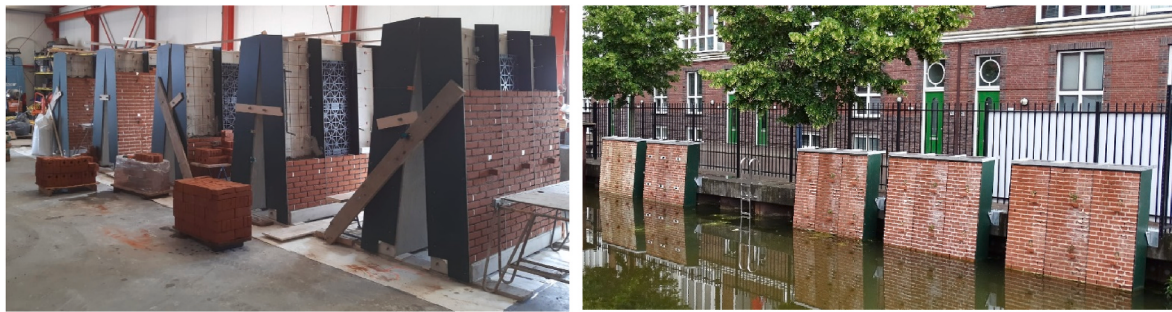
Fig. 2. left: Building of the walls; in the middle panel space between the masonry and the concrete slab is left for pouring of the substrate (the plastic containers had only a safety function); right: South facing walls placed at test location.

The walls were constructed at a building location and then moved to the site (Fig. 2 left). The substrate was poured in the cavity, 10 days after completion of the wall, when the masonry had acquired enough strength. The pointing mortar was applied after removing the outer part of the bedding mortar (up to 2 cm depth), directly after application. Some vertical joints were left without mortar, to favour water flowing and nesting of insects. On two spots at the right-end side of each panel, the mortar joints were not smoothed at the surface, but left protruding and rough. This way the influence of the surface roughness on bio-receptivity could be assessed.

When ready, the walls were transported to Breda and placed in the canal (Fig. 2 right). The lower part of the walls, up to 40 cm, is immersed in water. At this point the plants were potted; later, the sensors for monitoring of the climate and surface temperature of the panels were

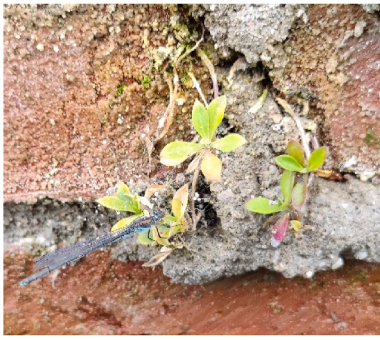
Fig. 11. Wallflower growing in the cracks present in a rough mortar joint.

Irregularities, such as protruding rough mortar joints, empty vertical joints and dilation joints, were shown to favour germination of seeds and subsequent plant growth. This is particularly evident in the left and right panels and it is probably related to the fact that these irregularities offer grip for plants (Fig. 11). This confirms the positive effect of surface roughness on bio-receptivity reported in the literature [13,37]. Germination of Wallflower is observed also in the frog of the protruding bricks, where rain water accumulates; however, seedlings did not develop into plants, due to insufficient supply of organic material.
