## Algorithm for automatic detection and analysis of cracks in timber beams from LiDAR data

Cabaleiro, M.; Lindenberg, R.; Gard, W. F.; Arias, P.; van de Kuilen, J. W. G

2017

Construction and Building Materials

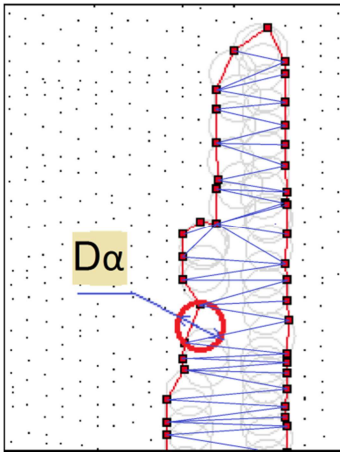
Figure 6. Alpha parameter  $D_\alpha$ . The area of the crack is the sum of the area of all triangles.

patches in buildings in large-scale and noisy raw point clouds [31]. In both these works, Alpha-shapes are used for finding the outside edges of large surfaces. In our case however Alpha-shapes are applied for estimating the location of the inside edges of small holes in the wood, where the diameter  $D_\alpha$  is critical in obtaining an optimal result.

For too small values, the results outline individual points while for too large values no crack is found at all. Because of this, it is necessary to identify that value  $D_\alpha$  that enables finding all cracks with maximal accuracy. When Alpha-shapes are used, not only true cracks are detected, but also some false positives may be obtained (Figure 7).

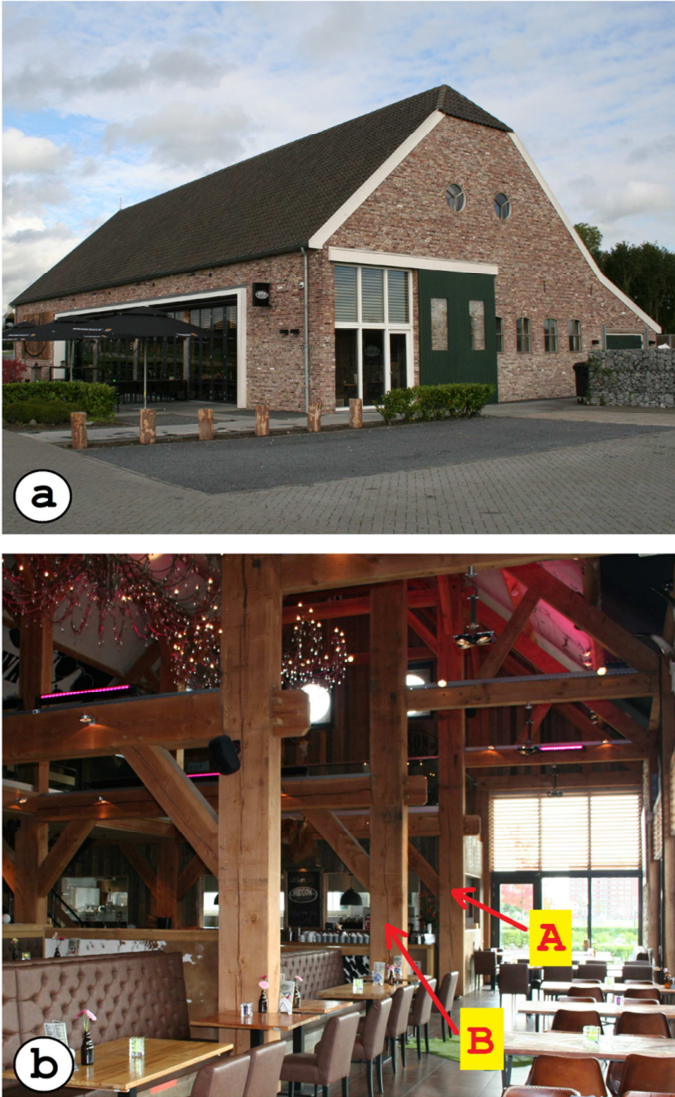
Figure 13. a) Outside of the scanned real structure. b) Inside of the scanned real structure.

The developed algorithm also has been tested on a real timber structure. This structure is situated in Zoetermeer (The Netherlands) and nowadays supports a restaurant (Figure 13). The main dimensions are 13 m wide, 21 m long and 10 m high. The building was built around 2009. Its structure has been made of solid timber beams (wood species: *Pinus sylvestris L.*) with cross section of 450 mm x 300 mm. The structure has a lot of cracks (Figure 13b).
