## The revival of the Byzantine church Hagia Irene in Istanbul

Priscilla Üncü – 1520660

## Summary

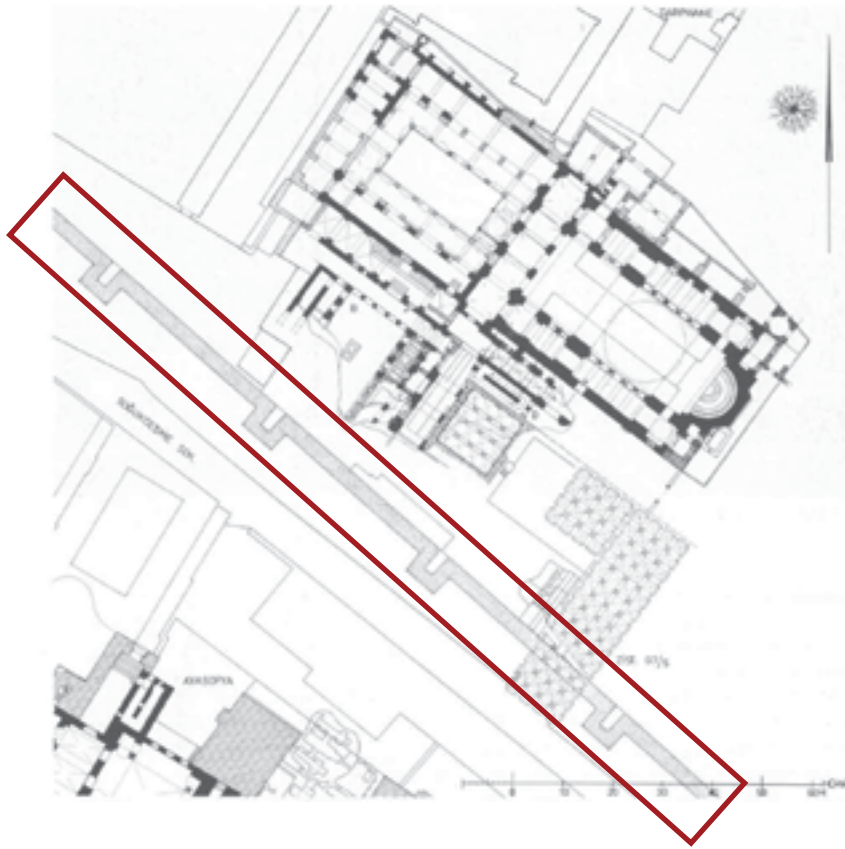
Figure 1 The Hagia Sophia and the Hagia Irene separated by the Topkapi Palace wall (based on plan taken from Müller-Wiener, 1977)

When the conquest of the Ottomans introduced Islam as the new religion of Istanbul – a city that until then had been the capital of Orthodox Christianity – most churches were transformed into mosques, including the Hagia Sophia. The Hagia Irene was separated from the Hagia Sophia, but did not become a mosque, partly because of its protected location behind the defence walls (figure 1) of the Topkapi Palace that was built during that time. Instead, it was given various other functions, including an arsenal, a museum of arms, a storehouse for antiquities and a madame tussauds. Today, it is used as a museum, and occasionally as a venue for classical music concerts.

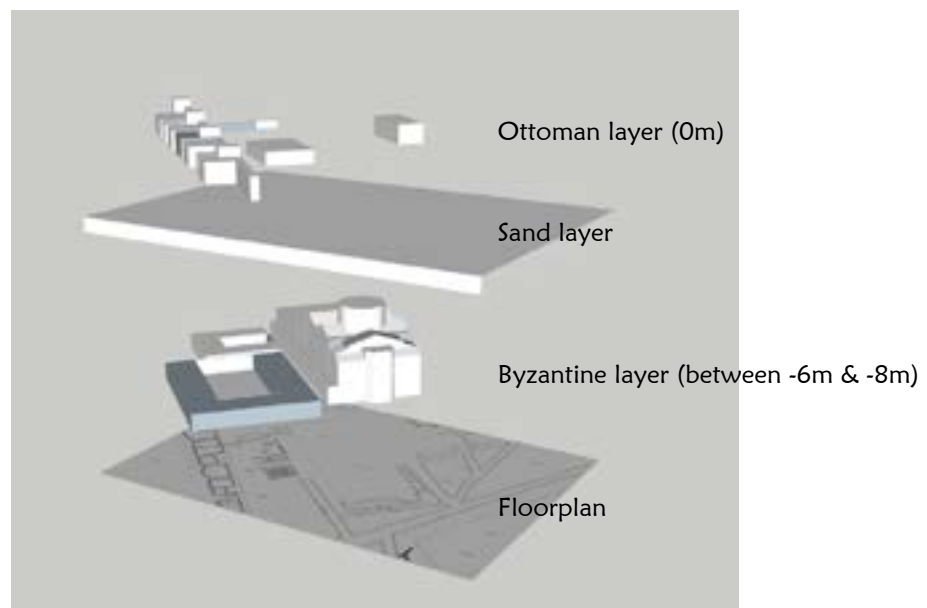
Figure 2 Different layers of time in the close surroundings of the Hagia Irene (Illustration by author)

The various historical phases or "layers of time" of Hagia Irene and its immediate surroundings is still visible today (figure 2). The visible fragments of the Byzantine layer include the Bishop's house, a small part of the Sampson hospital, and the church itself (Figure 17). The Ottoman layer is completely visible.

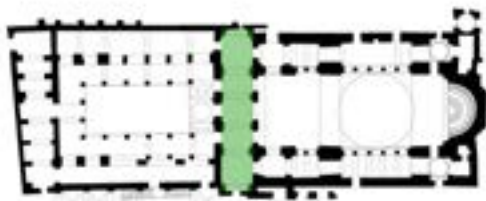
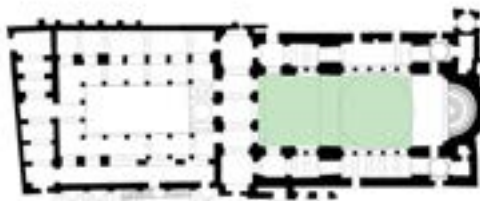
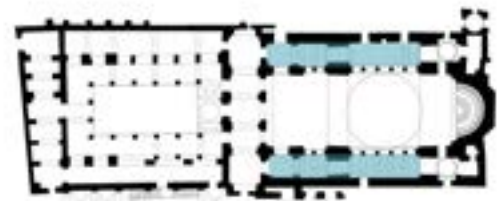
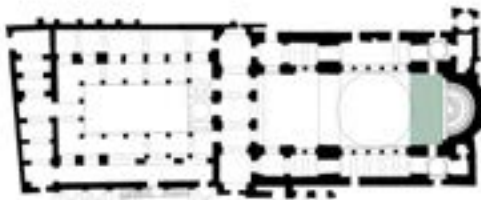
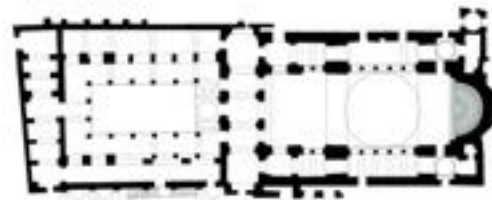
The narthex

The nave

The aisles

The bema

The apsis

Figure 4 Division in space (based on plan taken from Müller-Wiener, 1977)

One common characteristic of Byzantine churches is the plan, which is of three types: the Basilica, Octagonal or Circular, and the Cross plan (this last type, however, is no longer present in Istanbul) (Van Millingen, 1912). These simple spatial organizations (figure 4) create unexpectedly complex spatial geometries, an effect that I felt very strongly during my site visits.

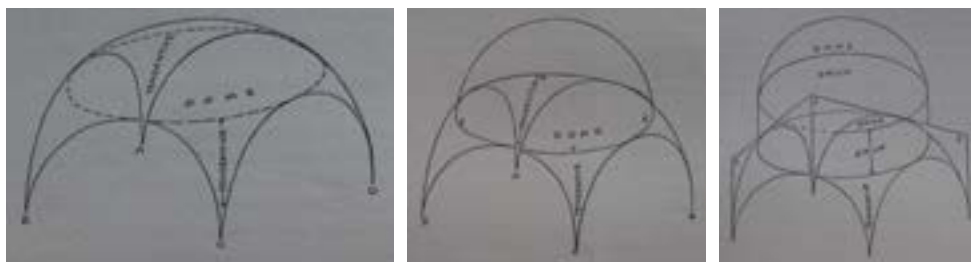
Figure 5 The domes (van Millingen, 1912)

A second characteristic that defines Byzantine churches is the dome. They exist in several variations, three of which are illustrated in figure 5. As well as playing an important role in defining the interior space, the dome is a key structural element of the church. (Van Millingen, 1912)

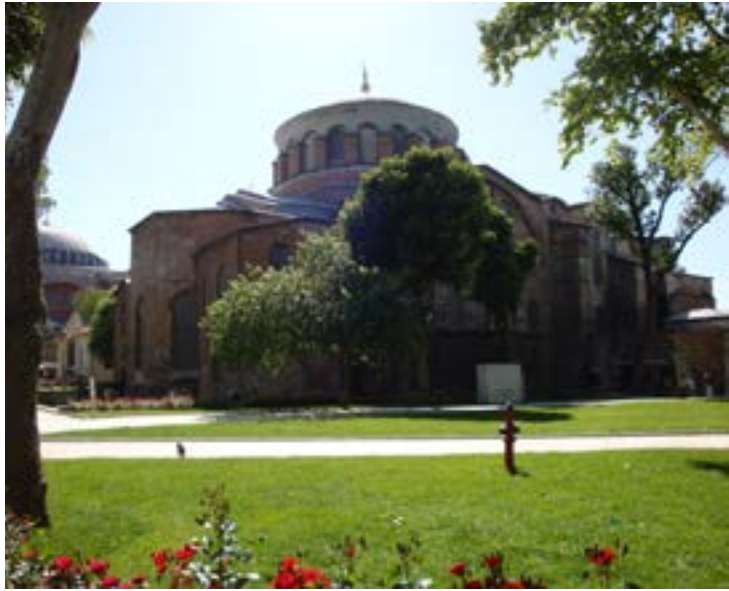
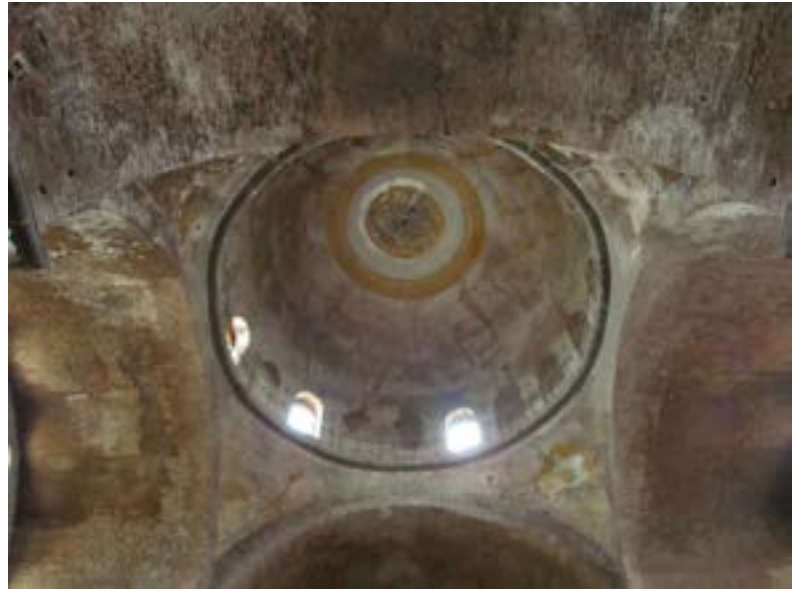
Figure 6 The main dome of the Hagia Irene from the outside and the inside (photo taken by author)

Hagia Irene's dome (figure 6) is of particular historical importance because it played a key role in the development of dome construction (Van Millingen 1912). While previous domes were low and imperfect, Hagia Irene's dome, built around 740 A.D., has a high drum, and its domical system of roofing achieves a more complete integration than in previous churches. On the exterior, Hagia Irene's dome is polygonal. Building on this development, subsequent Byzantine domes were also made with a high drum, aided by rib or hollow structures on the interior.

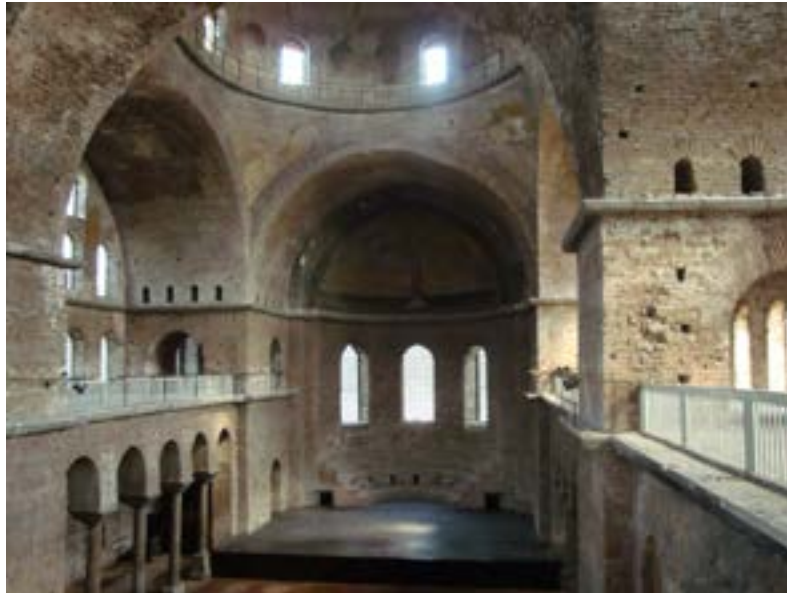
Figure 7 The construction of the Hagia Irene with the dome, thick walls and arches (photo taken by author)

The characteristic brick structure of Byzantine churches is likewise a defining aspect of the Hagia Irene (figure 7). It has thick walls and arches, and from the exterior it reads as simple masses of brick. The structure around the main dome consists of peaked roofs, except for the western roof, which is an elliptical dominical vault. Three pairs of piers are located in the central part of the nave. These piers have slender columns between them to support the galleries on the side and stand on the corners of two large bays. They don't have a base moulding, but stand on damaged blocks, which are likely either cores of marble pedestals or simply reused material. (Freely & Cakmak, 2004). While this brick construction dominates both the exterior and interior of the church today, the parts of the original interior decoration that are still visible give a hint of the rich decoration that once characterized the space.

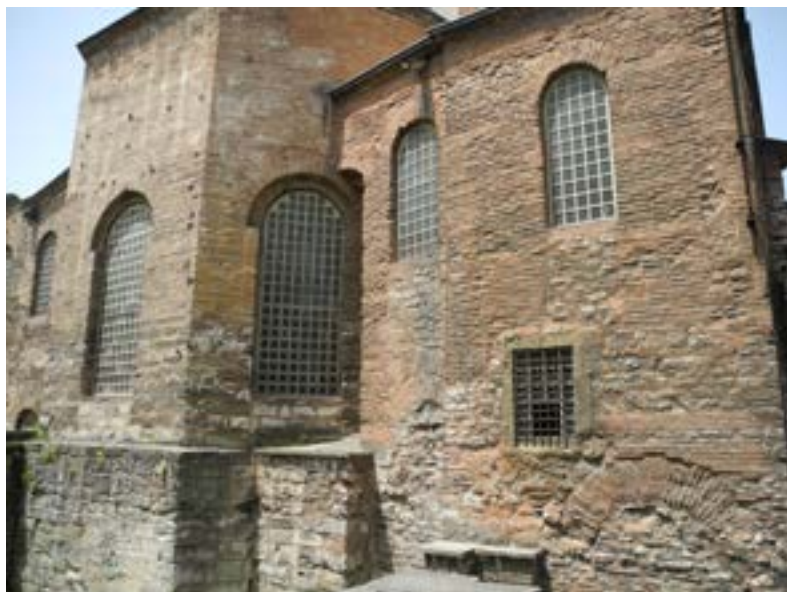
Figure 8 Different kinds of bricks and compositions in the outer part of the east façade at the apsis (photo taken by author)

Today, the Hagia Irene bears the mark of various historical layers, a quality that can be understood as "layers of time". These layers are partly the result of several earthquakes, struggles and fires. Van Millingen states that some parts of the church were seriously injured and rebuild after being damaged. This was all before the Turkish conquest. Van Millingen mentions parts from three different time periods. The first change were the walls of the body of the church, until the springing of the vaults of the aisle, which are built by Justinian after the Nika Riot in 532. The second change were the repairs probably also made by the same emperor after the fire of 564. This contains the narthex, aisle vaults next to it and the upper part of the western end of the south wall. The third change was because of the earthquake in 740. Only the narthex was left standing. The upper part of the building, the apse, the dome-arches, the dome-vault and the dome including its drum were all reconstructed. Additions are also made in these periods. (Van Millingen, 1912) These changes are visible in the church today. For instance, different kinds of bricks and compositions from different time periods are visible in the outer part of the east façade at the apsis (figure 8).

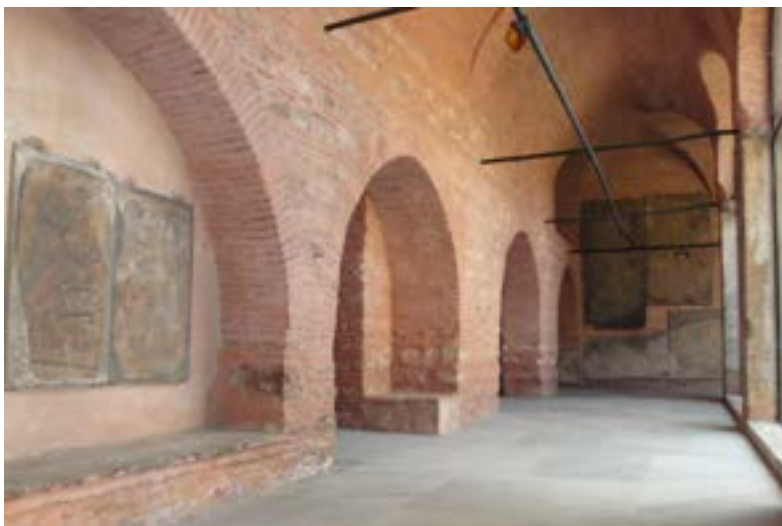
Figure 10 The double portico which reduced the original atrium (photo taken by author)

In addition to the reconstructions following damage to the church, the changes in culture and religion brought about by successive empires throughout Istanbul's history have also left their mark on Hagia Irene. (Ahunbay, 2012; Freely & Cakmak, 2004; Van Millingen, 1912). Traces of these changes are evidenced, for instance, by the marks of different empires (figure 9). The most significant change, however, was the double portico with a peristyle that was added to the inner perimeter of the atrium courtyard (figure 10) following the Ottoman conquest, reducing its original size (Freely and Cakmak,

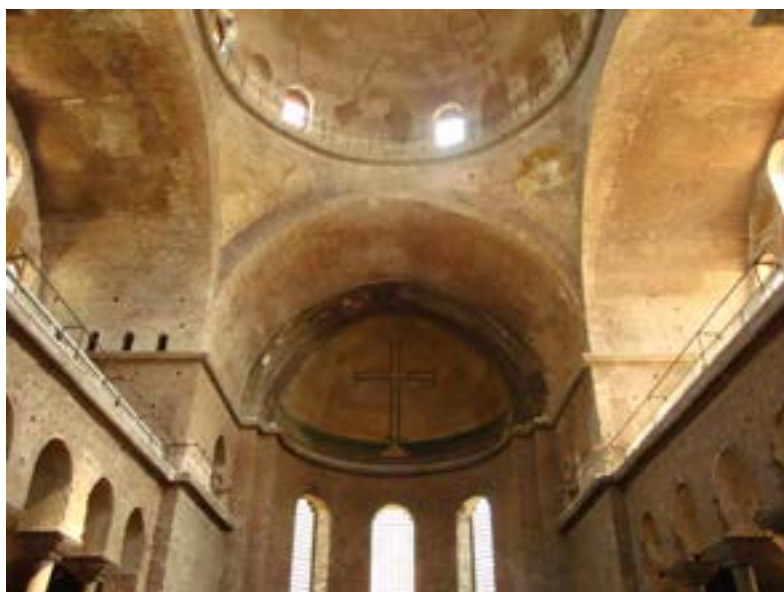
Figure 11 Mosaics at the apse and the bema (photo taken by author)

The mosaics that have been preserved on the ceiling above the apsis (figure 11), and immediately drew my attention when I entered the church. On a gold background with an outlined geometric border, black cross with flared, teardrop-shaped ends that stands on a base of three steps. Below this mosaic, a double green band and moulding runs along the base of the semi-dome. These mosaics probably date from the rebuilding of the church in the eight-century. (Freely & Cakmak, 2004)

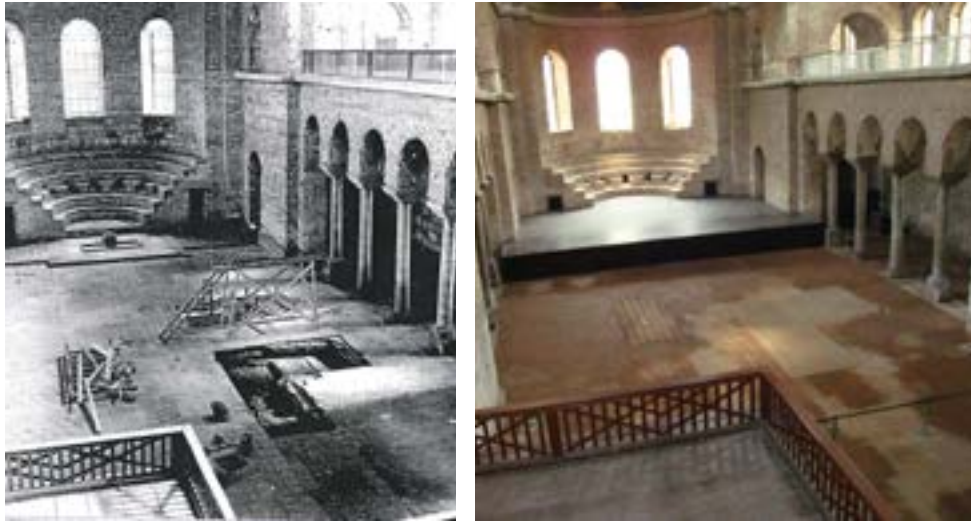
Figure 12 The stage before and after (Unknown, photo taken by author)

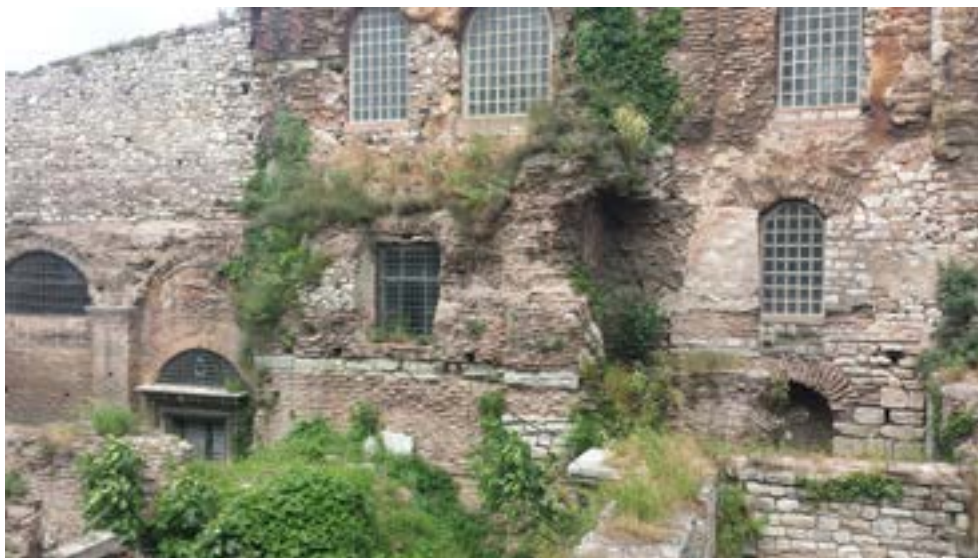
Figure 13 Remaining's on the outside of the southern wall of the narthex (photo taken by author)

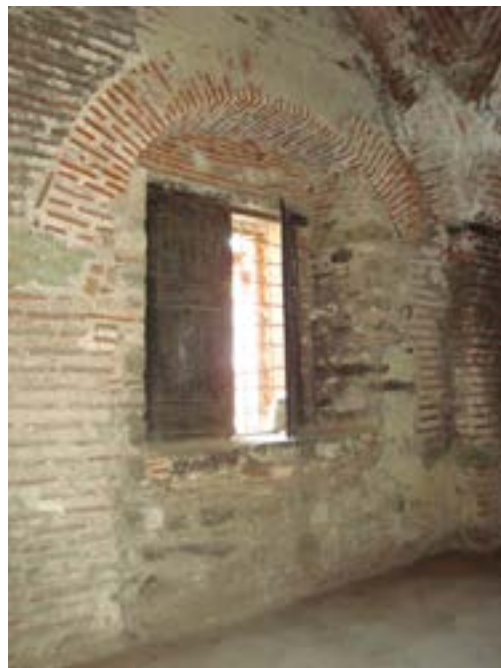
Figure 14 Windows on the gallery above the narthex which are not typical Byzantine (photo taken by author)

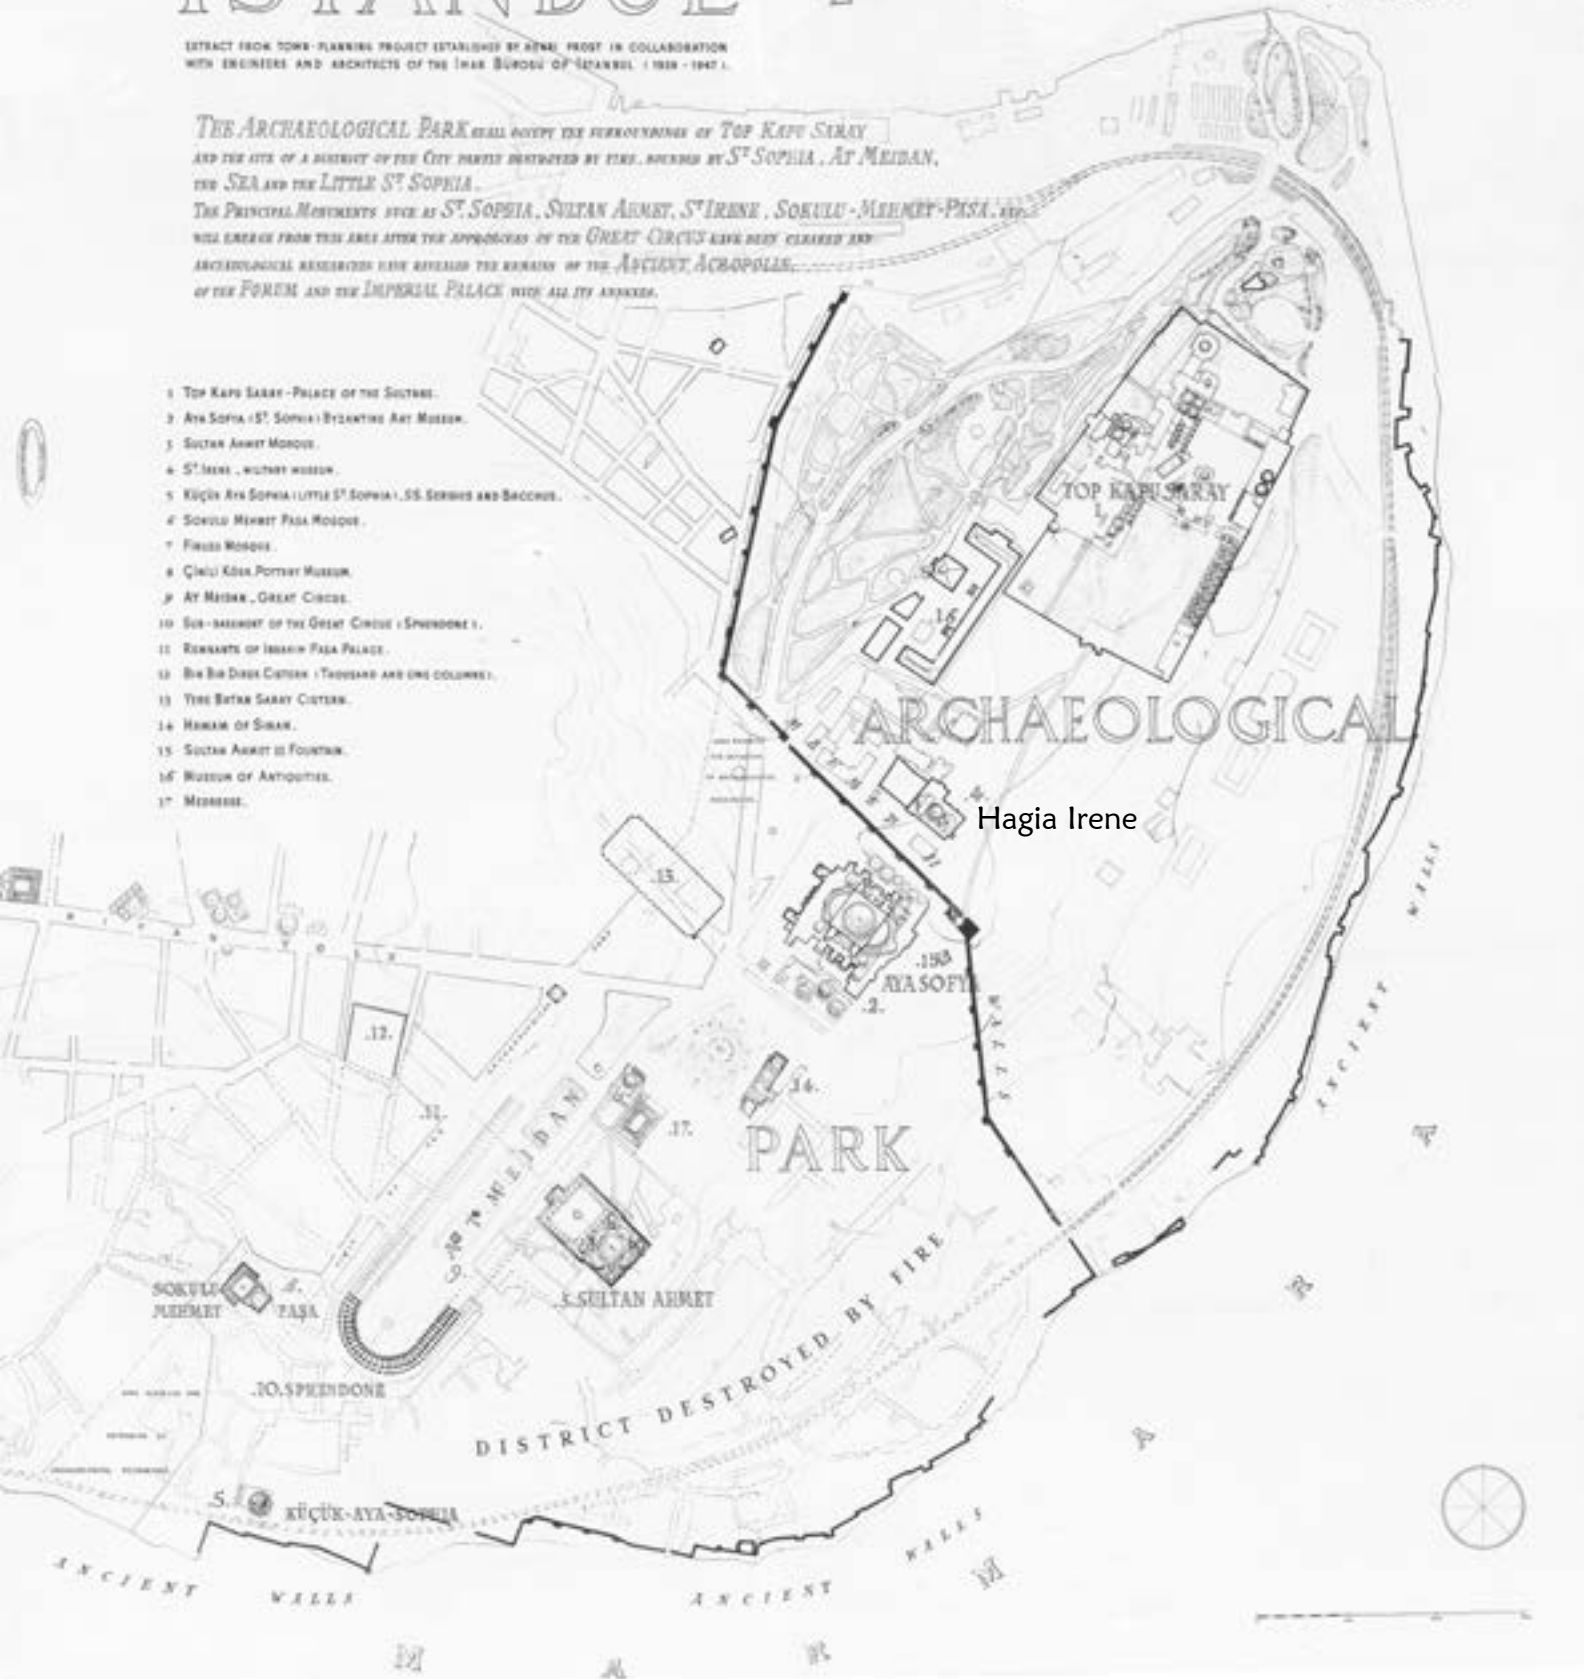
*THE PRINCIPAL MONUMENTS SUCH AS ST SOPHIA, SULTAN AHMET, ST IRENE, SOKULU-MEHMET-PASA, AND WILL EMERGE FROM THIS AREA AFTER THE APPROACHES OF THE GREAT CIRCUS HAVE BEEN CLEARED AND ARCHAEOLOGICAL RESEARCHES HAVE REVEALED THE REMAINS OF THE ANCIENT ACROPOLIS, OF THE FORUM AND THE IMPERIAL PALACE WITH ALL ITS ANNEXES.*

- 1 TOP KAPU SARAY - PALACE OF THE SULTANS.
- 2 AYI SOPHIA (ST. SOPHIA) BYZANTINE ART MUSEUM.
- 3 SULTAN AHMET MOSQUE.
- 4 ST. IRENE - HOLY TRINITY.
- 5 KÜÇÜK AYI SOPHIA (LITTLE ST. SOPHIA) SS. SERGIUS AND BACCHUS.
- 6 SOKULU MEHMET PASA MOSQUE.
- 7 FINESS MOSQUE.
- 8 ÇİLEKİ KÖK POTTARY MUSEUM.
- 9 AY MEİDAN - GREAT CIRCUS.
- 10 SUB-BASINMENT OF THE GREAT CIRCUS (SPHENDONE).
- 11 REMAINS OF İBRAHİM PASA PALACE.
- 12 BİN BİN DİRİLİŞ ÇİFTLİK (TWO THOUSAND AND ONE COLUMNS).
- 13 YENİ BÜYÜK SARAY ÇİFTLİK.
- 14 HANIKAH OF SİRAK.
- 15 SULTAN AHMET II FOUNTAIN.
- 16 MUSEUM OF ANTIQUITIES.
- 17 MEDRESE.

Figure 15 Archaeological park (Türel, 2014)

Today, the Hagia Irene is situated in an “archaeological park” (figure 15), an excavated area is left as it is in order to reveal the ancient features of the city, to preserve and present them to the public. (Ahunbay, 2012). Henri Prost, a French architect and urban planner, created this park because of the historic importance of the area, which includes two layers of architecture from different time periods. The first layer is the Byzantine layer (figure 16 illustrates this original situation and figure 17 illustrates the current situation), which includes the Hagia Irene. It lies six to eight meters below ground level, and is still partly buried under the sand layer that was placed over it during the Ottoman period. The second layer is the Ottoman layer, which is also the current ground level. An analysis has been made (Figure 18) to identify these two layers.

The historical richness of Hagia Irene's surroundings (figure 15) attract many tourists. In addition to museums that are surround the Hagia Irene, the church itself is located in the courtyard of one of the most visited sights: the Topkapi Palace. South of the Hagia Irene, there is the Karakol Restaurant, built on the ruins of the Sampson hospital. There are also two doors in the defence wall of the Topkapi alace that previously connected this part of the courtyard with the Soguk Cesme street (a quiet street seldom frequented by tourists) and the former mansions along the other side of the wall. These wooden former mansions have been transformed into hotels, restaurants and a library. The wall of the Topkapi Palace has towers between the walls where some of the doors are still visible between the former mansions. It is not clear if there is still a possibility to enter the terrain of the Topkapi Palace through the old doors. Towards Alemdar street, there is a restaurant placed in a former cistern called Sarnic Restaurant. There are also several small cafés and shops.

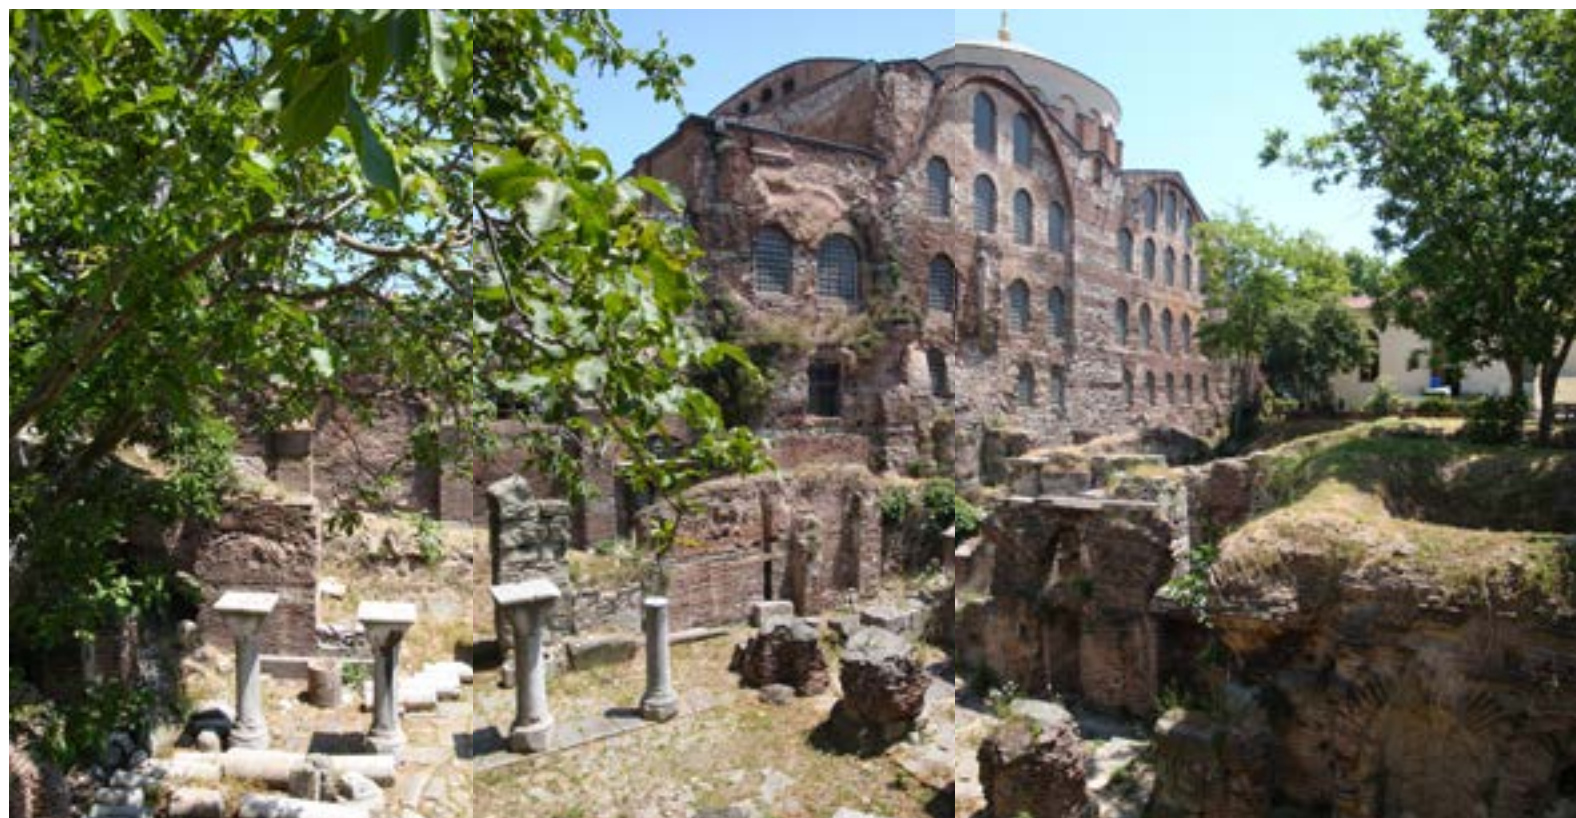
Figure 17 The current situation of the Byzantine layer on the south of the Hagia Irene (photo taken by author)

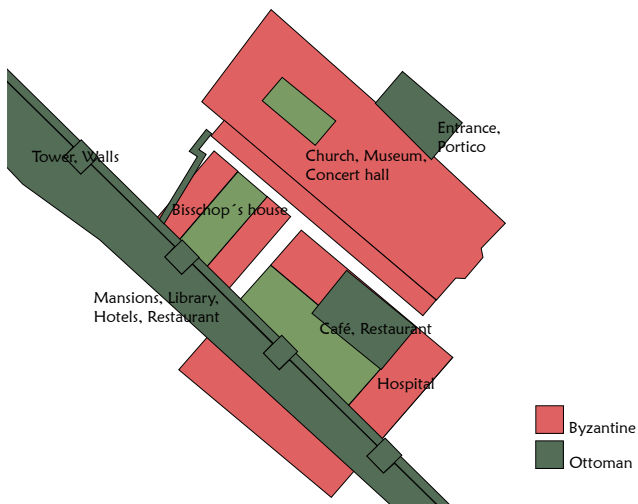
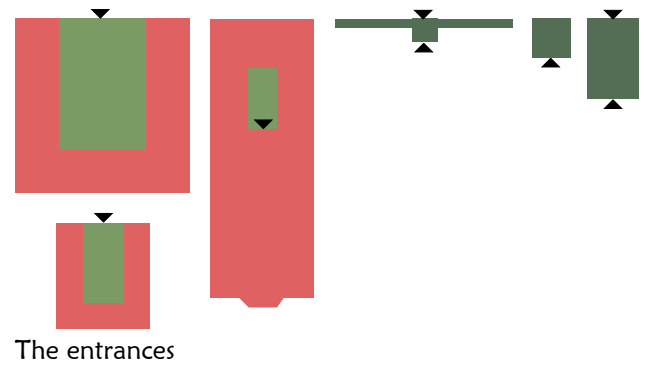
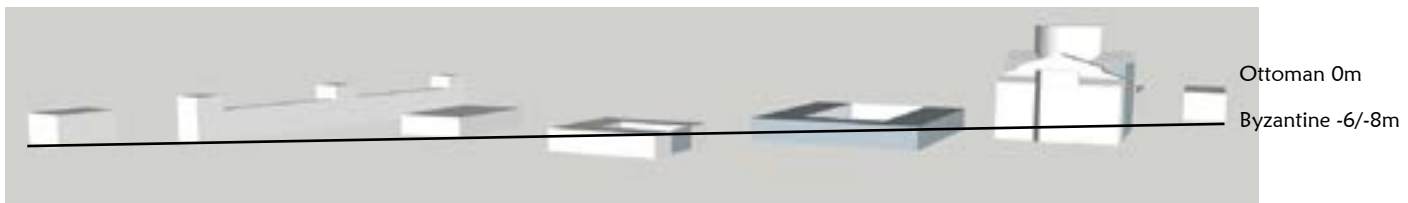
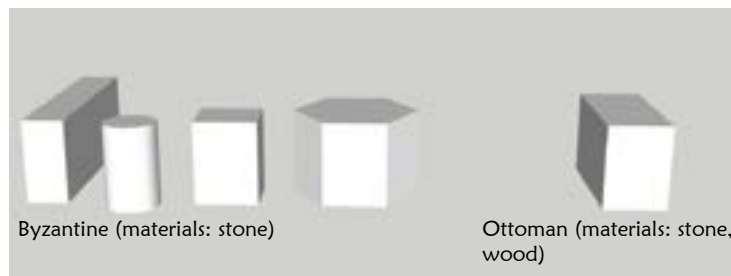
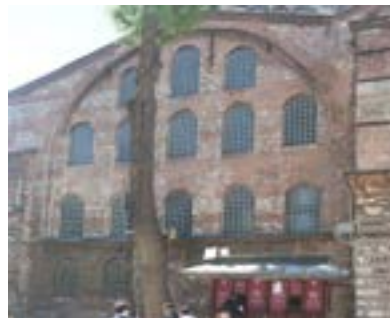
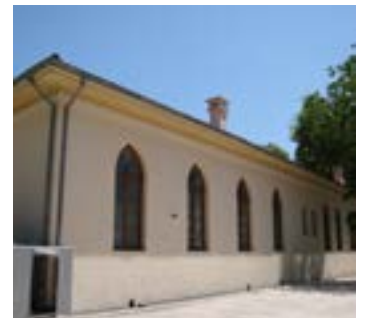
The buildings and their ground level

Byzantine; thick walls, bows, columns, dome

Ottoman; thick walls

Figure 18 Analysis of the location (photo's and illustrations by author)

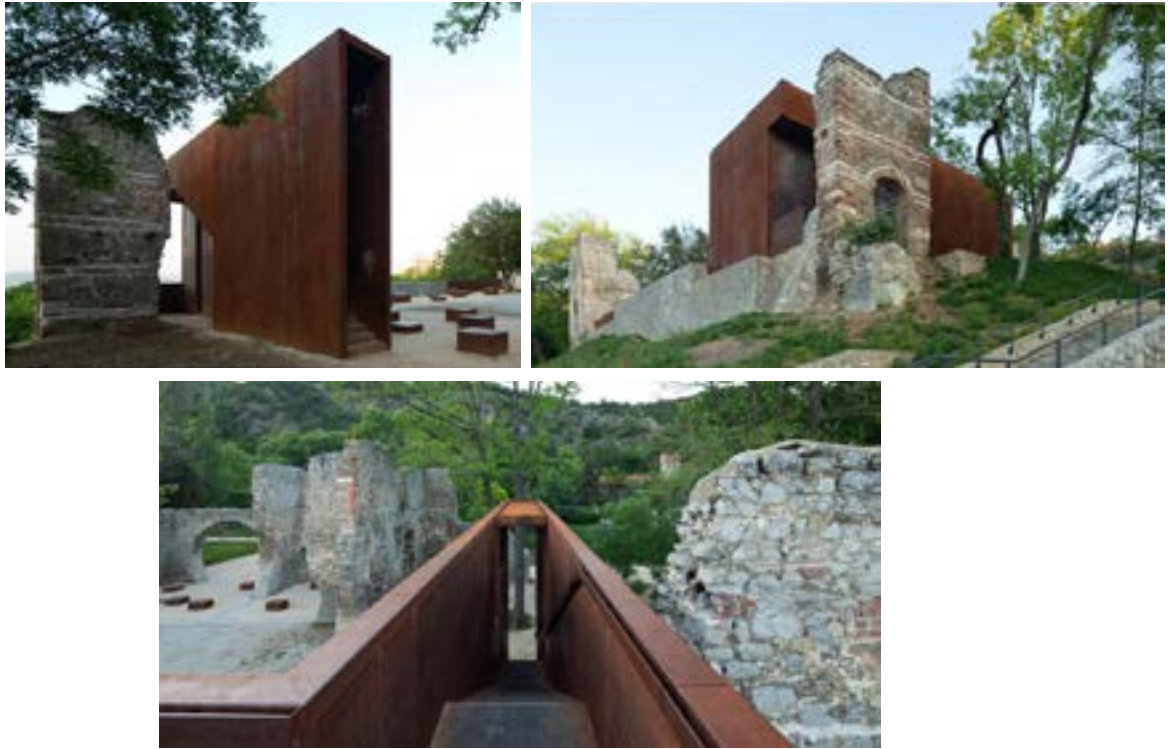
Figure 21 The Szathmáry Palace (Steph, 2012)

The new design for this summer theatre stabilizes and strengthens the old part of the building, repairs the floor levels, attaches and fills the eroded parts, and refers to the past. (divisare, 2012) The addition of a staircase also provides a view on the surrounding natural landscape (figure 20). Corten steel elements are added to form a stage for the theatre, and boxes are placed around it to provide sitting places from which to view the surroundings and watch the play.

MARP, the design team, state that this L-shaped steel staircase structure is not meant to be a formal reconstruction. The architects did not intend to 'complete' the ruin with this design. Therefore it does not directly imitate the original ruin. Instead, they wanted to create a mass in the place of the former wall corner, strengthening the ruin's character by creating a contrast between the new and the old. The stair case, together with the theatre's support spaces, are contained within a deep wall that bends to form a corner, enclosing a "room" that was once part of the palace. (divisare, 2012)

The addition also refers to the past by accentuating the borders of the former walls. However, doesn't strictly follow or contrast the old grid of the building, but does something in between. The division of the floorplan derives from the former use and refers to it by different materials and colours. For instance, the original floorplan is marked with the wall placement. Referring to the past is also done by written inscriptions on the new structure and openings in the new construction through which the old construction can be seen. Light is also used to accentuate the site's characteristics. In this way, the new addition contrasts with the old structure, while at the same time bringing attention to it.

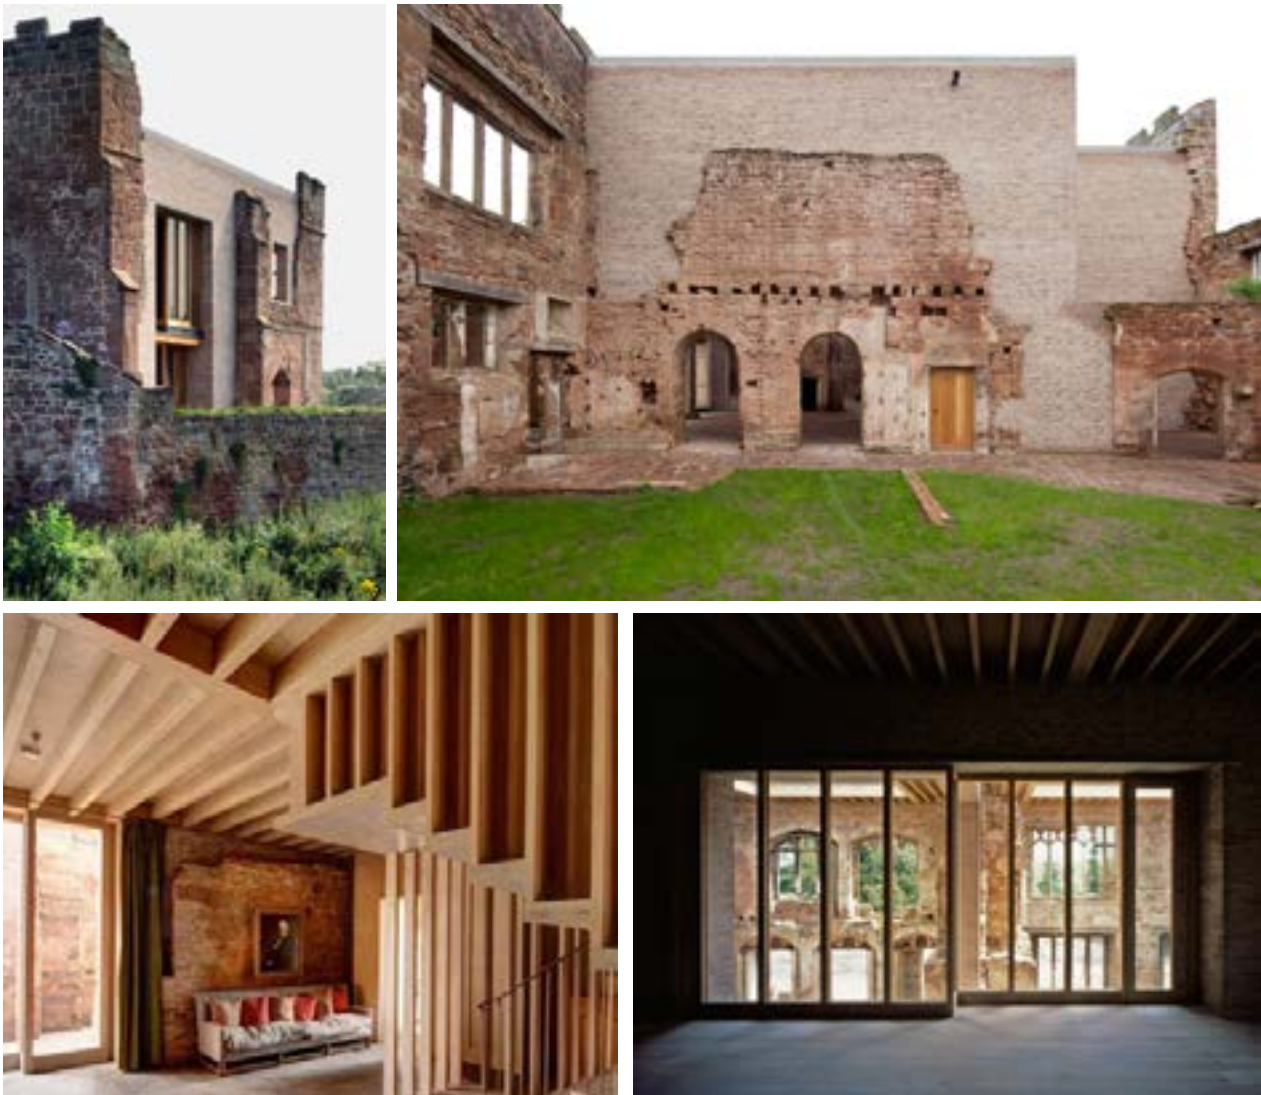
Figure 22 Astley Castle (Minoli, 2013; Steph, 2012)

Witherford Watson Mann Architects' strategy for intervening in the ruined castle strikes a balance between making the building suitable to live in, and preserving its experience as a ruin. This balance was achieved by adding a new addition of concrete, steel and brick construction that acts as a stabilizing element for the ruin (Harris, 2013). Thin bricks fuse with the ruin's jagged edges, and fill

certain gaps, making the ruin solid again (Townsend, 2013). This new addition effectively frames the old ruin, bringing attention to it. It does so by using the original brick material, but in a brighter colour, bringing attention to the old, worn stones. The formal simplicity of the addition also contrasts with the ruin.

In addition to framing the ruins, the intervention gives importance to the experience of the surrounding landscape by placing the bedrooms on the ground floor and the living and dining spaces upstairs, where the extensive view can be enjoyed through large, modern window frames (Harris, 2013). As well, two open courtyards are left as a ruin, with added structure that provides stability. (Townsend, 2013).
