## Fragility curves for light damage of clay masonry walls subjected to seismic vibrations

Korswagen, Paul A.; Longo, Michele; Rots, Jan G.

Bulletin of Earthquake Engineering

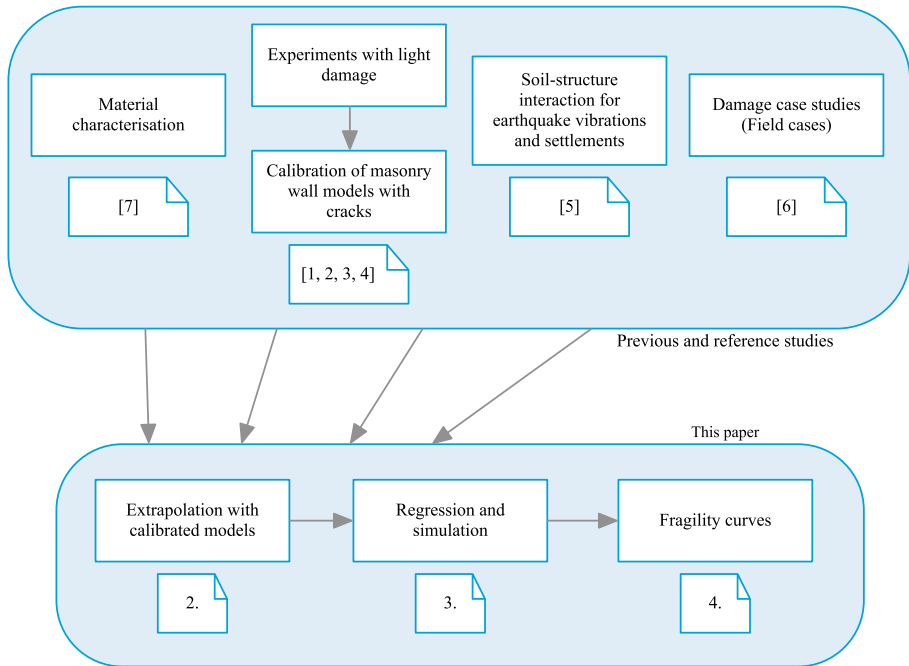
**Fig. 1** Earlier studies, with references ([1 to 4] Korswaghen et al. 2019a, b, 2020a, b; [5] Longo et al. 2020; [6] Staaldunin et al. 2018; [7] Jafari et al. 2017), and the flow chart of this paper, indicating chapters (2. to 4.)

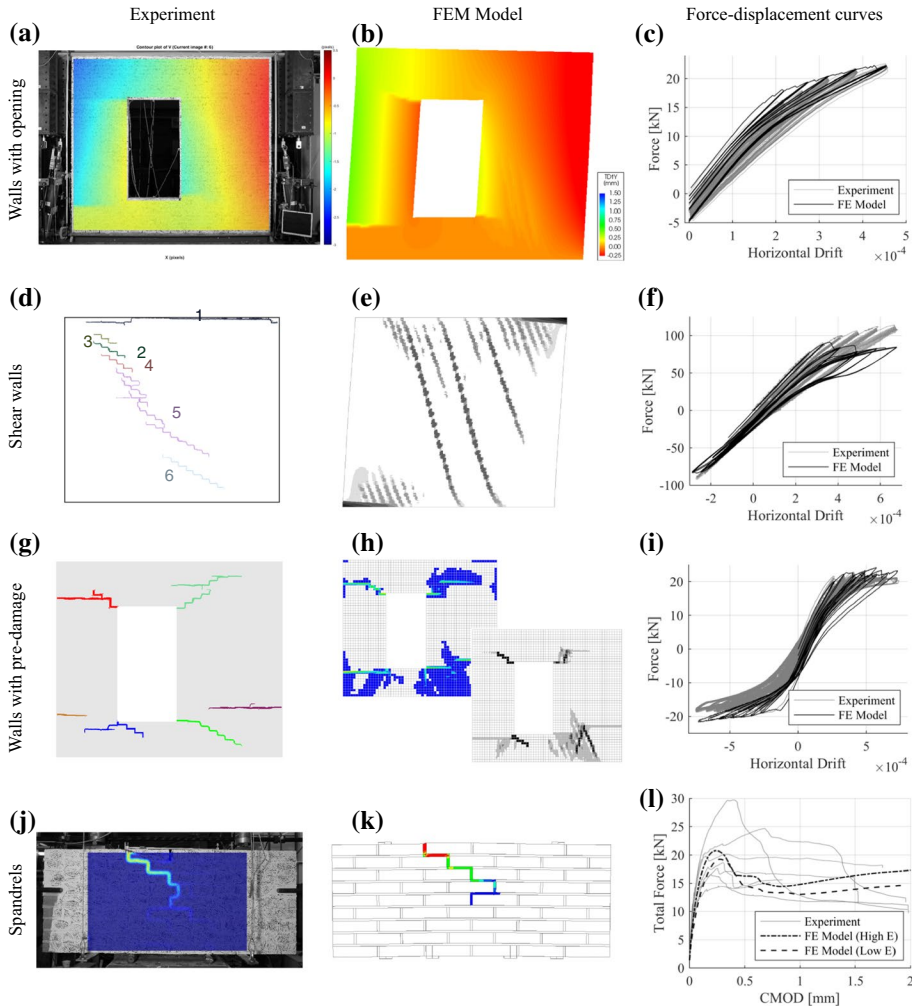
**Fig. 2** Graphic overview of experimental tests (left column), comparable crack patterns in finite element models (middle column) and comparison between experimental and computational force-displacement curves (right column). **a** Vertical displacement field captured with DIC from a laboratory wall with a window. **b** FEM model of the same wall. **c** Comparison of the force-displacement curve between the experimental (**a**) and the model wall (**b**). **d** Automatic crack identification from the DIC data for a laboratory wall without a window. **e** Crack strain plot of a FE model of the same windowless wall. **f** force displacement curve of (**d**) and (**e**). **g** Crack locations for a wall with pre-damage. **h** FE model of such a wall, for tensile (left) and shear cracking (right). **i** Force-displacement graph for (**g**) and (**h**). **j** Spandrel-type wallet (window bank) surveyed with DIC displaying crack strains. **k** FEM micro-model of said wallet. **l** Force-displacement graph of the wallet for several experiments with monotonic loading (**j**) and two FEM models differing in the Young's modulus of the masonry material (**k**)

displacement fields and crack patterns and the middle column shows the equivalent view from a calibration FE model; the right column compares the force–displacement curve between experiment and model. Similarly, the first row depicts one of the tests on a virgin wall with an opening, while the second row outlines the case of a windowless wall. In both cases the loading protocol, inferred from the graphs, is asymmetric, consisting of a one-way cyclic displacement and a two-way cyclic portion with larger positive amplitude, respectively; and accordingly, the crack patterns displayed are not symmetric. The resolution of the imaging and processing systems for the laboratory cracks produced clear cracks, and the smeared models presented sufficient crack-localisation that the experimental patterns could be recognised; the crack locations, and their properties such as crack width, length and overall damage measured by  $\Psi$  (Korswagen et al. 2019a; Korswagen and Rots 2020b), contribute to the calibration process. The following two rows showcase the experiments with walls with two pre-cracked mortar joints and the wallets or spandrels; for the former, the full two-way cyclic loading protocol is presented, while for the latter, some of the monotonic tests are compared to two model possibilities. The figure presents, at a glance, the various calibration campaigns undergone.

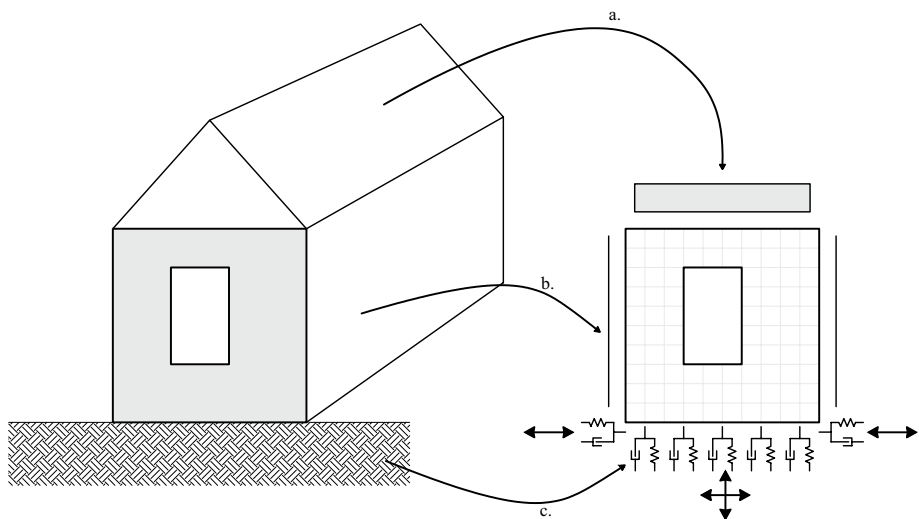
**Fig. 3** Schematisation of the model (right) with the representation of some of the model's features: **a** top weight and dynamic mass, **b** lateral constraints, and **c** soil-structure interaction

The above models, that were calibrated and validated against the laboratory tests, are subsequently extended into the nonlinear time-history domain so as to assess the effect of seismic vibrations and replace the laboratory boundaries with the constraints provided to a masonry wall by a real structure; in this light, these models become extrapolations from the validated laboratory scenario to real field cases while maintaining the geometry of the wall. The adaptations applied to the models are presented in Fig. 3 and are listed below:

- *Overburden* a vertical pre-compression of 0.12 MPa is applied at the top edge after the self-weight gravity load. This stress corresponds to the weight of one concrete floor or two timber storeys.

- *Top boundary* no steel beam is used at the top of the wall as in the laboratory; instead, a stiffness-free line mass element is incorporated to mimic the dynamic effect of a floor. The mass is set at 10 ton to simulate the presence of a fictitious rigid floor, an upper masonry wall, an upper floor and a roof. While the wall doesn't carry the vertical weight of these components, their mass does affect the horizontal in-plane behaviour of the wall; as such, the line mass does not influence the static condition. The mass is also used to calibrate the natural periods of the walls to match those of low-rise masonry buildings from which the walls are extracted. The flexible wall has a fundamental natural frequency of about 9 Hz and the stiff wall of about 13 Hz; depending on material, soil, and initial masonry condition, these periods can vary by up to  $\pm 2$  Hz.

- *Rayleigh damping* a 2% damping based on the first two modes, as judged by order of participating mass, is included in the model.
- *Soil-structure interaction* the bottom steel beam used during the calibration phase is replaced with a combination of springs and dashpots. These are placed underneath the wall in order to simulate the effect of the soil on the structure. Stiffness and damping are provided by two separate interface elements: (a) A non linear 2D line boundary interface (CL6TM-NL), which accounts for the stiffness and for the soil's behaviour, is characterised with a Coulomb friction law. The cohesion is set to 0.1 MPa while the friction and dilatancy angles to 0.61 rad. Additionally, a no-tension criterion is enforced for the springs representing the fact that no tension can develop between soil and foundation. (b) A similar, yet linear-elastic interface (CL6TM-LE), which includes the damping coefficients and offers no stiffness, is also included.

- *Input motion* the load introduced as an in-plane, quasi-static displacement at the top of the wall in the experiment is replaced by horizontal and vertical accelerations applied at the base of the wall. This extrapolation is twofold: first, the accelerations become inertia loads, focused at the top but also distributed throughout the wall, this modifies the validated behaviour slightly; and second, the appearance of cracks could be different when tested dynamically, however, the damage behaviour with dynamic tests has not yet been studied; hence, this becomes a reservation in the present study. Nevertheless, the assumption of transitory or transient damage as the residual damage is conservative (Korswagen and Rots 2020b).

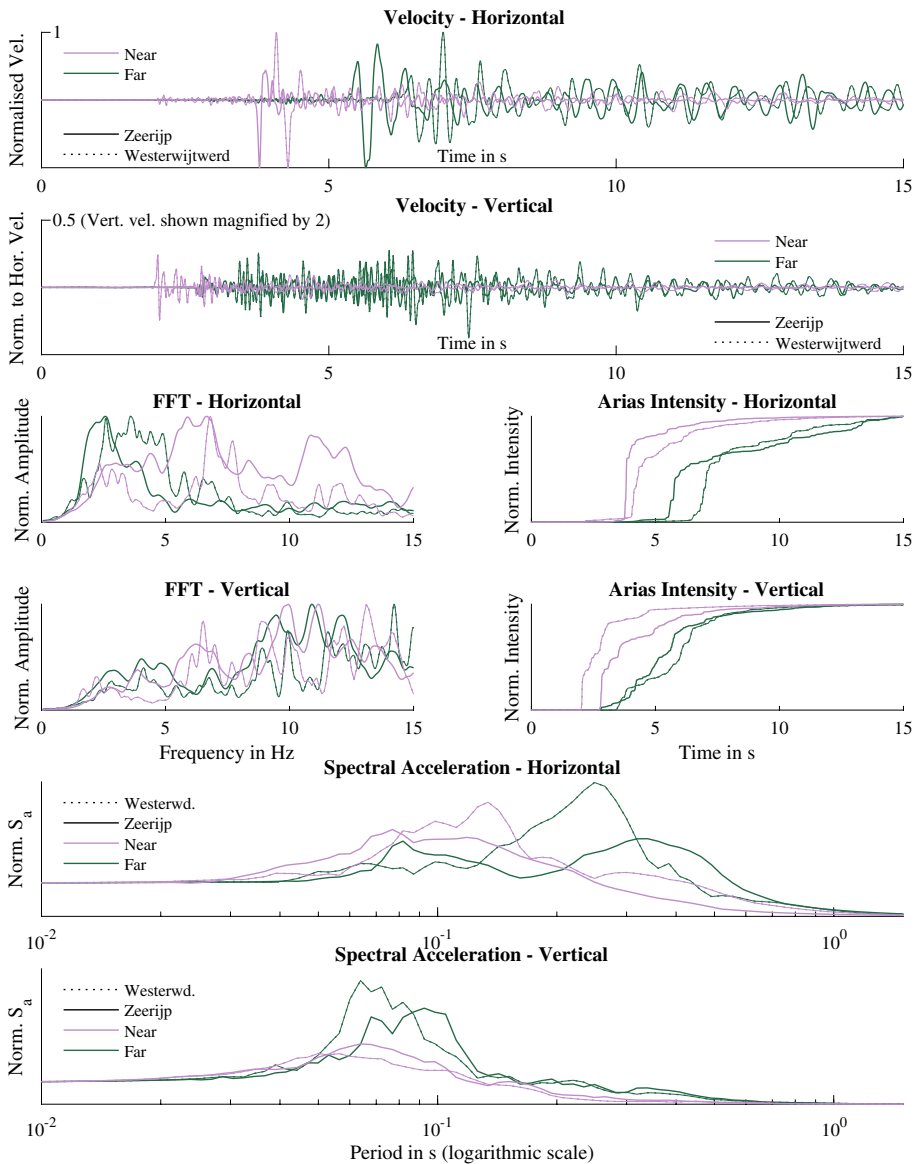
**Fig. 4** Comparison between records of the Zeerijp and Westerwijtwerd earthquakes. For each event two time-series have been selected: recorded at relatively near and far stations; see Table 5. Records are normalised to the horizontal peak ground velocity for comparison purposes

Garsthuizen and Appingedam, located 2.5 km and 7.5 km from the epicentre, respectively (Bezemer and Elk 2018; KNMI 2020), and two to the earthquake of Westerwijtwerd of May 22nd, 2019 ( $M = 3.4$ ) recorded at the Stedum (3.2 km) and Hoeksmeer (9.7 km) stations. These natural motions are depicted in Fig. 4 and are categorised as ‘near’ and ‘far’ with the amplitude of the motions normalised to 1. This grouping, based on the distance of the station to the epicentre, also corresponds to similar properties between records even if they belong to different earthquakes and are measured at different stations. In fact, Fig. 4 shows that the horizontal component of the seismic motion arrives noticeably earlier at the near locations and contains a fewer number of effective cycles, while the far records display a larger number of cycles of similar amplitude. This is also reflected with a Fast-Fourier Transform analysis which reveals that the horizontal components of the far records are heavily loaded with low vibration frequencies in the order of 2 to 4 Hz, while for the vertical components the frequency content is more alike between the records. The Arias plots also show how the energy of the near records is focused in a small part of the record, while the far records spread their energy over a longer significant duration. In comparison to their horizontal components, the far vertical records exhibit a PGV amplitude of about one third of its horizontal component, while the near vertical records present a PGV amplitude of about one fifth of its horizontal component. Finally, in terms of spectral amplification, the horizontal components of the records reach similar amplification but the far records are active over a much longer interval of structural periods. In comparison, the vertical components, especially of the far records, display a higher dynamic amplification but are limited to periods close to 0.1 seconds. These variations are present when comparing both earthquake types as long as both are scaled to the same value of peak ground velocity. Note that the variations in the records, and in particular the spectral response, do not only originate from their distinct epicentral distances, but are also the result of the different site conditions, such as the local soil characteristics, the composition of the soil between epicentre

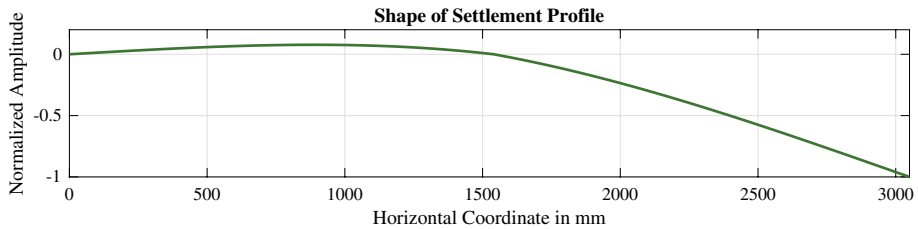
**Fig. 5** Normalised profile of the settlement displacement applied to the base of extrapolation models with pre-damage

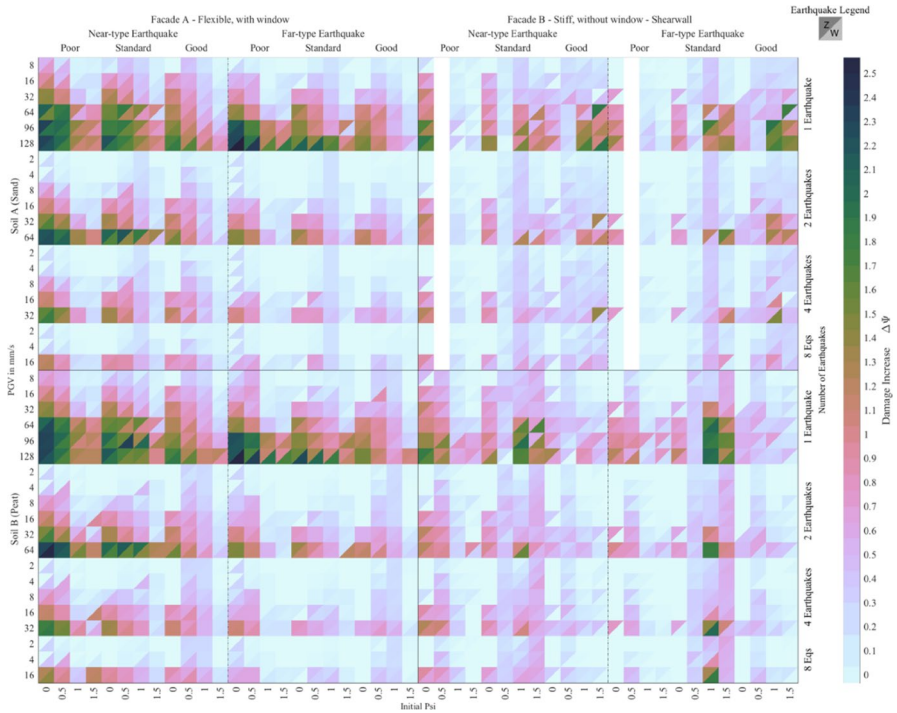
**Fig. 6** Overview of results from the modelled scenarios for the four records of the earthquakes of Zeerijp and Westerwijrtwerd measured and expressed as the increase in damage,  $\Delta\Psi$ . The darker triangles correspond to the larger increases in damage in respect to the initial damage ( $\Psi_0$ )

First, the wall type or façade type revealed that the flexible wall (A) showed a higher increment of damage ( $\Delta\Psi$ ) in respect to façade B, consistently, at least for the near-type earthquake records. An example is provided in Fig. 7a in which two damage patterns of different façades are presented. The window opening of façade A contributes to an easier initiation of cracks due to stress concentration at the window corners. The

lateral constraints and top mass enhance the damage to the lateral side and above the window opening respectively. Façade B presents minor shear cracking at the mid-left of the model and some smeared cracking to the lateral side. Horizontal cracks at the bottom are also visible. For the case represented in Fig. 7a, when the two façades are placed on soil A, having weak material, no pre-damage, and subjected to a single, near Zeerijp event of 32 mm/s, façade A experiences 25% more damage than façade B. In other words, for most of the cases, the wall with the window appears more vulnerable to damage than the rigid wall. It should be noted that these results display the maximum of crack strain in all Gauss points that occurred over the entire NLTH analysis. This explains the rather wide zones or ‘clouds’ of smeared cracks. At certain discrete times, the crack strain plots show a more localised pattern as some Gauss points soften while others unload. As an alternative, discrete crack/slip micro-models in predefined interface elements were used to study these localisations (Korswagen et al. 2020b); yet, these more detailed models are severely more computationally expensive and did not lead to significantly better calibration results; hence, they were not considered for this large number of analyses.

The trends observed in the multitude of analyses run to produce Fig. 6 can be captured in a regression model that incorporates the effect of every parameter varied and the relationship between the most relevant of these parameters. To avoid a ‘black box’ effect where an arbitrary model is fit precisely to the existing data points but may produce unexpected results outside of the domain of the data, a ‘reasoned model’ is employed where the relationship between the input parameters and damage can be understood. First, clear trends are gathered in the following order:

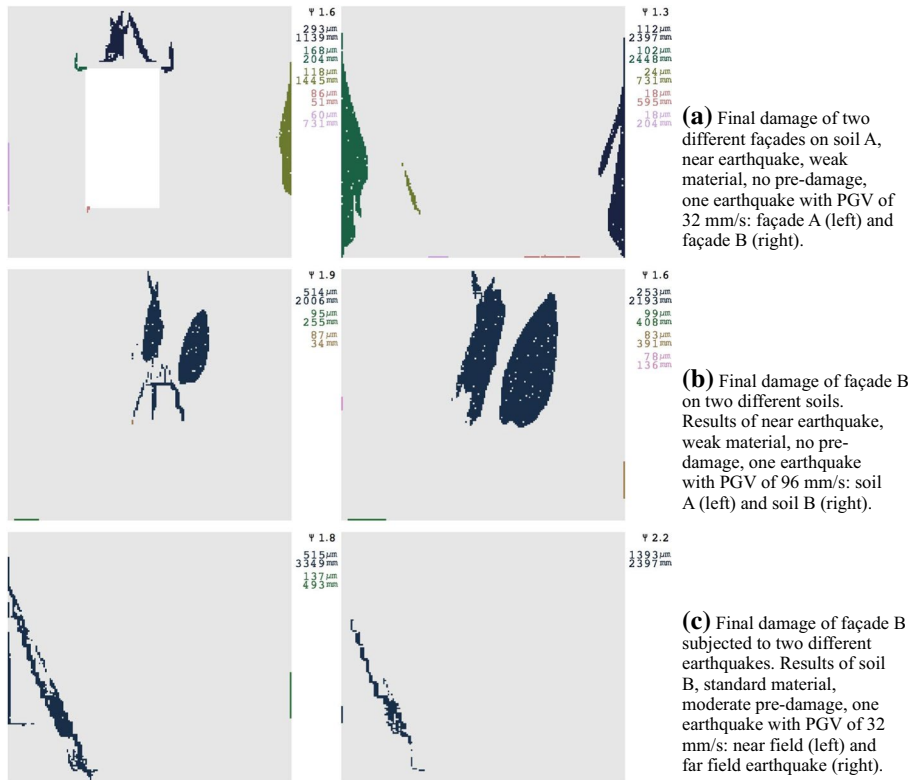
**Fig. 7** Hand-picked examples for comparison of the effect of the three binary variables: flexible or rigid wall type (top row), good or poor soil type (middle row), and near or far earthquake type, both for the Zeerijp event (bottom row)

higher stresses and damage in the walls. Figure 7b shows the virgin, rigid wall with weak material and subjected to a single, near earthquake (ZN) of 96 mm/s as PGV, analysed with two different soils. A similar crack pattern is detected for the two models, which depict diagonal shear cracking at the middle of the wall. Cracks in models with soil A appear more concentrated and wider than the smeared shear cracking of the one on the weaker soil B. In this case the difference in damage at the end of the protocol reaches about 20%.

For the earthquake type, near or far from the epicentre using the two records of the Zeerijp event, Fig. 7c presents the effect on façade B on soil B with standard material and moderate pre-damage. Both earthquake types are scaled to a PGV of 32 mm/s and a single motion is run. The results show a different crack propagation; while for the near-field motion the existing crack pattern grows mainly in length with some additional parallel lateral cracks, the far motion depicts mainly an increase in width without affecting much its length. This behaviour is frequently seen in façade B when the far record often produces higher damage. On the other hand, the flexible façade (A) appears more sensitive to the near motion. This observation is likely related to the different frequencies present in the two signals which interact in distinct manners with the two types of walls.

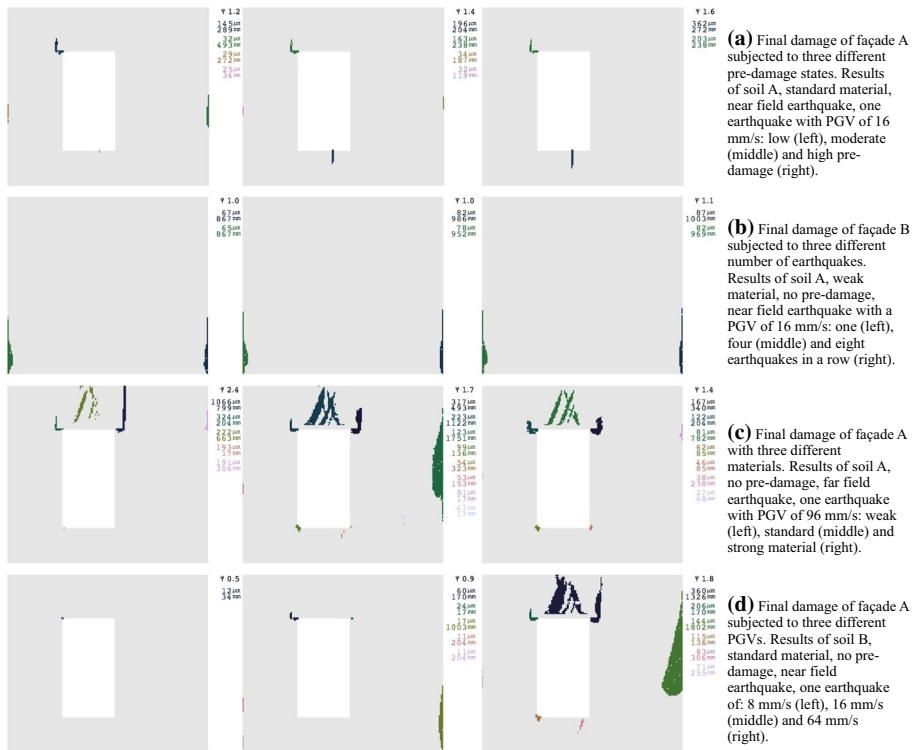
**Fig. 8** Hand-picked examples for comparison of the effect of the four continuous variables: initial condition (top row), event repetition (second row), material strength (third row), and earthquake intensity in PGV (bottom row)

Next, Fig. 8a. depicts the effect of different pre-damage situations on the final damage condition at the end of one motion; only the cases subjected to settlement are shown in the

graph. The analyses concern façade A with standard material on soil A and subjected to one near earthquake (ZN) of 16 mm/s. The pre-damage values ( $\Psi_0$ ) are about 0.5, 1.0 and 1.5 respectively for low, moderate and high pre-damage cases. As can be seen, increasing the damage at the initial condition, produces higher final damage. The detected values are 1.2, 1.4 and 1.6  $\Psi$  with increasing level of pre-damage. The model of the same category without initial settlement loading, generates a final damage of 0.8  $\Psi$ . It must be noted that, the increment of damage  $\Delta\Psi$  diminishes when a higher pre-damage is adopted. In fact, considering the initial state, the difference between final and initial damage ( $\Delta\Psi$ ) is equal to 0.8, 0.7, 0.4, and 0.1  $\Psi$ , respectively for no, low, moderate and high pre-damage. This observation can be generalised for many other cases.

Regarding the quantity or number of earthquake records, the cumulation of damage gained from multiple earthquakes in a row is summarised in Fig. 8b. The presented façade B on soil A with weak material and no pre-damage is subjected to three different number (repetitions) of near-type earthquakes (ZN), all with PGV of 16 mm/s; one, four and eight motions are applied. As expected, a higher number of earthquakes leads to a higher value of final damage. After each earthquake motion, the cracks increase in width and in length. The increase is minor, about 2 to 5%, but consistent throughout the entire table of results; lower PGVs are also associated with a smaller increment rate.

Similarly, the variation in material presents a congruous observation: the weaker masonry material leads to a more flexible model, but also to lower values of resistance to tensile and shear failure, consequently, a larger increment of damage can be observed when the material properties are weak. An example of this trend is shown in Fig. 8c where the flexible façade A is subjected to a 96 mm/s far-field earthquake (ZF). The model is placed on soil A and has no pre-damage, and the results at the end of the motion of the three different material configurations are shown in the figure. The façade with weak material develops two cracks at the top window corners, together with damage in the top spandrel. The two stronger material variations depict additional tiny cracks located at the other window corners and a more distributed damage to spandrel and lateral sides; nevertheless, the width of these cracks and their length result in a final damage value lower than that of the case with the weak material.

Finally, varying the intensity of the earthquake motion, where the intensity is given by the scaled value of peak ground velocity, offers the expected relationship that, at higher intensity, the increase in damage is also higher. The effect of different PGVs on façade A is shown as an example in Fig. 8d; the model is placed on soil B, with standard material and virgin initial condition. The wall is subjected to one earthquake of the near type (ZN) and three PGVs are selected: 8, 16 and 64 mm/s. The final damage is remarkably different between the three models with an almost 100% increase between them. This underlines the large effect of this parameter on the results.

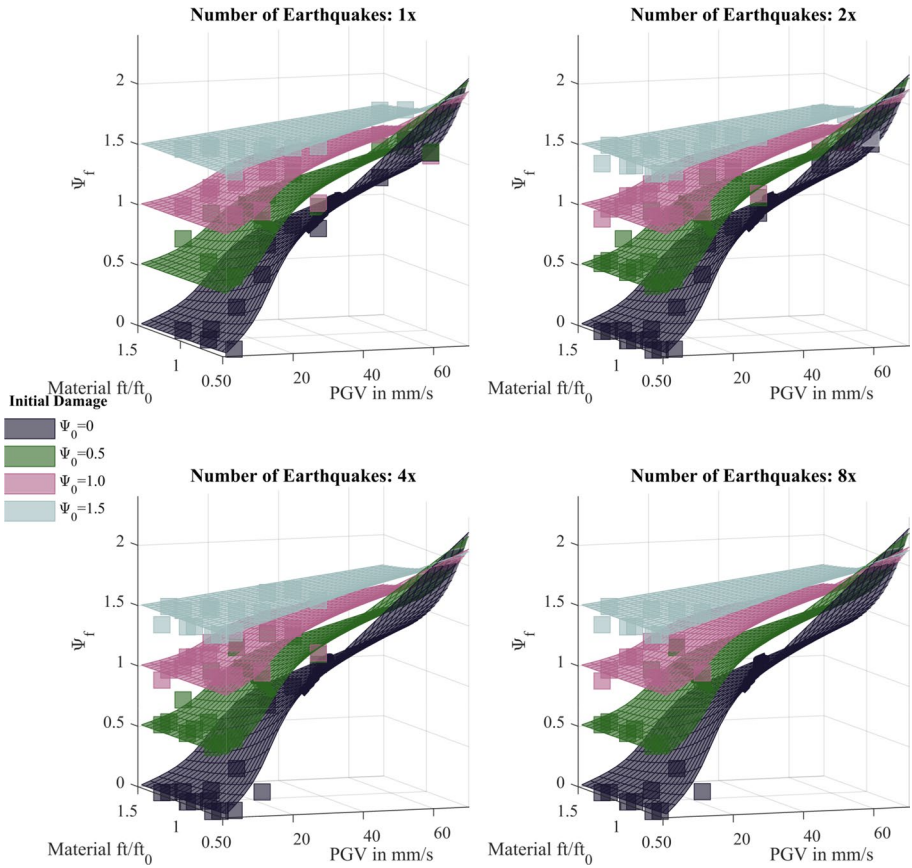
**Fig. 9** Example of the model shape and fit to the data points (squares) for the combination of soil A, façade A and far record of the Zeerijp event

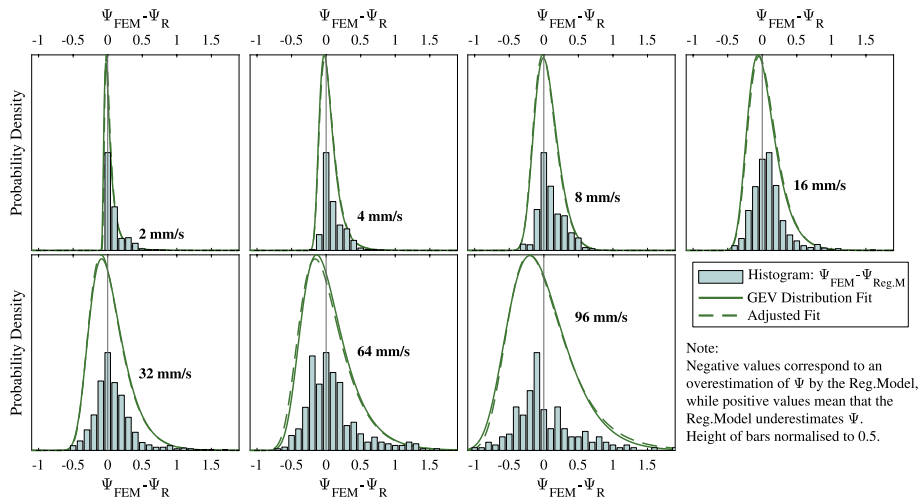
**Fig. 10** Residuals to the fit of the regression model segregated by PGV and Generalised Extreme Value (GEV) distribution fit for the uncertainty parameter

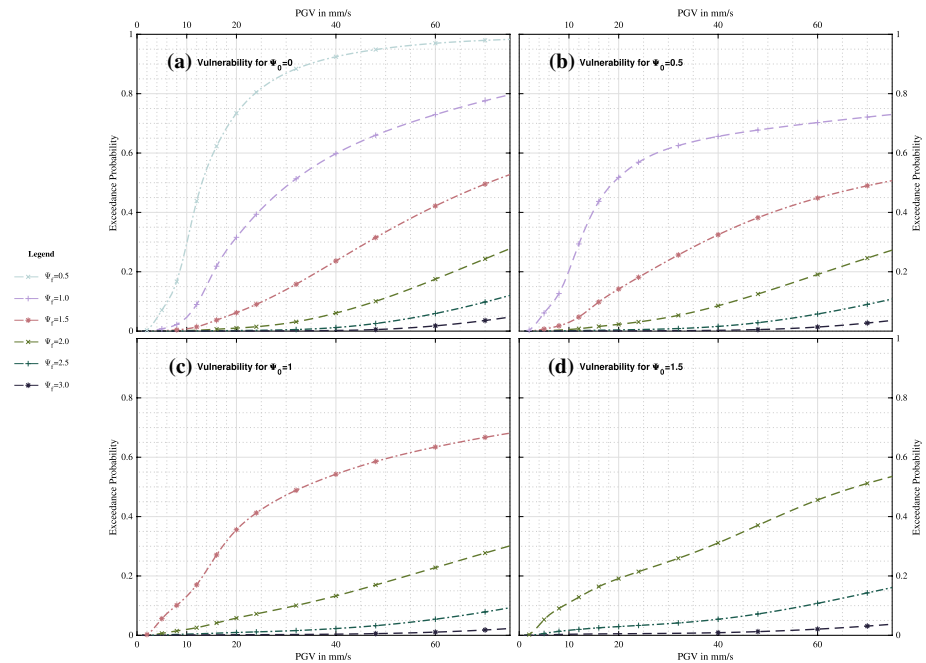
**Fig. 12** Vulnerability or fragility curves obtained from the MonteCarlo simulation for four different values of initial condition ( $\Psi_0$ ): **a**  $\Psi_0 = 0$ , no initial damage; **b**  $\Psi_0 = 0.5$ , damage invisible to the naked eye; **c**  $\Psi_0 = 1.0$ , barely visible damage with cracks around 0.1 mm in width; and **d**  $\Psi_0 = 1.5$ , clearly visible initial damage with cracks approximately 0.4 mm wide

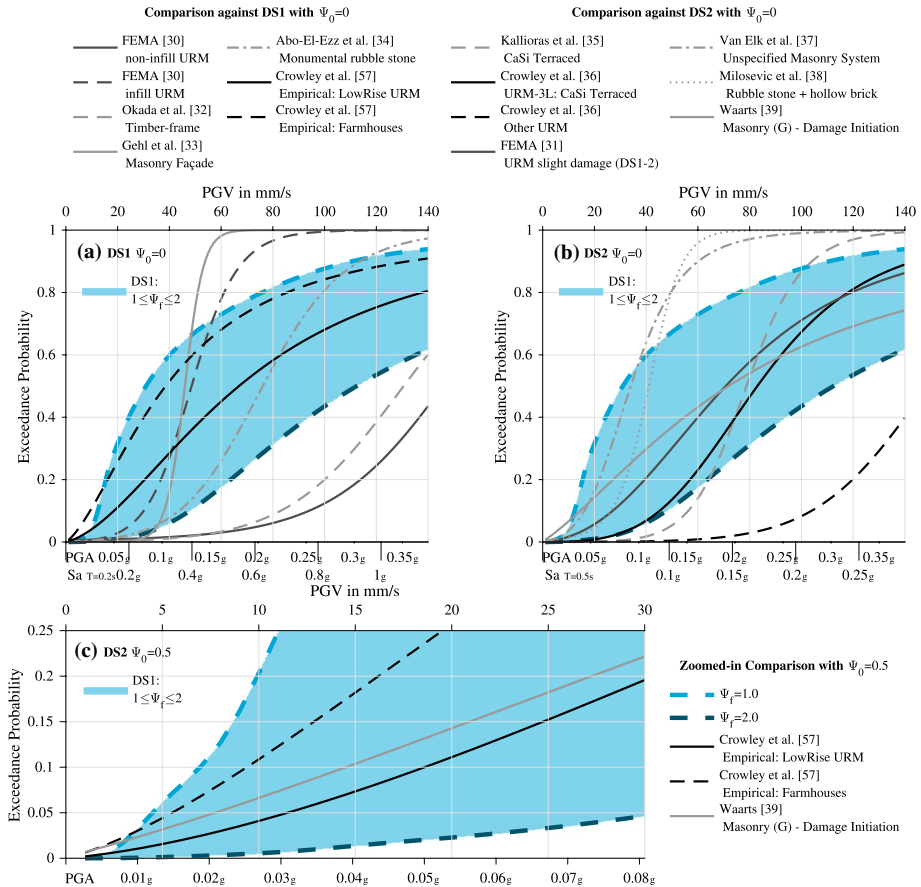
**Fig. 13** Comparison against other authors for  $\Psi_0=0$  and DS1 and DS2 (a, b), and (c) zoomed-in comparison of the fragility curves for imperceptible initial damage ( $\Psi_0=0.5$ ) against select curves for DS1 from literature

Additional literature for DS2, which should correspond to the end of DS1 given herein, is compared in Fig. 13b. These comparisons are relevant since a larger portion of the set also evaluates Groningen masonry. First, Kallioras et al. (2018) based their results on dynamic, large-scale tests representing calcium-silicate masonry terraced houses. Here, two differences are noted: firstly, this treats terraced houses which usually have a weak

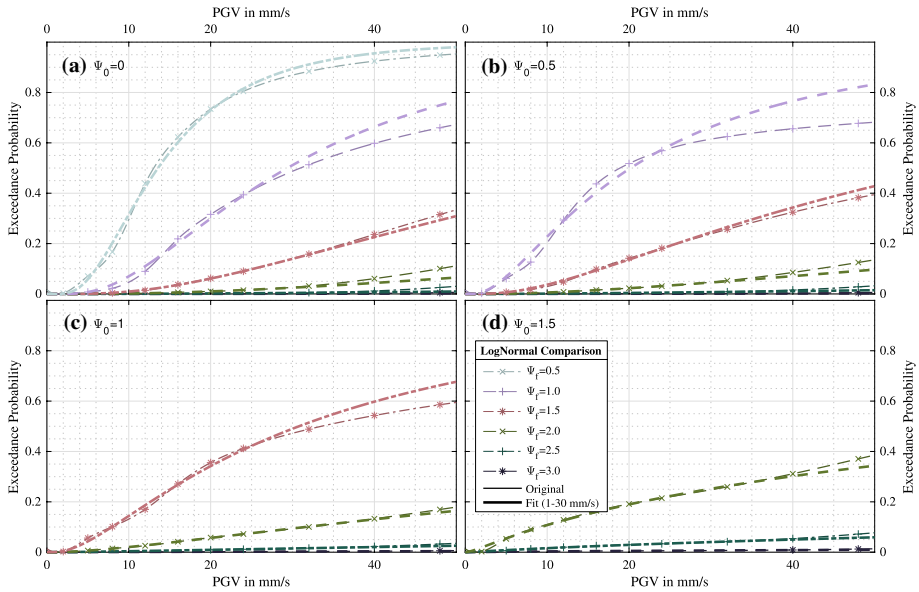
**Fig. 14** LogNormal fit to the fragility curves developed. The fit is enforced only for PGV < 30 mm/s
