The Balance Between Cultural Historical Values and Sustainable Adaptations in Monumental Canal Houses in Amsterdam

Delft University of Technology
AR2A011 Architectural History Thesis
Hilde Sennema
2023/24 Q3
18-04-2024

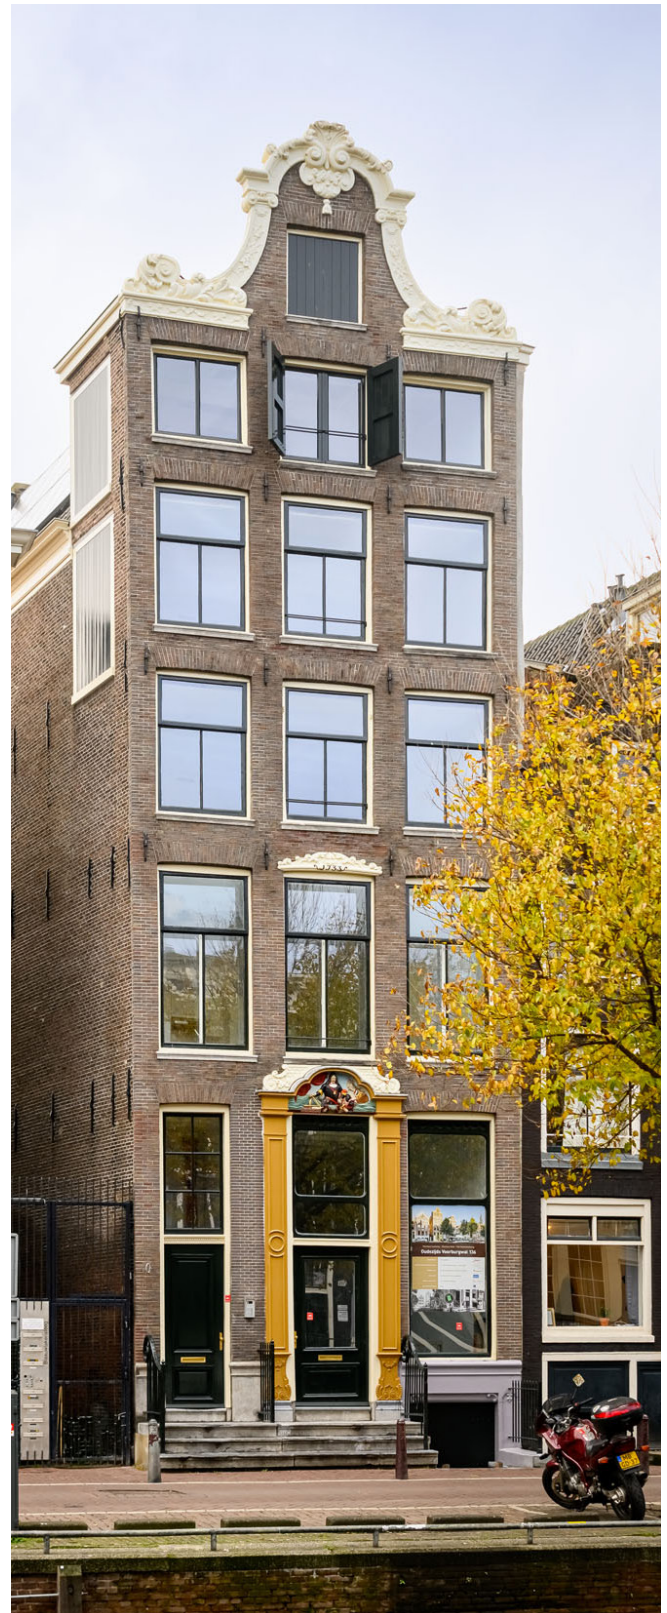
Figure 1: Oudezijds Voorburgwal 136 (Buro van Stigt, 2024)

In 2018, De Groen Grachten initiative commenced its sustainability efforts in this region, with the property located at Oudezijds Voorburgwal 136 (*Figure 1*) being one of its inaugural projects and serving as a model endeavor. Architectural firm Van Stigt, client NV Zeedijk, and De Groene Grachten collaborated to facilitate this sustainability initiative. Understanding the sustainable renovations of Oudezijds Voorburgwal 136, while considering the authentic values of the building, contributes to gaining insight into how sustainable renovation of monumental buildings can be approached.

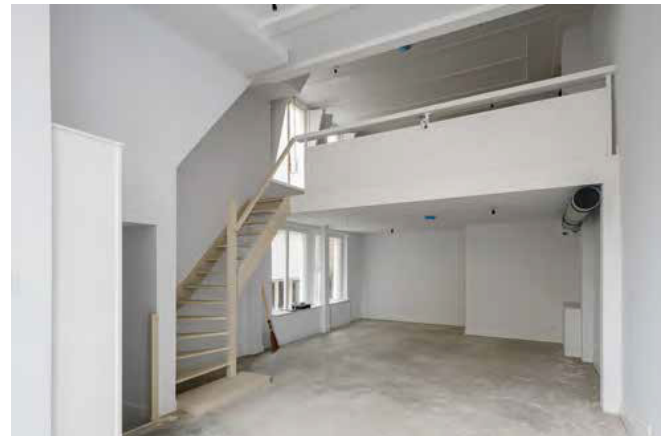
Figure 7: Additional floor was inserted, known as a “hangkamer” or “insteek” (Oudezijds Voorburgwal 136) (Veldt, 2022)

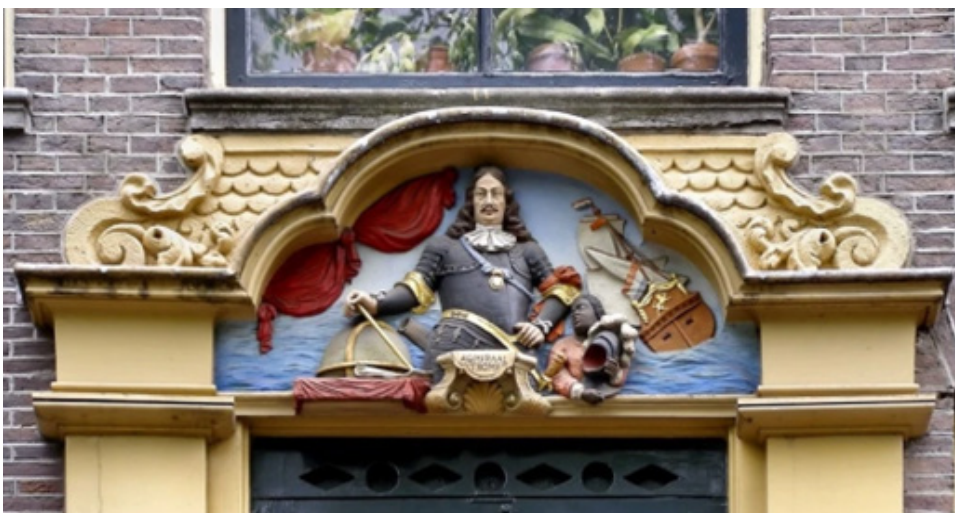
Figure 10: Cornelis Tromp depicted on the facade stone above the central door on Oudezijds Voorburgwal (Onno Boers, 2007).

During the repainting of the building in 1941, the door lintel was restored (Boers, 2007). The Dutch admiral Cornelis Tromp (1629-1671) is painted above the central door on Oudezijds Voorburgwal 136 (Figure 10). During the Golden Age, Tromp had a residence on Oudezijds Voorburgwal in Amsterdam, where he resided during the winter months when not at sea. The ship depicted on the right is "de Gouden Leeuw", the flagship of the Admiralty

of Amsterdam, on which Tromp celebrated triumphs in various naval battles, including the Battle of Kijkduin in 1673. Although the ship appears to be listing heavily, the woodcarver had no choice but to 'translate' the rectangular engraving into the semicircular relief. The African servant boy wearing his master's plumed helmet also appears in a portrait by Jan Mijtens of Margaretha van Raephorst, Tromp's wife (Figure 11). Since both servants are identically dressed, it is plausible that the Tromp couple indeed had a young African boy as a servant, a practice not uncommon at that time.

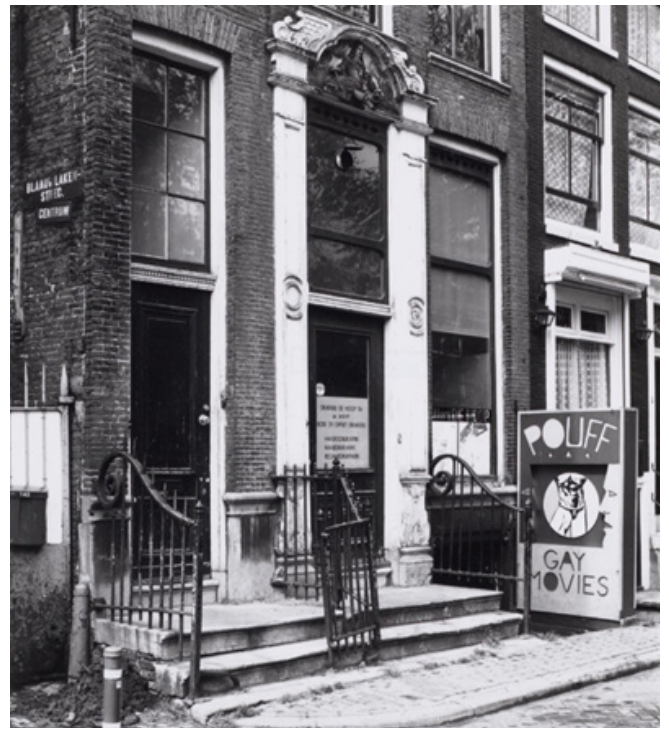
Figure 12: Sexshop in the basement of the building (Stadsarchief Amsterdam, 1983)

In 1954, an application was submitted to the City of Amsterdam (1954) to convert the sou-terrain of the building into a basement. This alteration was achieved through the installation of a poured concrete cellar pit and an elevated ground floor, increasing the clearance height at this location in the building from 175 cm to 190 cm (Figure 13). Consequently, this modification facilitated the establishment of a sex shop in the basement (Figure 12). There were several small video viewing booths for watching pornographic videos and later DVDs.

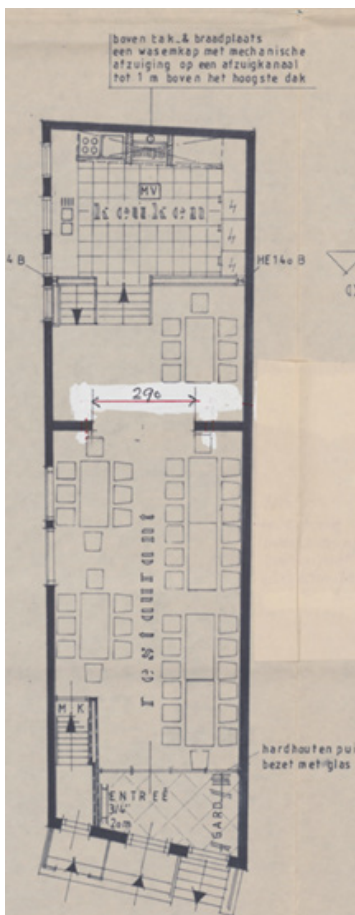
Figure 14: The plan for the restaurant in 1990 (Gemeente Amsterdam, 1990)

In 1990, a request was submitted to the municipality of Amsterdam (1990) to transform the printing press into a restaurant (*Figure 15*). This transformation would involve converting the rear part of the building into a kitchen, while the ground floor would accommodate seating for 40 diners (*Figure 14*). The request to the municipality and the monument conservation authority entailed a change in designation and an application for a ventilation pipe at the rear of the property at Oudezijds Voorburgwal 136 (*Figure 16*). However, objections were raised against the plan at the

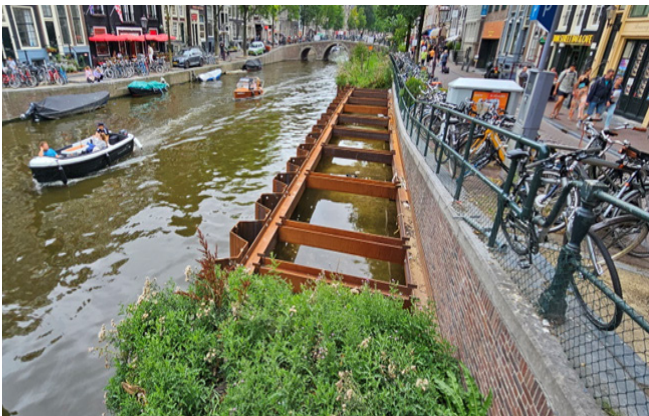
Figuur 19: Reinforcement of the canal wall at the Oudezijds Voorburgwal (Gemeente Amsterdam, 2024)

The canals are an integral part of Amsterdam's authentic cityscape. However, the canal walls are becoming increasingly vulnerable, and along the Oudezijds Voorburgwal, they are already severely weakened and damaged both above and below the waterline. Cracks are visible in the wooden foundation and masonry, and the piles supporting the canal wall are leaning. To ensure the continued safe use of the quay, reinforcement of the canal wall was undertaken (*Figure 19*) (Gemeente Amsterdam, 2024).

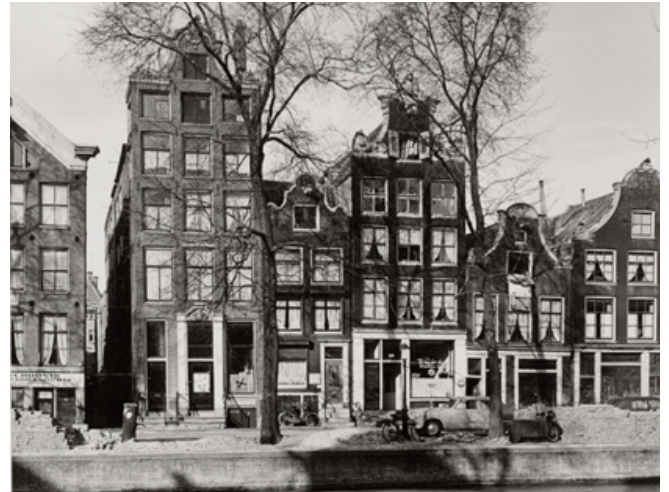
Figure 20: Inclination of the building (Stadsarchief Amsterdam, 1955)

The history of the canal house on Oudezijds Voorburgwal reveals that the building is constructed on wooden piles. This method of foundation has indirectly contributed to the authentic structure of the building, as over the years, the building has gradually tilted. This inclination is clearly visible in *Figure 20* & *21*, particularly noticeable in the alleyway. This effect can be attributed to various factors such as inferior quality, insufficient length, or inadequate thickness of the wooden piles. The aging and quality of these wooden piles

cause the canal buildings in Amsterdam to sink unevenly into the ground, resulting in the house appearing skewed. Another contributing factor to the tilting may be the decay of the wooden poles, which occurs when the water level is lowered by the Waterschap agency, exposing the poles to oxygen.

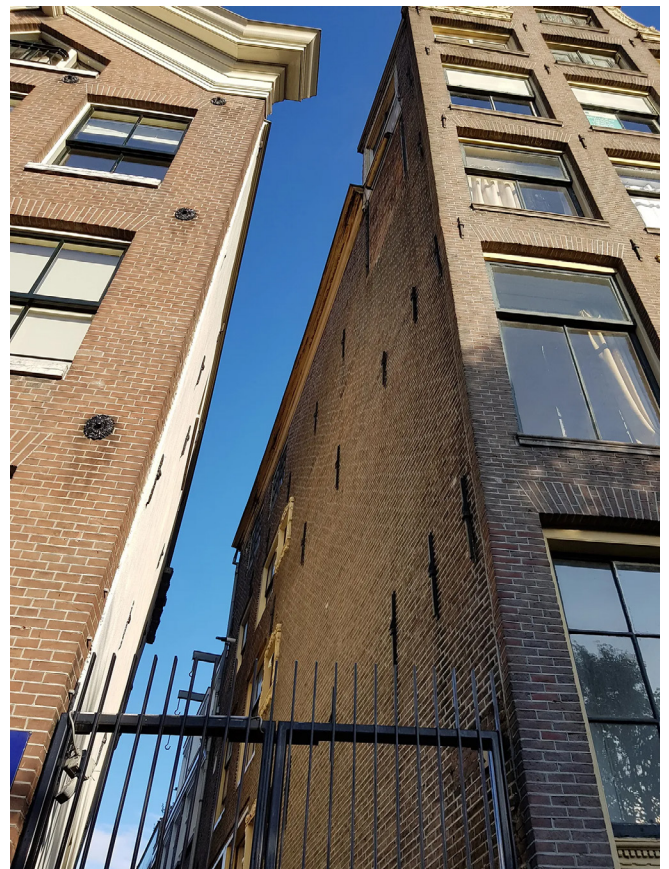
Figure 21: Inclination of the building (Buro Van Stigt, 2024)

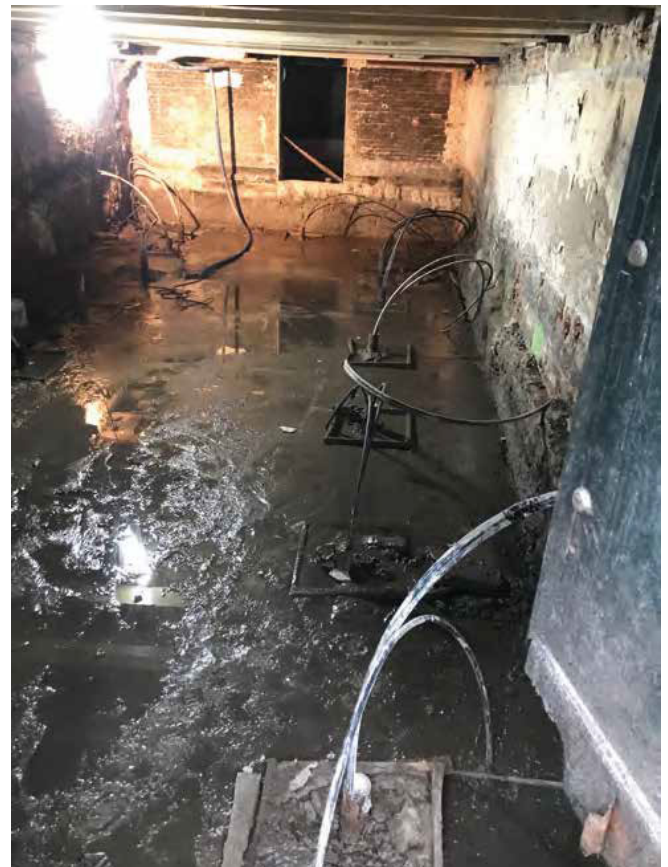
Figure 23: Nineteen Green Poles were installed in the new basement (Veldt, 2022)

As part of the renovation, foundation piles from De Groene Paal were incorporated into the basement pit. These foundation piles also function as ground source heat exchangers, with screw injection piles installed with embedded pipes (Figure 22). These pipes extract heat from the ground and are connected to a collector linked to the apartment’s heat pumps. This system operates similarly to a ground heat source, enabling cooling during the summer months. In total, 19 piles were installed up to 20 meters deep into the first layer of sand, each providing 1 kW of power, sufficient to heat the apartments (Figure 23). Additionally, an air source heat pump is installed in the basement for the ground floor

commercial space. The Energy Piles also fulfill their usual structural function, together with the basement pit, they have taken over the load-bearing function of the existing masonry foundation strips and wooden piles.

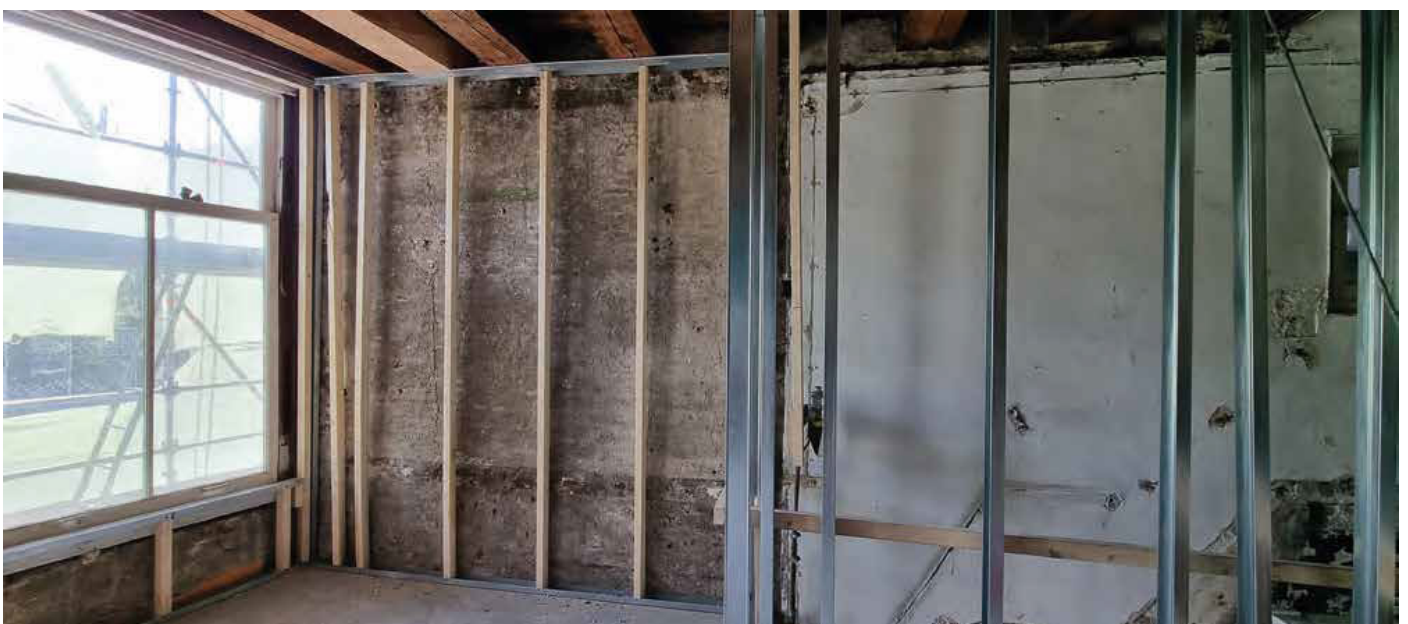
Figure 25: Standard insulation layer applied to the interior in the form of insulated cladding (Veldt, 2022)

To maintain the monumental red-orange brick exterior, a standard insulation layer was applied to the interior, based on the sustainability plan of the Groene Grachten (2021), in the form of insulated cladding (*Figure 25*) (Van Cappelleveen, 2022). The walls are kept two centimeters away from the outer walls for ventilation purposes. The partially restored and replaced beam heads of the wooden floors are also kept away from the insulation to prevent condensation from forming locally. For insulation, seven centimeters of PIR with an Rc value of $3.5\text{m}^2\text{K/W}$ was used, meeting the requirements of existing buildings. "If you want to meet new construction standards, you lose so much space here, which is not realistic," explains Heslinga the choice. "Moreover, the large window frames constitute the largest thermal bridge. You can indeed provide the small intermediate posts with 20 centimeters of insulation, but that does little overall."

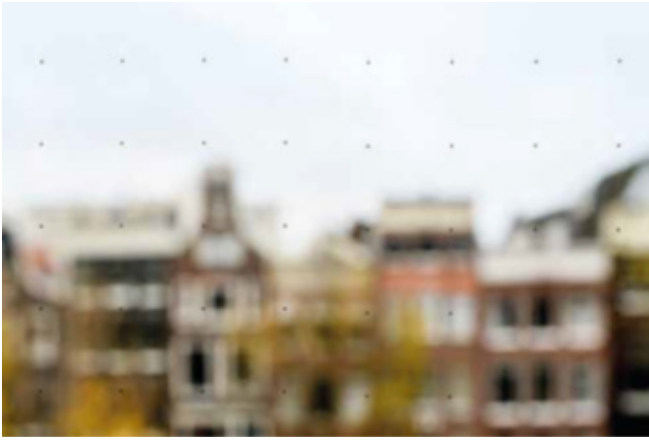
Figure 26: Fineo vacuum glass (Veldt, 2022)

The window frames are insulated with Fineo vacuum glass (*Figure 26*) in two different ways. The first method is simply by replac-

ing the single glazing with vacuum glass and setting it in the (modern) putty. Due to the monumental appearance of the building, the frames were only minimally allowed to be affected. Heslinga explains, "The beauty of Fineo is that it is only 7.7 mm thick. So you don't have to mill out much wood from the window and can almost directly replace the glass." The other method is to install secondary glazing with the vacuum glass incorporated (*Figure 27*). "We only did this on the first floor. There were still three monumental, drawn glass panels that had to remain in place. This immediately shows what the alternative is if you don't want or can't replace the existing glass."

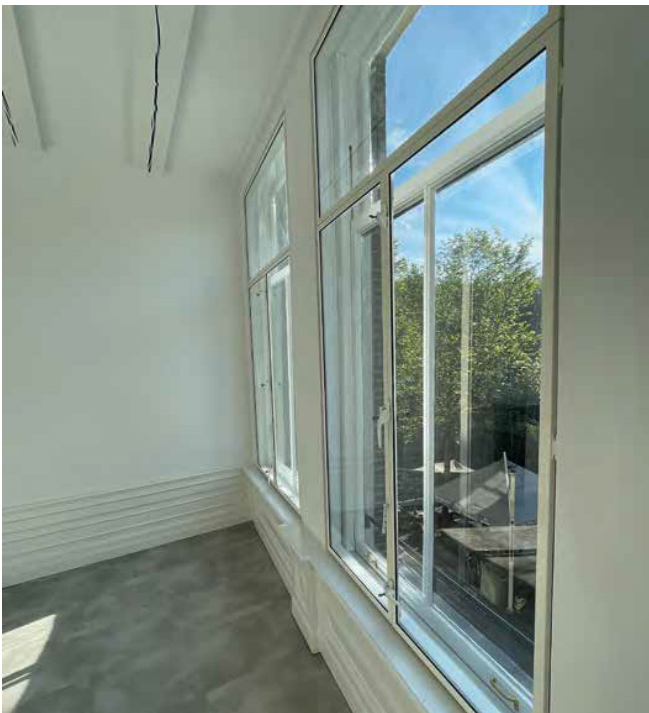
Figure 27: Secondary glazing incorporating vacuum glass (Van Cappelleveen, 2022)

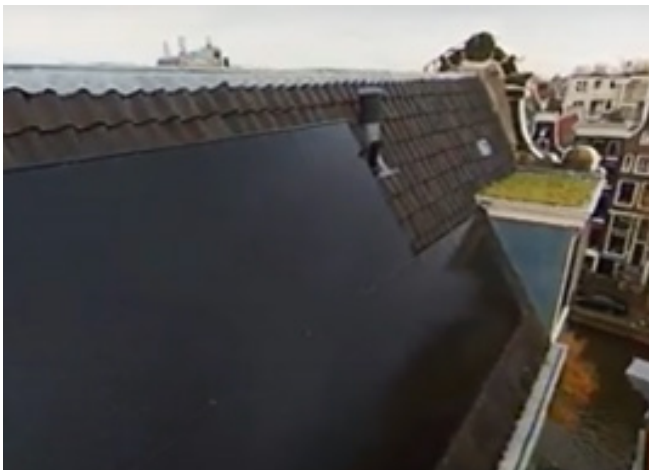
Figure 28: Solar panels not visible from the public space (NV Zeedijk, 2022)

The blue-gray roof tiles on the building also contribute to its monumental appearance. However, De Groene Grachten wanted to generate as much green energy as possible from solar panels. After , they were ultimately allowed to be installed on the roof (*Figure 28*), but they were not allowed to be visible from the public space (Buro Van Stigt, 2024).

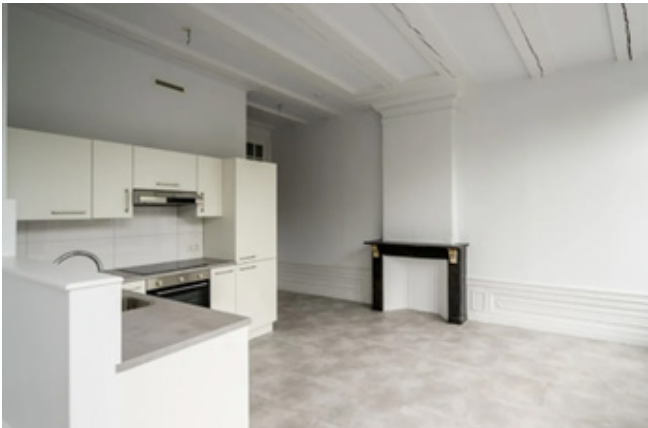
Figure 29: fireplaces provides indexical cues to the past (Veldt, 2022)

The canal houses are one of the earliest examples of buildings that could house different functions (Bronsvort, 2012). One of the important aspects of this flexibility was that the building had fireplaces in all the rooms. This gave the dweller the option to turn every room into a sleeping room, working room or dining room for example. Many of today's installations were not yet invented at the time of construction of the canal house. The main installation features that were taken into account during the design of canal housing were heating and later on sewerage. Heating was done by fireplaces at several different places inside the dwelling. Nowadays, the fireplaces provide only as indexical cues to the heating system of the past (Figure 29).

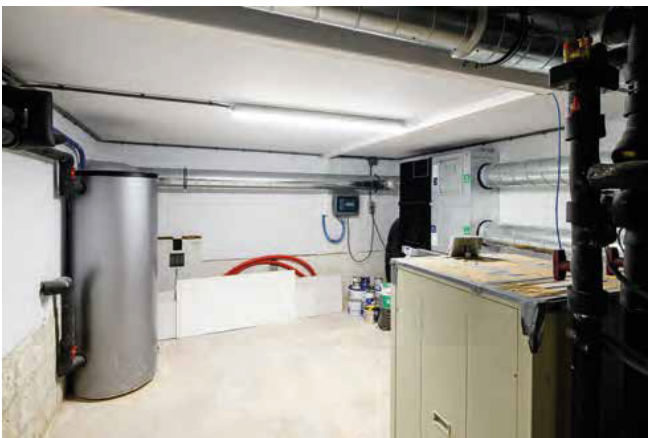
Figure 30: HRV ventilation system on the right side of the basement (Veldt, 2022)

New sustainable installations were considered during the 2021 renovation. Due to the sightlines from the street, it was not feasible to place these new installations on the roof or hang them on the facade. Consequently, the installations had to be mainly installed indoors, which posed a significant challenge according to the architect (Van Cappelleveen, 2022). The apartments are equipped with two separate HRV (Heat Recovery Ventilation) systems (Figure 30): one for all living spaces and one for all bathrooms. The reason for this division was limited space. "Horizontal pipes under the ceiling reduce the clear height. Because the technical rooms and bathrooms are located in the same place on each floor plan, by splitting the HRVs, we only had to install vertical ducts," explained Heslinga. The commercial space on the ground floor has its own HRV ventilation system.

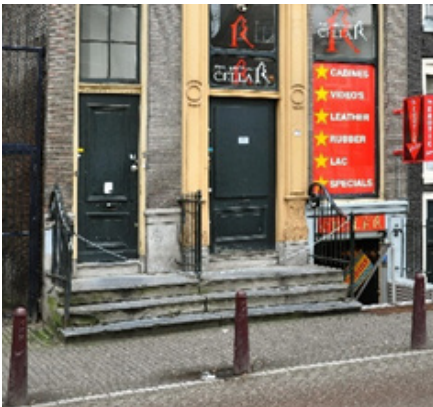
Figure 31: Elevated entrance (Amsterdam Stadsarchief, 2009)

Bronsvort (2012) observes that an authentic indication of the canal house is the elevated entrance (*Figure 31*). This elevation relative to street level serves multiple purposes. The souterrain constitutes the lowest level of the building and is situated half a floor higher in the ground. This was due to the groundwater level in Amsterdam, making a completely submerged cellar nearly impossible. Additionally, it was very convenient for routing purposes. When the building on Oudezijds Voorburgwal was used as a printing house, this floor was used as storage space. Goods could easily be transported in and out of the building through the street hatches. The main entrance was located on the elevated ground floor (*bel étage*). The elevation creates a semi-private space that provides distance between the public street and the private residence. The elevated entrance is highly characteristic of authentic canal houses in Amsterdam.

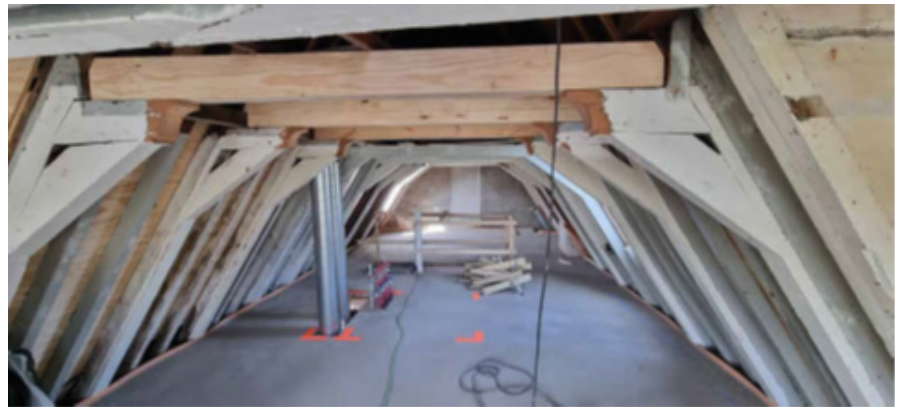
Figure 32: beams were sawn through providing an additional height of 20 centimeters (Veldt, 2022)

tinue to accommodate changes in functions due to its oversized structural framework and floor areas. However, the structural beams in the attic were a subject of discussion during the sustainable renovation in 2021. The attic was previously used as storage where a high space was not necessary. The authentic wooden roof trusses hung quite low, resulting in a restricted height of 1.85 meters for the apartment. To address this issue, the beams were sawn through, and new beams were laid on the corbels, providing an additional height of 20 centimeters (*Figure 32*). The intervention was not straightforward, as the Monumentenwacht (Monument Inspection Agency) only agreed to it if two of the trusses remained in their original state (*Figure 33*) (Van Capelleveen, 2022).

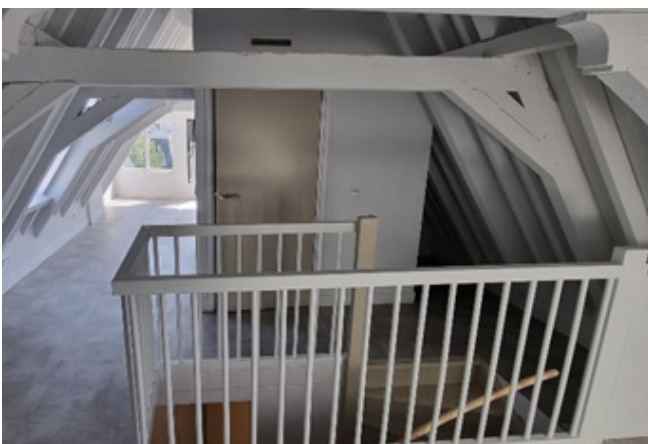
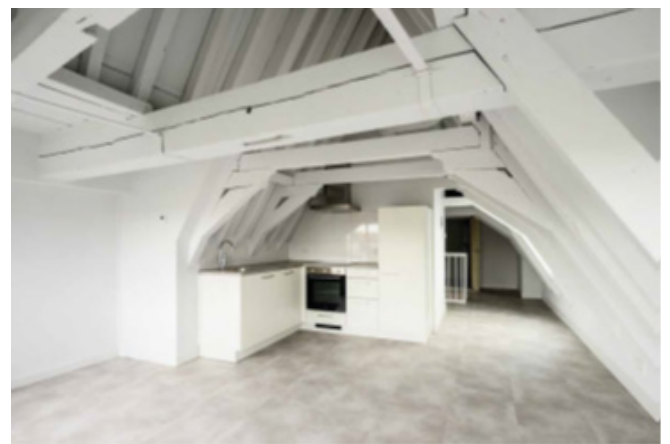
Figure 33: The two trusses that remained in their original state (Veldt, 2022)

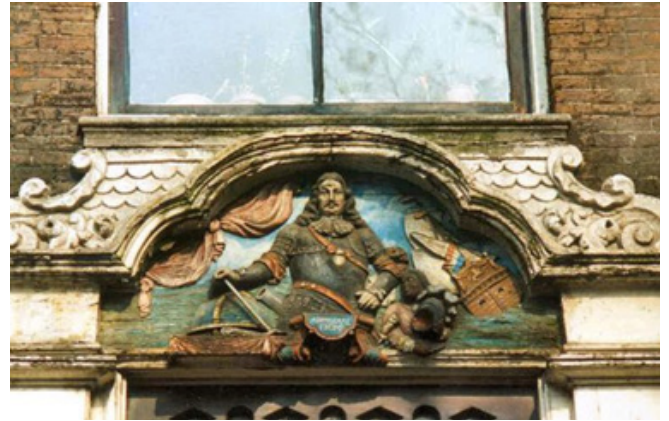
Figuur 34: Wooden relief featuring Admiral Tromp before restoration (Boers, 2007)

Boers (2007) observed that during the repainting of the building in 1941, the door lintel was also restored. At that time, the relief was covered with a thick crust of yellowish paint and had lost all sharpness (*Figure 34*). Even the inscription was no longer legible. Upon removing the paint crust, the old polychromy was discovered, highlighting the detailed nature of the carving. The relief was subsequently cleaned, repaired in parts, and painted in the colors found. In this way, it once again became a showpiece on the Oudzeijds Voorburgwal (*Figure 35*).

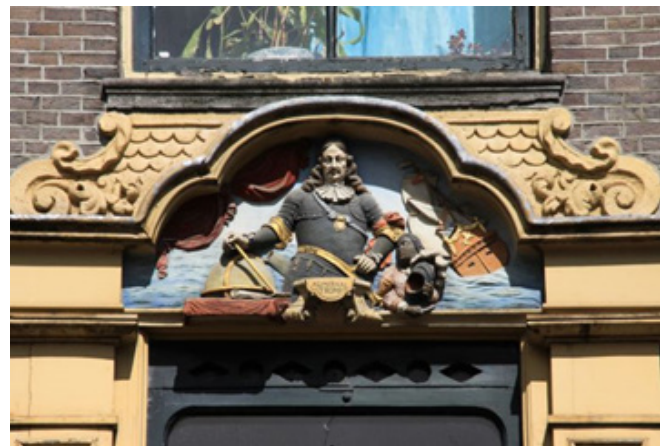
Figuur 35: Wooden relief featuring Admiral Tromp after restoration (Boers, 2007)
