## Bio-Based Composite Footbridge: Design, Production and *In Situ* Monitoring

This paper deals with the design, production and monitoring of a bio-composite footbridge with a span of 14 m across the river Dommel in the city of Eindhoven, the Netherlands. The specific bio-composite material that was used for this research is a Natural Fibre Reinforced Bio-Polymer (NFRBP). The goal of the research is to prove that NFRBP can be applied as a load-bearing structure in an outdoor environment. For this purpose, a multidisciplinary team of academic researchers from two universities and from the Centre of Expertise Biobased Economy, together with a manufacturer from the NFRBP industry, have developed a feasible design that could be produced in a short period of time and within a limited budget. The footbridge was designed, built and installed within less than one year. In the two years after the installation of the footbridge, the structural behaviour of the bridge was monitored by means of optical fibre glass strands, integrated within the structure, with the purpose of measuring deformations and change in elasticity that occur over time.

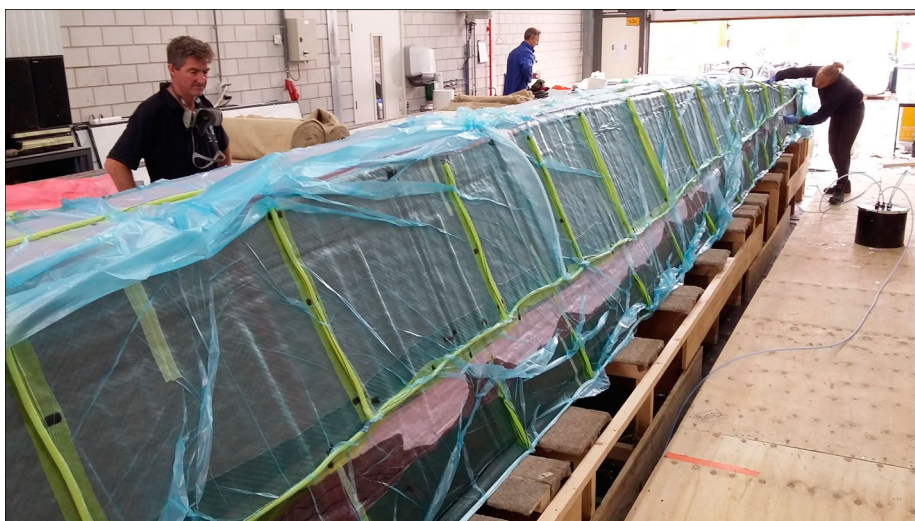
Fig. 4: Production of the 14m long bridge
