KATOENVEEM RECONNECTED

RESEARCH AND DESIGN OF KATOENVEEM (KEILESTRAAT 39, ROTTERDAM)

P5 PRESENTATION_25JAN2018//XIHAO YI_4506995 // TUTORS=ALEXANDER DE RIDDER+FRANK KOOPMAN+SARA STOUX

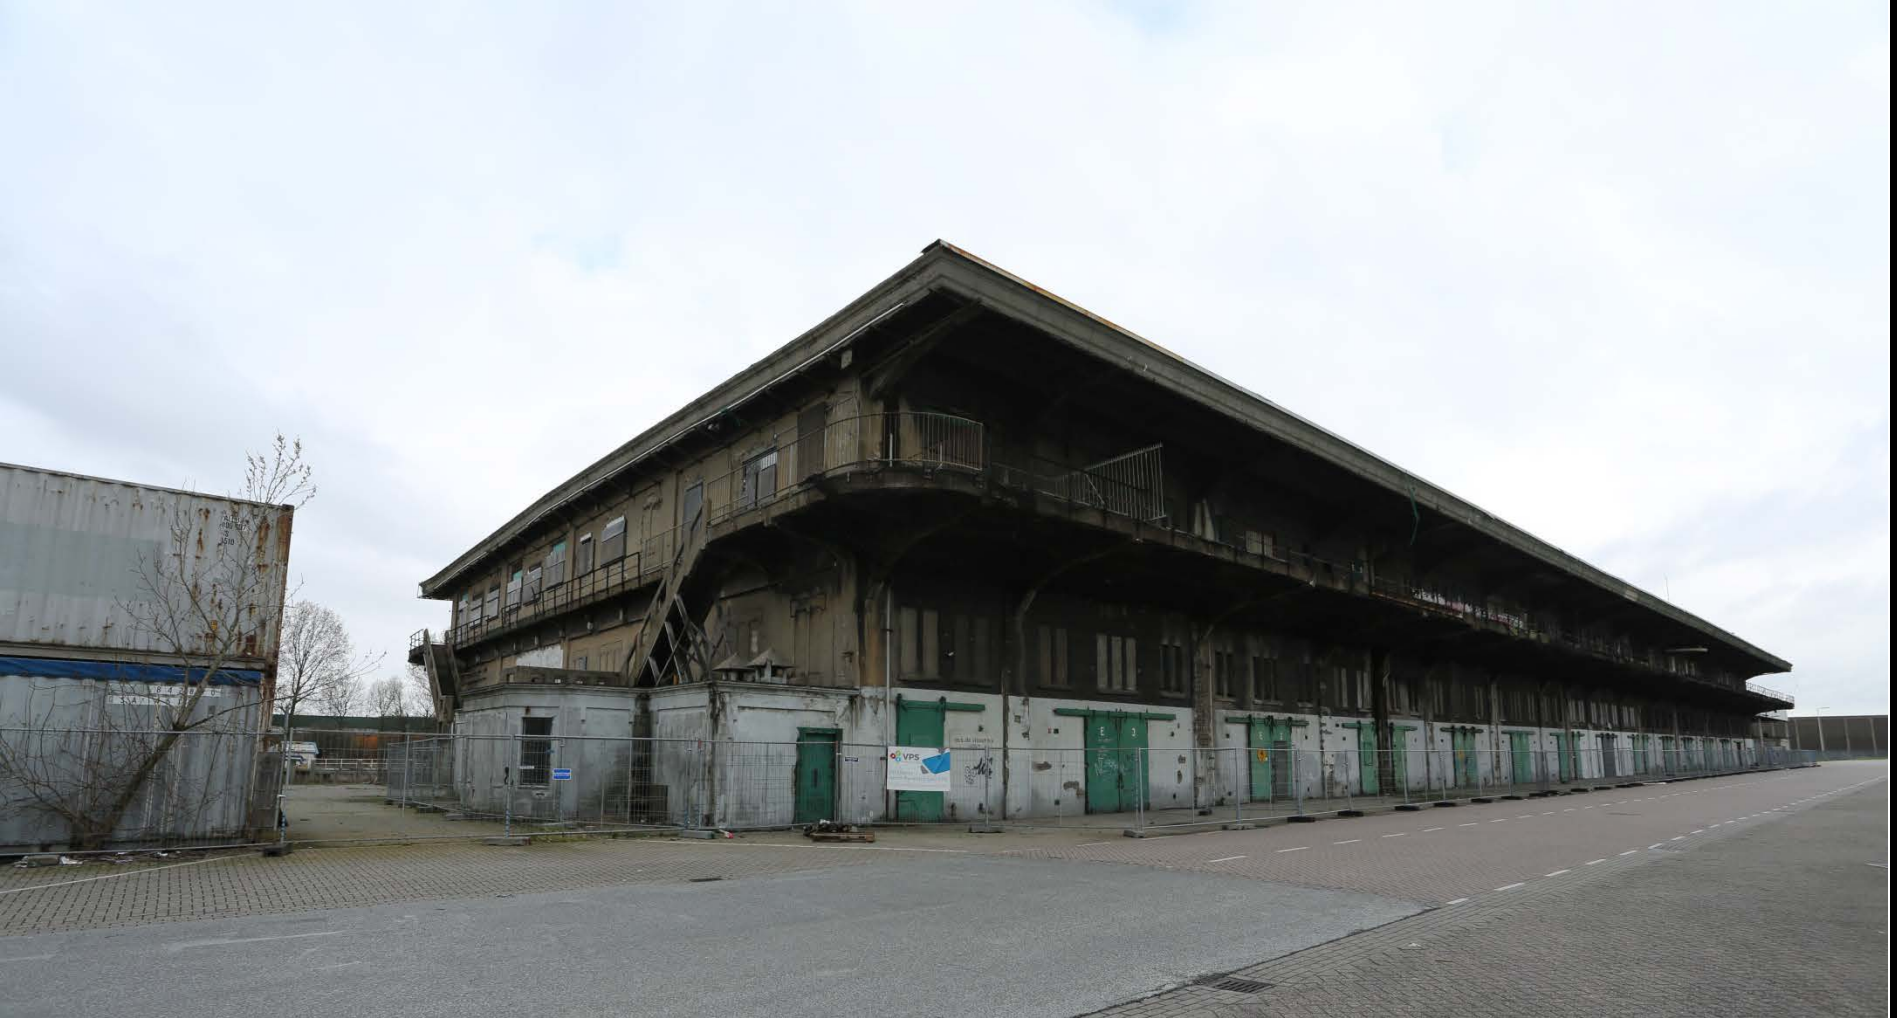
EXTERIOR: CLOSED , REPETITIVE AND LONG

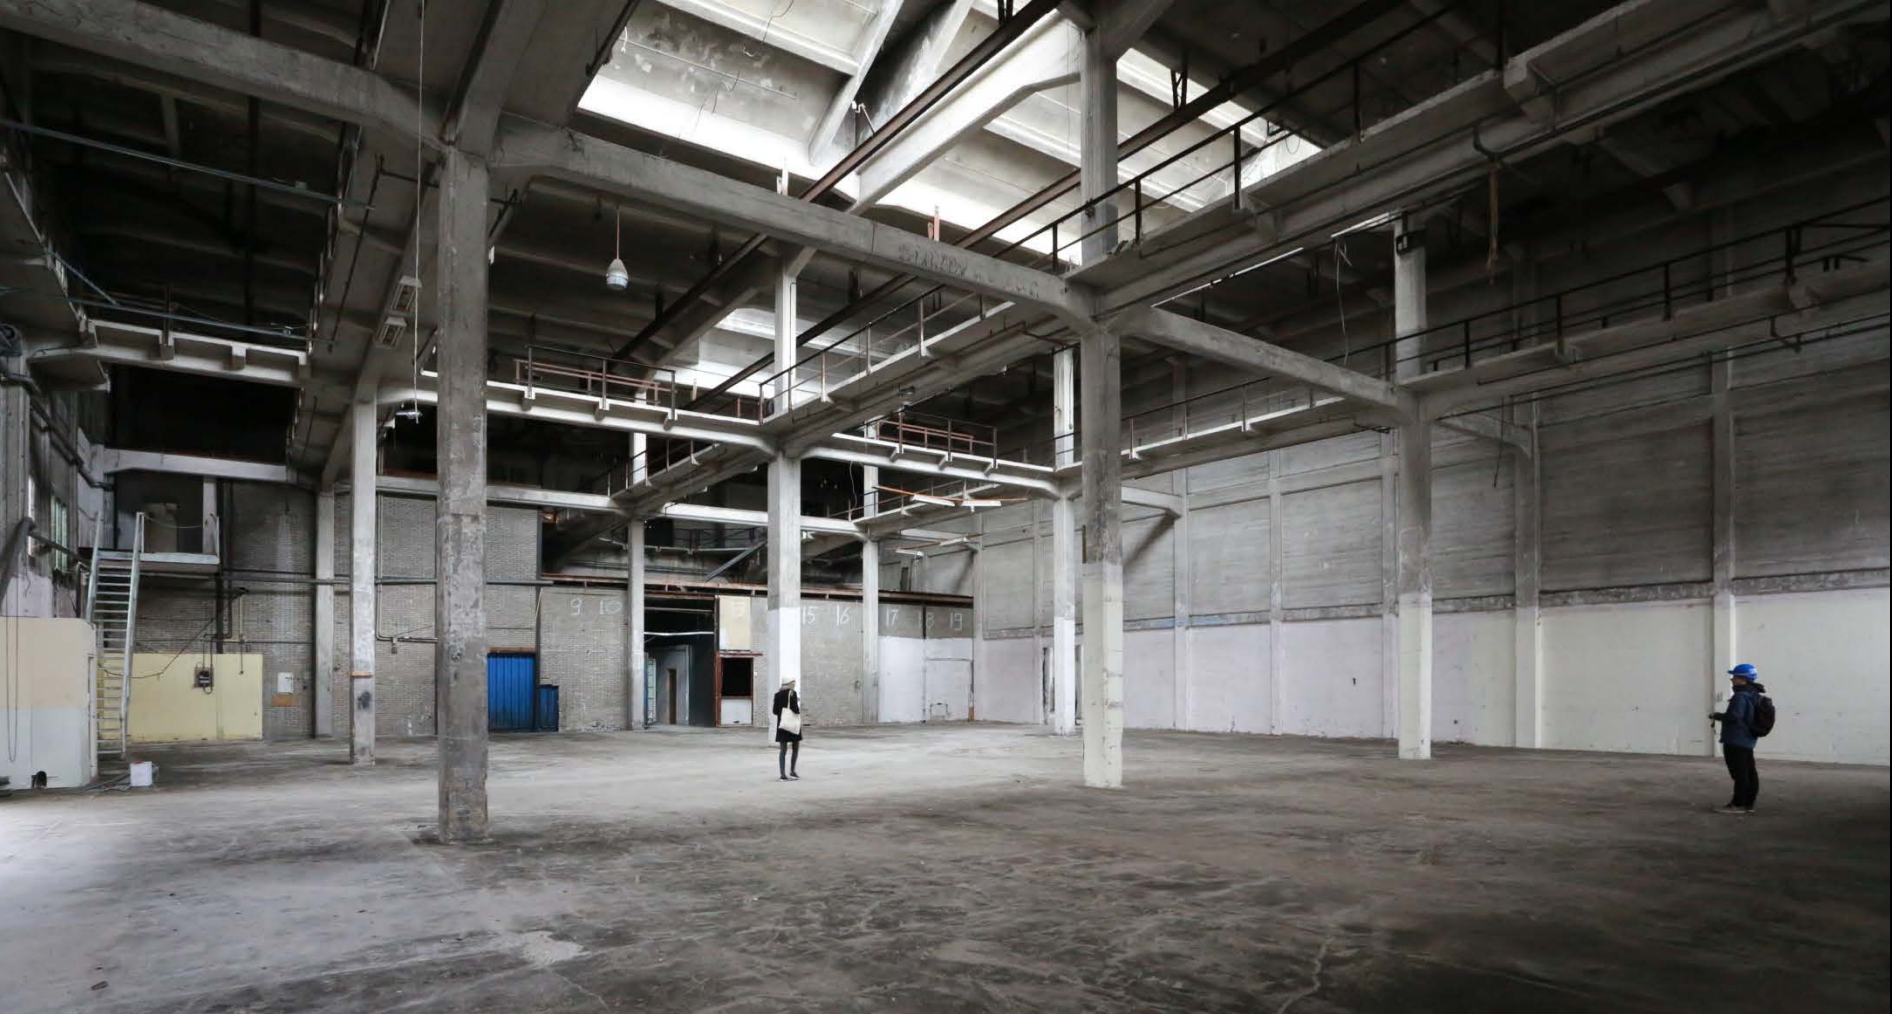
INTERIOR : SEPARATED GRID SPACE WITH SKYLIGHTS

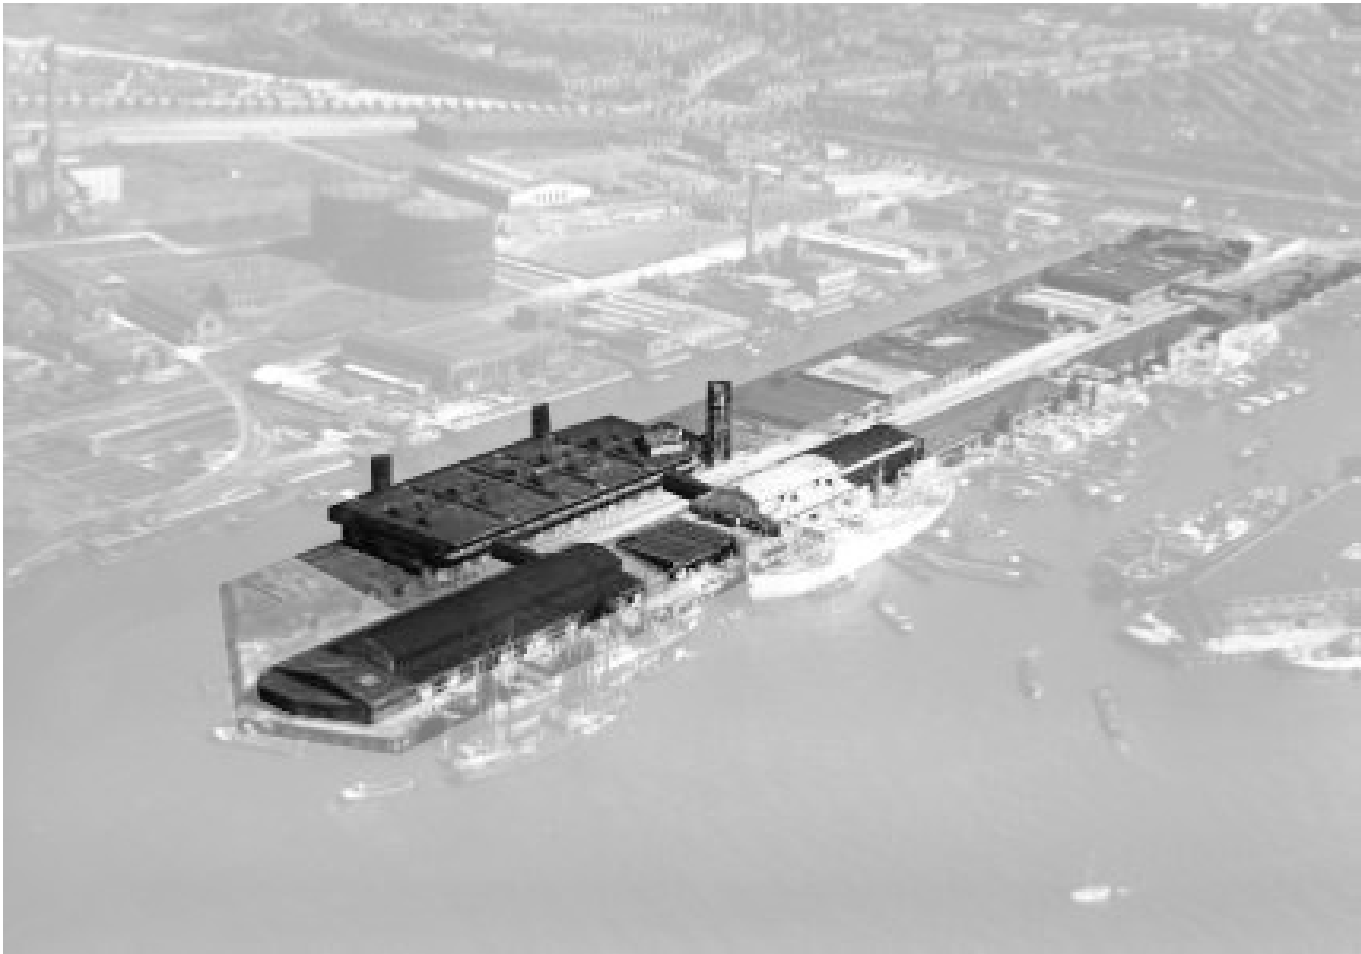
1921 full complex

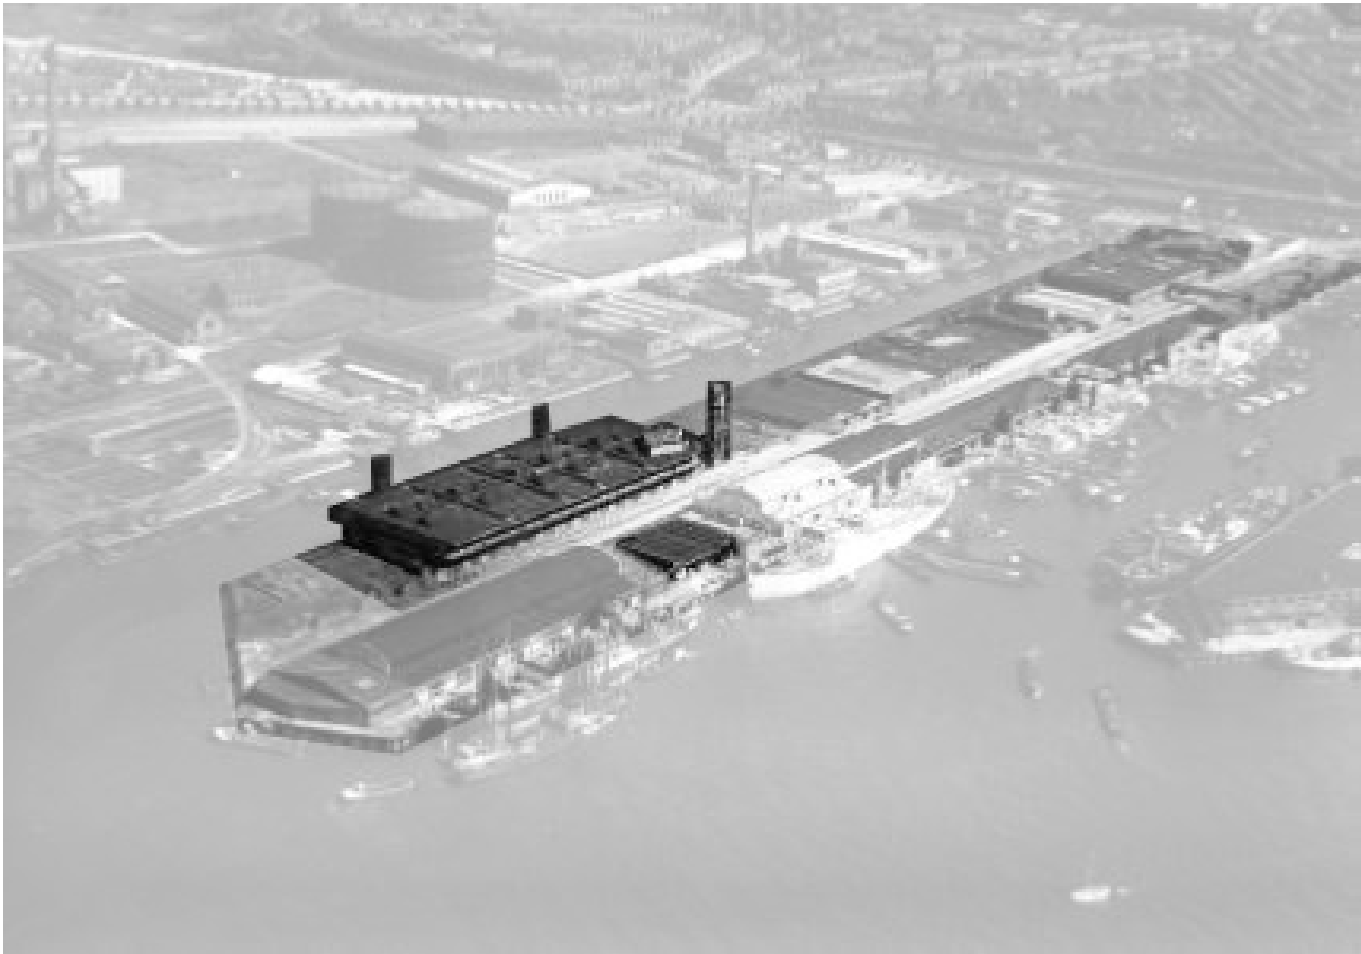
1931 Demolition of two former warehouses and connection bridges

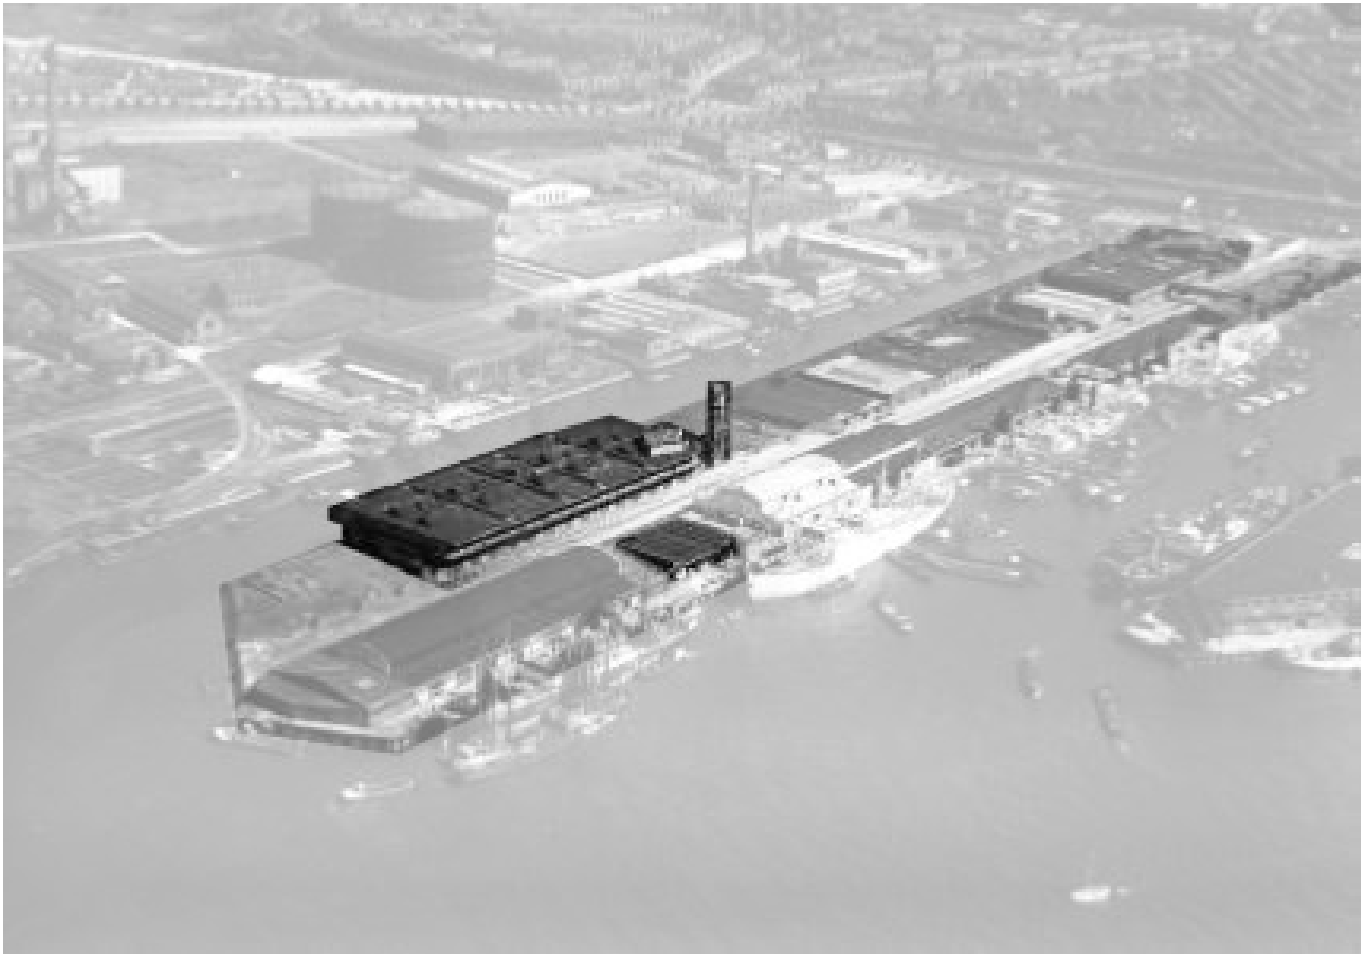
1964 Demolition of cranes. End of function as cotton warehouse

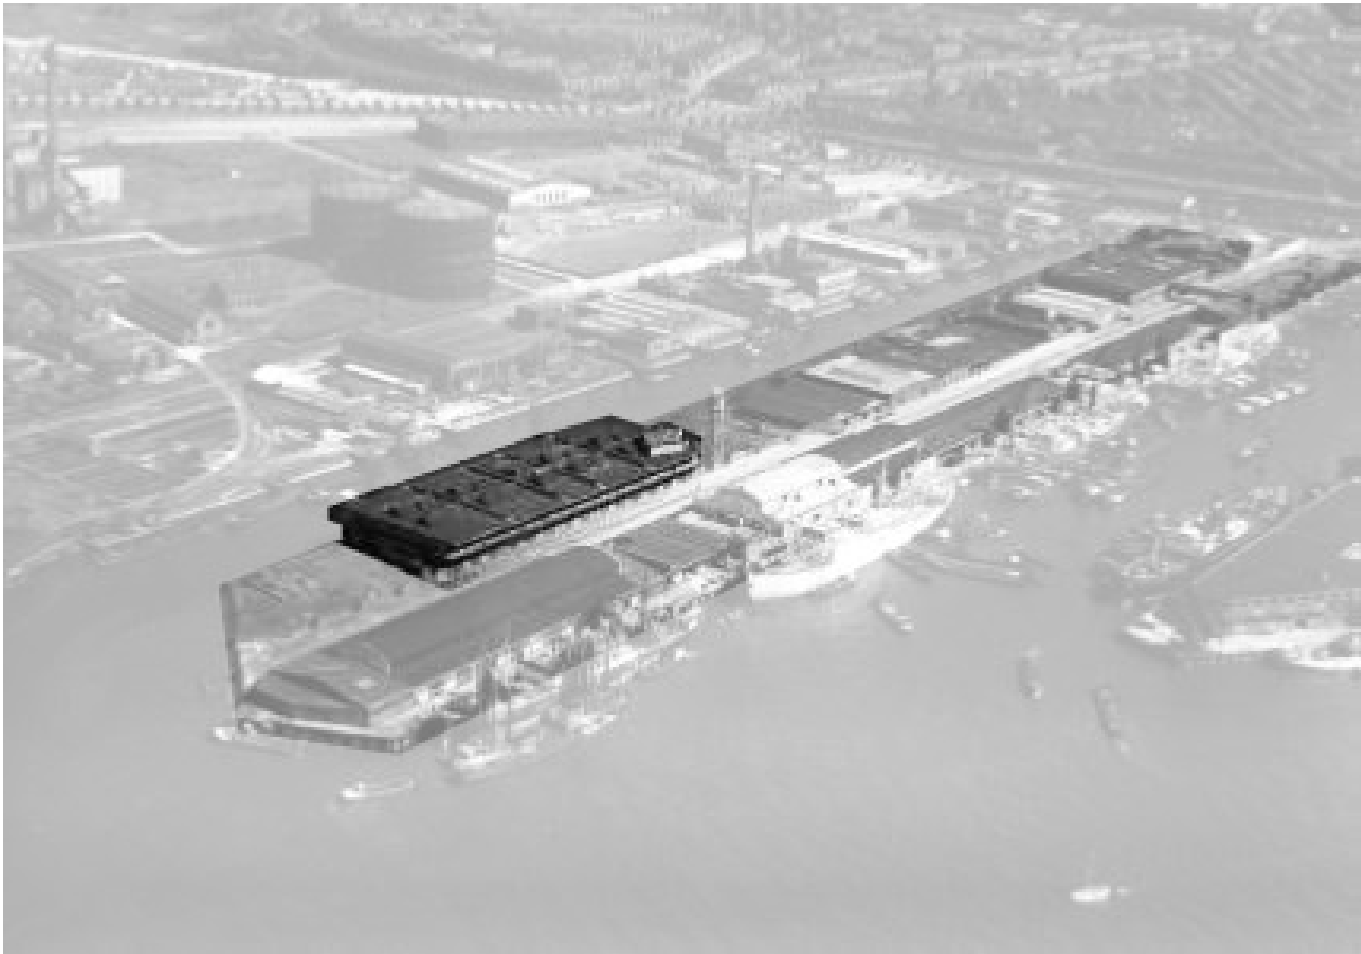
1966 Demolition of water tower and shed. Katoenveem became an isolated building.

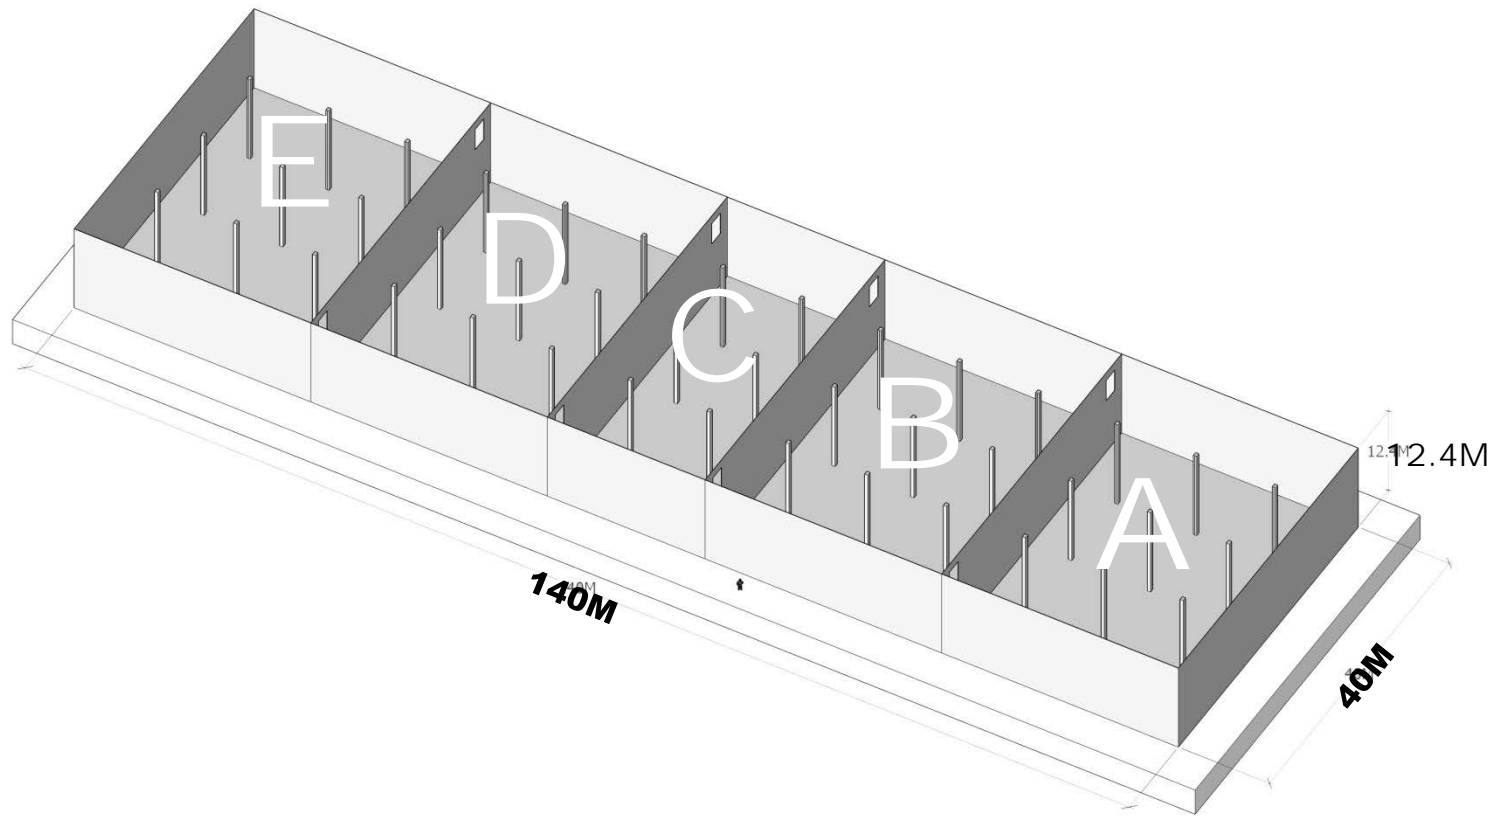
Dimension and Separated 5 compartments

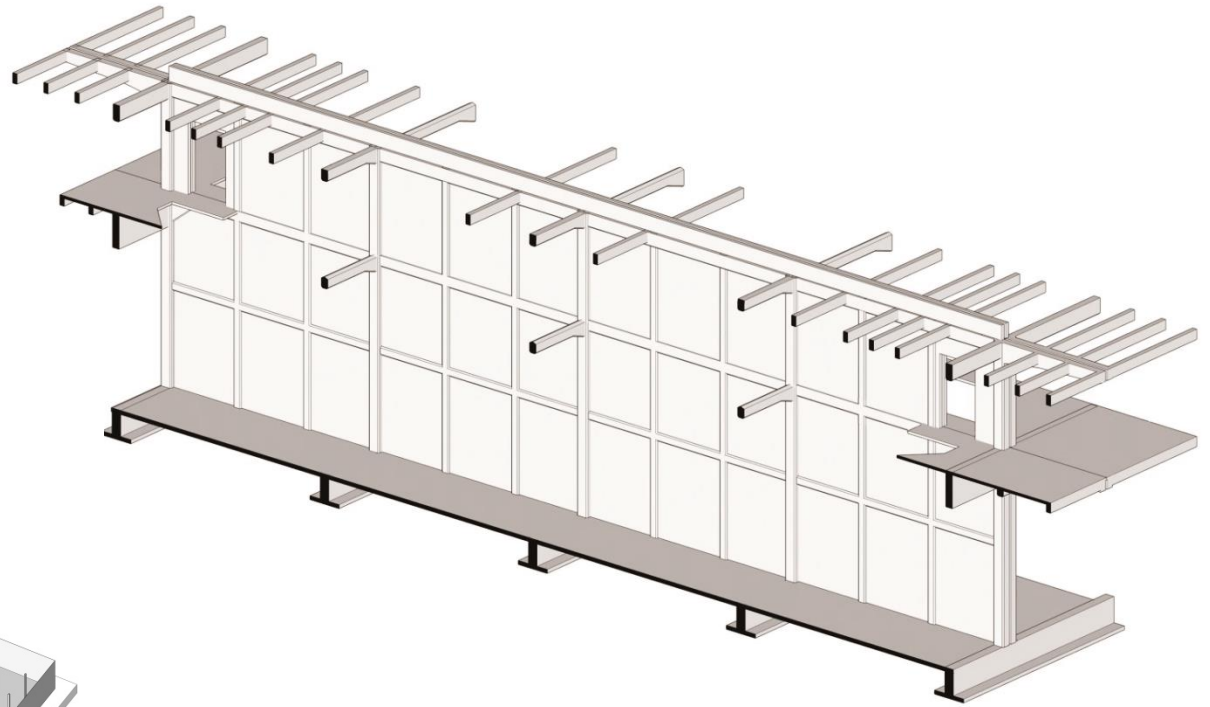
Compartment walls

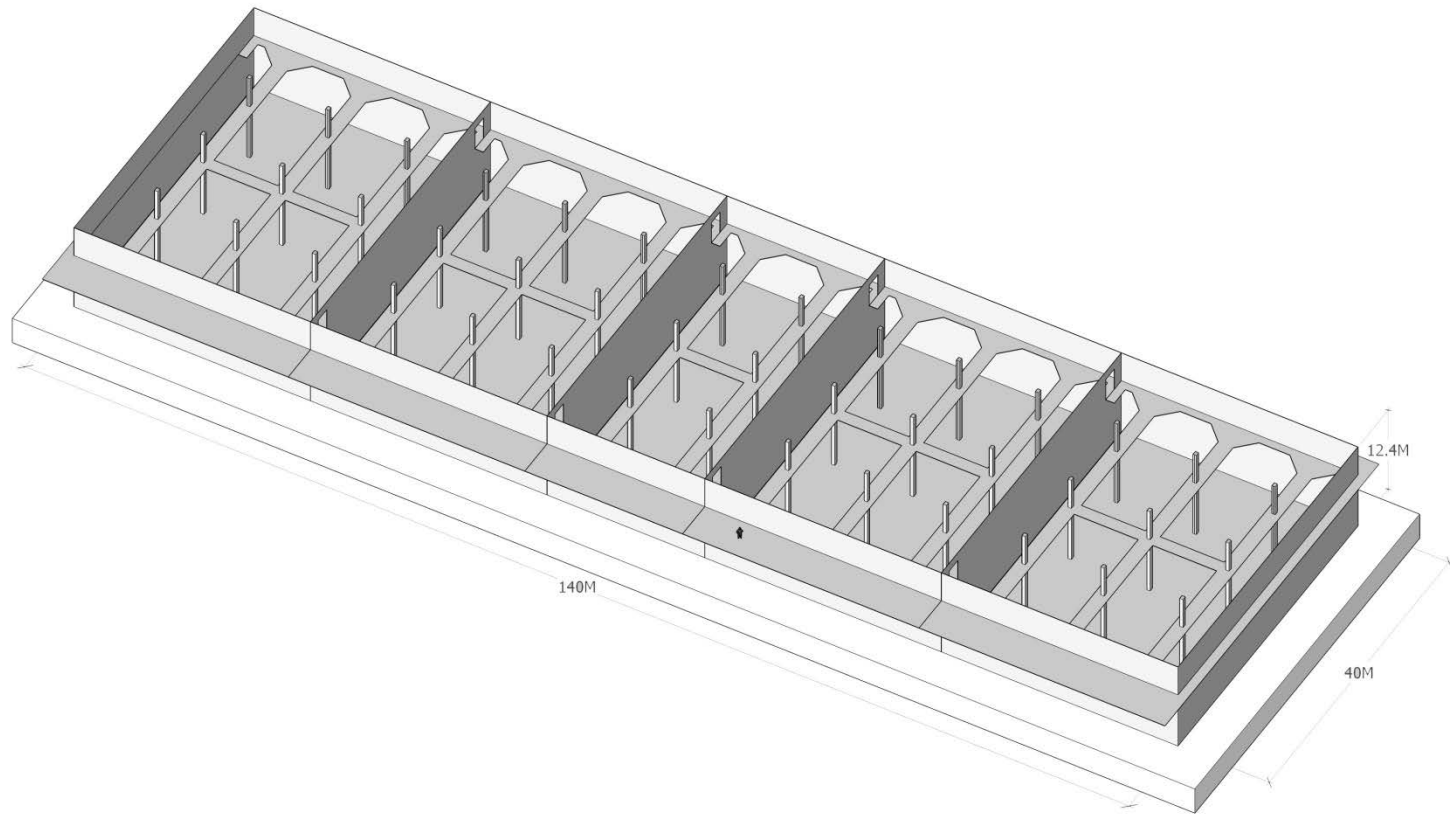
Walkways on the first floor

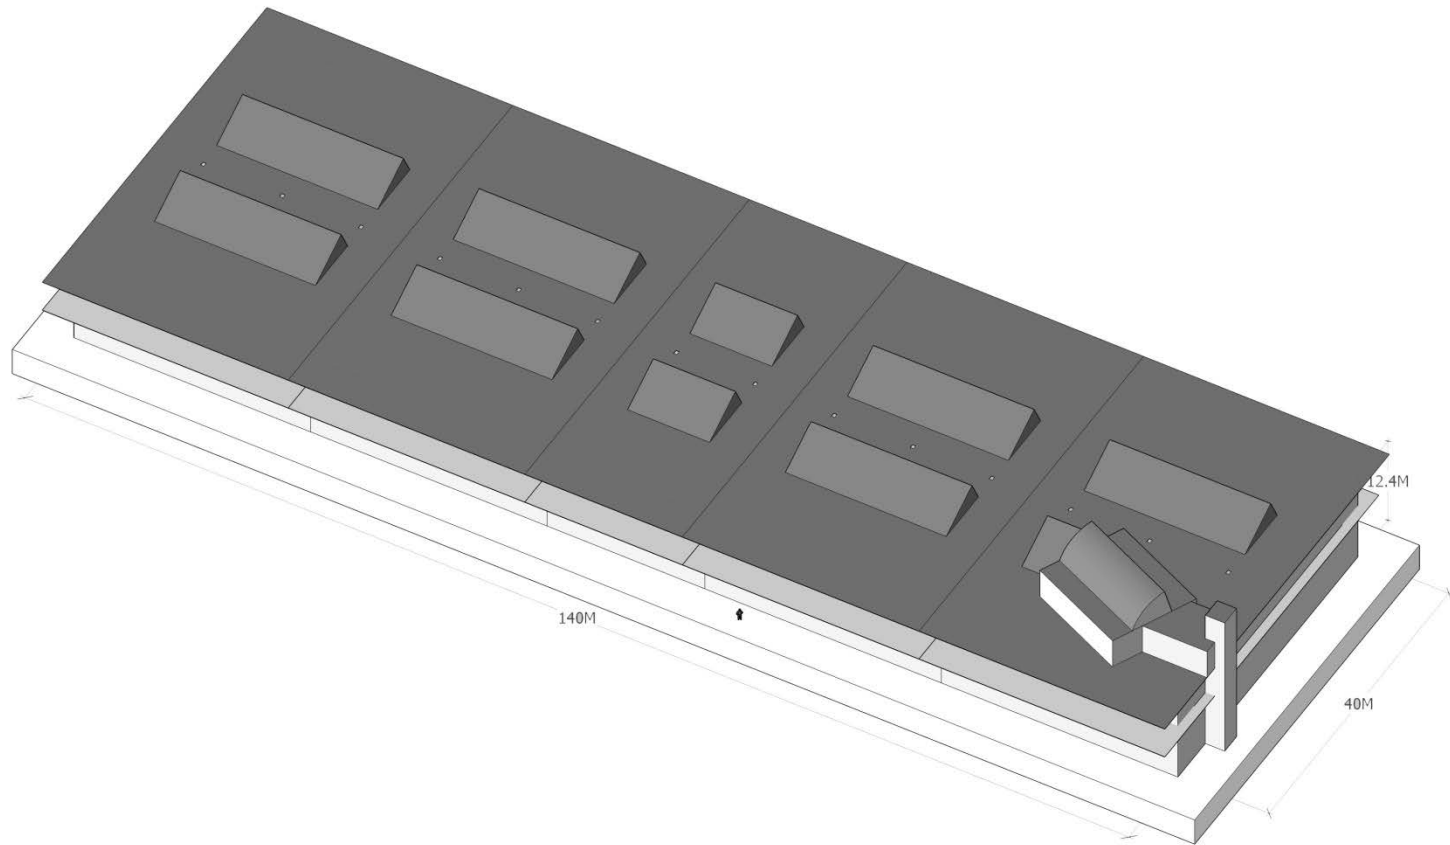
Skylights and a sample room facing north

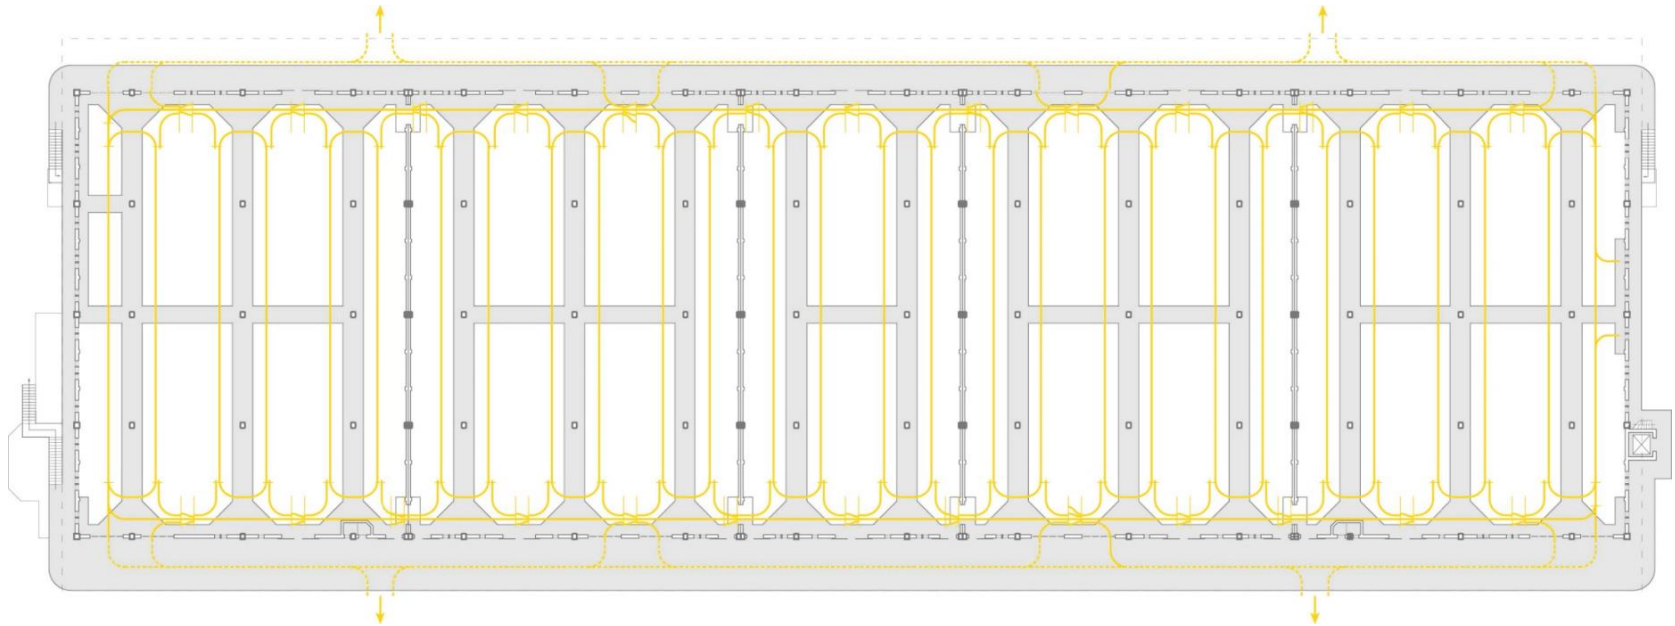
Location of conveyor system by Elmer Pietersma

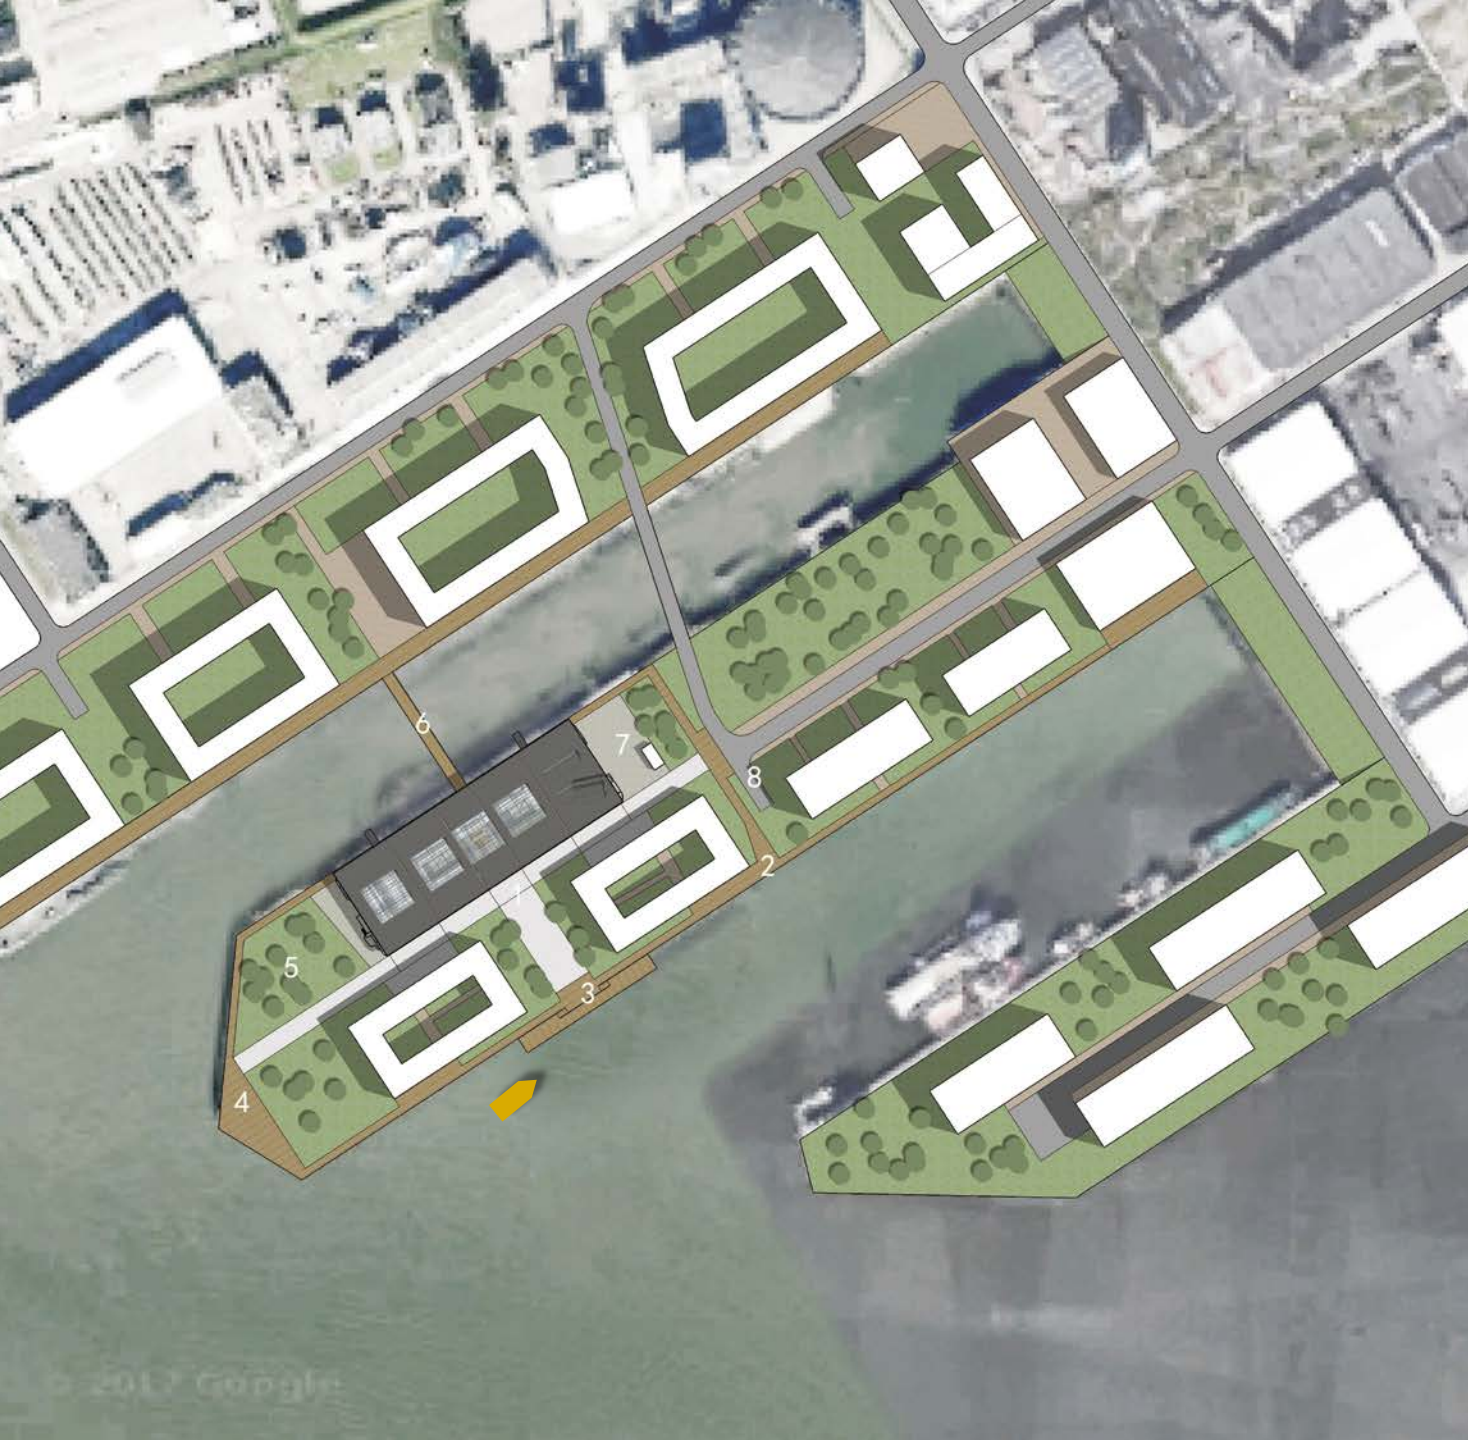
MASTERPLAN

- Restore the sense of complex
- Center of the community
- Connection with surroundings
- Place for multiple purposes

- 1/main axis
- 2/pedestrian loop
- 3/waterbus station
- 4/sightseeing deck
- 5/park
- 6/pedestrian bridge
- 7/outdoor exhibition
- 8/underground parking

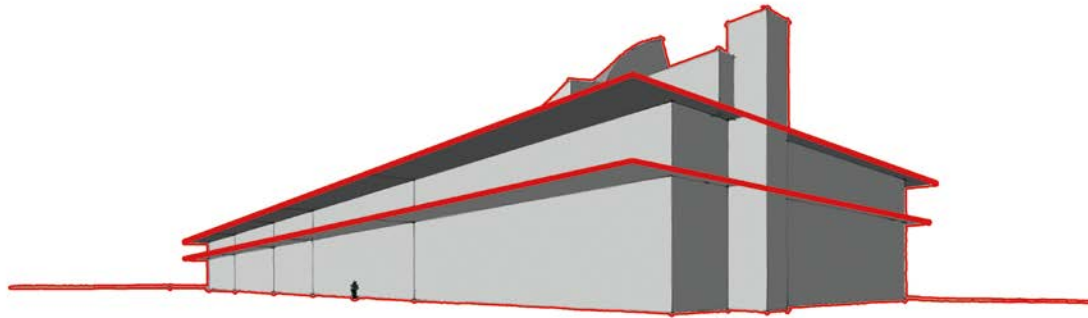
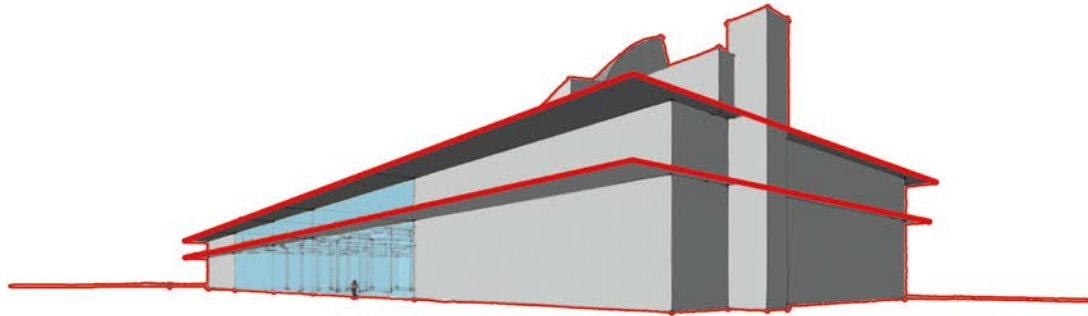
CLOSE → OPEN

Opening up the middle part of the north and south façade makes the building not unreadable anymore. The transition between inside and outside is more smooth. This operation has maintained the contour of the building and hence the horizontal characteristic remains.

5 COMPARTMENTS → 3 COMPARTMENTS

With the demolition of 2 compartment walls in the middle, compartments B,C and D merge into one big compartment where more possibilities will happen. While compartment A is chosen as a representative of the compartmentation.

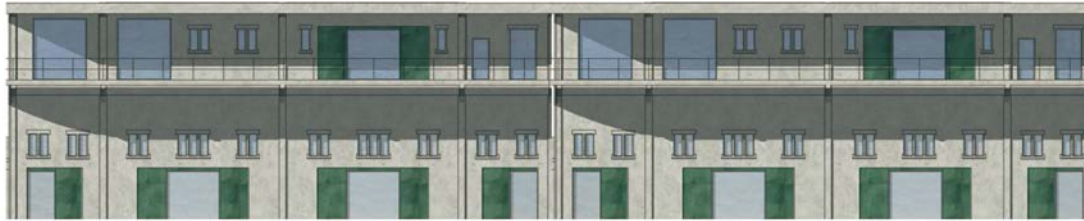
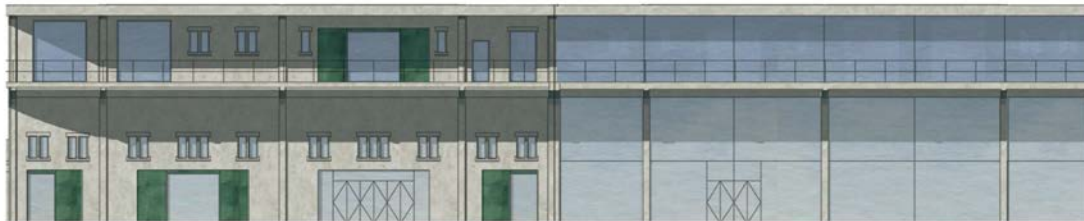
REPETITION → VARIATION

Part of the repetitive facade, mainly on the south and north façade, are to be replaced by transparent curtain wall.

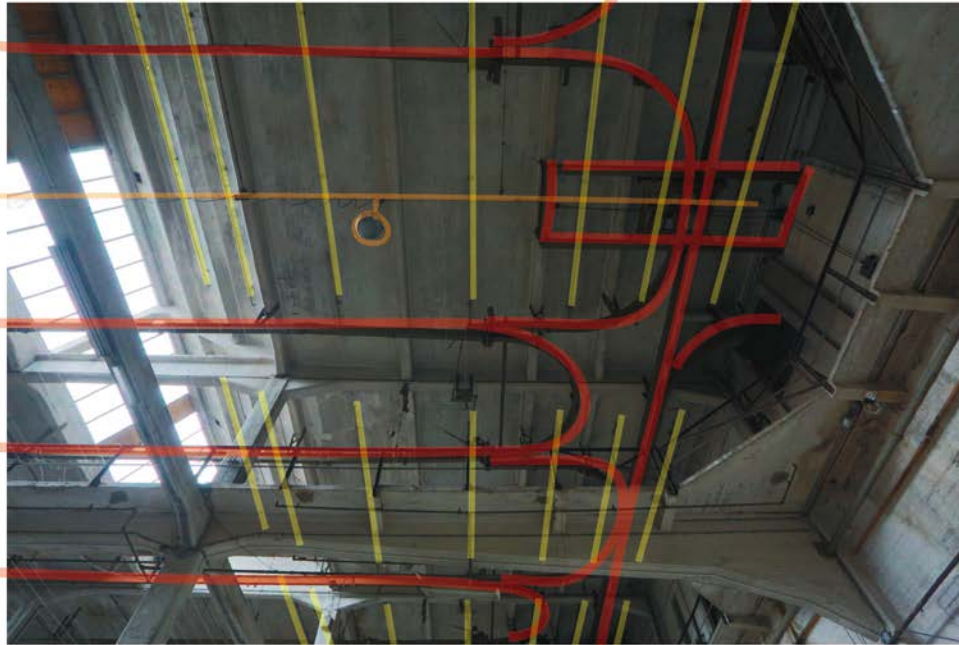
SERVICES STAY

The services of the Katoenveem, including the conveyor system, sprinkler system, and moveable lights stay as vivid evidence of the original functionality.

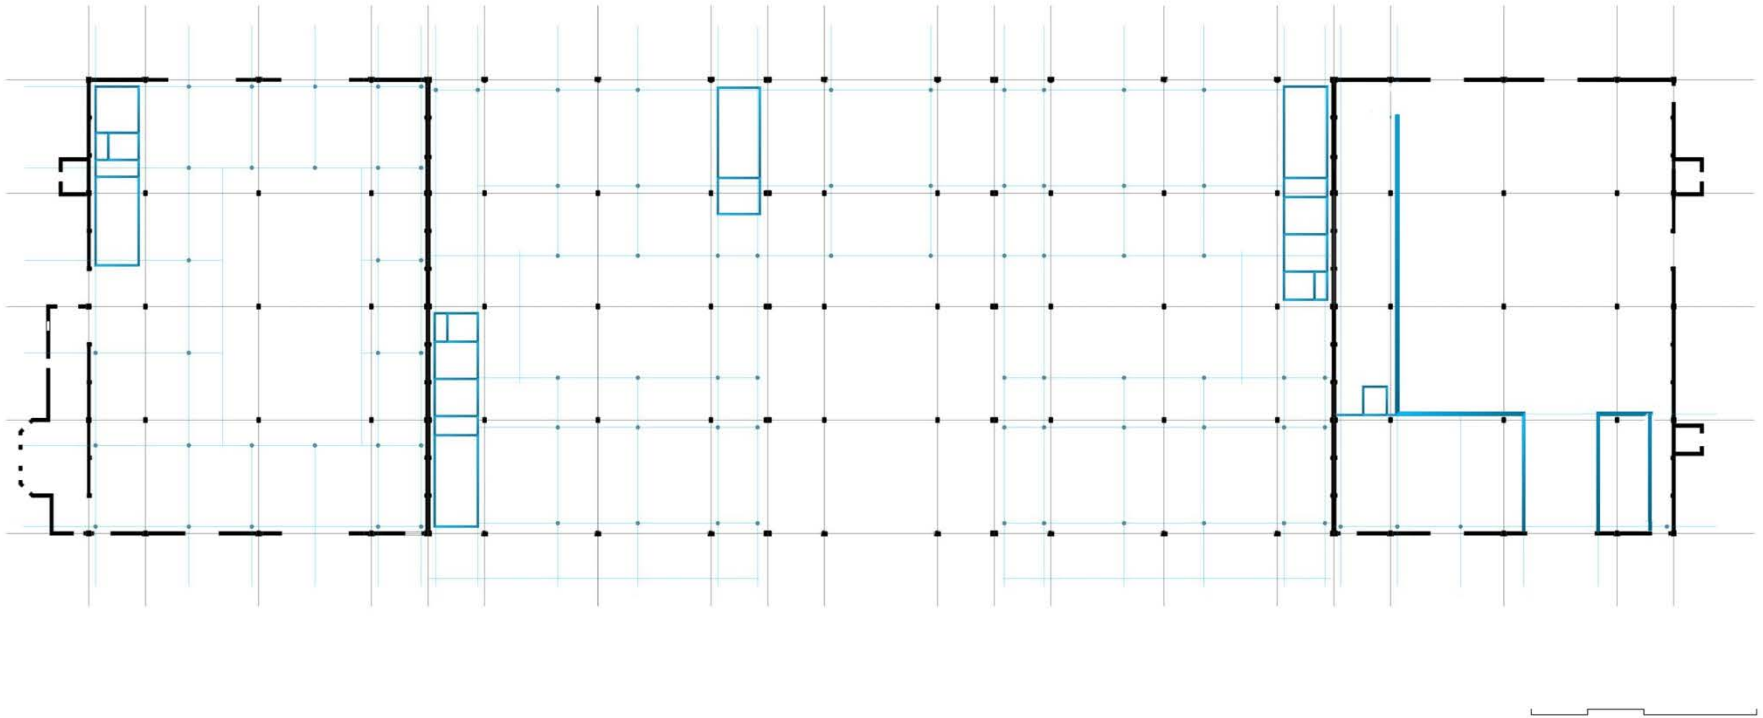
OLD AND NEW GRIDS

New grids of steel frames are parallel to the old grids, while do not intervene with the old beams and columns for the vast majority.

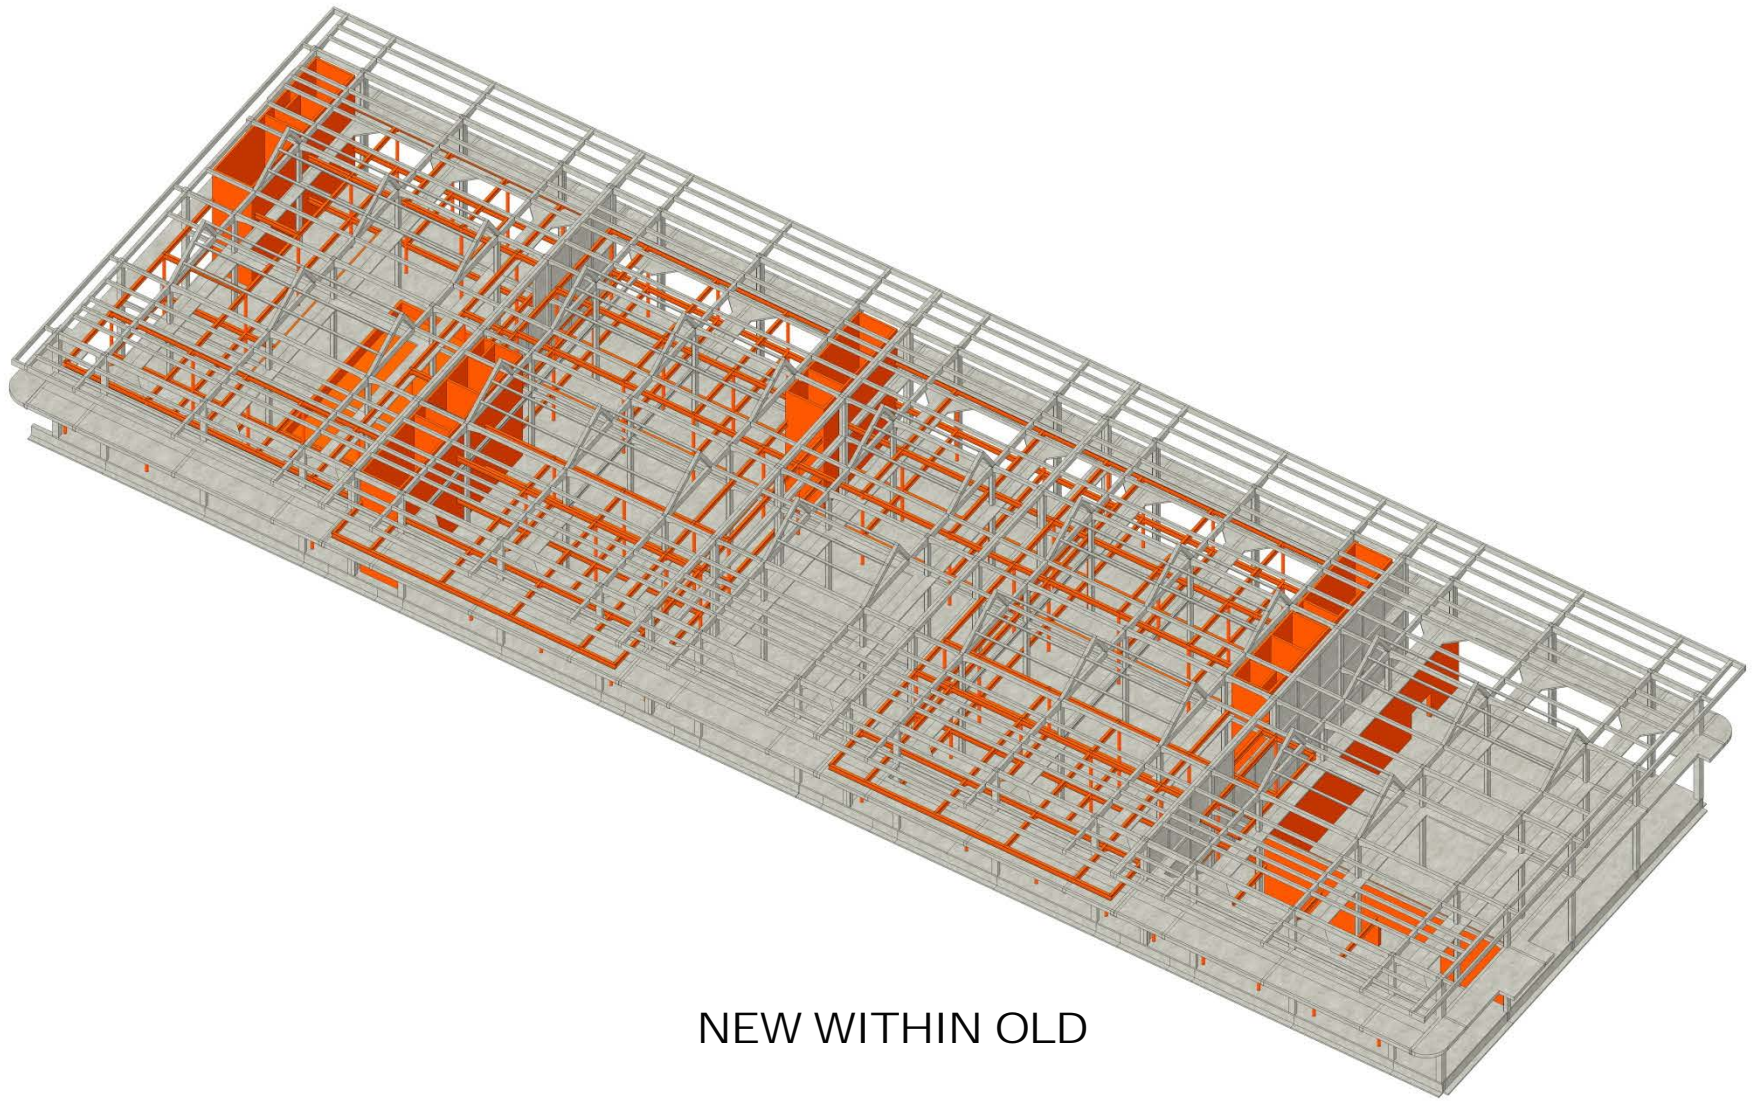
NEW WITHIN OLD

Orange: new structure. Grey: old structure
