KATOENVEEM RECONNECTED

RESEARCH AND DESIGN OF KATOENVEEM (KEILESTRAAT 39, ROTTERDAM)

P5 PRESENTATION_25JAN2018//XIHAO YI_4506995 // TUTORS=ALEXANDER DE RIDDER+FRANK KOOPMAN+SARA STOUX

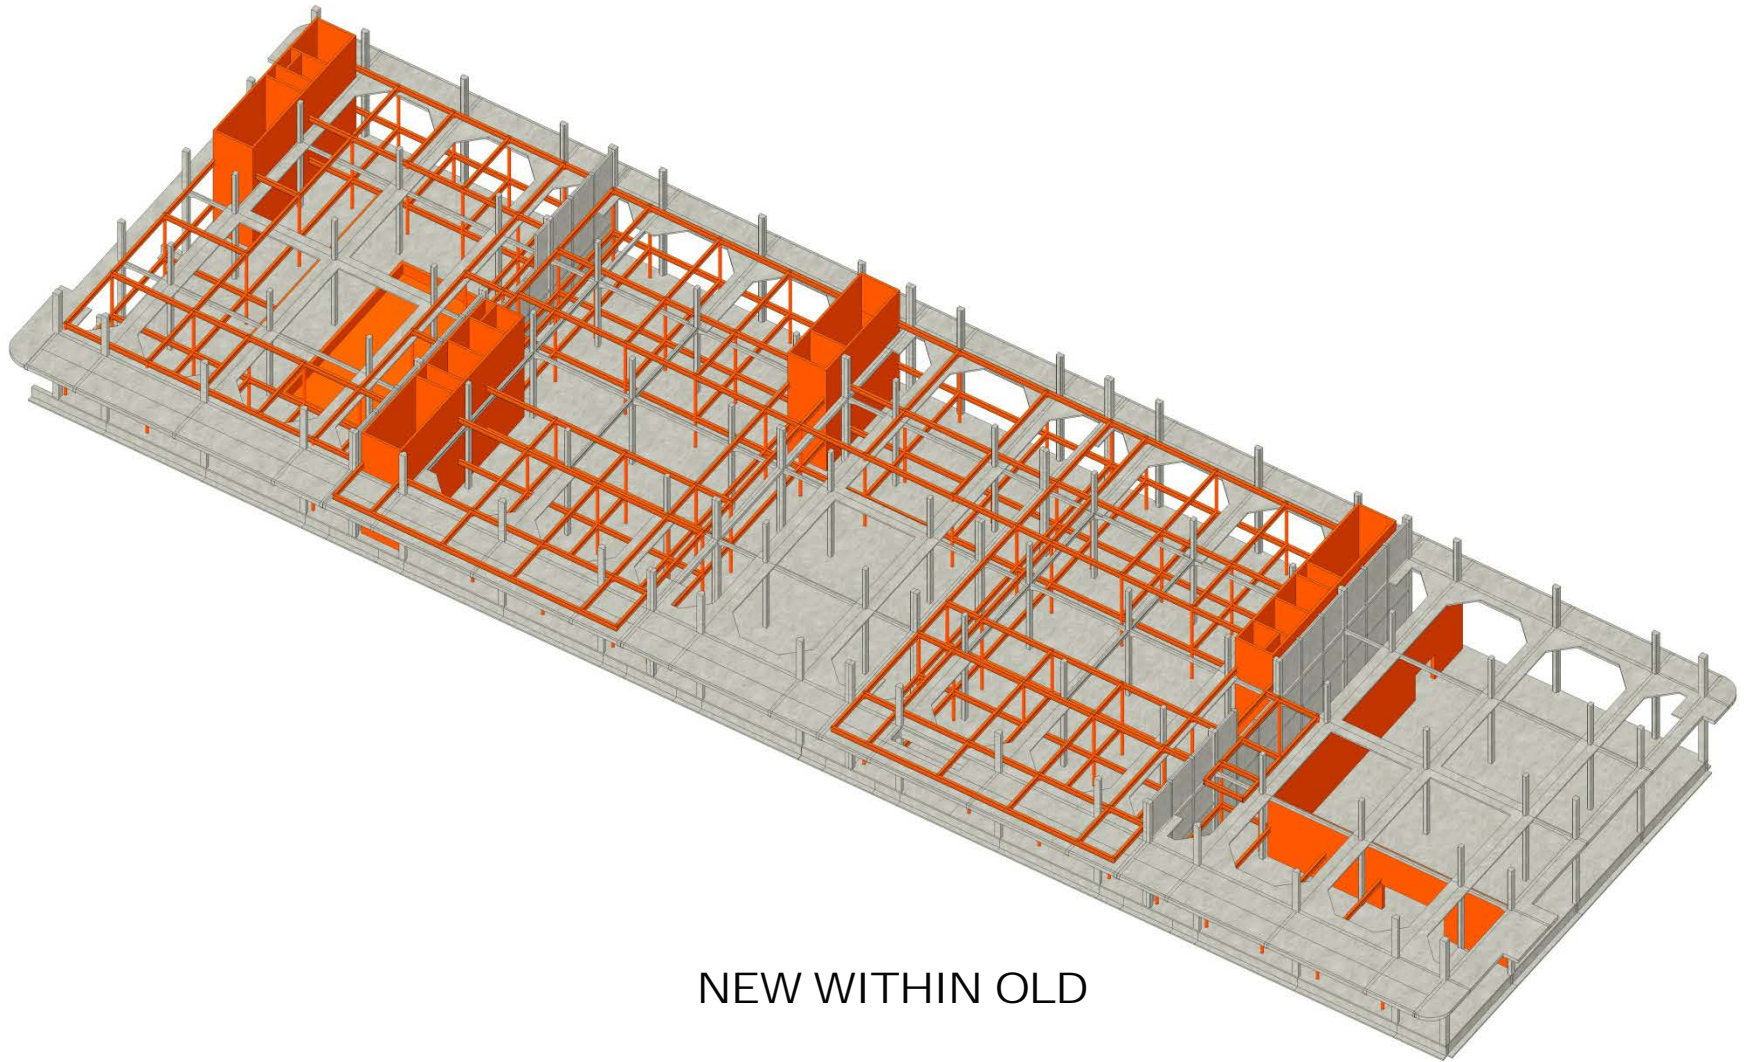
NEW WITHIN OLD

Orange: new structure. Grey: old structure

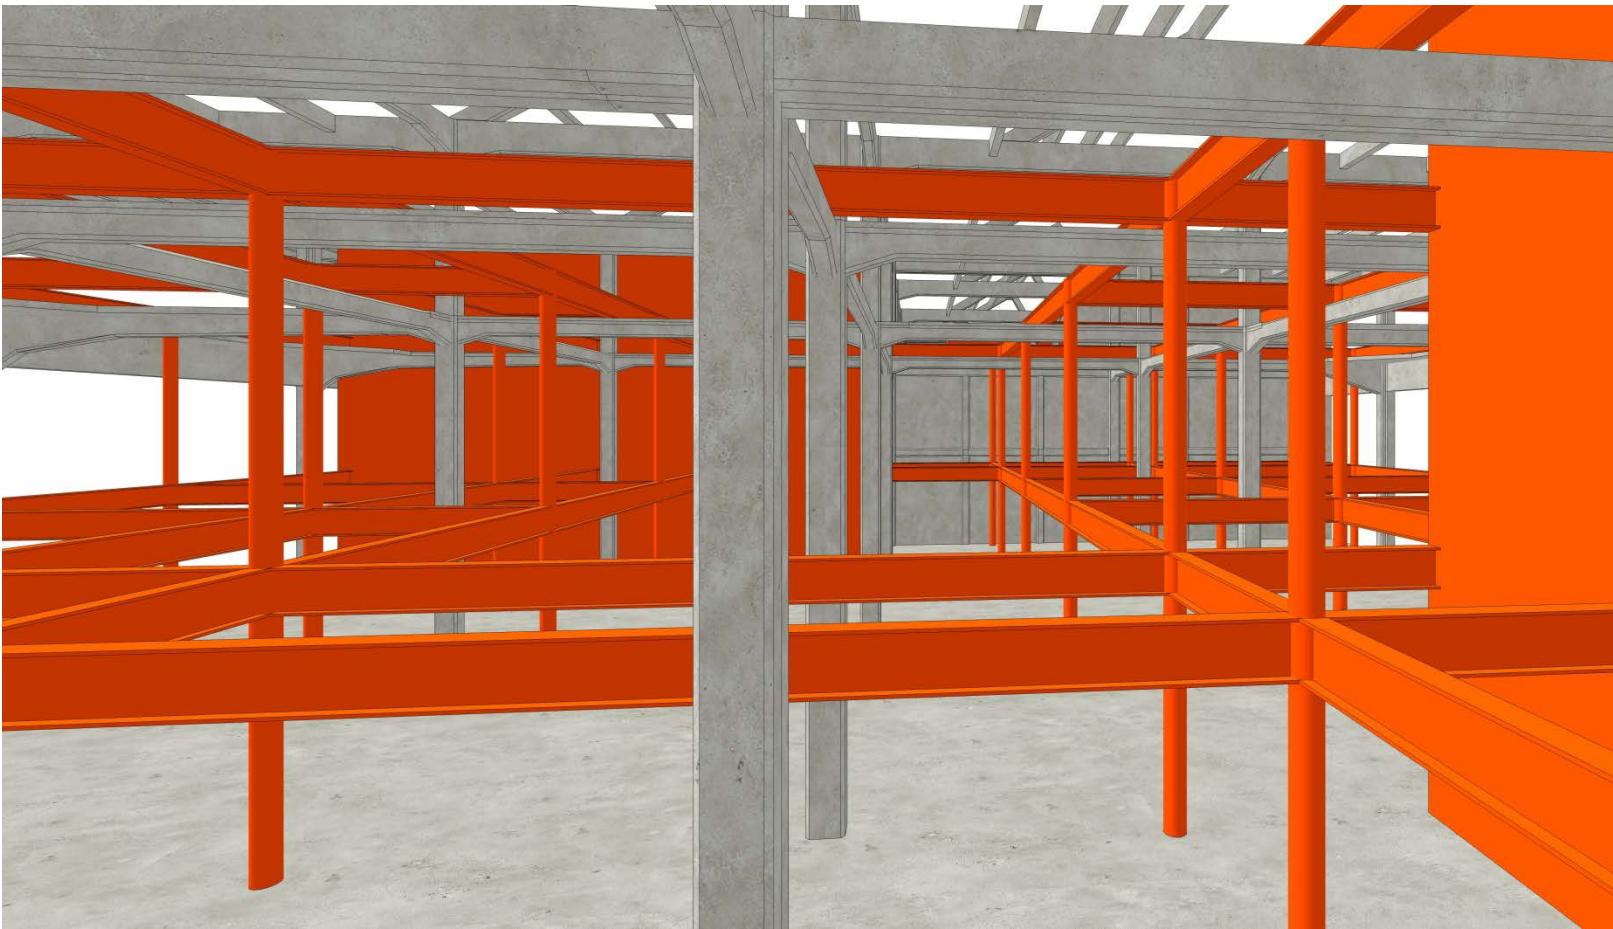
NEW WITHIN OLD

Orange: new structure. Grey: old structure
