# EXPERIMENTAL STUDY INVESTIGATING VARIOUS SHOREFACE NOURISHMENT DESIGNS

D.J.R. Walstra<sup>1,2</sup>, C.W. Hoyng<sup>3</sup>, P.K. Tonnon<sup>1</sup>, L.C. Van Rijn<sup>1,4</sup>

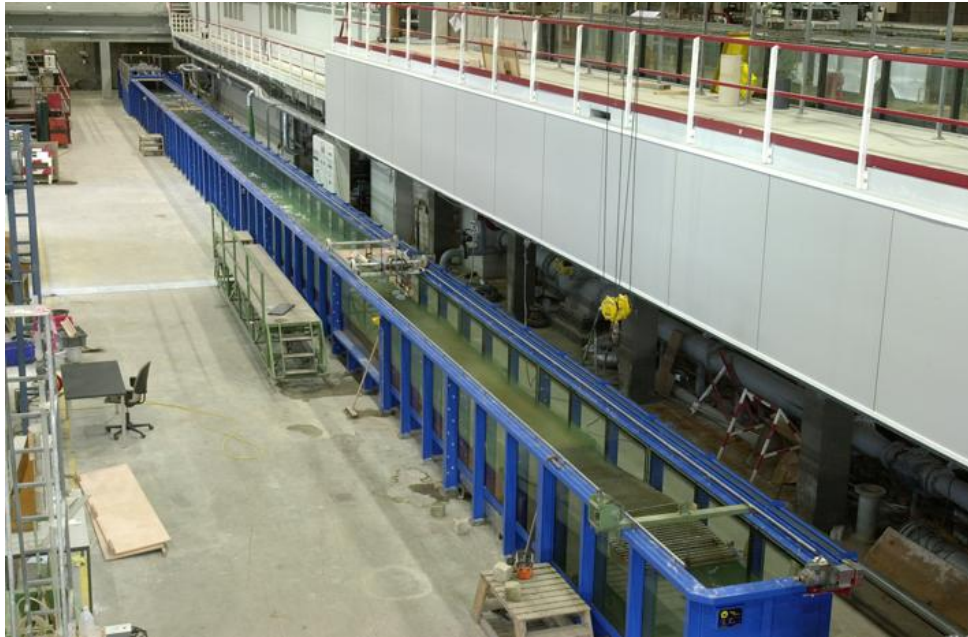
Figure 1. Scheldt flume at Deltares.

The experiments have been conducted in Deltares' Scheldt flume. The flume, consisting of an iron bottom and glass walls, has an overall length of 56 m, a width of 1 m and a depth of 1.2 m. The wave generator located at the beginning of the flume is equipped with an online active reflection compensation in which reflected waves are compensated for by separating them from outgoing waves. In addition, the wave board is equipped with second order wave steering to compensate for spurious waves.

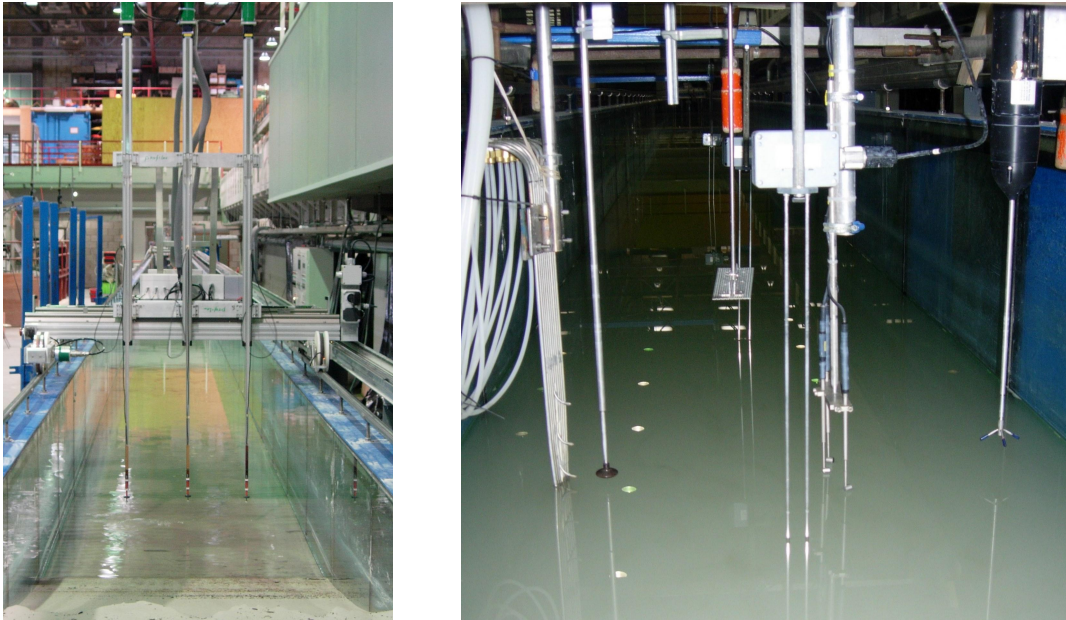
Figure 2. Left: bed profiler with three probes. Right: carriage with (from left to right): TSS, EMS, reference rod, WHM, ASTM and ADV.

During the experiments, bed profiles, water level variations, flow velocities, sediment concentrations and sediment transport have been measured. The flume is equipped with a rail-guided carriage, which allows automatic profile surveying. Three probes at a mutual distance of 25 cm move up, forward and down again (Figure 2). At fixed time intervals the bed profile is measured by the bed profiler. The results of the three parallel measurements give the average bed profile. Cross-shore non-uniformity of the bed profile has been checked and can be neglected.

During each test, five process-based measurements were carried out. These process-based measurements focused on measurements of wave-induced velocities and sediment concentrations. The flow velocities were measured with an ADV and EMV. The suspended sediment concentrations were measured using an acoustic sediment transport monitor (ASTM) and a Transverse Suction System to simultaneously measure time-averaged suspended-sediment concentrations at ten different heights (TSS, Bosman et al., 1987). A reference rod was used to determine to position the instruments consistently 1.5 cm above the bed. This equipment was all attached to a second rail-guided carriage (see Figure 2). The ADV, EMV and ASTM measured for 5 minutes at the exact vertical location of the 10 TSS suction tubes.

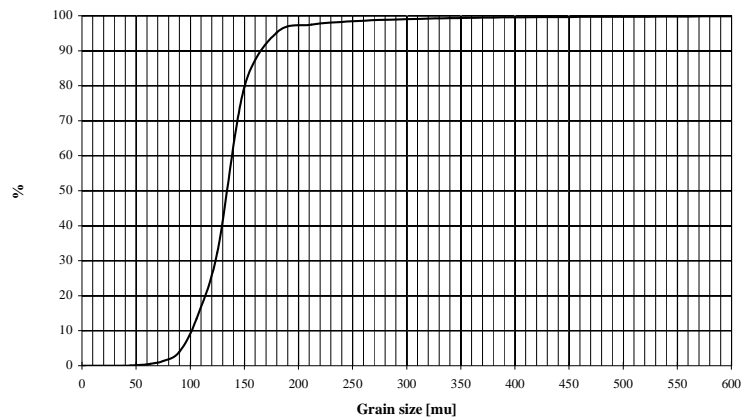
Figure 3. Grain size distribution of the sediment in the Scheldt flume.

The sediment used for the tests in the Scheldt flume is Sibelco AF100 sediment. D50 is slightly larger than 130  $\mu\text{m}$  (Figure 3).

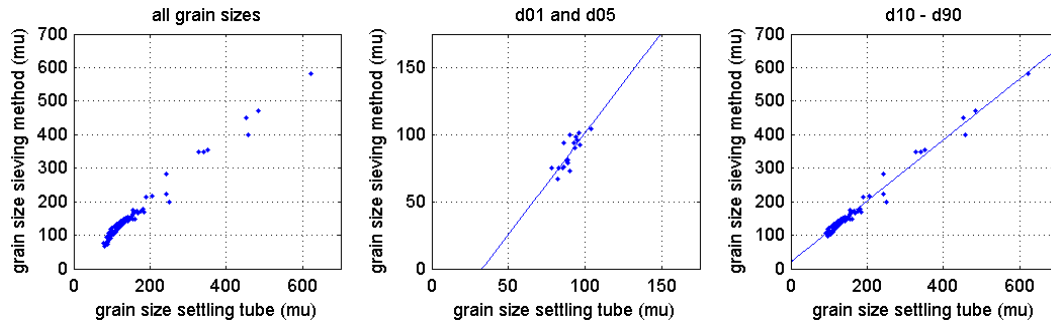
Figure 4. Calibration of Visual Accumulation Tube (VAT) with sieved sediments.

A Visual Accumulation Tube (VAT) was used to determine the suspended sediment grain size and fall velocity from the sand collected by the TSS. The VAT consists of a settling tube with a length of about 2 m and a diameter of approximately 3 cm. The sample is released on top of the tube by means of a simple clamp device. Under the settling tube a small tube is suspended in which the deposit height can be determined as a function of time. Based on this information, the fall velocity distribution can be determined. In the left plot of Figure 4 sieved sand is compared with VAT estimates. It can be seen that for smaller sediment the VAT under-estimates the grain size slightly. This due to the fact that for small grains cohesive forces and trapping becomes relative more important. Therefore separate conversions were determined which are shown in the middle and right plots of Figure 4:

$$\begin{aligned} D_s &= 1.5D_{vat} - 49 && \text{for } D_{01} \text{ to } D_{05} \\ D_s &= 0.91D_{vat} + 20 && \text{for } D_{10} \text{ to } D_{90} \end{aligned} \quad (1)$$

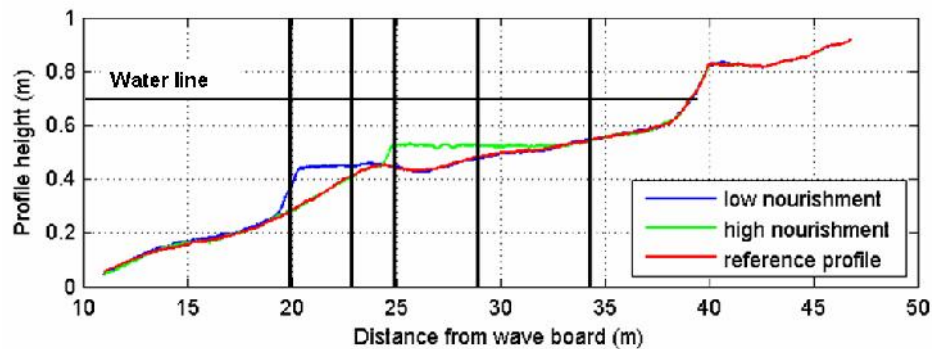
Figure 5. Initial profiles for the reference case and both nourishment cases, vertical black lines indicate positions of detailed hydrodynamic and sediment concentration measurements.

The experiments were designed to investigate two different nourishment designs with identical volumes: a nourishment relatively high in the profile covering the trough and a nourishment relatively low in the profile just seawards of the breaker bar (see Figure 5). In addition a natural profile was also considered to act as a reference. All profiles were subjected to an accretive and an erosive wave condition (Table 1).

Besides regular profile measurements (0, 1, 3, 8, 16, 24 hours) detailed velocity and sediment concentration measurements were carried over the water column out at five horizontal locations (indicated in Figure 5).

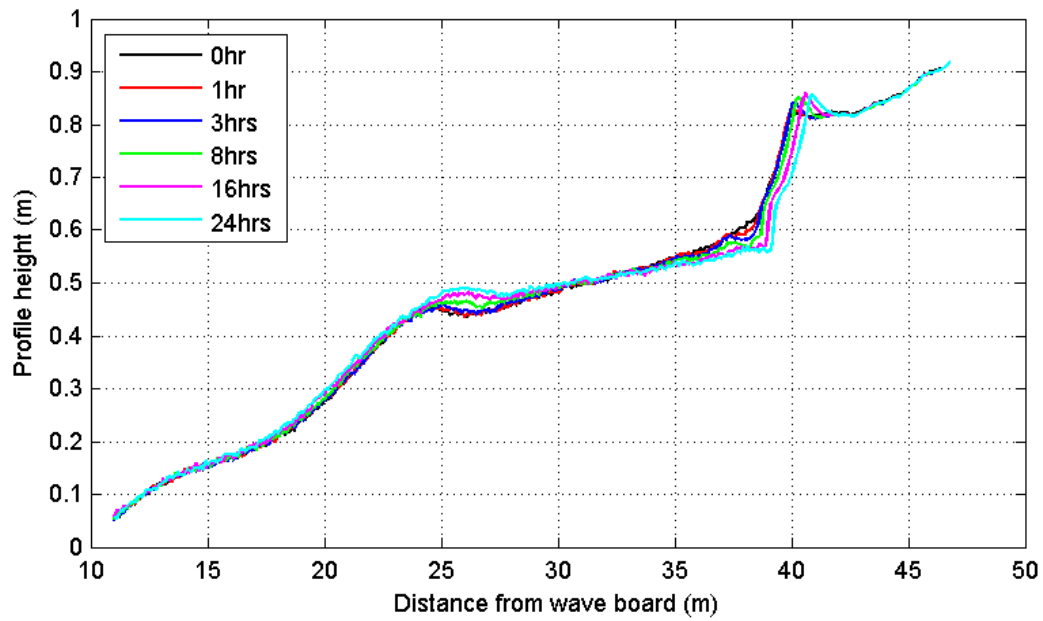
Figure 6. Observed profile development for the reference profile under accretive wave conditions.

In Figure 6 to Figure 11, the beach profile development of the reference tests and the tests with the two nourishment designs are shown. It is clear that for the both accretive and erosive wave conditions the upper part of the profile ( $x > 32$  m) is eroding. However, for the reference case (Figure 6 and Figure 7), the bar at  $x=24$  m is showing an opposite migration response to both wave conditions. The erosive wave condition results in an offshore migrating breaker bar, whereas the accretive wave condition results in a landward migration of the breaker bar.

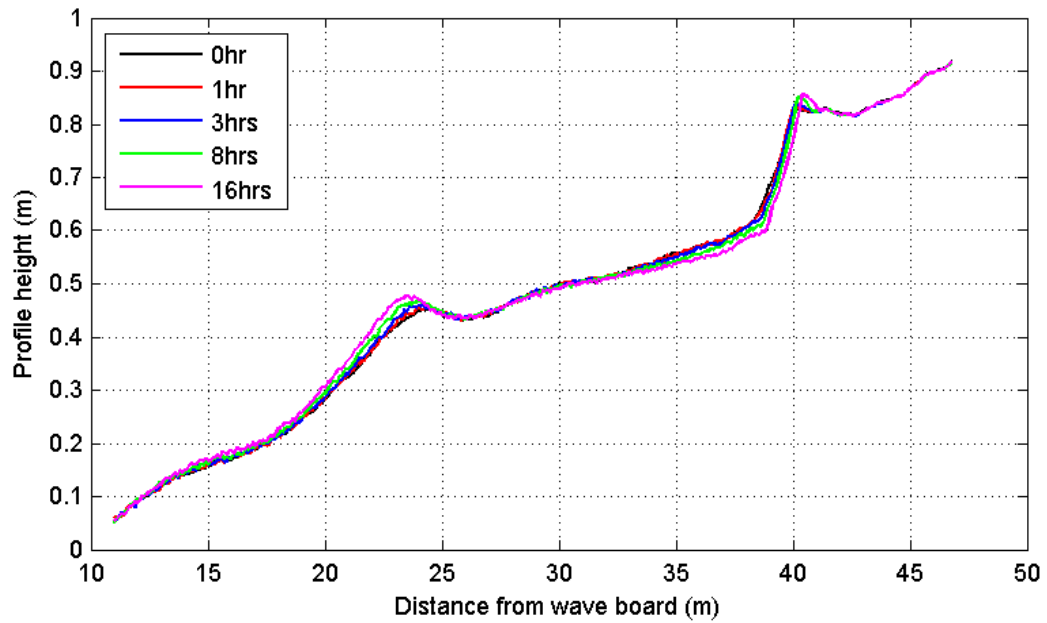
Figure 7. Observed profile development for the reference profile under erosive wave conditions.

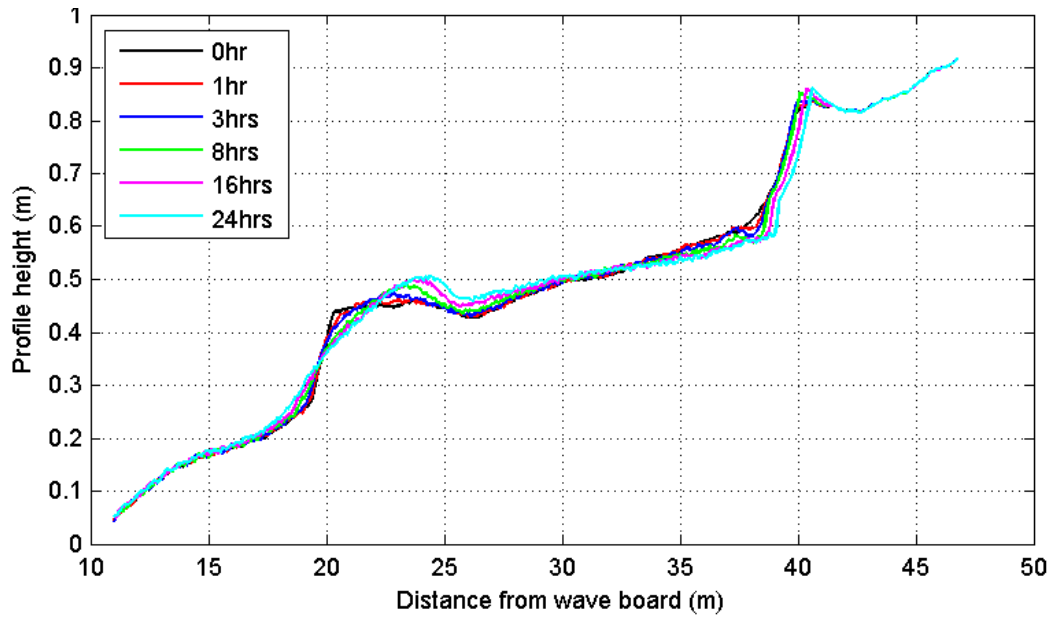
Figure 8. Observed profile development for the low nourishment profile under accretive wave conditions.

The observed nourished profile developments under accretive waves (Figure 8 and Figure 10) show that the low nourishment has a similar response as the reference profile, whereas the high nourishment is more or less stable. The height of the breaker bar of the reference tests and of the test with the low nourishment increases. The nourished sand is transported landward and a bar is developing with a crest at about 0.5 m. However, the upper part of the profile is still eroding for both nourishment designs.

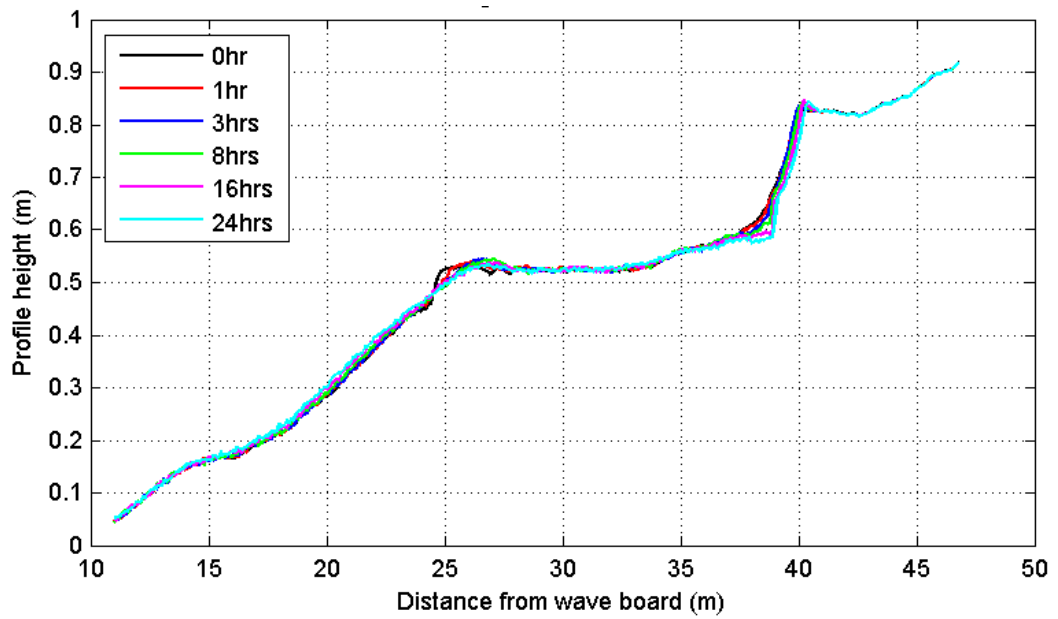
Figure 9. Observed profile development for the high nourishment profile under accretive wave conditions.

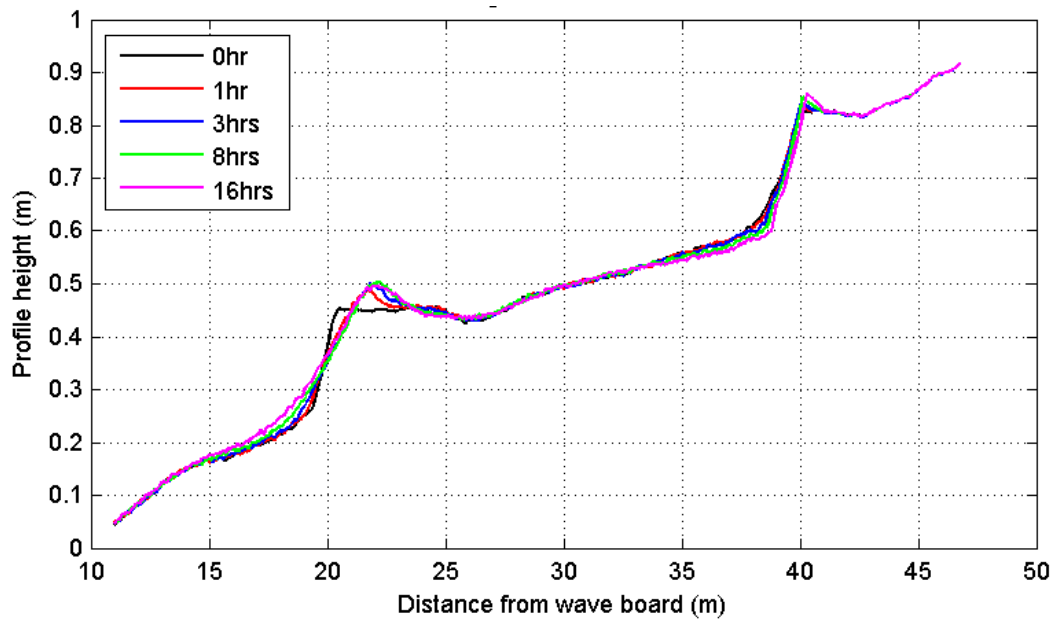
Figure 10. Observed profile development for the low nourishment profile under erosive wave conditions.

For the erosive wave condition the lower nourishment reacts in a similar way as for the accretive wave condition: a bar is developing at the nourishment with a crest height of about 0.5 m. The high nourishment now shows a clear offshore migration with a bar emerging with a similar crest height of 0.5 m.

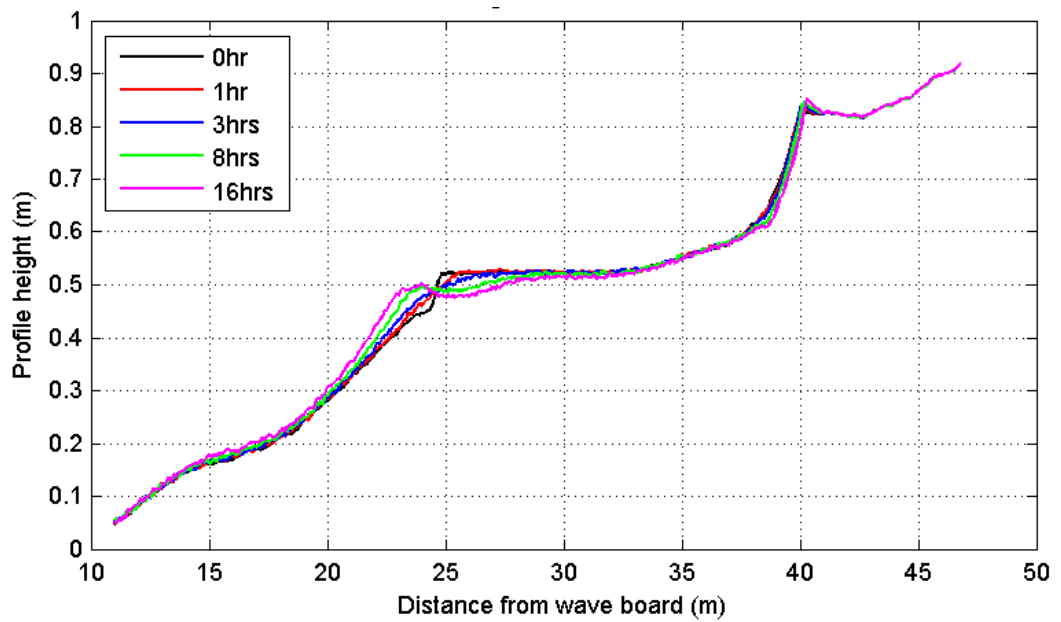
Figure 11. Observed profile development for the high nourishment profile under erosive wave conditions.

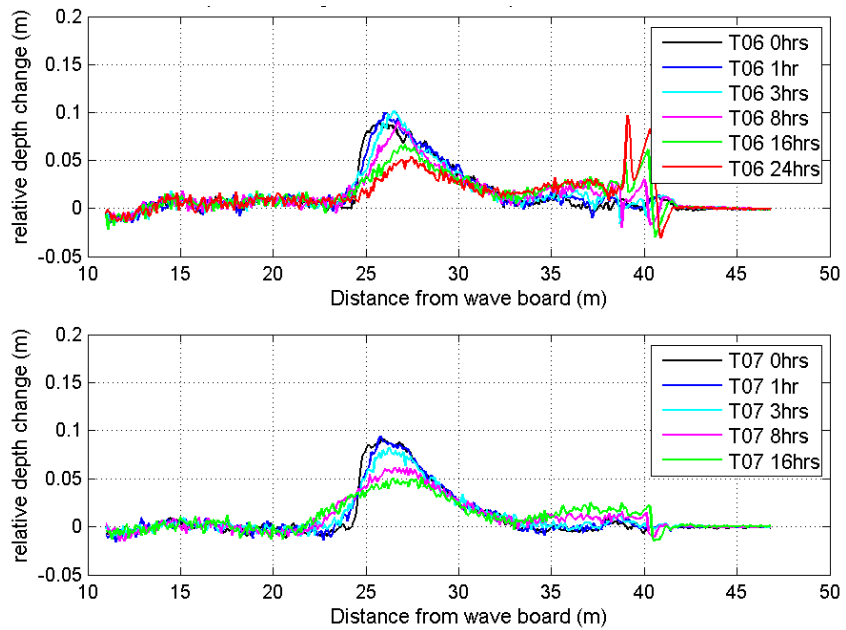
**Figure 13. Profile change relative to reference case for the high nourishment design (top: accretive conditions, bottom erosive conditions).**

By subtracting the reference profiles from the nourished profiles the impact of the nourishments is visualized. As the profiles were measured at the same times, the relative impact can be assessed as the profiles are changing during the experiment. In Figure 12 the relative changes for the low nourishment design are shown for the accretive condition (top plot) and erosive condition (bottom plot). For the accretive wave condition a relative large part of the sediment is moved onshore. For the erosive wave condition more of the nourished sediment is stable with some diffusion at both distal ends. The upper part of the profile shows a relative increase which, as both the nourished and reference profile are eroding in this area, should be interpreted as an absolute decrease of the erosion due to the nourishment. The same relative changes are evaluated for the high nourishment design in Figure 13. Compared to the low nourishment, the high nourishment shows more diffusion of nourished sand across the profile. The high nourishment design results in a decreased erosion of the upper part of the profile for both the accretive and erosive wave conditions.

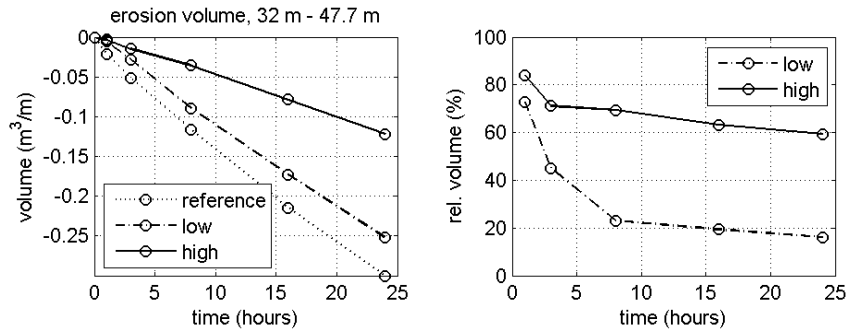
Figure 14. Left: absolute erosion volumes for the accretive tests for the reference profile (T02), the low nourishment design (T04) and high nourishment design from  $x = 32\text{m}-47.7\text{m}$ . Right: temporal development of same volume, relative to the reference profile.

The erosion volumes are determined for the upper part of the profile ( $32\text{m} < x < 47.7\text{m}$ ) to quantify the effect of the two nourishment designs. Figure 14 (Figure 15) shows the erosion volumes of the accretive (erosive) tests for the reference and nourished profiles. It can clearly be observed that both designs have a positive influence on the upper profile development. The reference profile is subject to the largest erosion,  $0.3 \text{ m}^3/\text{m}$  for the accretive test and approximately  $0.2 \text{ m}^3/\text{m}$  for the erosive test. The larger erosion of the upper part of the profile for the accretive waves is most-likely caused by the fact that the initial profile in the present experiment was obtained by subjecting a profile to 8 hours with the erosive wave condition (the starting profile was the measured final profile from the experiments by Koomans and Bosboom, 2000). Therefore the upper part initial profile is probably more in equilibrium with the erosive wave condition, resulting in less erosion for this wave condition.

The low nourishment reduces the erosion to  $0.25 \text{ m}^3/\text{m}$  for the accretive test and  $0.12 \text{ m}^3/\text{m}$  for the erosive test. The high nourishment results in the largest reduction for both wave conditions:  $0.12 \text{ m}^3/\text{m}$  for the accretive test and  $0.08 \text{ m}^3/\text{m}$  for the erosive test.

To obtain better insight into the effects of the nourishments on the bed profile development, the relative increase of sand volume in the coastal zone is shown in the right plots of Figure 14 and Figure 15. The low nourishment results in a relative increase of sand volume, 20% for the accretive condition and 40% for the erosive condition. The high nourishment has the largest relative increase of sand volume: 60% for both wave conditions.

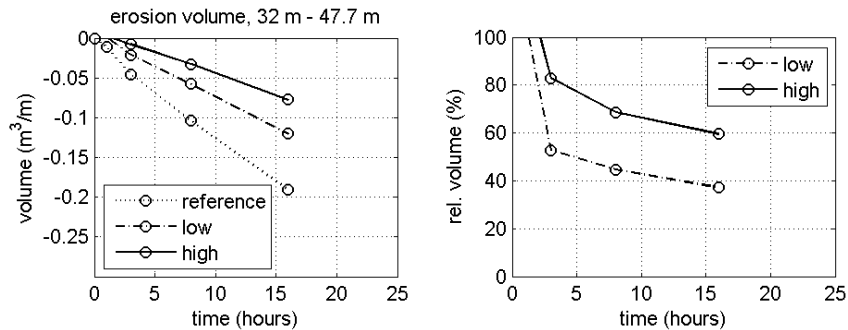
Figure 15. Left: absolute erosion volumes for the erosive tests for the reference profile, the low nourishment design and high nourishment design from  $x = 32\text{m}-47.7\text{m}$ . Right: temporal development of same volume, relative to the reference profile.

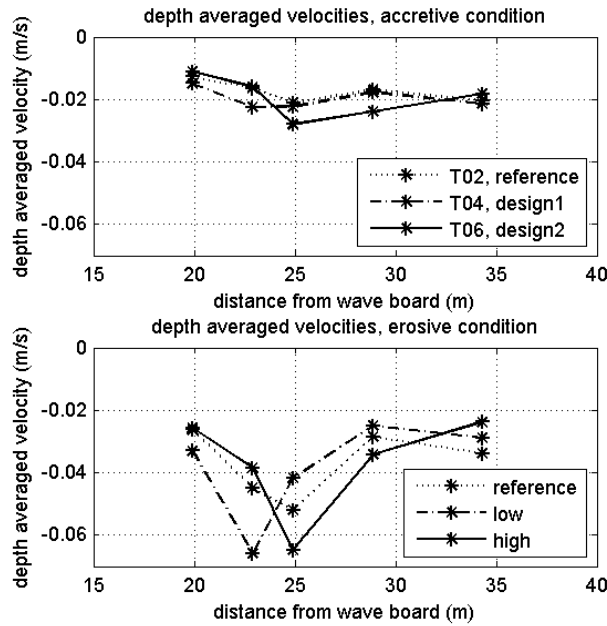
Figure 17. Depth-averaged velocities for the accretive (top) and erosive (bottom) wave conditions.

The associate depth averaged wave induced return flow is compared in Figure 17. Enhanced velocities are present at the nourishments due to wave breaking. Near shore the effect of the nourishment is negligible for the accretive wave conditions, but for the erosive wave conditions the depth-averaged velocities have reduced noticeably for both nourishment designs.

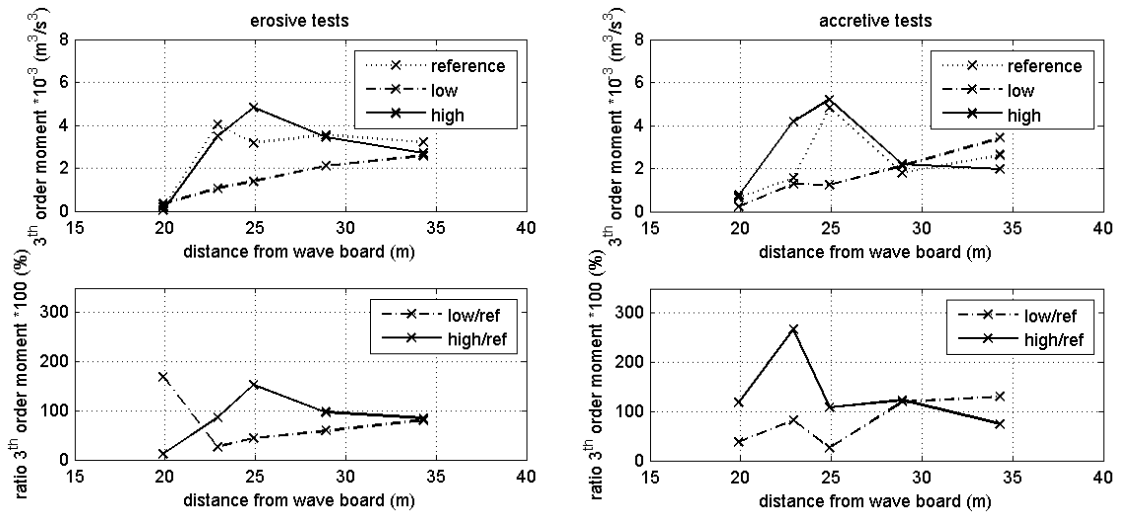
Figure 18. 3<sup>rd</sup> Order velocity moments for the erosive conditions (left) and accretive conditions (right). Top row: absolute values, bottom row: ratio of the velocity moments of the nourishment designs and the reference profile.

Third order velocity moments, shown in Figure 18, are an indicator for the transport due to wave skewness. For the erosive condition, on top of the high nourishment, the third-order velocity moments are significantly larger than the other two tests. The third order velocity moments close to the coastline are more or less the same. However, as the wave heights are lower in the upper part of the profile, similar velocity moments imply increased wave skewness.
