Impacts of Hurricanes Frances and Jeanne on Two Nourished Beaches along the Southeast Florida Coast

Lindino Benedet,^{1,2} Thomas Campbell,¹ Charles W. Finkl¹, Marcel J.F. Stive,² and Rick Spadoni¹

1. Coastal Planning & Engineering, Inc.
2481 N.W. Boca Raton Blvd, Boca Raton, FL
lbenedet@coastalplanning.net

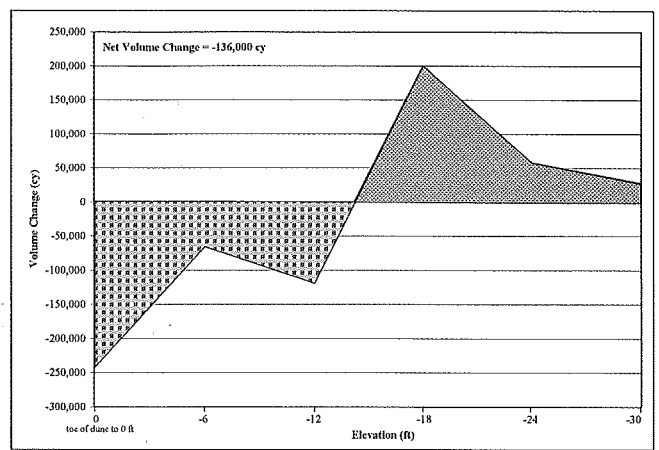
Figure 6. Volumetric changes along the Boca Raton project area. Sediment eroded from the toe of the dune to the 0 foot elevation and deposited from around the -12 foot elevation to -22 feet. Volume changes are minimal seaward of the -22 ft contour are minimal. The peak of erosion was observed at subaerial beach while the peak of deposition was observed around -18 feet deep.

Volumetric changes along the project area per depth contours are shown in Fig-

ure 6. It is noted that most of the erosion occurred from the toe of the dune to the -12 foot to -13 foot depth contours and deposition occurred mostly from the -12 feet to -22 feet contour. Most of the erosion was verified on the subaerial beach as the recently built fill construction template adjusted cross-shore (240,000 cy, 30 cy/foot) eroded from the toe of dune to the 0 foot contour). The total erosion from the toe of dune to the -12 foot contour was -421,500 cy (53 cy/foot), the deposition from the -12 foot contour to the -30 foot depth was 285,500 cy (36 cy/foot). Therefore, the net volume loss along the project area (R-216 to R-222), between the dune to the -30 foot depth contour, was -136,000 cy (17 cy/foot), which is roughly equivalent to 28 percent of the original volume placed by the dredge contractor. On the other hand, the volume loss to the design closure depth (-18 feet) was -222,000 cy (28 cy/foot), which is roughly equivalent to 46 percent of the volume placed by the contractor. Because good closure was observed in the profiles it is inferred that the net volume change to the -30 foot contour was lost by alongshore sediment transport while the changes to the design closure of -18 feet correspond to the volume lost from the project template by alongshore and cross-shore processes.

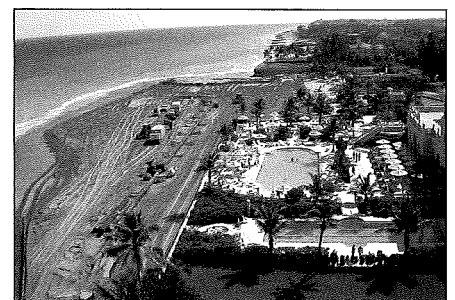
Figure 8. Construction of the Palm Beach 2003 beach nourishment project. The area illustrated is located south of The Breakers (between R-94 and R-95).

A photograph of the project under construction is provided in Figure 8. The property on the right side of the photograph is the internationally famous The Breakers hotel. Originally constructed in 1896, the property was one of the first major developments of the barrier island. After the passage of Hurricanes Frances and Jeanne, little beach was left in front of The Breakers, nevertheless the large beachfront property sustained minor wave damage from the storms because a nourished beach was in place prior to the storms. The public beach about a mile south of The Breakers experienced no significant damage from the two hurricanes, as shown in Figure 9. For comparative purposes, a picture of non-restored beach just south of the nourishment project is provided in Figure 10. This non-nourished

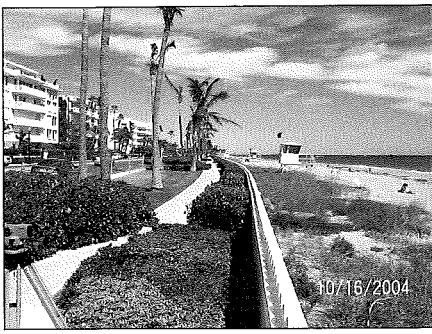
Figure 9. The Palm Beach Mid-Town nourishment project area soon after the passage of Hurricane Frances and Jeanne. The photograph was taken from FDEP monument R-98, view looking towards the north. The photograph was taken during the post-hurricane beach profile surveys (notice the survey level instrument on the lower left corner of the

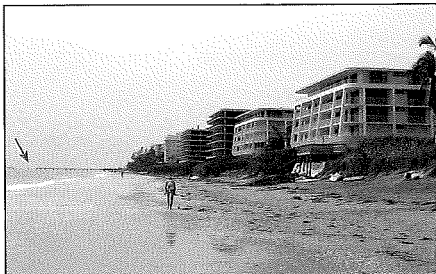
Figure 10. Non-nourished beach located less than five miles south of the Palm project. Notice the undermined structures on the right-hand side of the photograph and the destroyed fishing pier indicated by the black arrow.

area suffered significant dune escarpment and the buildings were undermined.

A qualitative indication of the magnitude of the storm is shown in Figure 10, where the Lake Worth fishing pier (indicated by the arrow on Figure 10) was almost totally destroyed. The coast north of the project area (25 miles to 200 miles north) was directly hit by Hurricane Frances and Jeanne; in these segments, the damage to coastal infrastructure, especially along non-nourished beaches, was significantly larger than at the town of Palm Beach as shown by other papers in this special issue (see Clark, and Barker and Bodge, this issue).
