**THE CHURCH CROSS AND THE STORM OF 1674**  
**THE INTANGIBLE ENIGMA OF UTRECHT**  
a history thesis by Dimitri Nalmbantis

Student number 4577906  
Tutor Dr. Everhard Korthals Altes  
Academic year 2020 / 2021

DELFT UNIVERSITY OF TECHNOLOGY  
FACULTY OF ARCHITECTURE, URBANISM AND BUILDING SCIENCES

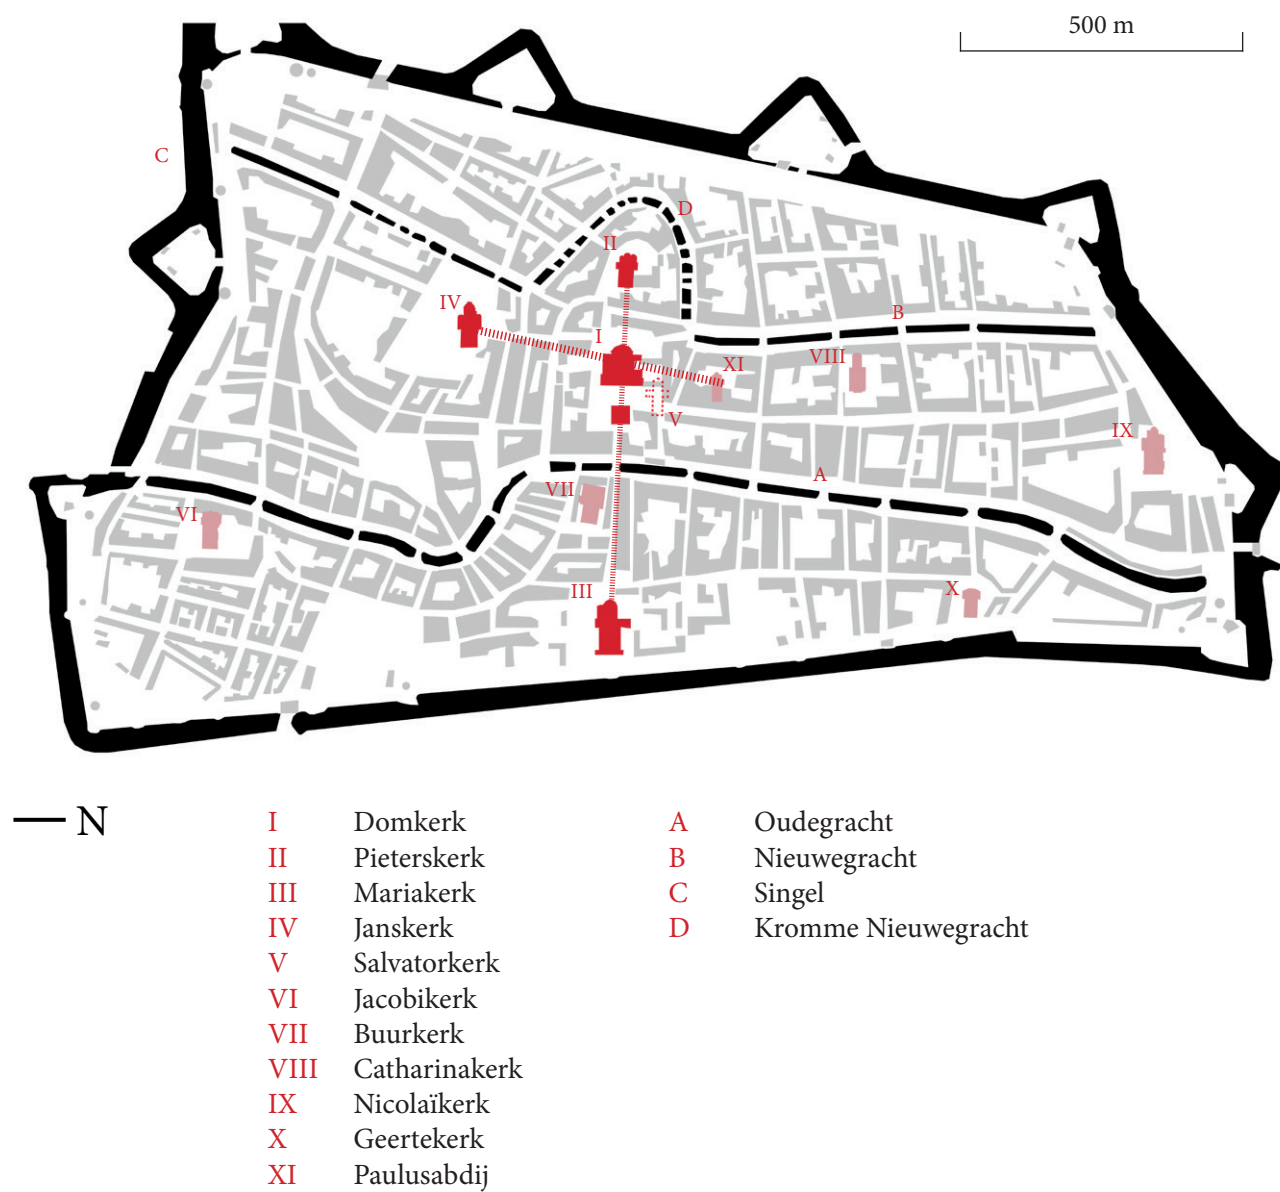
1 | Utrecht figure ground map, with cross plan | own illustration, based on Van Vianen, 1695

The position of these churches in the city's plan was to form a Christian cross with the Domkerk in the centre (1), following bishop Bernold's plan. The surrounding churches will be referred to as the perimeter of the cross in this research. The form of a cross was not planned precisely since the Salvatorkerk was built against the Domkerk, and the Janskerk was positioned two hundred metres from this middle point. As a result, the bishop planned the Paulusabdij to literally finish the cross, even though this location was still not forming a perfect symmetry. Furthermore, collegiate churches have major differences from monastery and parish churches. An important aspect that collegiate churches did have was an immunity sector. This was a separated district within the city where the religious law of the corresponding church applied. These immunities were often surrounded by a waterway, for instance the Kromme Nieuwegracht (D) circling the immunity of the Pieterskerk. While this was the case, some buildings were still present between the churches. Therefore, it can be concluded that the symbolic value of the Christian cross was the main goal instead of a monumental experience of axes placed in the form of a cross.

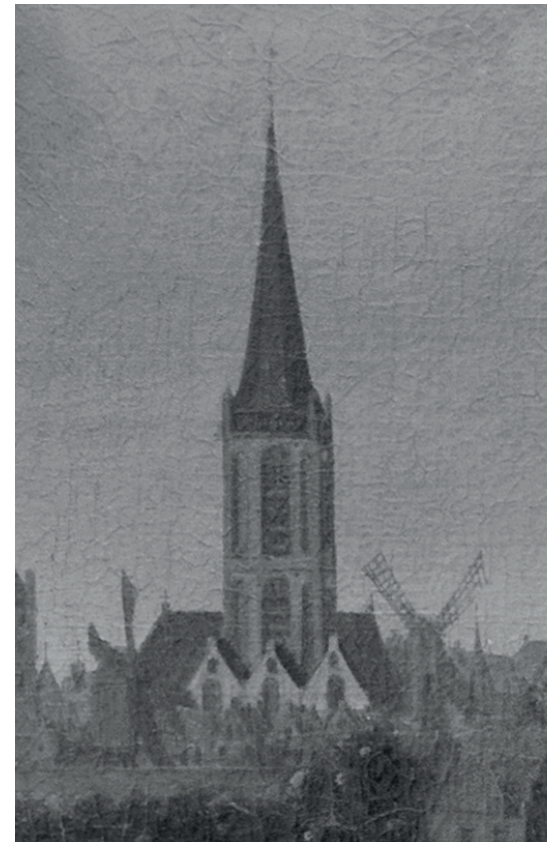
10 | Before the storm | Joost Cornelisz Droochsloot, 1660 - 1665 (Centraal Museum)

The storm of 1674 destroyed the spire of the tower completely. The tower was also destroyed from the top until the bells, resulting in the bells to fall down the tower, damaging the roof and most windows (Van Hulzen, 1985). The damaged church bells were molten down to pay the renovations needed for the essential elements of the church to function. This led to a cheap solution of the lost church spire. The church, once known for its needle spire, has a new spire in a stump shape (11). A so-called tent roof (Wilmer, 2005).

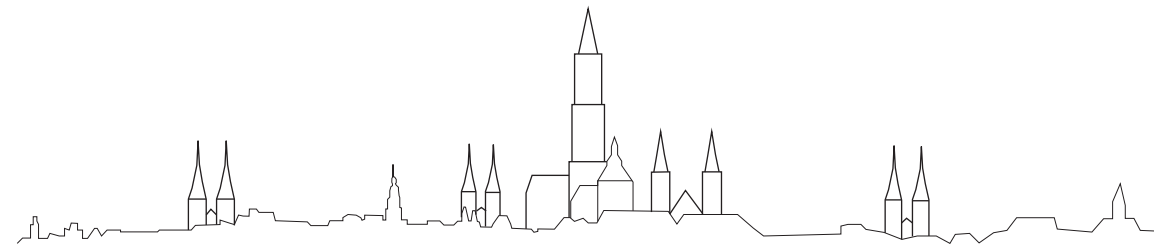
20 | Combined skyline; northwest elevation | own illustration

For the Jacobikerk and the Nicolaïkerk, the change of shape from needle spires to stump spires caused the verticality to be largely erased from the skyline. The new spires looked more like the deprecated style of Romanesque churches. In addition, the Janskerk and the Pieterskerk lost complete towers, which also had pointy spires positioned on the top. This consequently degraded the prestige of Utrechts' skyline.

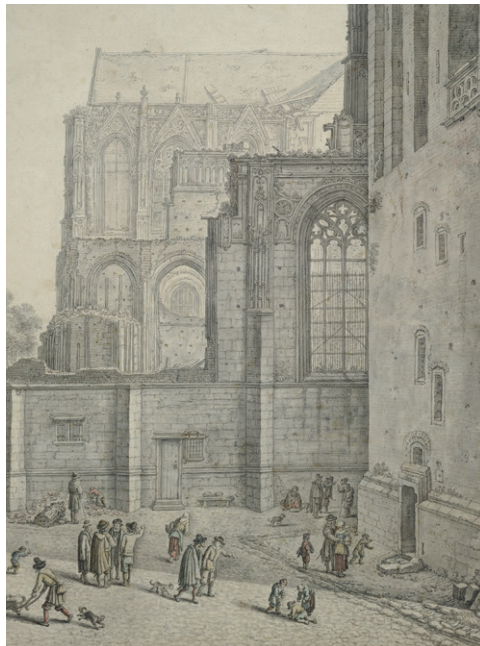
29 | West facade with the Domtoren (right)

| Herman Saftleven, 1674 (Utrechts Archief)

The choir, which in contrast was built with buttresses, mainly survived the storm, except for the decorative elements. Likewise, the tower and west facade were still standing. At first glance it seems strange how the west facade, which was built from only a flat wall with some pilasters, survived the storm. Be that as it may, it also has a possible and logical explanation. For the nave to have failed this badly, it means that the winds and tornado must've passed perpendicular. The west facade stands ninety degrees on the destroyed nave, which means that the storm passed parallel. Therefore, it didn't have a large surface area for the wind to pressurize on. When looking at the images by Saffleven (27 and 29), we even see that the window remained intact. This can be explained by its close position to the Domtoren, which might have blocked the

winds. The same goes for the two main gates on this facade. Above these gates, the bridge connecting the west facade to the Domtoren, also survived.

That the Domtoren didn't collapse was a miracle. From the drawings by Saftleven it also looks largely intact. However, the danger for the tower was not over yet. Since the French, in 1672, left Utrecht in a poor state, the city didn't have the money to pay for a reconstruction of the nave nor the maintenance of the Domtoren. As a result of this decay, the tower was at the fringe of collapsing in 1833 (Domtoren, n.d.).

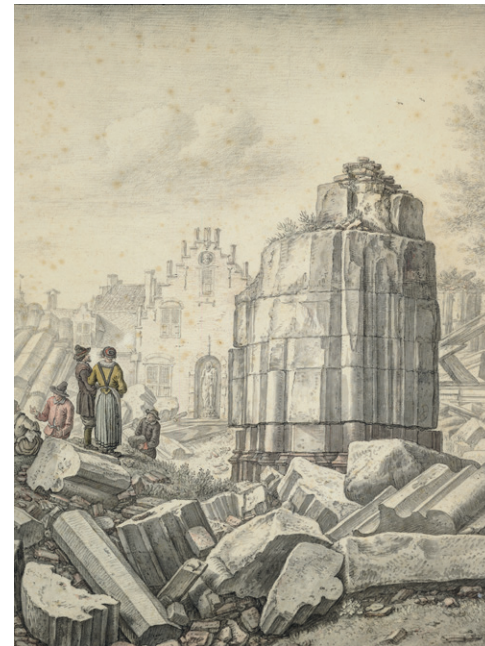
30 | Destroyed arcade pillar |  
Herman Saftleven, 1675 (Utrechts Archief)

In the drawing (30), the broken pillar on the north wall is visible. A broken pillar of this size compared to the size of people on the left speaks for itself. It must've been a tremendous force that the Domkerk had to cope with. Even though the missing buttresses were a main issue, the weather conditions were simply exceptional. On the south facade, two small chapels survived the storm. These are still visible today (Wilmer, 2005).
