# Briefing: Lessons learned from failures of flood defences

**1 Sebastiaan N. Jonkman**

**2 Timo Schweckendiek**

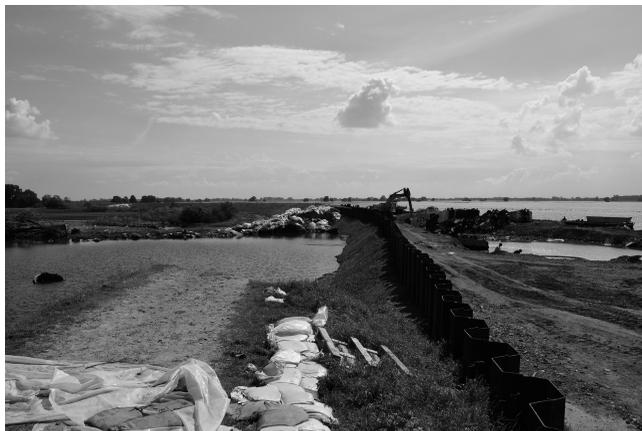
**Figure 1.** Breach of about 100 m width at Fischbeck along the Elbe (Germany, June 2013) induced by a geotechnical failure. The photograph shows the breach with the emergency repair works, consisting of a sheet pile in a soil embankment

During the flood events along the Elbe, the dyke failure in Wilnis and the flooding of the central parts of New Orleans, geotechnical failure mechanisms such as instability and internal erosion (piping) were the main causes of flooding (see Figure 1 for an example of a geotechnical failure). These mechanisms occur while the outside water level is below the crest or top of the flood defence structure. Uncertainty in ground conditions and the presence of unidentified adverse geological details are common causes of failures (Danka and Zhang 2015). This highlights the need for proper site investigation and the use of all the information that can be obtained on the (sub)soil conditions.
