MECHANICAL ENGINEERING REPORT
MS-122

THE FATIGUE STRENGTH OF BUTT-WELDED AND PLAIN
SPECIMENS OF 18(250) MARAGING STEEL PLATE

J. A. DUNSBY AND A. C. WALKER
NATIONAL AERONAUTICAL ESTABLISHMENT

OTTAWA
MAY 1969

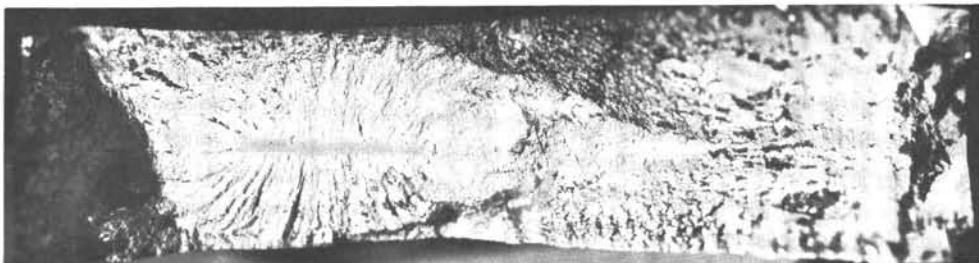
FIG. 11c: FRACTURE SURFACE — INCOMPLETE PENETRATION

FIG. 11b: MULTIDIRECTIONAL
ULTRASONIC INDICATION

This specimen gave two ultrasonic indications; the weaker appeared to be from a planar defect while the stronger gave a multidirectional return signal and might therefore be associated with pores or inclusions. Figures 11a and 11b show the magnitudes of the signals obtained (the relevant signal in these and subsequent illustrations is that part in the gate on the time base of the oscilloscope trace, the latter being used to position the centre of the weld). The specimen was tested at a maximum stress of 70 ksi (483 MN/m²) with the weld bead removed after heat treatment, and failed after 16×10^6 cycles. The fracture surface, shown in Figure 11c, reveals the origin of the failure as incomplete penetration at the centre of the weld, and the position of the origin was found to correlate with the weaker return signal. This signal was identified as being from a planar defect that obviously generated a more severe stress concentration than did the pores or inclusions associated with the stronger signal.

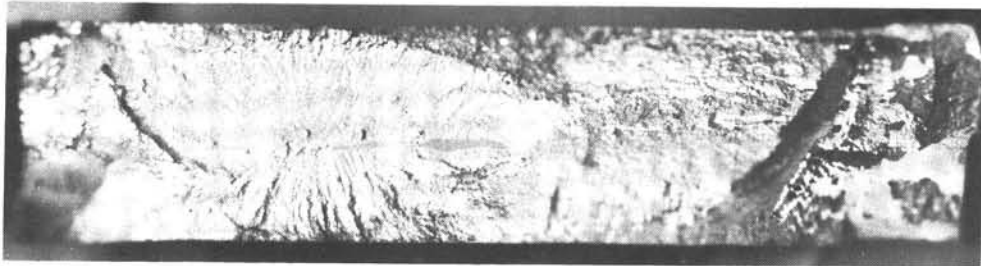
FIG. 14: FRACTURE SURFACE

NOTE: ORIGIN AWAY FROM REGION OF INCOMPLETE PENETRATION

Specimen B-6W-AG was interesting in that, although no significant defects were located by non-destructive testing, two imperfections are clearly visible in the fracture surface (Fig. 14). The origin of the failure appears to be an inclusion near the centreline of the weld; the crack has also passed through a region of incomplete

penetration. In spite of the presence of the two imperfections in this weld, there were no serious consequences to the fatigue strength. The specimen was ground after aging and survived 12×10^6 cycles at a maximum stress of 55 ksi (379 MN/m²), and failed after a further 1.4×10^6 cycles at 75 ksi (517 MN/m²).
