WAVE OVERTOPPING SIMULATOR TESTS ON VIETNAMESE SEA DIKES

Little is known about the strength of the land-side slopes of the Vietnamese sea dikes under overtopping attack. Some grass-covered slopes were tested by a wave overtopping simulator. The paper describes the simulator and presents the test results. The tested grass covers could withstand overtopping rates varying from 20 to 100 l/s per metre of dike length in some hours. Damage usually started at bare spots, at the transition between the slope and the toe, at the transition between different materials, and around objects (e.g., big trees). These features reduce the strength of a grass cover and therefore should be avoided.

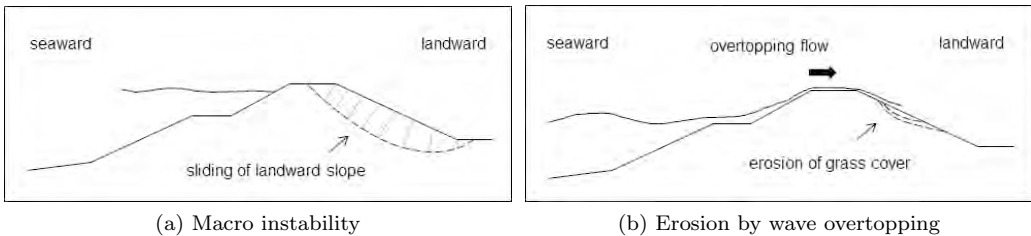
Fig. 1: Failure mechanisms of landward slopes.

Wave overtopping may cause damage to the crest and the land-side slope of a sea dike covered with grass. In principle, two different mechanisms can be distinguished as shown in Figure 1. The first one, i.e., sliding of landward slope, mainly occurs on steep slopes, especially between 1/1.5 and 1/2.0, due to water infiltration and sliding. This sliding may directly cause dike collapse. However, the mechanism is not likely to be due to wave overtopping, but rather due to large quantities of water infiltrating the dike body. This process may be aggravated by heavy rainfall.

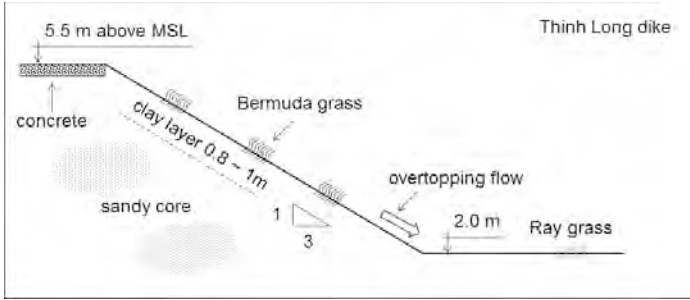
Fig. 3: Cross-section of the Thinh Long sea dike.

The first site was in Nam Dinh province, where the Thinh Long dike was constructed of sand (core) and clay (outer layer). The dike crest level is at +5 m above Mean Sea Level (MSL), and the crest width is 4.5 m and is paved with 20 cm-thick concrete. The dike toe was about 10 m long and was covered with Ray grass (*Panicum Repens*). The 1:3-inclination slope was 10 m long, and was covered with mainly Bermuda grass (*Cynodon Dactylon*), sometimes in combination with Casuarina trees. Bermuda grass was about 4 years old when testing. Three sections were selected. TL1 was a regular slope covered with good grass; TL2 had a big Casuarina tree in the middle; and TL3 had some open spots (i.e. no grass). Water was pumped from a brackish water canal parallel to the dike toe. The Thinh Long dike cross-section is graphically illustrated in Figure 3.

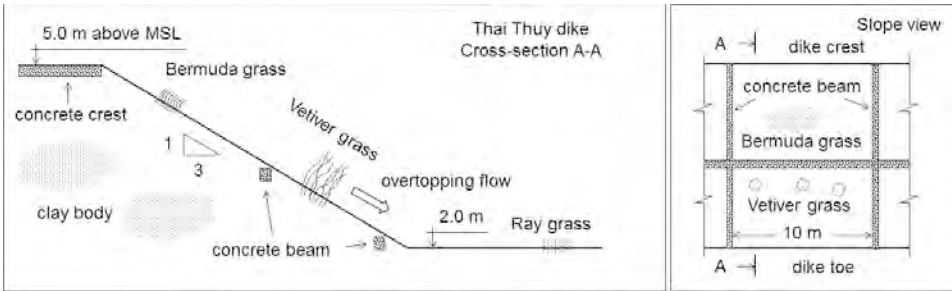
Fig. 4: Schematization of the Thai Tho sea dike.

The second site was on a estuary dike in the Thai Tho commune, Thai Thuy district, Thai Binh province. A combination of Bermuda grass of 5 years old and 6-month-old Vetiver grass (*Vetiver Zizanioides*) on the riverside slope was tested at three positions: TT1, TT2 and TT3. The dike body was constructed of clay and the 1:3-inclination slope was reinforced with concrete frames from crest to toe. These sections were chosen to have different concrete beam configurations and grass

quality. The horizontal toe was regularly covered with a dense sward of Ray grass. Water was pumped from Tra Ly river. A schematization of the Thai Tho dike is given in Figure 4. A brief description of all slope sections is given in Table 1 such as the length of the slope and how evenly the slope is covered by grasses.

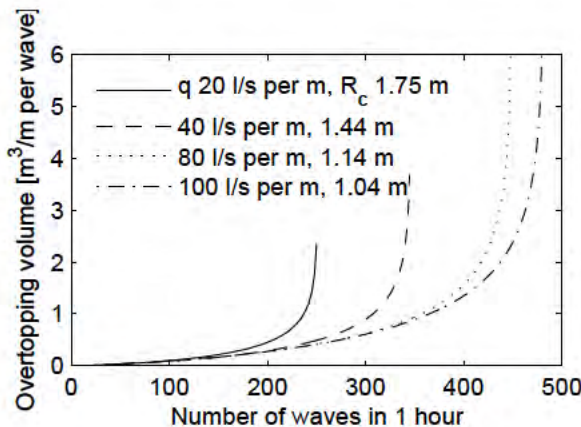
Fig. 5: Non-exceedance curve of overtopping wave volumes (m^3/m per wave) in 1 hour with different values of mean discharge using $H_{m0} = 1.5$ m, $T_p = 6$ s and the theory of the Overtopping Manual EurOtop 2007. The dike crest freeboard is R_c .

are computed with a given condition of wave and discharge. The procedure and formulas of the computation follow the theory presented in the Overtopping Manual [Pullen, 2007]. Figure 5 shows the non-exceedance curve of overtopping water volume per each wave per unit width. In reality, wave overtopping is a random process and for that reason, the volume order depicted in Figure 5 is randomized. This random series is used to to steer (open/ close) the butterfly valve of the simulator to release water flows on a real dike crest. More explanation is given in Appendix A.

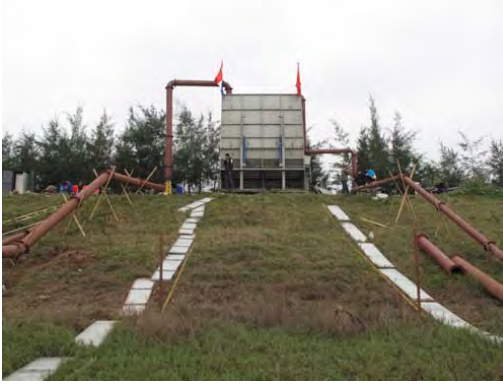
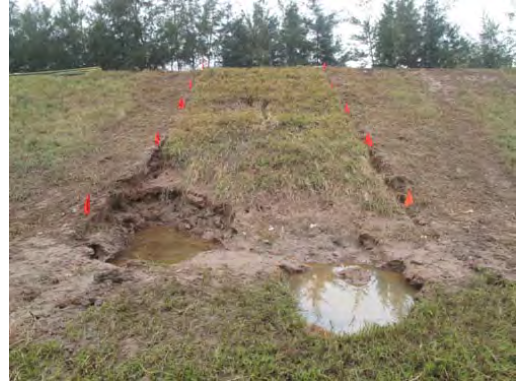
(a) Before testing

(b) After testing

Fig. 6: Grass cover at Thinh Long TL1 section, maximum applied discharge was $q_{max} = 70$ l/s per m.

At section TL1, the slope started to be eroded after three 4 hour discharges of 10, 20 and then 40 l/s per m. After that, 1 hour of 70 l/s per m was applied and damage was clearly recognised at various points on the slope and at the toe. Testing two more hours with 70 l/s per m seriously damaged the grass cover, and the test was stopped. Figure 6 compares the condition of grass cover before and after testing at the TL1 section. Figure 7 illustrates the slope profiles measured along a line parallel to the left side wall with a distance of $a = 2.5$ m. Changes of these profiles give an impression of the deepest eroded hole at the dike toe. The vertical axis gives the elevation above the Sea Water Level (SWL) and the horizontal axis gives the horizontal distance from the crest edge where the grass cover starts.

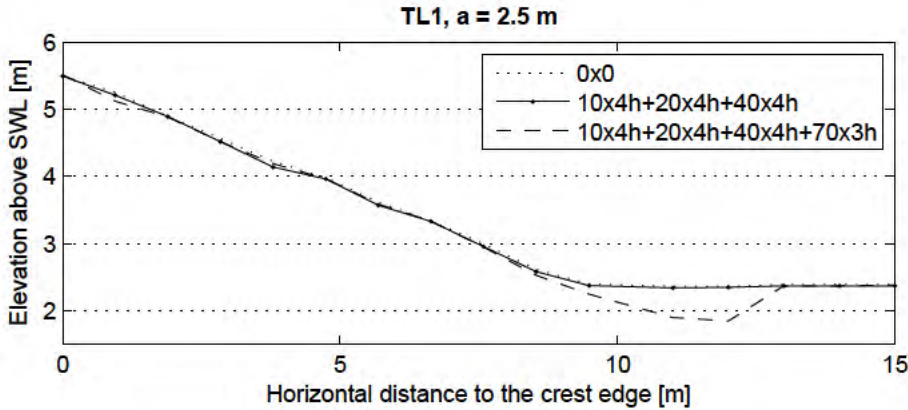
Fig. 7: Changes of the slope profiles measured parallel to the left side wall (facing the simulator gate) with a distance of $a = 2.5$ m at section Thinh Long TL1. 0x0 is the initial profile; $10 \times 4h + 20 \times 4h + 40 \times 4h$ is the profile measured after 4 hours of 10, 20 and 40 l/s per m each.

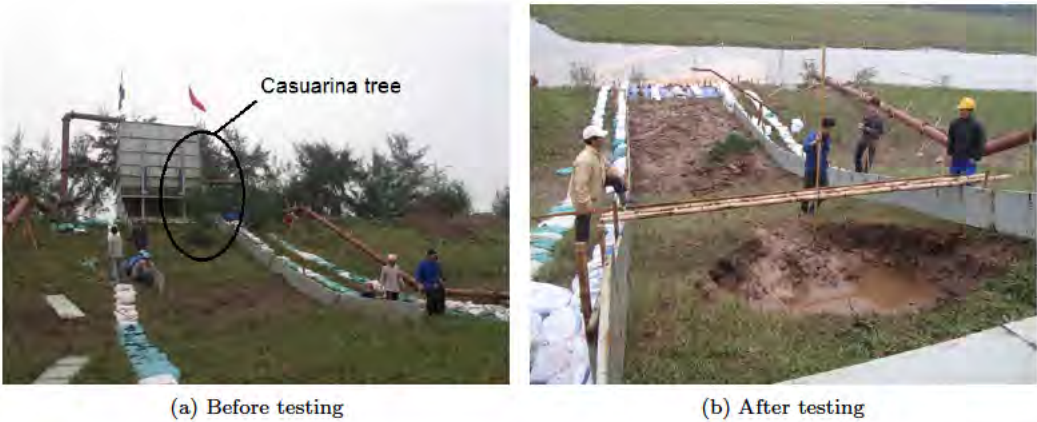
Fig. 8: Grass cover at Thinh Long TL2 section, maximum applied discharge was $q_{max} = 20$ l/s per m.

At section TL2, there was a *Casuarina* tree with a trunk diameter of 7 cm in the middle of the slope. After a couple of hours testing with 10 l/s per m, the first damage was extended from an existing hole towards the tree. After 2 more hours of 10 l/s per m and 30 minutes of 20 l/s per m, the tree was swept away, thus resulting in a large hole with a length of 3 m (in the crest-to-toe direction) and a depth of about 1 m, as can be seen in Figure 8. The changes of the slope profiles measured along a line parallel to the left side wall with a distance of $a = 2.0$ m is depicted in Figure 9.

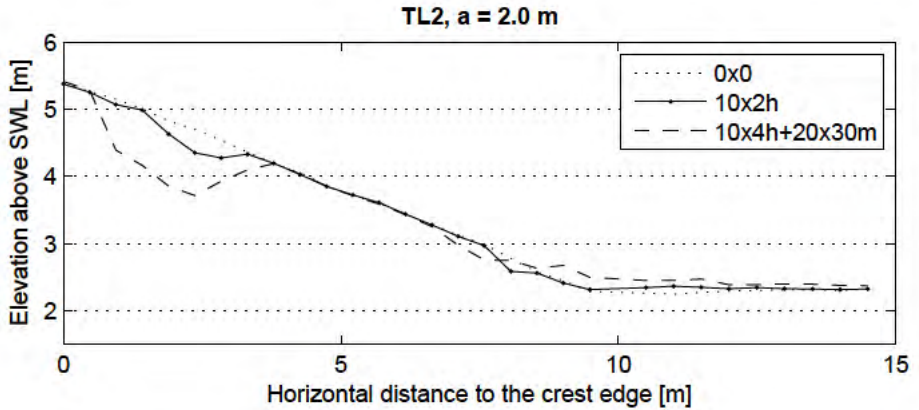
Fig. 9: Changes of the slope profiles measured parallel to the left side wall (facing the simulator gate) with a distance of $a = 2.0$ m at section Tinh Long TL2. 0×0 is the initial profile; $10 \times 4h + 20 \times 30min$ is the profile measured after 4 hours of 10 l/s per m and 30 minutes of 20 l/s per m.

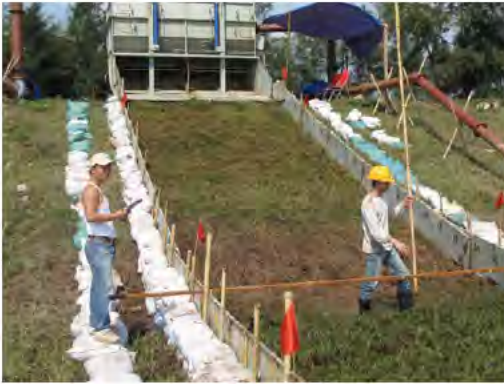
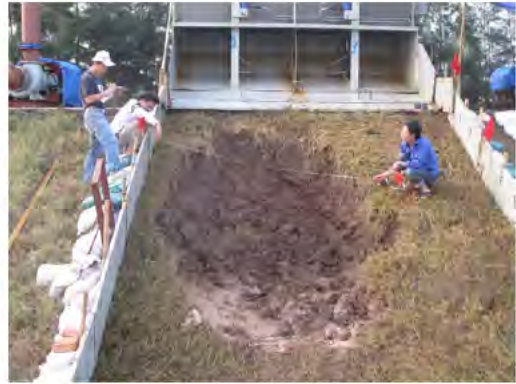
(a) Before testing

(b) After testing

Fig. 10: Grass cover at Tinh Long TL3 section, maximum applied discharge was $q_{max} = 40$ l/s per m.

The third section TL3, which was unevenly covered with a combination of Bermuda grass and some small *Casuarina* trees (trunk diameter of 1 cm), was first eroded after 4 hours discharge of 10 and 20 l/s per m each. The slope was damaged at several points after 2 more hours discharge of 40 l/s per m. The test finished

after another hour of 40 l/s per m discharge when one of the eroded holes became significantly large with a length of 5 m (in the crest-to-toe direction) and a depth of 1 m. The initial and final condition of the grass cover are shown in Figure 10. Changes of slope profiles measured along a line parallel to the left side wall with a distance of $a = 1.5$ m are given in Figure 11.

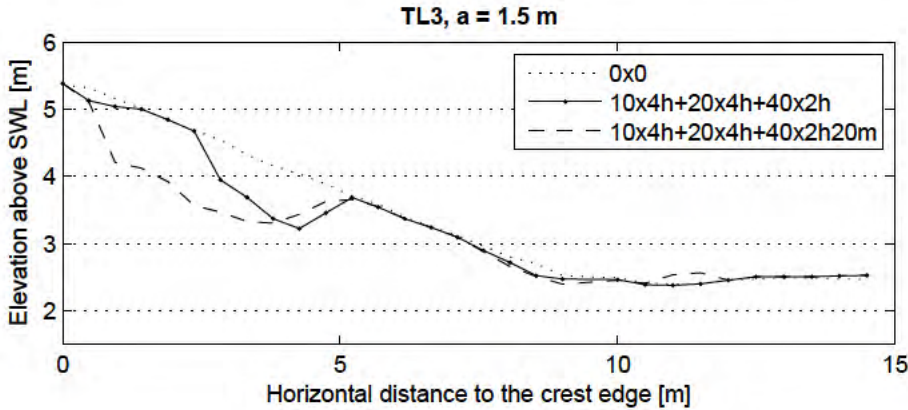
Fig. 11: Changes of the slope profiles measured parallel to the left side wall with a distance of $a = 1.5$ m at section Thinh Long TL3. 0x0 is the initial profile; 10x4h+20x4h+40x2h20min is the profile measured after 4 hours of 10 and 20 l/s per m each, and 2 hours and 30 minutes of 40 l/s per m.

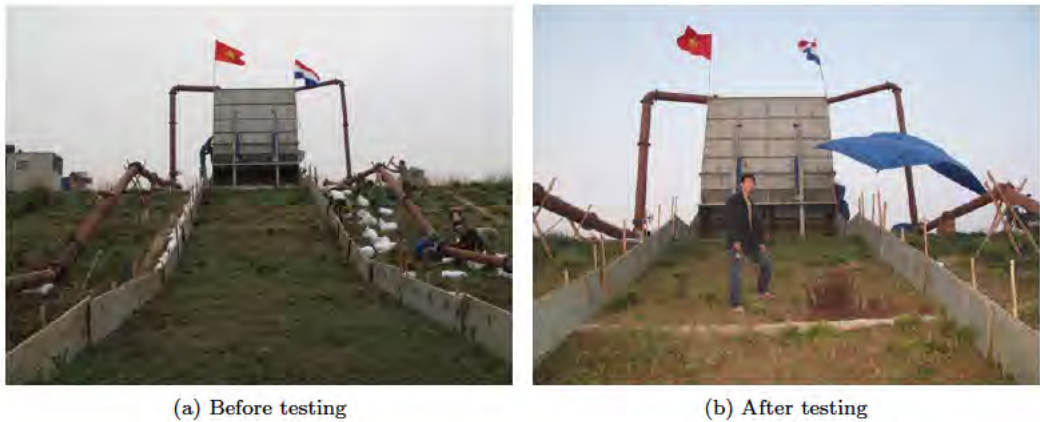
Fig. 12: Grass cover at Thai Tho TT1 section, maximum applied discharge was $q_{max} = 100$ l/s per m.

At section TT1, Bermuda grass was dominant while Vetiver clumps were scattered. The first damage took place above the horizontal concrete beam after three 4 hour tests of 20, 40 and 80 l/s per m. The slope failed after 4 hours discharge of 100 l/s per m. The initial and final condition of the grass cover are shown in Figure 12. Figure 13 illustrates the changes of the slope profiles measured along a line parallel to the left side wall at $a = 3.0$ m.

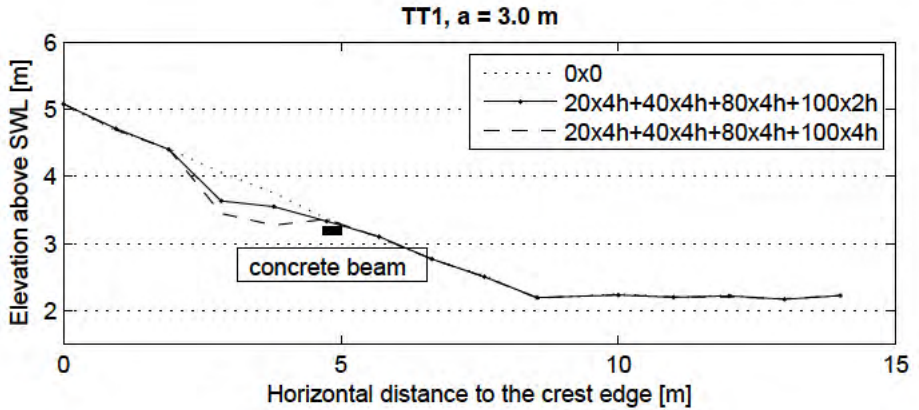
Fig. 13: Changes of the slope profiles measured parallel to the left side wall with a distance of $a = 3.0$ m at section Thai Tho TT1. 0x0 is the initial profile; $20 \times 4h + 40 \times 4h + 80 \times 4h + 100 \times 4h$ is the profile measured after 4 hours of 20, 40, 80 and 100 l/s per m each.

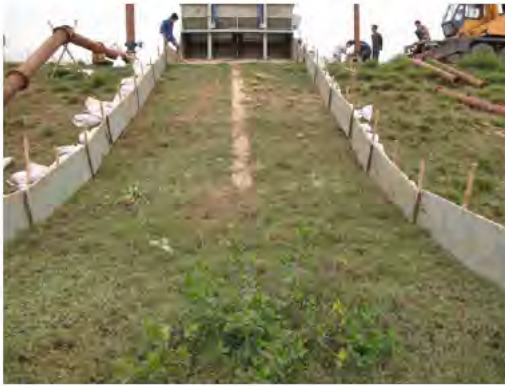
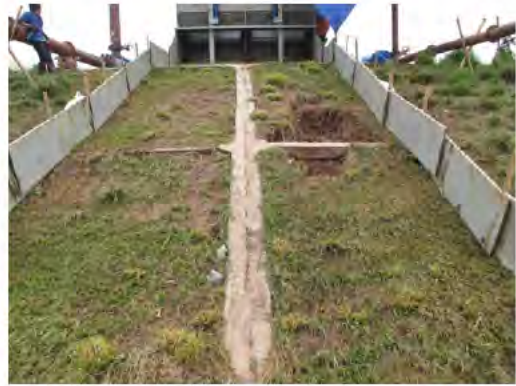
(a) Before testing

(b) After testing

Fig. 14: Grass cover at Thai Tho TT2 section, maximum applied discharge was $q_{max} = 120$ l/s per m.

Section TT2 showed a similar strength to TT1, as it was first damaged after 4 hours discharge of 20, 4 hours of 40 and 4 hours of 80 l/s per m. The slope failure occurred when one hour discharge of 120 l/s per m was applied. As shown in Figure 14, there was a hole under the horizontal concrete beam after testing. Repair to this kind of erosion is technically not easy, because it is difficult to compact soil under the beam. The slope profiles with the deepest hole after testing is presented in Figure 15.

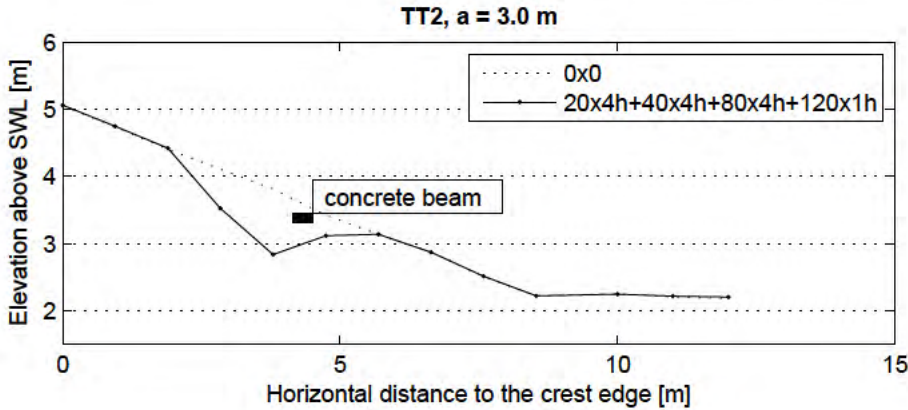
Fig. 15: Changes of the slope profiles measured parallel to the left side wall with a distance of $a = 3.0$ m at section Thai Tho TT2. 0x0 is the initial profile; 20x4h+40x4h+80x4h+120x1h is the profile measured after 4 hours of 20, 40 and 80 l/s per m each and 1 hour of 120 l/s per m.

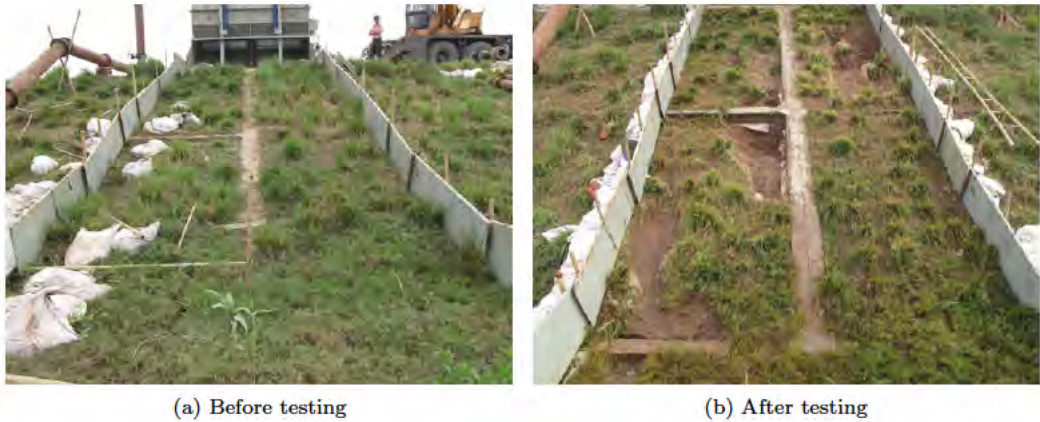
Fig. 16: Grass cover at Thai Tho TT3 section, maximum applied discharge was $q_{max} = 100$ l/s per m.

The third section TT3 showed first erosion after 4 hours of 20 and then 40 l/s per m, and 2 hours of 80 l/s per m. Erosion was observed at various points after 2 more hours discharge of 80 l/s per m. The section failed after 2 more hours testing with 100 l/s per m. Damage extended in the flow direction creating a hole 3 m long by 1 m wide (see Figure 16). Figure 17 compares the slope profiles on both sides of the concrete beam.

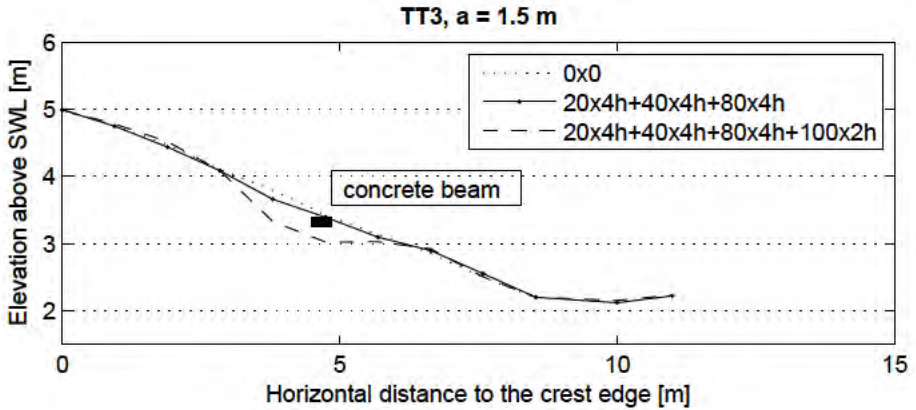
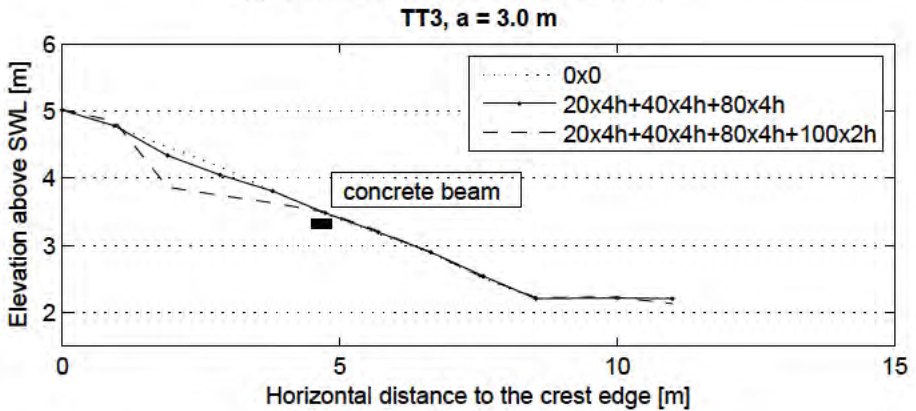
Fig. 17: Changes of the slope profiles measured parallel to the side walls at section Thai Tho TT3. 0×0 is the initial profile; $20 \times 4h + 40 \times 4h + 80 \times 4h + 100 \times 2h$ is the profile measured after 4 hours of 20, 40 and 80 l/s per m each and 2 hour of 100 l/s per m.

water was free to flow over the TT2 and TT3 toe. Minor damage were found at all three toes without any considerable difference. Configuration of the concrete frames was similar at TT2 and TT3 with both vertical and horizontal beams, but different from TT1 where there was only the horizontal beam. In general, damage concentrated in the areas around the horizontal beam.

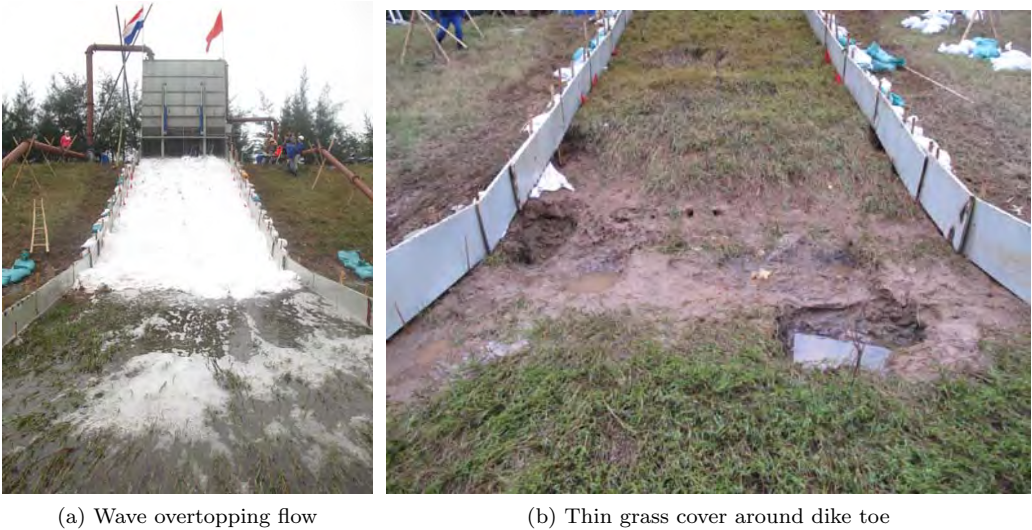
Fig. 18: Damage around the transition between the slope and the toe at TL1.

Section Thinh Long TL1 was eroded at the transition between the slope and the horizontal toe under a discharge of 40 l/s per m. At the transition area, Bermuda and Ray grass was poorer than on the higher part of the slope and the lower part of the toe (see Figure 18, right panel). Due to the thin cover of grass, soil was more directly exposed to wave overtopping flows. Furthermore, the load induced by these flows changed direction acting on the toe like water jet. Similarly, damage also took place at the sharp transitions from steep part to berm or toe in previous tests at Afsluitdijk and Vechtdijk in the Netherlands [Steendam, 2010].

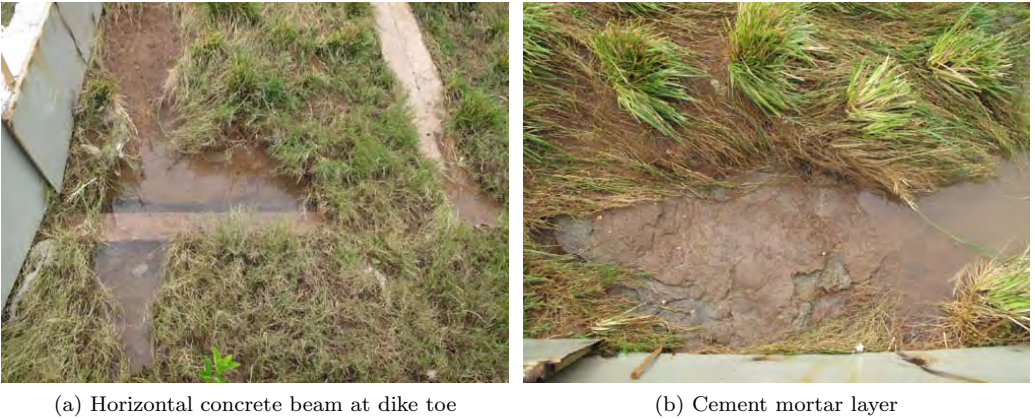
Fig. 19: Damage around the transition between the slope and the toe at TT3.

The damage at TT3 dike toe is shown in Figure 19. When the top layer of grass sod (about 10 cm thick) was eroded, a concrete beam and a thin layer of cement mortar were found preventing grass roots from penetrating deeply into the dike body. The grass sod and the mortar layer were easily eroded to reveal the body of soil underneath. In short, the damage at the transition between slope and horizontal toe was possibly facilitated by the existence of different material layers.

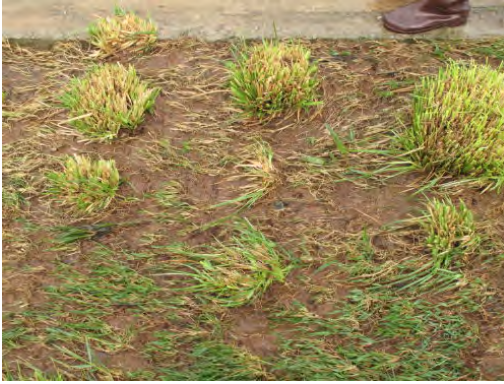
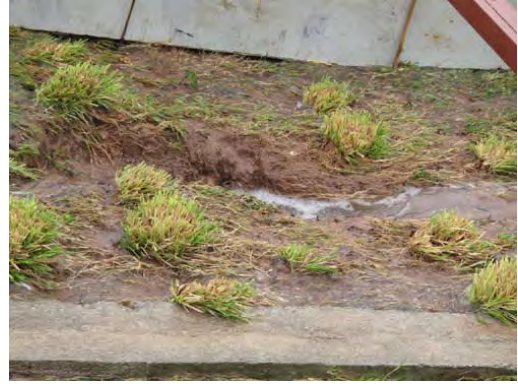
(a) Thin cover of Bermuda among Vetiver clumps

(b) Erosion of Bermuda among Vetiver clumps

Fig. 20: The grass-covered slope of the Thai Tho dike.

The Thai Tho dike slope was divided into separate cells by a system of concrete beams. The development of Bermuda grass was not in line with Vetiver grass to cover these cell surfaces. As can be seen in Figure 20, Vetiver clumps were shortened to expose a thin cover of Bermuda grass. Vetiver grass overwhelmed Bermuda grass; in addition, there was less grass and soil surface was lower (due to soil settlement) around the concrete beams than in the centre of the cells. Flow might have concentrated among separate clumps due to the high shape of Vetiver, and around the concrete beams due to the uneven transition from soil to concrete. As a result, trenches were formed as depicted in Figures 16 and 20. Using different grass species and concrete frames might cause slope discontinuity, making it vulnerable to wave overtopping flow attack. However, more tests are required to provide sufficient evidence before drawing conclusion about the effects of Vetiver grass and concrete beams on the strength of the dike slopes as well as the combination of Vetiver and Bermuda grass.

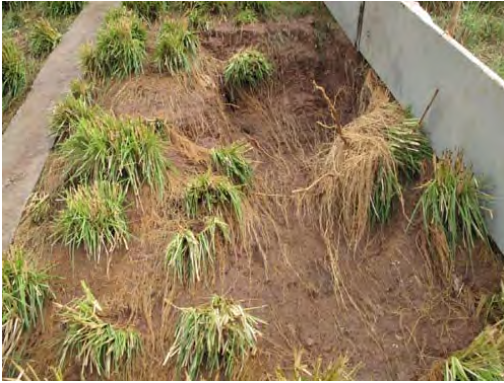
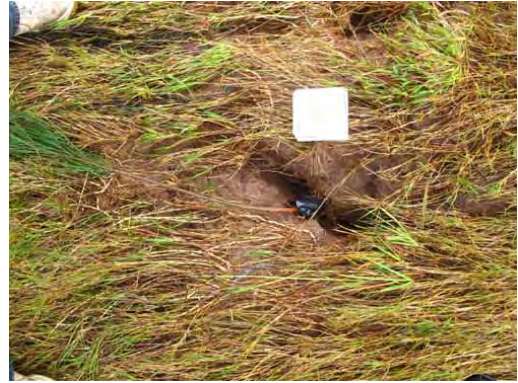
(a) Damage developed from a mouse-hole

(b) Erosion around a Casuarina tree

Fig. 21: Damage starts at eroded holes on grass-covered slopes.

It is hardly possible to prevent a grass cover from being damaged naturally or manually. At section TT3, erosion was first recognised at a mouse-hole as shown in Figure 21. Especially, small holes had been dug and then filled again to plant Casuarina trees at Thinh Long dike. These holes were quickly eroded by an overtopping rate of 10 l/s per m (see Figure 21) and then extended by greater values of discharges. Accordingly, damage easily starts or extends from potentially weak points already existing on a grass-covered dike slope.

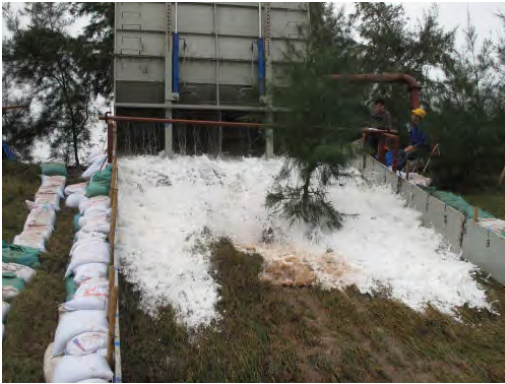
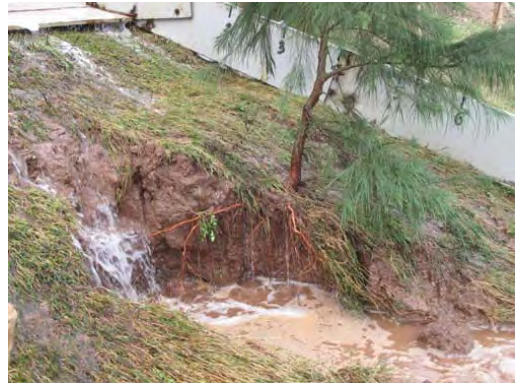
(a) Flow around the Casuarina tree

(b) Damage extended to the Casuarina tree

Fig. 22: Flow and damage around the 7-cm-trunk Casuarina tree, Thinh Long TL2 section.

At section TL2, damage started from an existing hole and then extended toward the 7-cm-trunk Casuarina tree. Overtopping flow eroded and carried away soil aggregates held by roots, gradually reducing the connection between the tree and slope. The anchoring force became weaker and weaker so that the tree collapsed. The amount of surrounding soil associated with this collapse was more considerable than what could be swept away by a grass sod erosion because the system of thicker and longer root threads of the Casuarina tree. Figure 22 gives impressions of the flow and damage around the Casuarina tree at section TL2.
