Friction stir weld-bonding defect inspection using phased array ultrasonic testing

Fortunato, J.; Anand, Chirag; Braga, Daniel F.O.; Groves, R. M.; Moreira, P. M.G.P.; Infante, V

International Journal of Advanced Manufacturing Technology

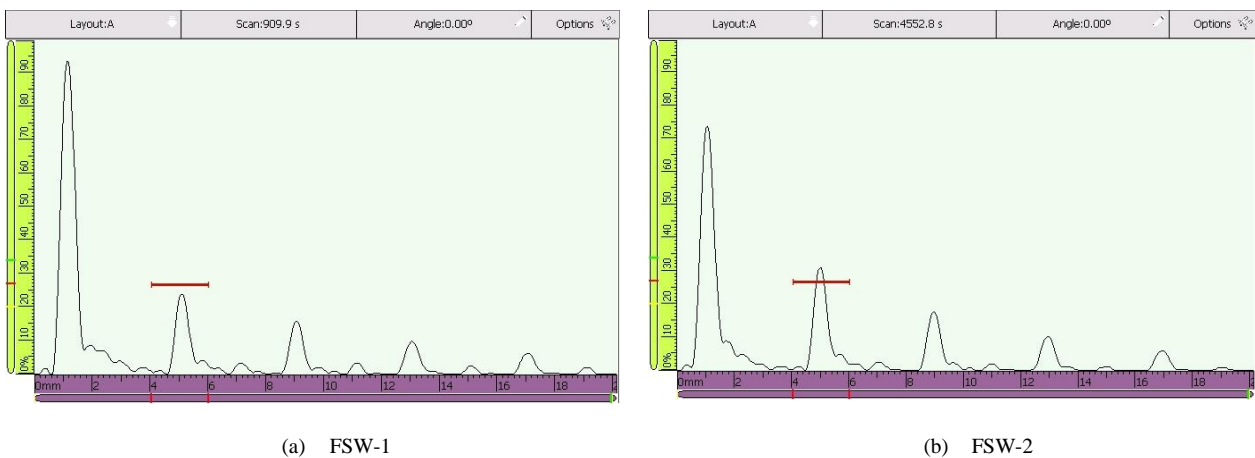
Firstly the FSW joints, FSW-1 and FSW-2, were inspected using PAUT. Figure 4 and Table 3 show the obtained results. No relevant reflections were observed along the thickness, indicating that these are defect-free welds.

Figure 4 PAUT results obtained for the simply FS welded joints. Vertical scale is wave amplitude in percentage, horizontal scale is distance [mm].

Regarding the FSW only specimens, the PAUT results were validated by the microscopy images, both revealed correctly welded joints. The lap shear strength results similar mechanical behavior.

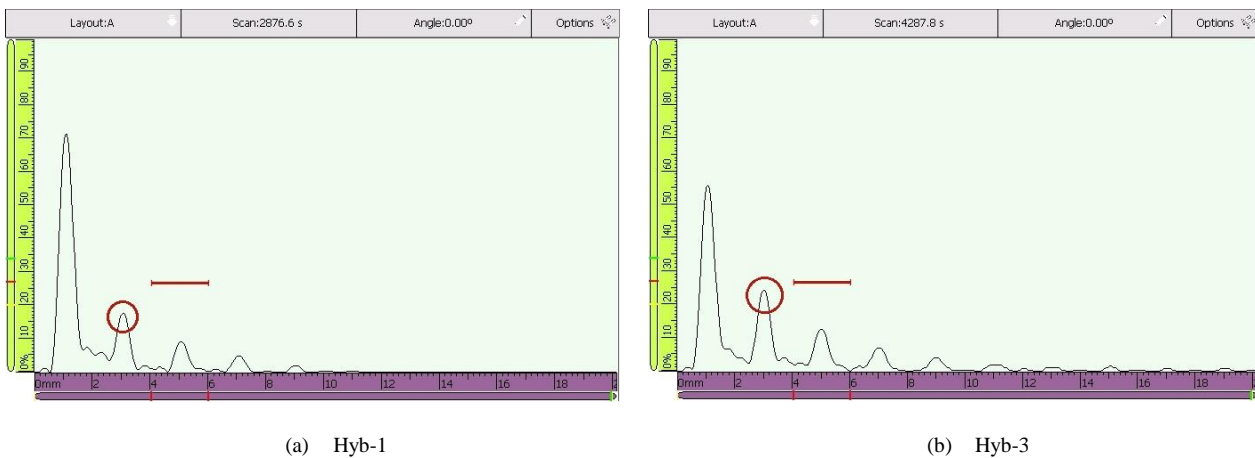
The information obtained from Figure 5 is summarized in Table 4. Figure 5 reveals a large reflection approximately at the middle of both joints' thickness for Hyb-1 and Hyb-3 (3.1 and 3 mm respectively). For joint Hyb-1 17% of the wave amplitude was reflected, while for Hyb-3 25% was reflected. This peak indicates a material discontinuity along the weld zone, which shows that in the interface of both joints an adhesive layer is present. The presence of an adhesive layer in the joints interface implies that the FSW tool was not able to disrupt the lap joint interface, due to low heat input created by the set of FSW control parameters used.

Figure 5 PAUT results obtained for hybrid specimens Hyb-1 and Hyb-3. The red circle signalizes the middle peak observed.

Vertical scale is wave amplitude in percentage, horizontal scale is distance [mm].

The PAUT results concerning specimens Hyb-1 and Hyb-3, in figure 5, showed a reflection in the middle of the joints thickness. The specimens microscopy, shown in figure 8, revealed the existence of an adhesive layer in the weld zone of the joints, validating the PAUT results. These inspections show that this specimen was very poorly welded, or even non-welded, which is proved by the extremely low mechanical strength presented.

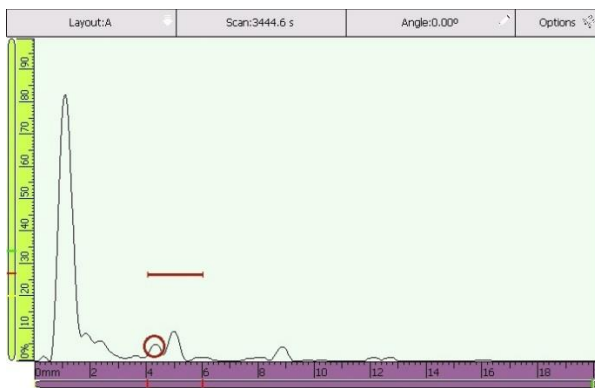
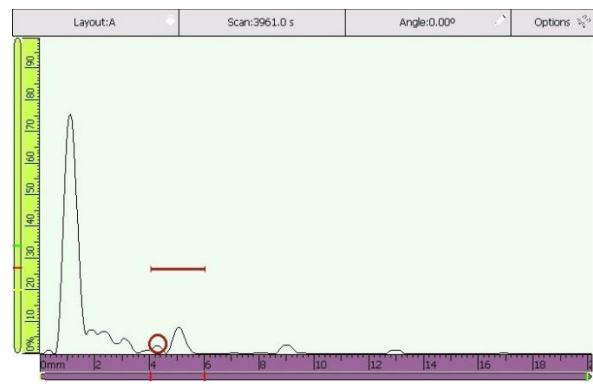
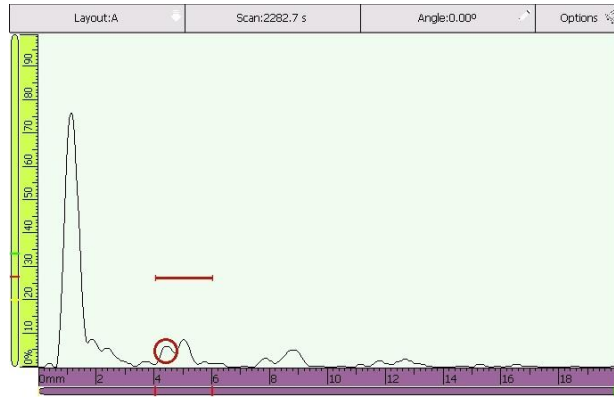
Specimens Hyb-2, Hyb-4 and Hyb-5 A-scans, shown in Figure 6, do not reveal any reflection at the middle of the joints, but a small echo is present near the back-wall reflection. Table 5 refers that 5%, 3% and 8%, respectively for joints Hyb-2, Hyb-4 and Hyb-5, of the wave amplitude was reflected. These peaks location is near the back-wall for every joint, more specifically, the peaks are located at 85%, 78% and 87% of the joint thickness respectively. Due to the material vertical movement that the FSW of lap joints demands, it is common that the interface of the joints is pushed upward. This movement leads to the formation of interface defects, typically hook defects. The fact that the reflected waves are located next to the back-wall is a clear indicator that specimens Hyb-2, Hyb-4 and Hyb-5 present hook defects.

Figure 6 PAUT results obtained for hybrid specimens Hyb-2, Hyb-4 and Hyb-5. The red circle signals the small peak observed.

Vertical scale is wave amplitude in percentage, horizontal scale is distance [mm].

Specimens Hyb-2 and Hyb-4 PAUT results, shown in figure 6, presented a reflection near the back-wall. This reflection is due to a hook defect filled with adhesive created by vertical movement of the material during the FSW process, as the microscopy results, in figure 9, confirm. In both cases the adhesive flow has been created by poor or incomplete FSW process, although in Hyb-4 specimen the material appears to be better stirred. In fact, the production of specimen Hyb-2 used high welding speed, probably leading to the very poorly stirred specimen since the rotating pin stayed a small amount of time in each segment of the joint. Hyb-4 specimen was produced with a more balanced set of FSW parameters, although using a low forging force, the low welding speed used balanced the process leading to a better joint than the Hyb-2 joint, as the lap shear strength tests reveal.

Specimen Hyb-5 also showed a small reflection near the back wall during the PAUT inspection, shown in figure 6. The microscopy analysis showed a small evidence of vertical movement of the material (hook defect) on the retreating side of the weld, however this specimen was correctly welded. This type of defect is a common feature in friction stir lap welding joints and is usual that correctly welded joints present small hook defects. Lap shear strength results prove that this specimen was correctly welded. PAUT successfully detected non-welded specimens - Hyb-1 and Hyb-3. However using PAUT it was impossible to distinguish specimens with major interface defects (such as Hyb-2 and Hyb-4) from the Hyb-5 specimen which is correctly welded.

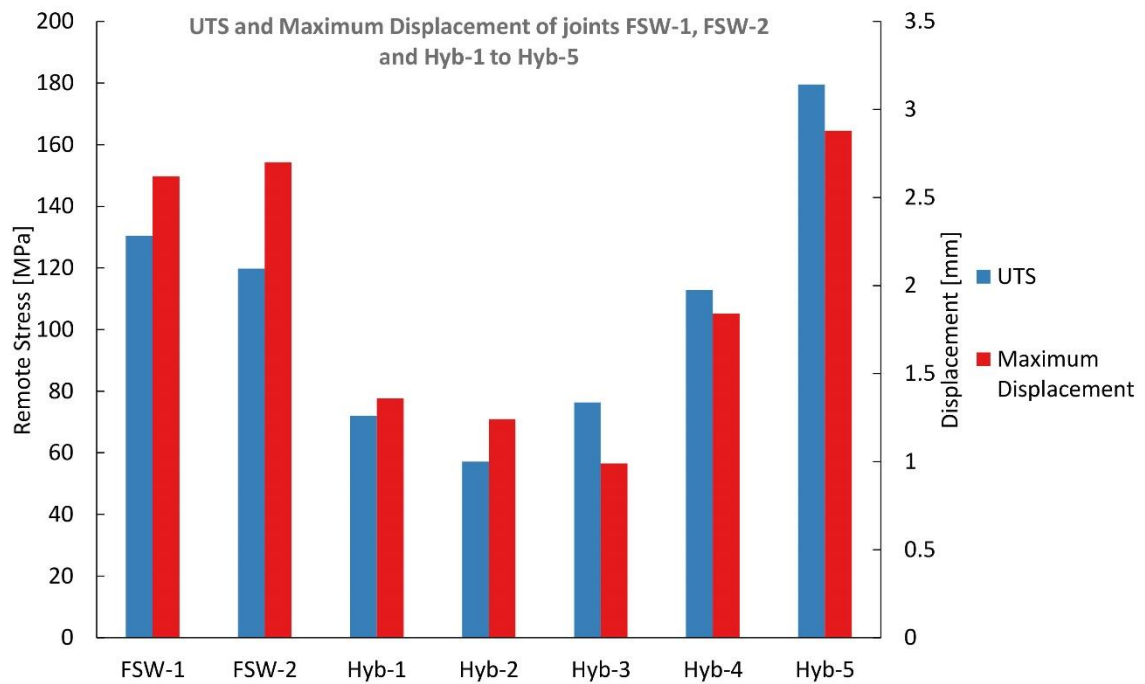
Lap shear strength tests were conducted in order to quantify the joints quality and determine the mechanical strength of the joints. Figure 11 shows the UTS and maximum displacement of the specimens.

Figure 11 UTS and maximum displacement comparison of every specimen tested.

FSW specimens - FSW-1 and FSW-2 - presented similar results. These specimens showed 45% and 41% of joint efficiency, respectively for FSW-1 and FSW-2. The lap shear tests performed on the hybrid joints showed three different groups of results. The hybrid specimen that presented better mechanical results was Hyb-5, which presented higher UTS and displacement than the FSW only specimens. Hyb-5 specimen showed 62% of joint efficiency when compared with the base material. Specimen Hyb-4 presented UTS similar to FSW-1 and FSW-2 specimens. The remaining specimens - Hyb-1, Hyb-2 and Hyb-3 - showed considerably lower strength than the FSW specimens. Specimen Hyb-2 UTS was 56% lower than FSW-1 and 68% lower than Hyb-5.
