# Effect of the barrage and embankments on flooding and channel avulsion case study Koshi River, Nepal

Lochan Devkota<sup>1</sup>, Alessandra Crosato<sup>2</sup>, Sanjay Giri<sup>3</sup>

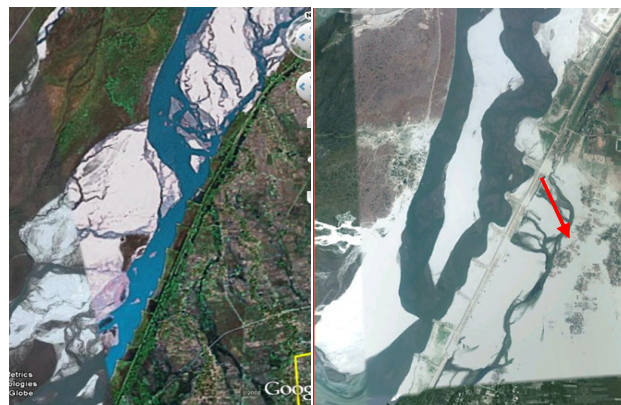
Figure 1: Koshi River before (left) and after (right) dike breach in 2008.

Flood event is common in the Koshi River since its historical time. In 18 August 2008, dike breach of Koshi River took place at Kusaha around 12 km (Chainage from the barrage 12.1 km to 12.9 km) upstream from the barrage and the river made an eastward jump of several kilometres. Sinha [13], describe that unlike the previous westward avulsions, the 2008 avulsion of the Koshi recorded an eastward jump of ~120 km which is an order of magnitude higher than any single abusive shift recorded in historical times. The avulsion was triggered by a breached in the eastern embankment and 80 – 85% flow of the river was diverted into the new course. Since, the new course had a much lower carrying capacity, the water flowed like a sheet, 15–20 km wide and 150 km long with a velocity of 1 m/s at the time of breach. Interestingly in some part, the new course did not join back the Koshi nor did this find through-drainage into the Ganga, as a result of which a very large area remained inundated/waterlogged for more

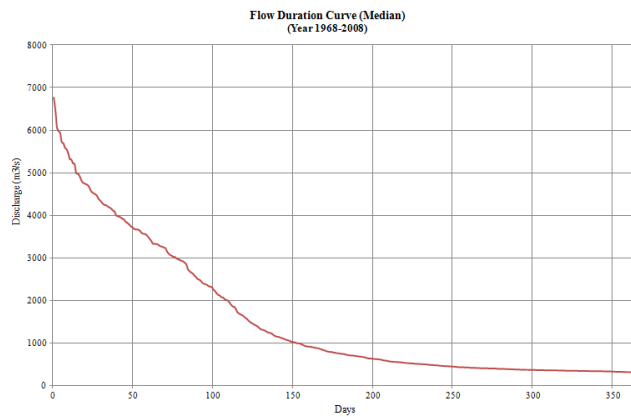
Figure 2: Flow duration curve of Koshi River near Chatara, 1967-2008.

Koshi catchment receives 80 to 85% of the total rainfall from the southerly monsoons which break towards the end of May and continue until October. The average annual rainfall in the drainage basin is increase from 1780 mm in the foothills to 3560 mm in the southern slopes of the Himalayan. Koshi exhibits a highly variable discharge. Average monthly discharge of the Koshi River varies from 500 to  $6,000 \text{ m}^3/\text{s}$ . The peak flow normally recorded from July to October following heavy rain falls in the catchment areas and may around ten times as large as the mean discharge in a single year. The mean annual flood discharge of the Koshi is around  $7,000 \text{ m}^3/\text{s}$ . During 67% of the time flow is less than mean annual discharge of  $1525 \text{ m}^3/\text{s}$  near Chatara as shown in Figure 2.

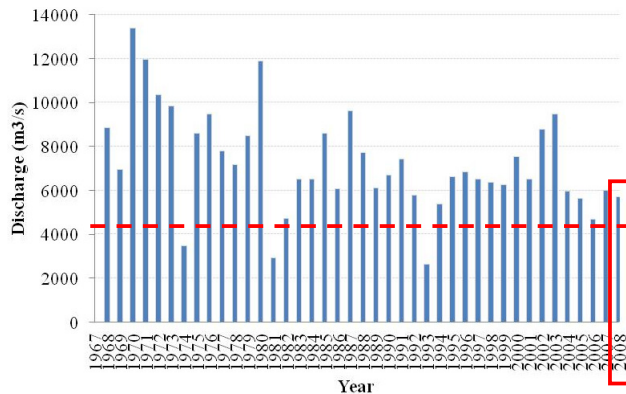
Figure 3: Annual maximum discharge of the Koshi River near Chatara, 1968-2008.

Furthermore, analysis carried out by Devkota [3] shows that 2008 event was occurred at normal hydrological year as shown in Figure 3. So, flood discharge during 2008 is not an extreme discharge to trigger the dike breach comparing to other years.

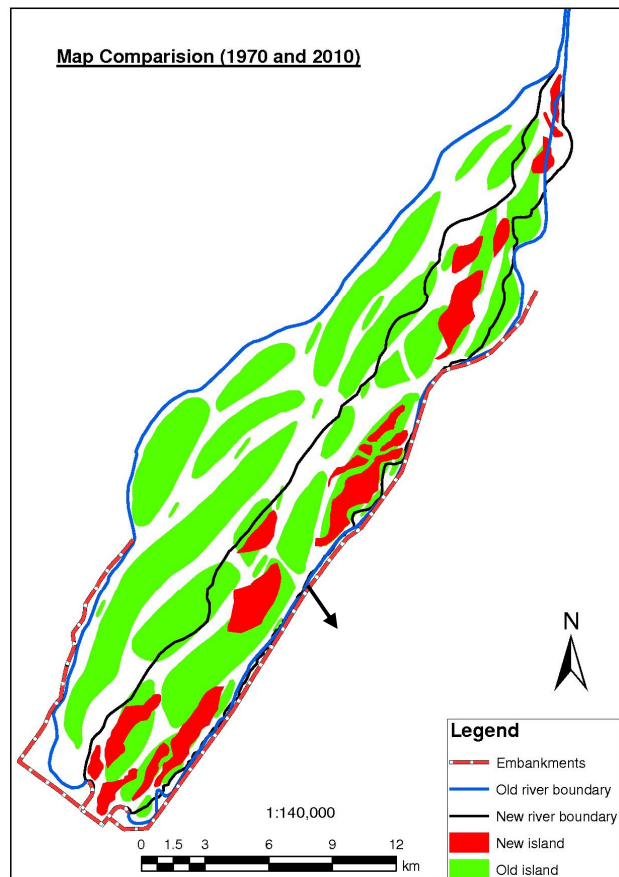
Figure 4: Comparison of two maps (1970 and 2010) with fixed embankments.

Available satellite image of November 2010 and Historical map from 1970's was considered as main sources of information including aerial photographs and Google images for map analysis. Topography 1970 shows that, river was wide up to 10 km (around 14 km upstream from the barrage) as shown in Figure 4. Initially, river was flowing through the whole embankments with three main channels. But, topography 2010 shows that, river is confined within less than 4.5 km and flow is concentrated towards the east. There are presences of few permanent islands with series of migrating and non migrating bars. So, almost in 40 years period, Koshi River significantly changes its course within its two embankments and barrage. Many changes in channel patterns, flow distribution and position of islands were observed as shown in Figure 4. There was huge sedimentation occurred over short period of time on the western side and river flow concentrate toward the east. Permanent islands presence in the topography 1970 on western side becomes permanent bank and flow concentrated towards the east. When these islands become permanent bank, other islands were also changed/modified their shape and position due to modified flow distribution and dominating channels pattern. Comparing to topography 1970 with topography 2010 one can notice that the number of islands is also reduced over time.

Closer view in Figure 4, near the dike breached area during 2008 (indicated by arrow) reveals that, there was huge sedimentation near the western bank and river section narrowed from around 10 km to 4 km. Analyzing these maps, one can conclude that the flow was concentrated toward east after construction of barrage and embankments, although historical map analysis of Chakraborty et. al. [1] study shows that Koshi River continuously migrated >113 km westward across the surface of the megafan over the last two centuries (1760 to 1960) before construction of barrage. So, significant influence of the embankments and barrage were observed during 40 year period for channel avulsion and upstream aggradation especially near the western embankment.

In addition to this, Figure 4 also reveals that barrage was not constructed in the middle of two embankments. Due to closer in eastward position of the barrage, all flow is concentrated towards the east following the shorter course where high slope occurred and leading sedimentation to westward. So, position of barrage gate also plays a significant role to shift the river towards the east.

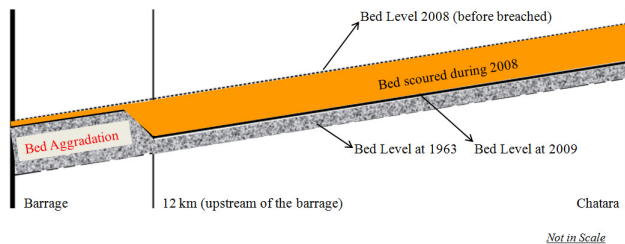
Figure 5: Sketch, bed level development in Koshi River after the Koshi Project.

Since, the future sedimentation rates are likely to be less than 0.10 m/yr; one can presume new flooding under ordinary hydrological conditions will occur after 40-50 years. However, if an extreme hydrological event occurs, this period will be much shorter. So, this gain "Time" can be used to take possible measures to prevent another flooding event.
