## Accuracy of visual inspection of flood defences

Klerk, W. J.; Kanning, W.; Kok, M.; Bronsveld, J.; Wolfert, A. R.M.

Structure and Infrastructure Engineering

Klerk, W. J., Kanning, W., Kok, M., Bronsveld, J., & Wolfert, A. R. M. (2021). Accuracy of visual inspection of flood defences. *Structure and Infrastructure Engineering*, 19(8), 1076-1090.  
<https://doi.org/10.1080/15732479.2021.2001543>

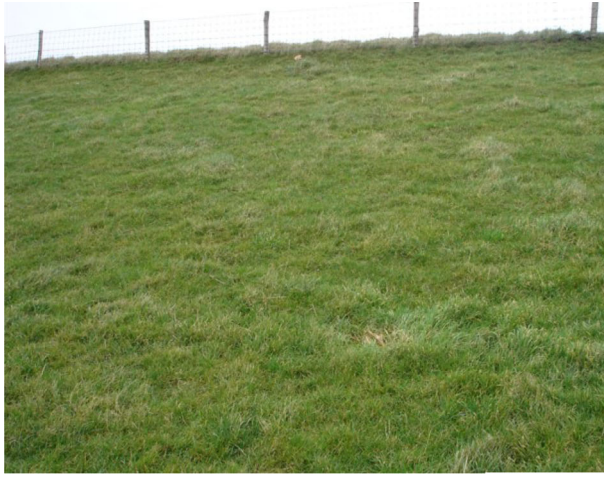
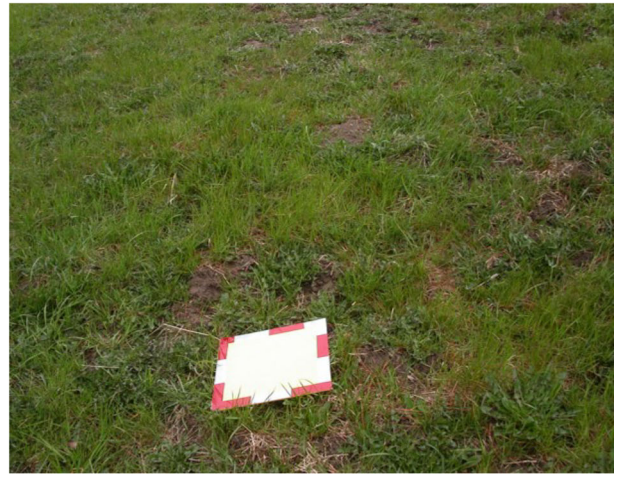
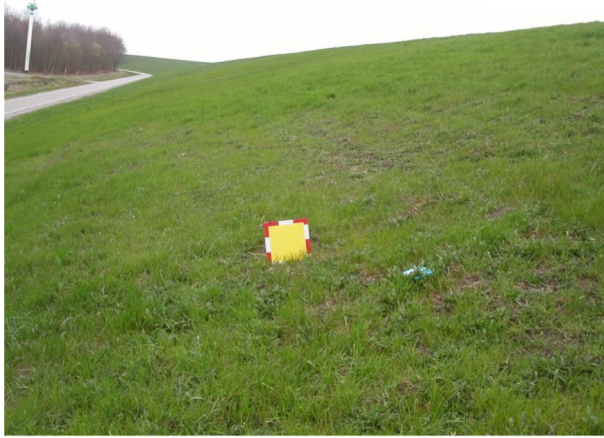
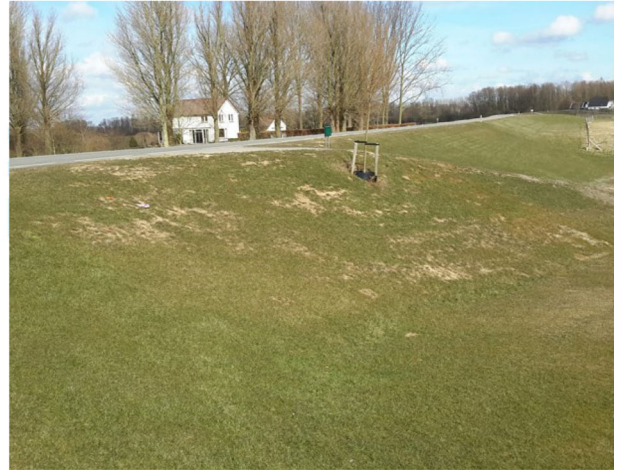
(a)  
Good: no bare spots.

(b) Reasonable: at most 5 spots with a diameter  $< 0.2$  m where vegetation is gone.

(c) Mediocre: at most 5 spots with  $0.2 \text{ m} < \text{diameter} < 0.3 \text{ m}$  where vegetation is gone.

(d) Bad:  $> 6$  spots with diameter  $> 0.2 \text{ m}$ , or 1 spot with diameter  $> 0.3 \text{ m}$  where vegetation is gone.

**Figure 1.** Example of Digigids classification for bare spots. panes a-d show increasing severity (good, reasonable, mediocre, bad). Captions for subfigures give description of category. All descriptions apply to an area of 25 square metres. All figures originate from Het Waterschapshuis (2016). (a) Good: no bare spots. (b) Reasonable: at most 5 spots with a diameter  $< 0.2 \text{ m}$  where vegetation is gone. (c) Mediocre: at most 5 spots with  $0.2 \text{ m} < \text{diameter} < 0.3 \text{ m}$  where vegetation is gone. (d) Bad:  $> 6$  spots with diameter  $> 0.2 \text{ m}$ , or 1 spot with diameter  $> 0.3 \text{ m}$  where vegetation is gone.

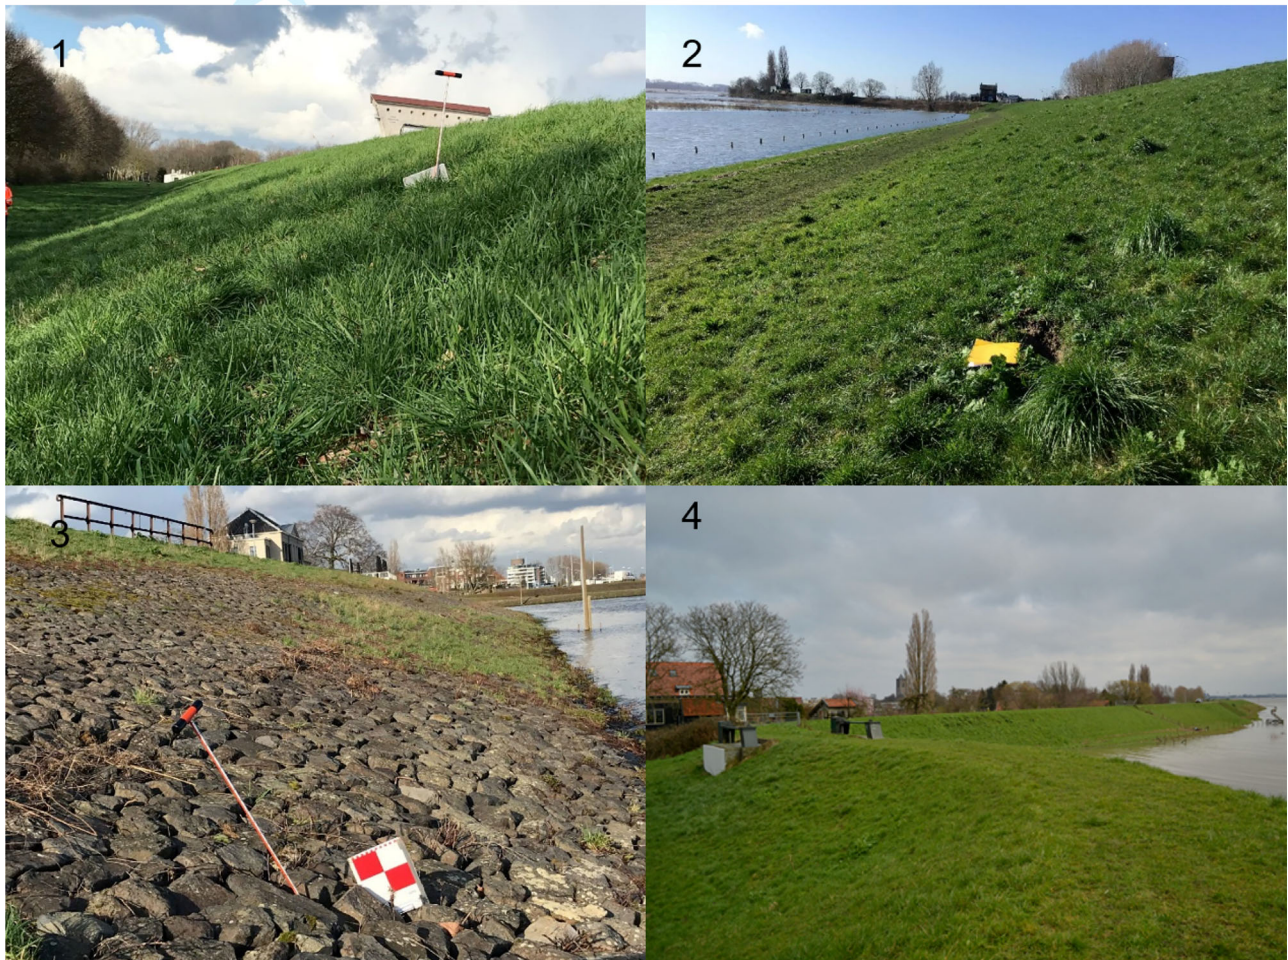
Figure 3. Impression of the 4 sections. Photos for sections 1, 2 and 3 were taken by inspectors during the test. Photo 4 was taken by one of the supervisors.

The field test was conducted at 4 dike sections near the city of Tiel, along the Waal river in the Netherlands. Pictures of the 4 sections are shown in Figure 3. The sections were

Section 1 is approximately 185 metres long. Here the inner slope, which consists of a grass revetment, was inspected. Several small damages are present to the grass cover, both burrows and other types of damage. Additionally the slope is deformed locally. Both the presence of burrowing at a section level, and the slope deformation are essential damages in an inspection of this section.

Section 2 is 200 metres long, and here the outer slope was inspected. The general shape of the grass revetment is good except for a few spots with weeds. However, there is a significant number of animal burrows, mostly caused by dogs who enlarged smaller pre-existing mice or rabbit burrows. It has to be noted that damage point 2\_6 developed during the field test and could therefore only be observed in 5 of 14 rounds. This is the only damage that developed in the period the field test was executed. Although there was high water during the test, the water level did not influence the inspectability at this dike section.

is in a relatively bad shape: there are several loose and missing blocks, the joint fill material has washed out and there are tree trunks that penetrated the revetment and displaced the blocks. Many of the damage points at this section are therefore classified as essential. The grass at the higher part of the slope is also not in good shape. It has to be noted that at section 3 the influence of the high water level conditions influenced the outcome of the test, as it was impossible to walk on the maintenance path at the lower part of the revetment. During some test sessions the inspectability was lowered as the revetment was wet due to rainfall and therefore difficult to access.

Section 4 is approximately 80 metres long, but here both inner and outer slope as well as the crest and the inlet structure had to be inspected. In general there is a significant amount of rough vegetation at this section, and the transition between revetment and structure is an important point of attention. Some parts of the outer slope contain a concrete lawn grid which is deformed in 1 location. The high water conditions had no influence on inspectability. [Figure 4](#) provides an example of the results from the Survey123 database for dike section 4. Here both registrations from the pre-assessment and the field test are shown for each damage point. All registrations have been manually coupled to the registrations, based on the attached photographs, description and location.

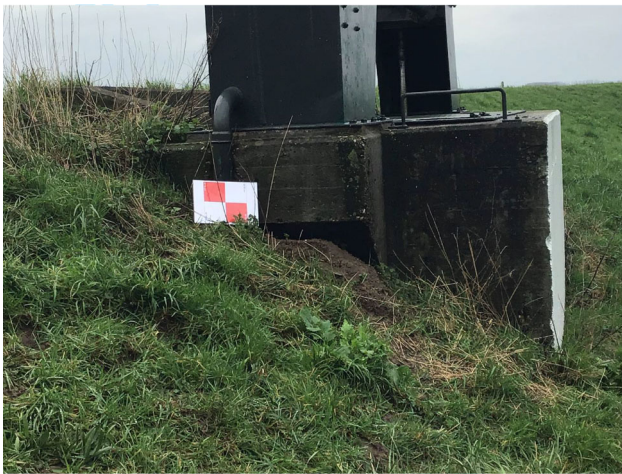
**Figure 9.** Example of the presence of multiple damage parameters at a single damage point (4\_3). At least bare spots, weeds and rough vegetation could be applicable here, while the cause of the bare spot (just right of the reference marker) could be burrowing.

spot, and possibly also burrowing. All these parameters were used by different inspectors and are at least partially representative for the situation.
