Falling aprons at circular piers under currents

Ben DESONNEVILLE¹, Greta VANVELZEN², Henk VERHEIJ³, Kees DORST⁴

¹Deltares

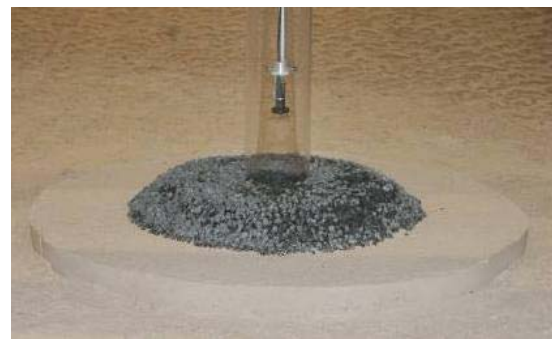
Figure 2b: Photograph of typical layout at start of test.

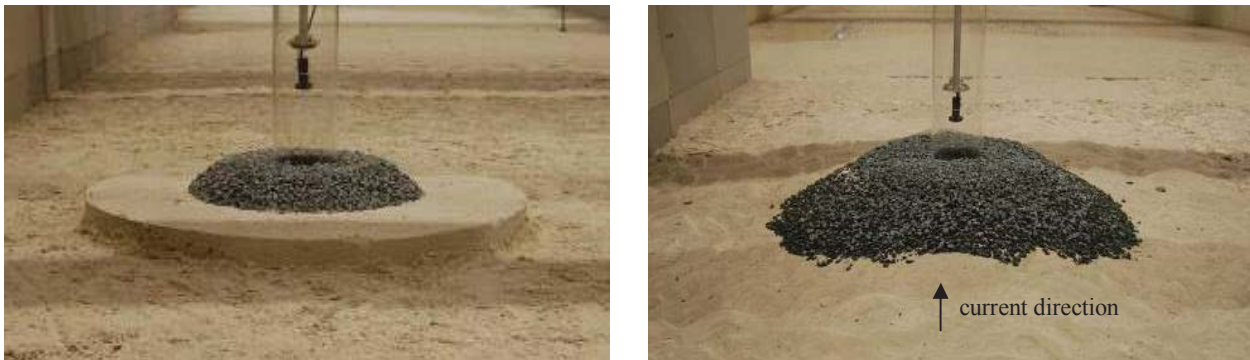
Figure 3: Photographs before (left) and after (right) test T-02 showing the redistribution of layout L03.

Visual inspection of the patterns after the test revealed that the sills applied beforehand had eroded almost completely (see Figure 3), except at the downstream side. The top bed level around the pile remained equal to before the test (no pier scour occurred). The maximum redistribution of stones occurred at the sides perpendicular to current direction. The angle of the external slope after the test was about 1:2 at those sides, slightly steeper at the upstream side (about 1:1.5) and slightly less steep at the downstream side (about 1:3).

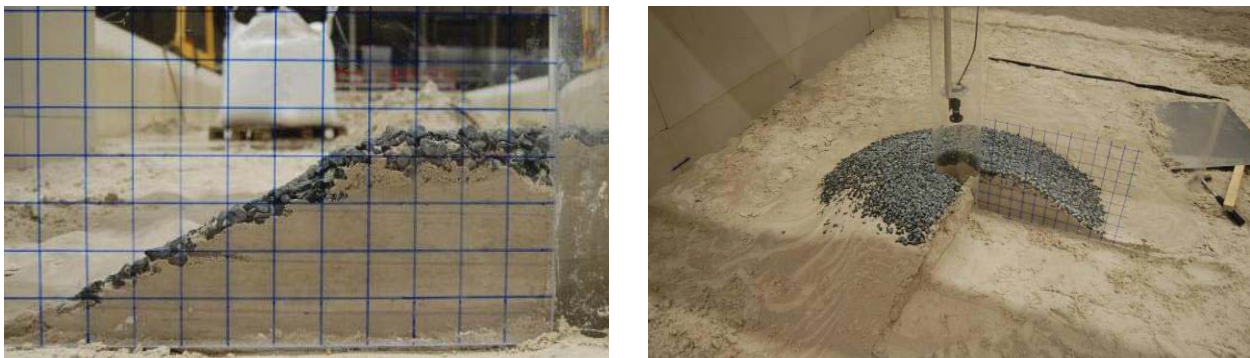
Figure 4: Photographs of cross-section of selected test (left) and the applied method (right).

Inspection of the cross-sections revealed that the layer thickness of the newly formed slope reduced gradually towards the outside (see Figure 4 - left). Please note that this differs from the single layer thickness earlier observed at falling aprons at river banks [Van der Hoeven, 2002].

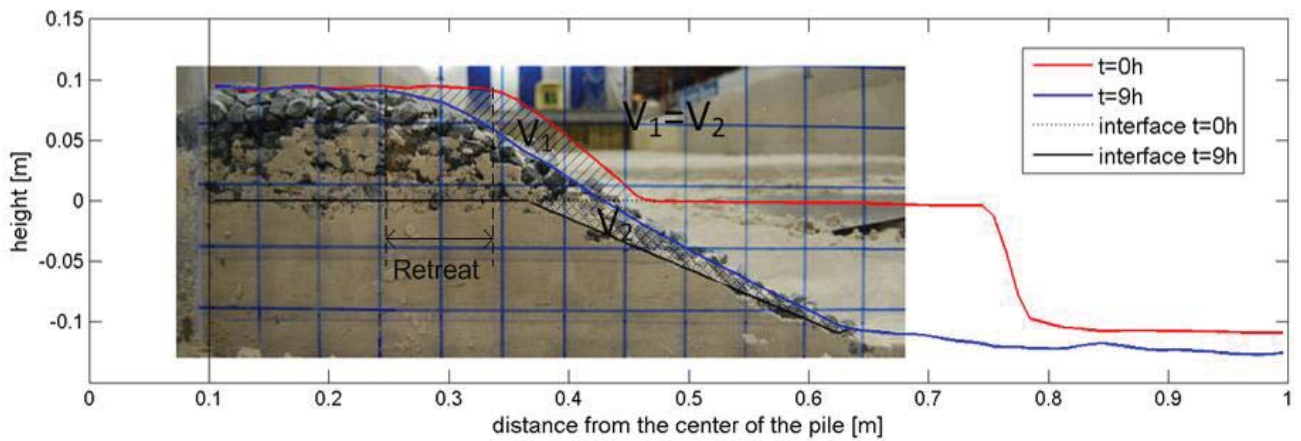
Figure 5: Schematic overview of applied volume balance, projected on photograph of cross-section.

The angle of the inner slope was calculated based on a volume balance (see Figure 5) in which the eroded volume (V_1) was assumed equal to the stone volume on the slopes (V_2). Both outer and inner slopes were assumed linear. The layer thickness was assumed to reduce in outward direction to a thickness of 1 times D_{50} at the toe of the mound. Figure 5 shows that with this method, the calculated inner slopes resembled the observed inner slopes reasonably well. The inner slope angle was in the order of 1:2.5.

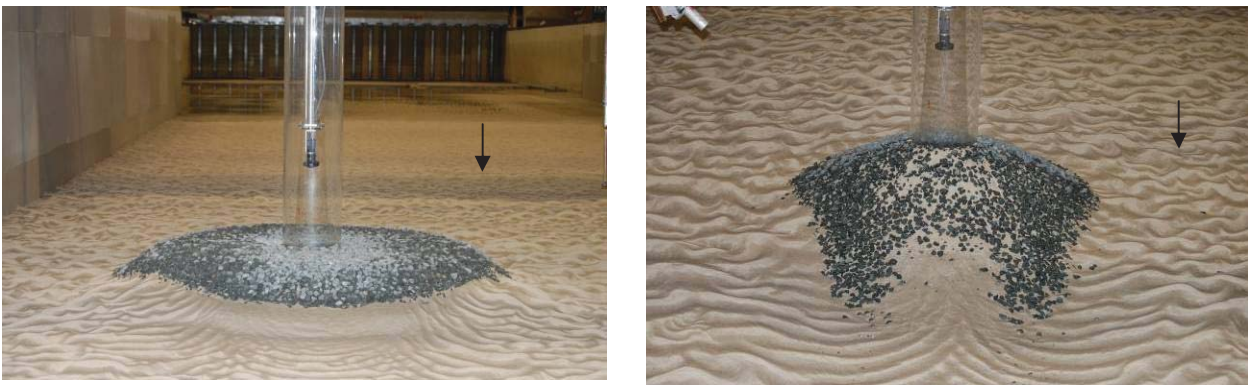
Figure 6: Photograph of results after test T-01 (layout L01) (left) and after test T03 (layout L06).

The layouts with a larger extent (layout L01; 6D) proved their conservativeness: only a relatively small part of the total volume was redistributed (see Figure 6; left). No scour (lowering of the top stone level) was observed at the pier. The tests with a smaller extent (layout L06; 3D) showed slight scouring near the pier ($\sim 0.25D$). With an even smaller extent (layout L07; 2D), significant scouring at the pier occurred ($0.5D$). The newly formed slope reached the pier and the layer thickness at the pier boundary was reduced as result of the large volume of redistributed stones (see Figure 6; right). At the piers with smaller extents two downstream gullies developed. Occasionally, rocks had been transported into these gullies.
