The 2021 flood event in the Dutch Meuse and tributaries from a hydraulic and morphological perspective

Strijker, Bart; Asselman, Nathalie; de Jong, Jurjen; Barneveld, Hermjan

JOURNAL OF COASTAL AND RIVERINE FLOOD RISK

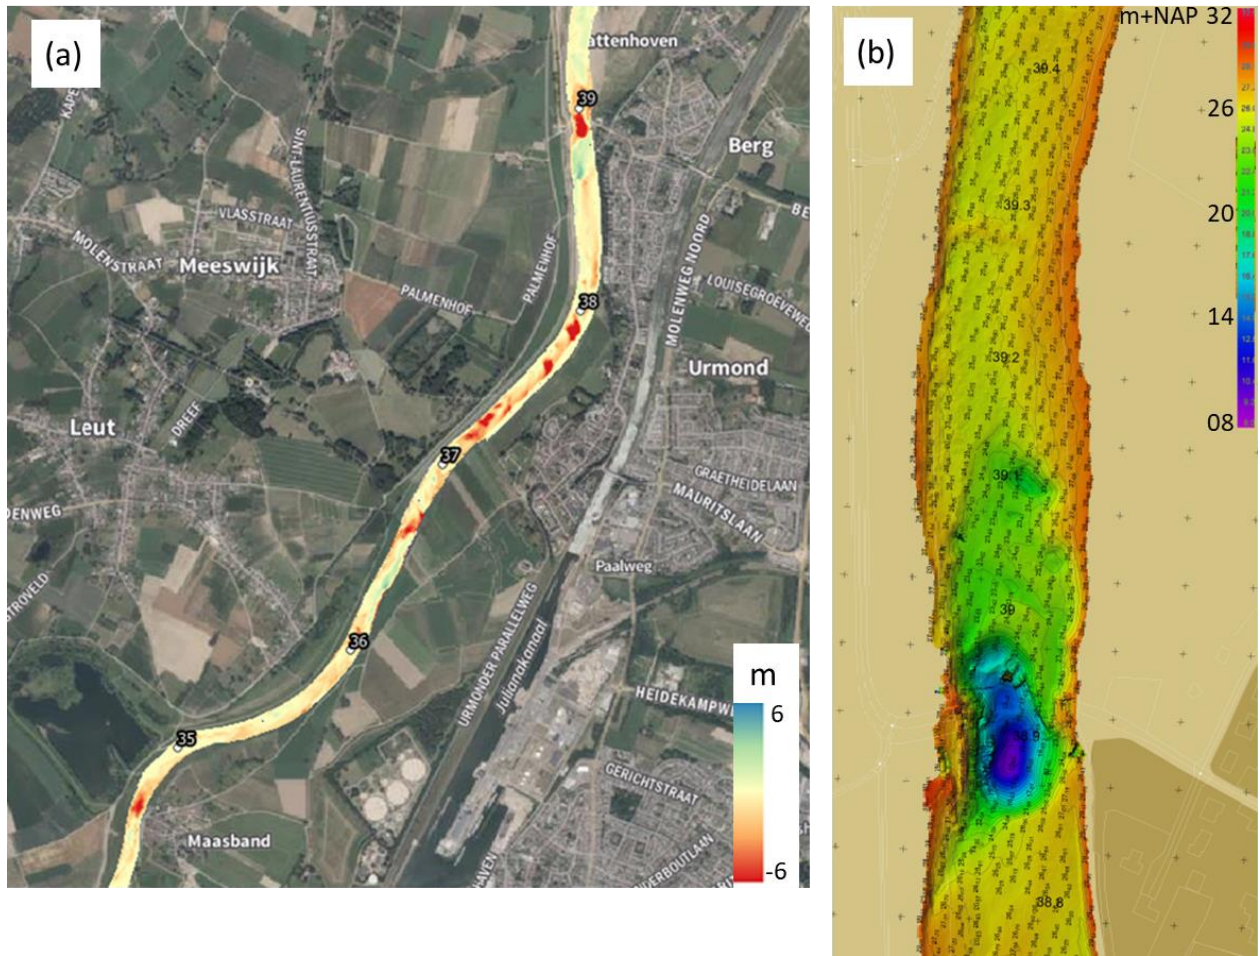
During the floods, at least 22 scour holes of 3 to 15 metres deep developed along the Common Meuse within a short section from rkm 34 to 40. Four of those scour holes were more than ten metres deep. Figure 11 shows the reach with most scour holes and a detail of the erosion hole at the location of the Berg-Meeswijk ferry. The scour holes caused severe damage to river infrastructure such as bank protection (rkm 34.65, 37.9 and 38.2), a ferry landing (rkm 38.9) and crossing pipelines (rkm 36.27). It should be noted that the scour holes developed in or just beside the main channel of the Meuse. Directly after the flood the damage to aprons downstream from the weirs still had to be verified but no major damage due to erosion occurred there or at the location of other structures such as bridges or sluices.

The deep scour holes developed as a result of the following combination of circumstances:

Figure 11: Bed level changes Common Meuse (a) between Maasband (rkm 34) and Nattenhoven (rkm 39.5) and (b) detail of scour hole near the ferry crossing of Berg (source: RWS CIV). Purple colours in figure b indicate low bed levels and red high. Water is flowing from the bottom to the top of the map.

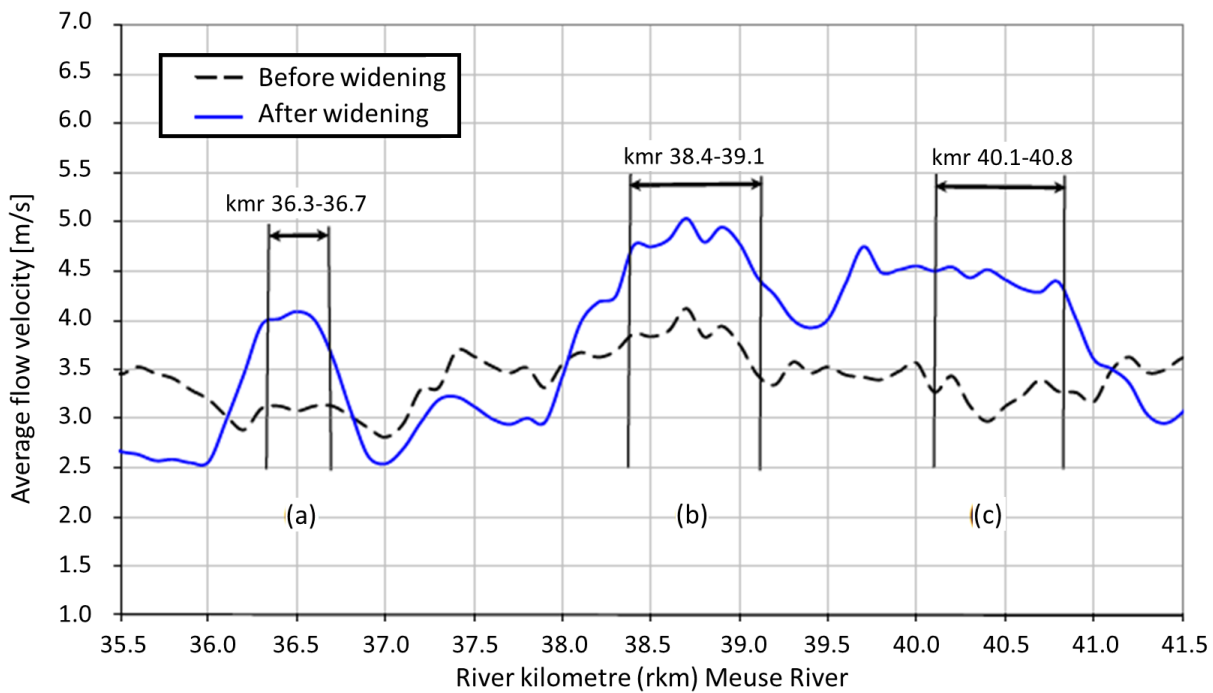
1. Very high flow velocities along the Common Meuse up to 4-5 m/s locally, see Figure 12. Locally, these velocities were even higher than during the floods of 1993 and 1995 as a consequence of non-continuous river widening measures that have been carried out along the Common Meuse (Meuse Work Programme).

Figure 12: Simulated cross-sectional average flow velocities for a flood discharge of 3,275 m³/s before the river widening measures carried out since 1995 and after implementation of these measures. At the locations of (a) Urmond, (b) Berg/Nattenhoven and (c) Obbicht no river widening was planned, so at these locations flow velocities have clearly increased. Source: Meijer & Vieira da Silva (2007).

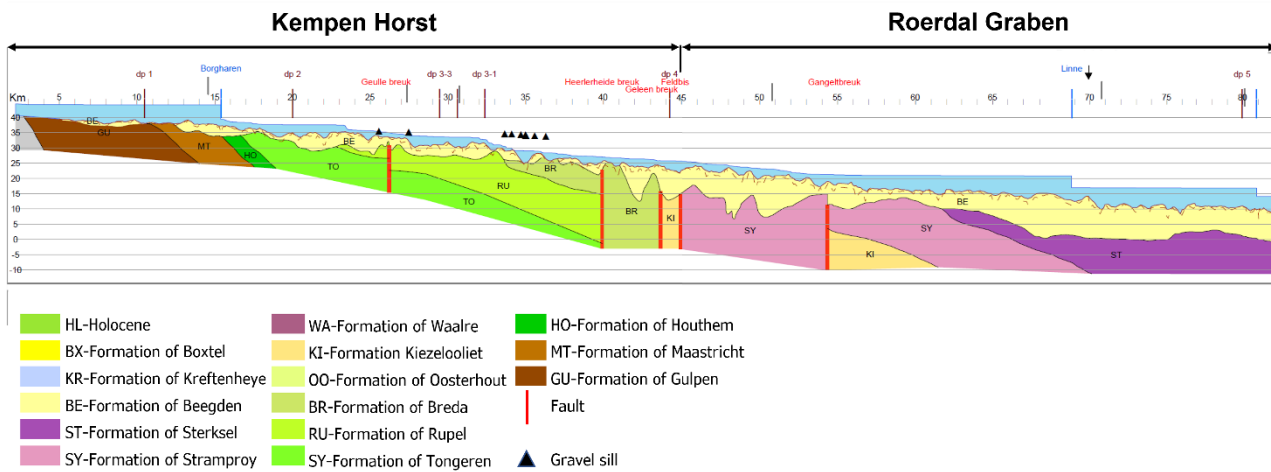
2. The local presence of fine sands under a thin layer of gravel. After the armour layer was mobilised and broke up, the thin layer of gravel underneath was also mobilised, and the underlying fine sand was able to erode quite easily (see Figure 13).

Figure 13: Geological profile of the Meuse valley between the border with Belgium (rkm 2) and rkm 80. The Kempen Horst (tectonically slowly rising area) and Roerdal Graben (slowly sinking) are indicated as well as the different layers of sediment. In the Kempen Horst the thin gravel containing formation of Beegden (yellow) and underlying formations of Breda (Miocene) and Rupel (Oligocene) in green containing fine marine sands are typical. Source: Meijer et al (2011).

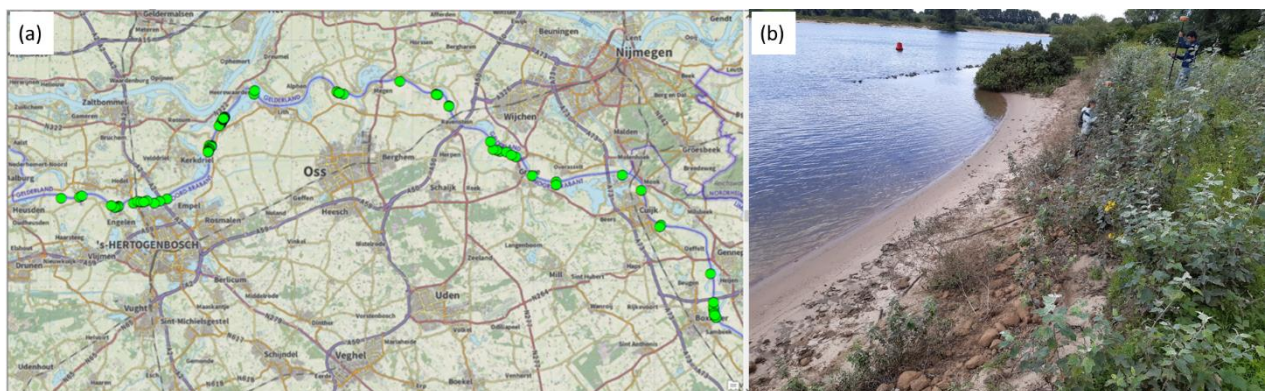
The consequences of the high flow velocities can be seen on the banks along the complete Meuse River. In August 2021, Wageningen University (WUR), in partnership with RWS, carried out fieldwork in order to map the sand deposits on the flood plains of the Meuse (see also below). When fresh bank erosion was found, the locations were noted and positions of top and toe of eroded banks were recorded. Naturally, that overview is not complete and does not provide complete information on the magnitude of the erosion, but it does confirm the idea that bank erosion occurred at many locations. The analyses of aerial photographs will provide a more complete overview of all the locations of erosion. During the field work it was found that the bank erosion along the Common Meuse was the largest. The steep edges of the new banks show that the banks consist largely of clayey material, incorporating horizontal layers of sand and gravel. This coarser material therefore also ended up in the Meuse River and may have been deposited downstream. But also along more downstream river reaches multiple locations of bank erosion were found, as can be seen for the Embanked Meuse River (Figure 14).

Figure 14: (a) bank erosion locations along the embanked Meuse from Boxmeer (rkm 150) to Ammerzoden (rkm 226) and (b) example of bank erosion location near 's-Hertogenbosch at a location downstream from the A2 highway bridge.

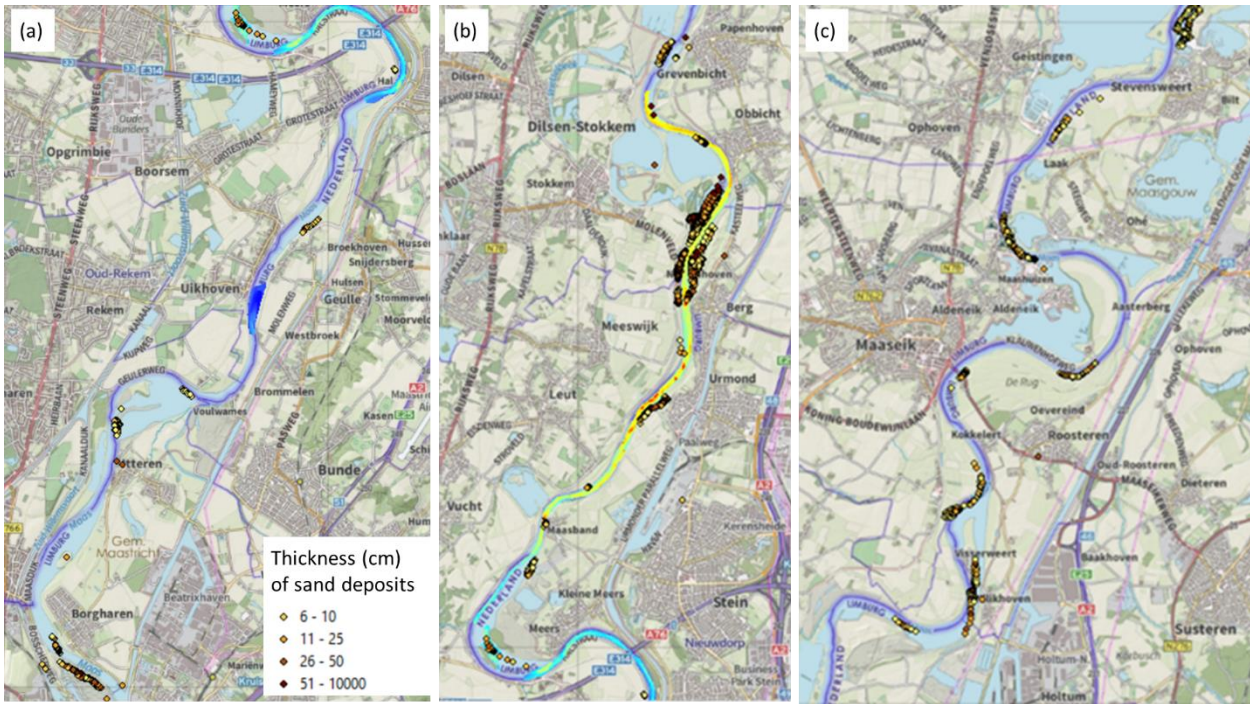
From 16 to 27 August, a team from WUR visited the flood plains of the Meuse in order to map the sand deposits on the flood plains. The survey showed that especially in the Common Meuse large deposits of fine sand were found, as shown in Figure 15. The locations of the scour holes are also shown on the map and it can be seen that large sand deposits near Negenoord and Grevenbicht (map (b)) were found downstream from the scour holes. Large sand deposits were also found near Bosscherveld, upstream of the scour holes. This sand was probably transported from Belgium in suspension or eroded in the river reach upstream between the border and weir Borgharen.

Figure 15: Sand deposits measured in the Common Meuse (a) reach Maastricht-Meers, (b) reach Meers-Grevenbicht and (c) reach Grevenbicht-Stevensweert. The colours in the circles indicate the thickness of the deposits, where the darkest colour is related to sand deposits over 0.5 m thick. The volume of sand deposits in this part of the Meuse River amounted to approximately 75% of the sand deposits found along the complete Meuse River in the Netherlands.
