Reliability of a Damaged RC Slab Structure using Model Code 2010 Safety Formats for NLFEA

This paper will show the assessment by nonlinear analysis of a reinforced concrete viaduct from 1963 with damage.

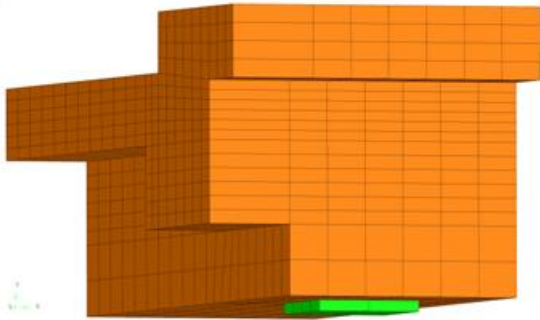
Figure 8. Element distribution at the support crossbeam

Figure 8 shows the concrete part and one bearing. The thickness of the bridge deck on the left side is divided over six elements, the edge of the bridge deck on the right side shows four elements over the height. The edge beam itself counts six elements on longitudinal direction and 14 elements over the height. The bearing part consists of 2×2×1 elements.

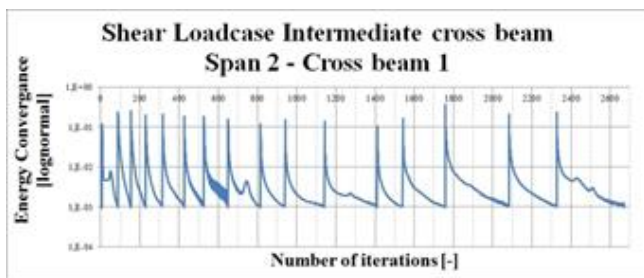
Figure 9. Energy convergence development versus total number of iterations

This process can be visualized by Figure 9, where all iterations of the different load steps converge below this limit of 1.E-03.

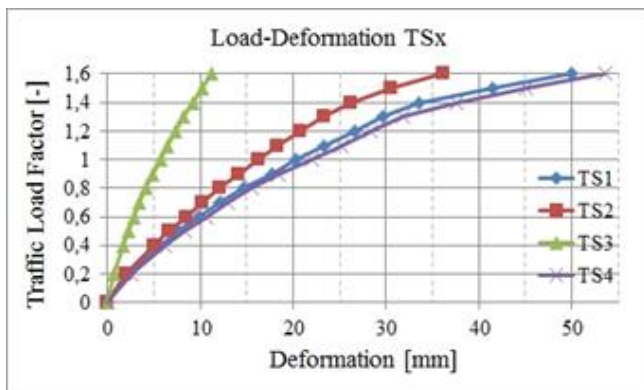
Figure 10. Load-deformation diagram traffic load cases

The first usual result of a nonlinear analysis is the load deflection curve. Here, Figure 10 shows the results for the four different wheel print load cases. Figure 10 shows that the difference in deformation between load cases TS1 (shear force) and TS4 (bending moment) is very small, where the shear force load case TS3, near the support cross beam, isn't relevant. Further important results are given in Table 2.

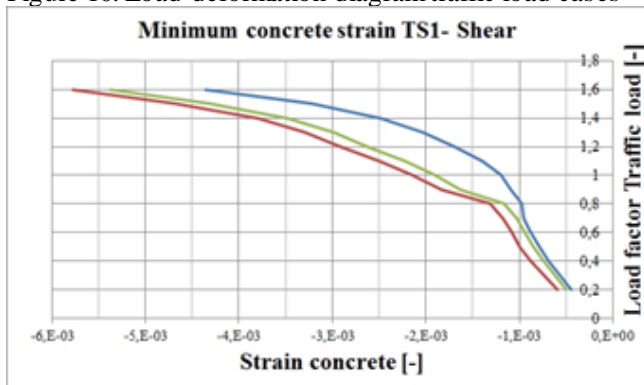
Figure 11. Concrete strain elements below the -3.5‰

(1.25). The maximum value of the reinforcement strains at a load factor of 1.6 shows 1.83%, which is far below the limit strain of 5%. However, the value for the concrete is -5.8‰, which is below the limit of -3.5‰. These concrete elements in the structure are located at the support cross beam and are very local at the edge, which is indicated in Figure 11.

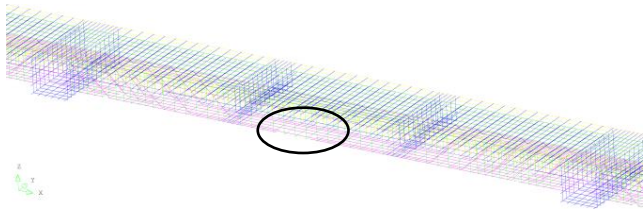
Figure 14. Excluded reinforcement edge beam mid span 2

The damage of the edge beam can be seen on the photograph of Figure 13. Two reinforcement bars are broken over a length of 1 meter and also some concrete cover is missing.

The damage results in a modification of the reinforcement bars of the edge beams, which is done by splitting two bottom level longitudinal reinforcement bars into two separate bars. This can be seen in Figure 14. The nonlinear analysis of the three traffic load cases belonging to mid part of span 2 are relevant.

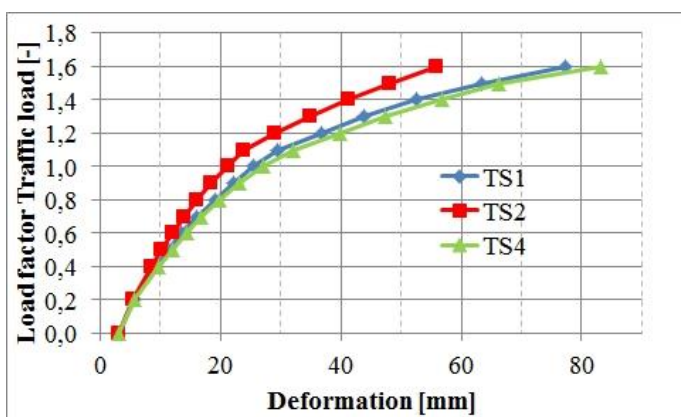
Figure 15. Load-deformation wheel print load cases

Figure 15 shows that the deformation results of the load case TS1 and TS4 are close to each other, where TS4 has still the maximum deformation. However, the increase of the deformation is rather large, changing from 53 mm to 83 mm!

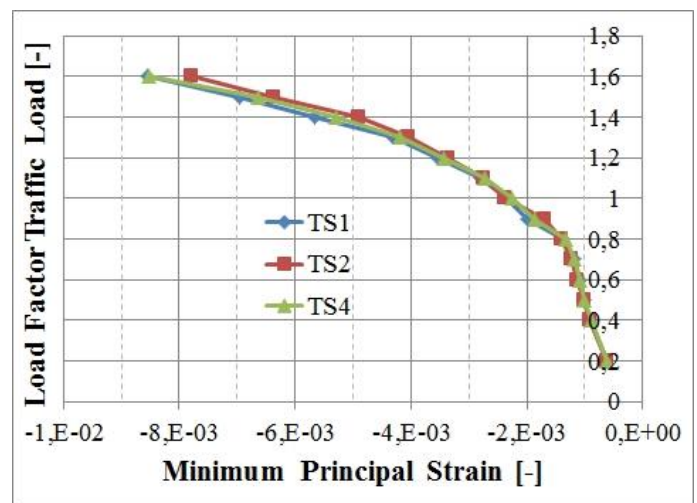
Figure 17. Development of the critical concrete strains

The critical principal concrete strains (Figure 17) shows still a load factor of 1.18, when the minimum limit of -3.5‰ is reached. The change from the edge of the crossbeam to the bearing plate region doesn't have effect on the load factor for the wheel print load.

Figure 17 counts five elements with a lower minimum strain, where Figure 11 shows only three elements with a lower minimum strain. However two elements (the most left and right element) in Figure 17 have a very small nodal area, where the minimum strain is reached.

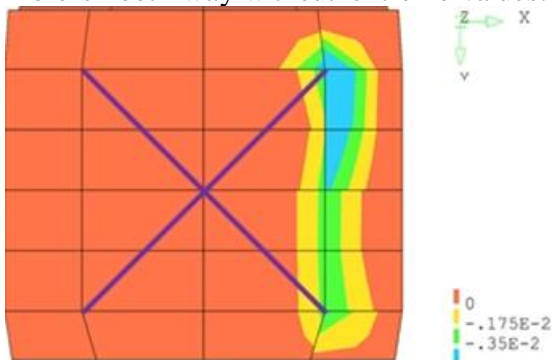
Figure 18. Concrete strain values around the bearing area

Figure 18 shows at the edge of the bearing area only low strain, where most of the area at the bottom fibre has a tensile strain. This behavior is rather overestimated by the way of modelling no pylons in this calculation. When the pylons have a normal length in the model and automatically also the be-

Figure 18 shows a principal concrete strain over half of the right side of the bearing area, which is indicated by the purple cross, with a value below -3.5‰. The other half of the right side has values between -1.75 and -3.5‰.
