Engineering Structures 366 (2026) 123376

Experimental out-of-plane seismic response of URM gables: Role of roof flexibility and differential input

Nicolò Damiani [a,b,*], Satyadhrik Sharma [c,d], Marta Bertassi [e], Marco Smerilli [b,e], Michele Mirra [f], Igor Lanese [b], Elisa Rizzo Parisi [b], Gerard J. O'Reilly [e], Francesco Messali [d], Francesco Graziotti [a,b]

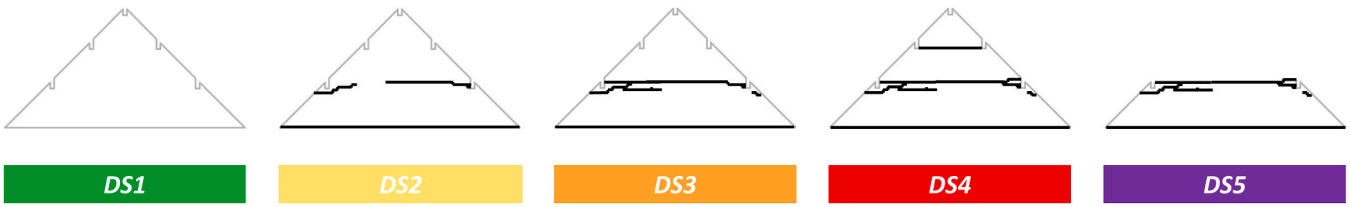
Fig. 6. Qualitative representation of DSs employed to describe damage progression in the specimens.

The results of the three full-scale shake-table tests are presented in this section in terms of observed damage patterns and failure mechanisms, the evolution of gable dynamic properties throughout the testing sequence, hysteretic response, and acceleration capacities. Before discussing these aspects in detail, the condition of each gable at the end of each test was classified according to the following five damage states (DS) adapted from [28,31]: DS1, no visible structural damage; DS2, light structural damage; DS3, moderate structural damage without the full development of crack pattern corresponding to collapse mechanism; DS4, heavy structural damage with the full development of crack pattern corresponding to collapse mechanism; and DS5, very heavy structural damage with partial or global collapse of the gable.

Fig. 6 qualitatively illustrates the five DSs for a representative gable specimen; all three tested gables were ultimately pushed to DS5. It should be noted that, given the nature of dynamic testing, it was not always possible to identify a clear, sequential transition between consecutive DSs, particularly between DS3 and DS4; in many cases the specimens progressed through more than one DS within a single test.

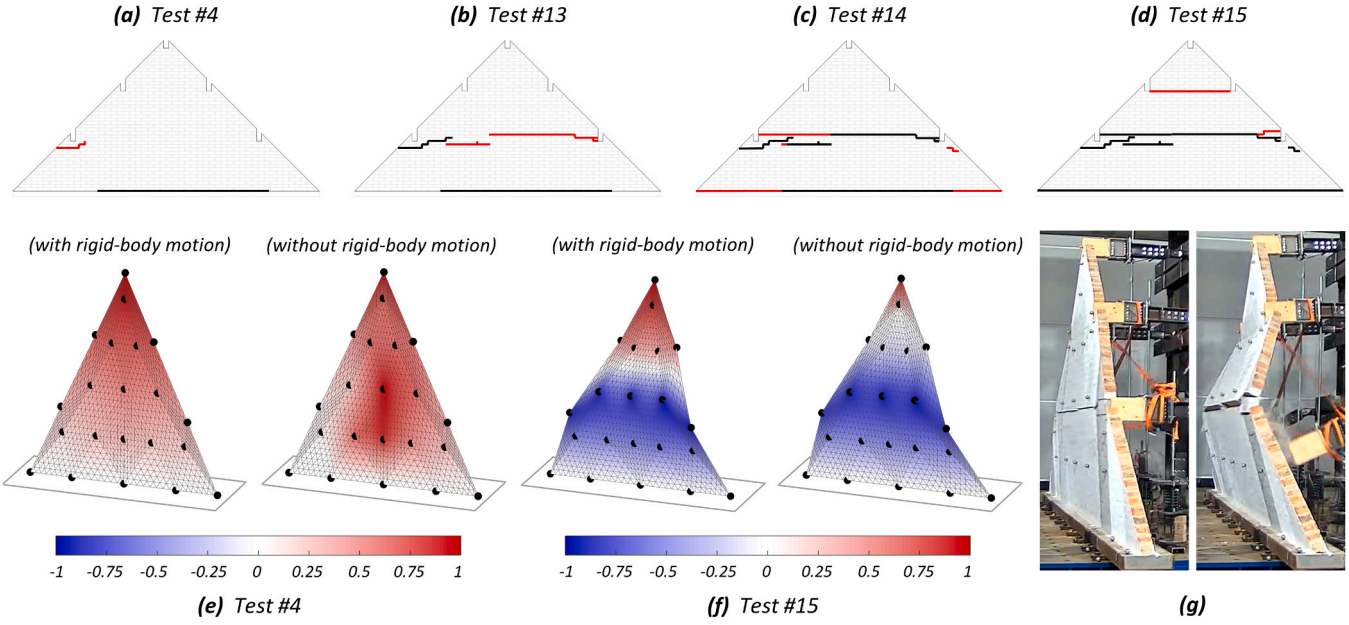
Fig. 7. Gable1-STIFF: evolution of the crack pattern (a–d); 3D deformed shapes with (left) and without (right) rigid-body motion at first cracking (Test #4) (e) and after the formation of failure mechanism (Test #15) (f); pictures of the collapse sequence (g).

Fig. 7 illustrates the damage evolution and failure mechanism of specimen Gable1-STIFF. In the reported crack patterns (corresponding to the gable façade opposite the loading frame), red lines indicate cracks that formed during the referenced test, whereas black lines denote cracks that had already formed in previous tests. Specimen Gable1-STIFF first exhibited slight damage, marking the transition from DS1 to DS2, after Test #4 ($PBA = 0.19$ g, $PRA = 0.39$ g, $\Delta_d = 4.6$ mm, peak $CPD = 0.3$ mm), when a horizontal crack developed beneath one of the lower-row timber purlins (Fig. 7a).

In subsequent tests, between Test #9 ($PBA = 0.57$ g, $PRA = 0.71$ g, $\Delta_d = 13.0$ mm, peak $CPD = 0.5$ mm) and Test #13 ($PBA = 1.17$ g, $PRA = 1.34$ g, $\Delta_d = 25.5$ mm, peak $CPD = -1.4$ mm), an additional horizontal crack developed below the purlin located at the opposite extremity of the same row. However, the specimen was still classified in DS2 because this second crack had not yet propagated across the full gable length and could therefore not act as an effective hinge line (Fig. 7b). The specimen transitioned to DS3 after Test #14 ($PBA = 1.51$ g, $PRA = 1.64$ g, $\Delta_d =$

31.8 mm, peak $CPD = 6.0$ mm). At this stage, the horizontal crack at the lower purlin level, together with the earlier crack at the gable base, had extended across the full width of the wall and began acting as hinge lines, enabling relative rocking between the upper and lower portions of the gable (Fig. 7c). Additional stepped and horizontal cracks developed around the pockets of the lower purlins, and noticeable sliding between the two purlins and the masonry was first observed during this test, indicating that the frictional resistance of the timber-masonry interfaces had been reached.

Test #15 ($PBA = 1.88$ g, $PRA = 1.86$ g, $\Delta_d = 38.1$ mm, peak $CPD = -48.5$ mm) caused further damage, including the complete formation of a second horizontal crack beneath the upper row of purlins (Fig. 7d). This new crack activated a secondary rocking mechanism, marking the transition from DS3 to DS4. Fig. 7e and f compare the deformed shapes of the gable specimen at first cracking and after the formation of the horizontal cracks responsible for initiating the OOP failure mechanism. Before the formation of the horizontal cracks connecting the purlin levels and triggering the one-way bending mechanism, the gable displayed a two-way bending deformed shape, with the peak CPD located approximately at its centroid (Fig. 7e). Once both hinge lines were fully formed, the response transitioned to one-way bending: the top gable portion, adjacent to the upper purlin row, remained nearly stationary, while most of the OOP displacements concentrated at the lower hinge line (Fig. 7f).

Ultimately, the gable reached DS5 and collapsed during Test #16 ($PBA = 2.33$ g, $PRA = 2.56$ g, $\Delta_d = 43.1$ mm). The collapse mechanism involved three-body rocking of the gable portions delineated by the horizontal cracks beneath the purlin rows, triggered by the pull-out of the lower purlin row from the masonry (Fig. 7g).

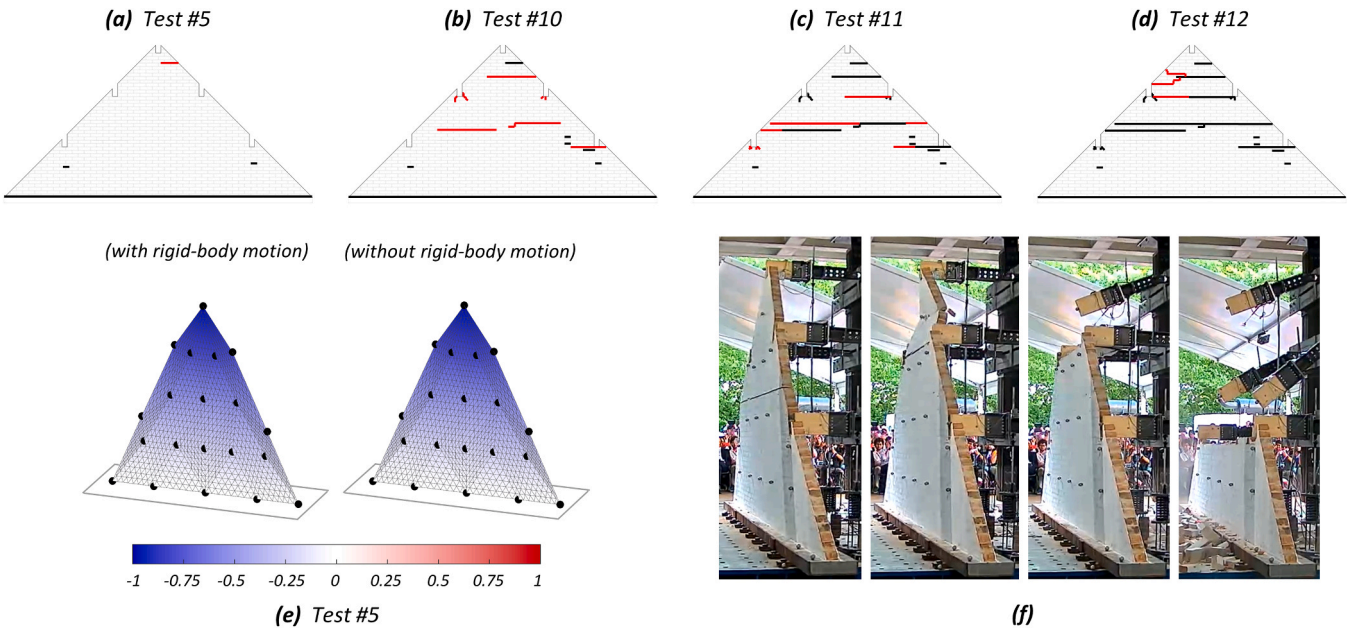
Fig. 8 illustrates the crack pattern evolution and failure mechanism of specimen Gable2-SEMIFLEX. This specimen exhibited visible damage, transitioning from DS1 to DS2, after Test #5 ($PBA = 0.28$ g, $PRA = 0.62$ g, $\Delta_d = 15.3$ mm, peak $CPD = 0.5$ mm), with only horizontal hairline cracks detected, in addition to the horizontal crack at the base already detected after Test #1 (Fig. 8a).

Fig. 8e shows the deformed shape at first cracking. Note that no optical data were available after Test #8, as the optical system was intentionally switched off; in fact, the second part of the IDT was performed live during the technical visit at the EUCENTRE laboratories organised as part of the World Conference on Earthquake Engineering (18th WCEE) held in Milan in July 2024, and the optical acquisition system is not compatible with the sunlight entering the laboratory when its external doors were fully opened to viewers.

Structural damage became more pronounced as the test progressed to higher input intensities. Significant crack formation occurred between the lower and upper sets of purlin pockets during Test #9 ($PBA = 0.57$ g, $PRA = 1.26$ g, $\Delta_d = 38.9$ mm, peak $CPD = -2.8$ mm) and Test #10 ($PBA = 0.71$ g, $PRA = 1.46$ g, $\Delta_d = 48.0$ mm, peak $CPD = -4.9$ mm). However, the specimen remained classified in DS2, as the horizontal cracking was still incomplete along the gable length and did not yet form fully effective hinge lines (Fig. 8b). During Test #10, non-negligible sliding (up to approximately 4 mm) was first observed between both the lower and upper pairs of purlins and the masonry, indicating full mobilisation of the frictional capacity at the timber-masonry interfaces.

After Test #11 ($PBA = 0.86$ g, $PRA = 1.86$ g, $\Delta_d = 56.9$ mm, peak $CPD = -8.7$ mm), new horizontal cracks developed and merged with the pre-existing one at mid-height, forming a continuous crack along the full gable length. Once continuous, this crack acted as a hinge line, marking the transition of the specimen into DS3 (Fig. 8c). In the upper part of the gable, additional horizontal cracks formed above and below the purlin pockets, although at this stage they were still discontinuous and had not yet propagated fully across the gable length. Residual sliding displacements of around 2 mm were observed between the upper pair of purlins and the masonry.

Test #12 ($PBA = 1.00$ g, $PRA = 2.15$ g, $\Delta_d = 66.6$ mm, peak $CPD = -29.9$ mm) produced further horizontal cracking in the upper portion of the gable, completing the propagation of previously initiated cracks along the full length. This test marked the complete formation of the failure mechanism and the transition to DS4 (Fig. 8d). After this test, residual sliding displacements up to about 15 mm were observed between the purlins and the masonry.

Finally, the specimen reached DS5 and partially collapsed during Test #13 ($PBA = 1.17$ g, $PRA = 3.31$ g, $\Delta_d = 75.4$ mm). The collapse mechanism, shown in Fig. 8f, involved rocking of the gable portions delineated by the horizontal cracks; in particular, the amplified rocking motion of the upper portion of the gable led to its overturning onto the shake table.

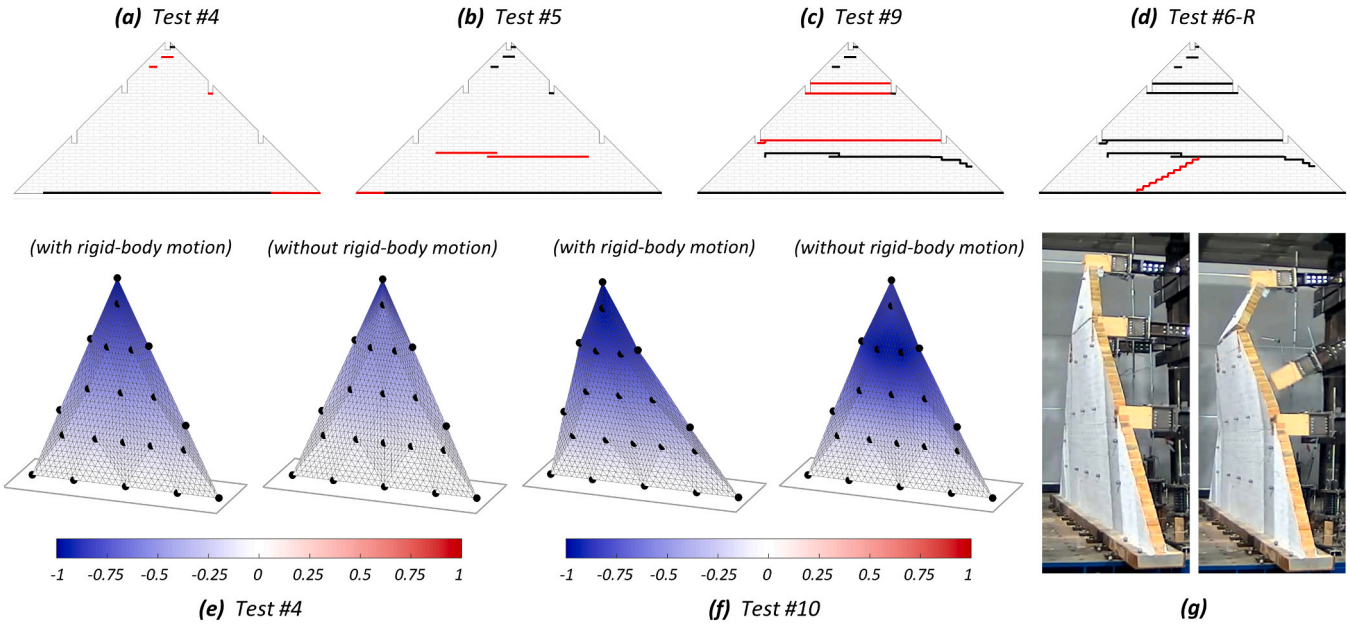
Fig. 9. Gable3-FLEX: evolution of the crack pattern (a–d); 3D deformed shapes with (left) and without (right) rigid-body motion at first cracking (Test #4) (e) and after the formation of failure mechanism (Test #10) (f); pictures of the collapse sequence (g).

Fig. 9 illustrates the damage evolution and failure mechanism observed for specimen Gable3-FLEX. For this specimen, the transition from DS1 to DS2 was observed after Test #4 ($PBA = 0.20$ g, $PRA = 0.84$ g, $\Delta_d = 26.7$ mm, peak $CPD = -1.2$ mm), when the horizontal crack along the gable base, partially detected after Test #1, extended further and additional hairline cracks formed in the upper portion of the gable (Fig. 9a). During Test #5 ($PBA = 0.28$ g, $PRA = 1.10$ g, $\Delta_d = 39.8$ mm, peak $CPD = -2.3$ mm) a new horizontal crack appeared in the central portion of the gable below the lower row of timber purlins, while the base crack propagated to span the full gable length (Fig. 9b).

Gable3-FLEX remained in DS2 up to Test #9 ($PBA = 0.57$ g, $PRA = 1.91$ g, $\Delta_d = 85.9$ mm, peak $CPD = -30.5$ mm). In this test, a marked increase in damage was observed. A continuous horizontal crack formed in the central part of the gable, connecting the bottoms of the lower purlin pockets and completing a hinge line at the lower purlin level. Simultaneously, two additional horizontal cracks developed in the upper portion of the gable, connecting the upper purlin row: one at the bottom and one at the top of the purlin pockets (Fig. 9c). The combined effect of these horizontal cracks led to the full development of the failure mechanism, analogous to that observed for Gable1-STIFF and Gable2-SEMIFLEX, resulting in the specimen transitioning directly from DS2 to DS4 within the same test. Moreover, significant residual sliding displacements of around 10 mm were observed between the lower and upper pairs of purlins and the masonry, indicating full mobilisation of the frictional resistance at the timber-masonry interfaces.

As discussed in Section 3.3, an additional shake-table test, denoted Test #6-R and corresponding to 100% FM1 ($PBA = 0.36$ g, $PRA = 1.33$ g, $\Delta_d = 53.9$ mm, peak $CPD = -22.3$ mm), was carried out after Test #9 to assess the ability of the damaged gable to sustain an induced-seismicity motion. This test did not cause significant additional damage and mainly led to the formation of an inclined stepped crack extending from the gable base to the horizontal crack developed during Test #5 (Fig. 9d).

Fig. 9e and f compare the deformed shapes of the specimen at first cracking and after the formation of the complete failure mechanism. Once the hinge lines were fully developed, the response transitioned to one-way bending, with the largest OOP displacements concentrated near the hinge line at the upper purlin level (Fig. 9f).

The specimen ultimately reached DS5 and partially collapsed during Test #11 ($PBA = 0.86$ g, $PRA = 3.02$ g, $\Delta_d = 127.9$ mm). The collapse mechanism was governed by the overturning of the two upper rigid bodies of the gable, located above the hinge line defined by the horizontal crack connecting the lower row of purlins, and was triggered by the pull-out of this lower row of purlins from the masonry leaf.
