The 2021 summer floods in the Netherlands
some findings and lessons

The 2021 summer floods in the Netherlands: some findings and lessons

By Bas Jonkman

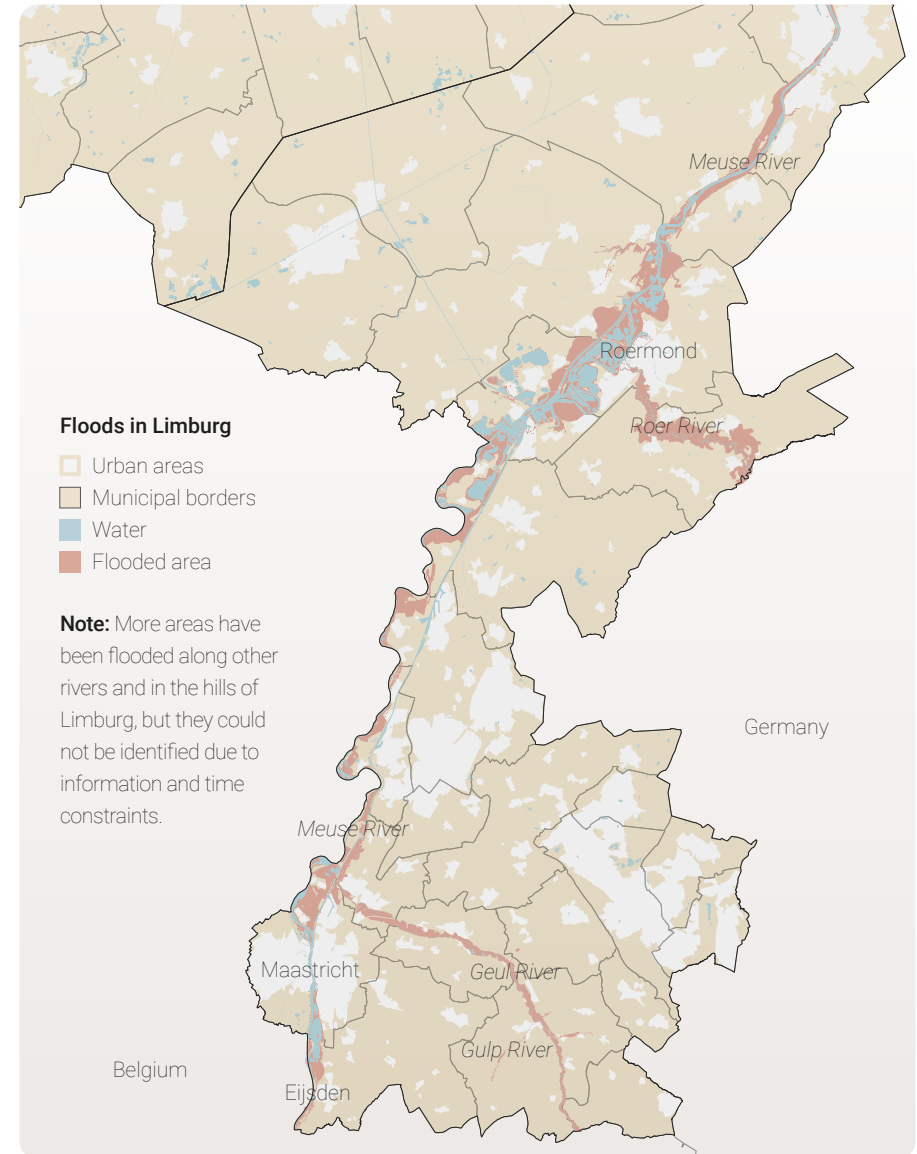
Floods in Limburg

Note: More areas have been flooded along other rivers and in the hills of Limburg, but they could not be identified due to information and time constraints.

Map of the 2021 floods in Limburg, the Netherlands, as a result of the fact-finding study for the Meuse river and the tributaries Geul, Gulp and Roer. Base map data from PDOK. Flood extents data by Slager et al. (2021). Illustration by Martijn Vos.
