Change lost: Corrosion of Roman copper alloy coins in changing and variable burial environments

We studied the corrosion of Roman copper alloy coins that experienced alternations or progressive changes in their burial environment. We used coins that were still embedded in soil or in a concretion selected from three professional excataved sites - Berlicum and Krommenie in the Netherlands and Kempraten in Switserland. mCT scanning and neutron scanning were used to record the 3-D properties of these coins prior to (destructive) analyses. It proved possible to tentatively identify the coins. Microscope observations and SEM-EDX analyses revealed complex corrosion processes, related to changing burial environments. In soil horizon with fluctuating groundwater levels in a region with upwelling reducing, iron-rich groundwater, the copper in a gunmetal coin is essentially replaced by iron oxides while tin remains and forms tin-oxide bands. Fluctuating redox conditions in marine-influenced environments was shown to transform a copper-alloy coin into strongly laminated copper sulphides with embedded gypsum crystals, with an outer surface of copper and copper-iron sulphides. Burial of bronze

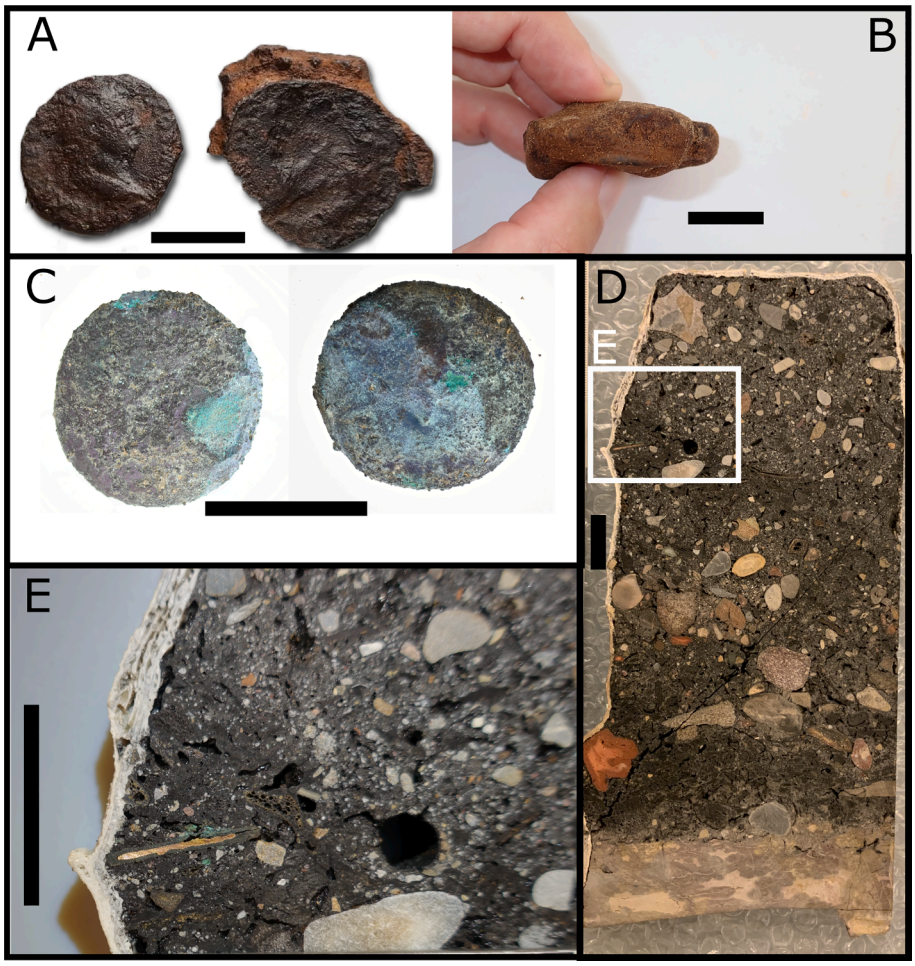
Fig. 4. The objects prior to the analyses. Scale bar = 2 cm. A: One of the coins at Berlicum that was found before the start of the fieldwork. Cracking it open in this case allowed the identification of the coin as an As of Titus. (Image Wim van Schaijk, reproduced from de Groot & de Kort 2021). B: The concretion with coin that was recovered during the fieldwork at Berlicum. C: The concretion with coin from Krommenie. The blue/green colours may have formed after it was excavated. D: Thin slice of the impregnated block of soil with plaster edge from Kempraten. The charcoal rich deposit is visible as dark layer with embedded stones and bones above the bedrock. The area of 4E is indicated in white. E: Detail of 4D, showing the coin embedded in a charcoal rich deposit. A metallic core with green-grey corrosion layer can be observed at the edge of the sample. (For interpretation of the references to colour in this figure legend, the reader is referred to the web version of this article.)

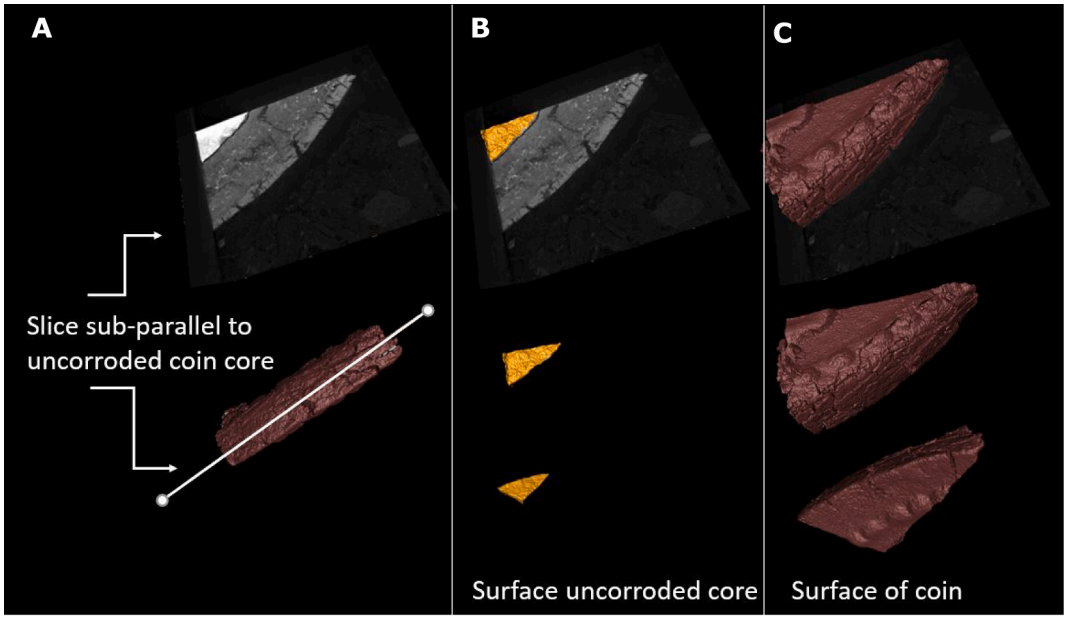
Fig. 7. Results of the mCT scan of the Kempraten coin fragment that is embedded in the impregnated soil block. The cross sections (A) clearly show the depleted outer rim with fissures and the metallic, uncorroded fragment in the core of the coin. The lack of corrosion crust made it possible to 3-D render the coin's surface (C) as well as other features, like the metallic uncorroded core remnant (B). The coin's rendered surface shows that the coin had a row of rounded dots near the edge. The fissuring at the rim is also apparent.

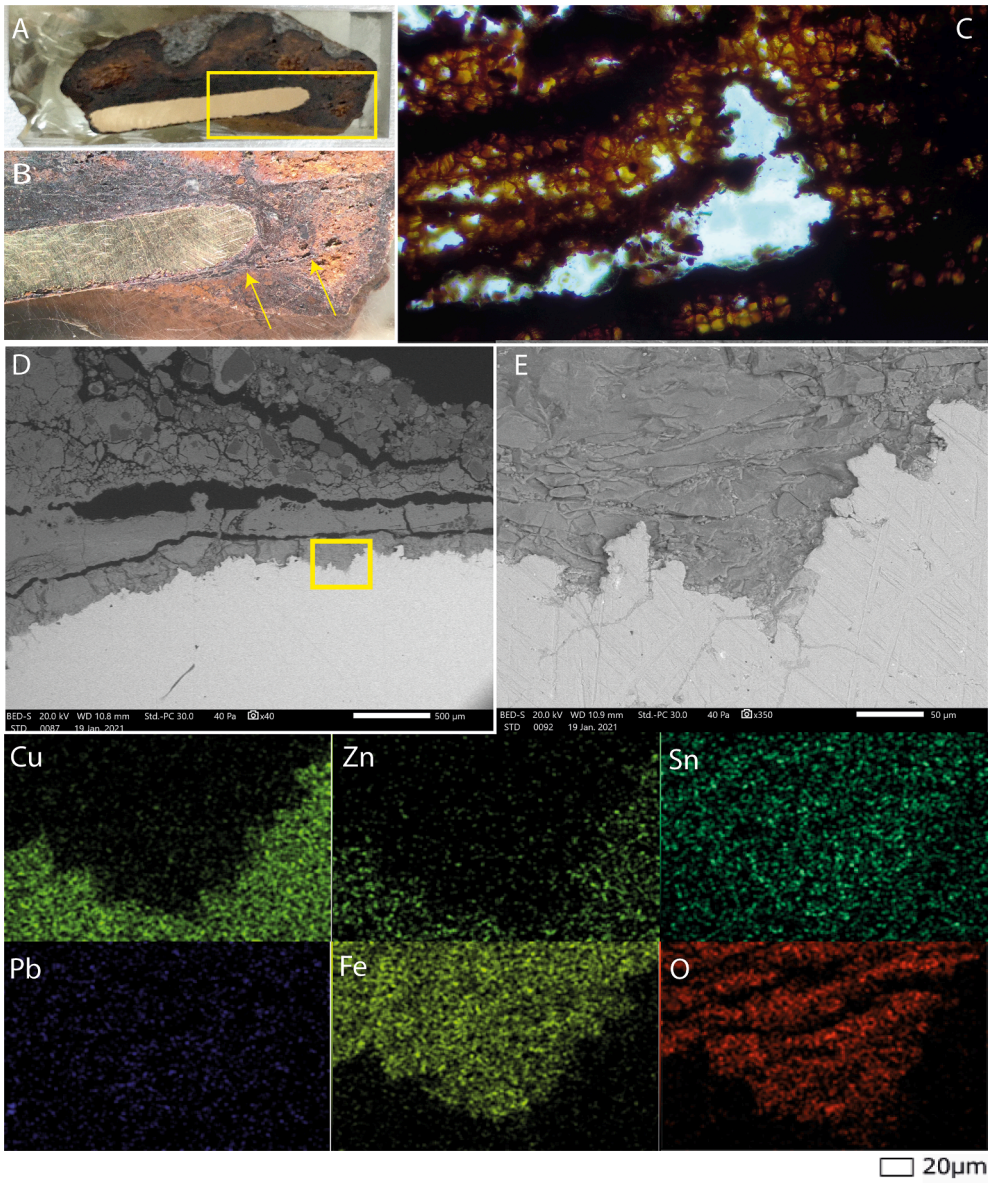
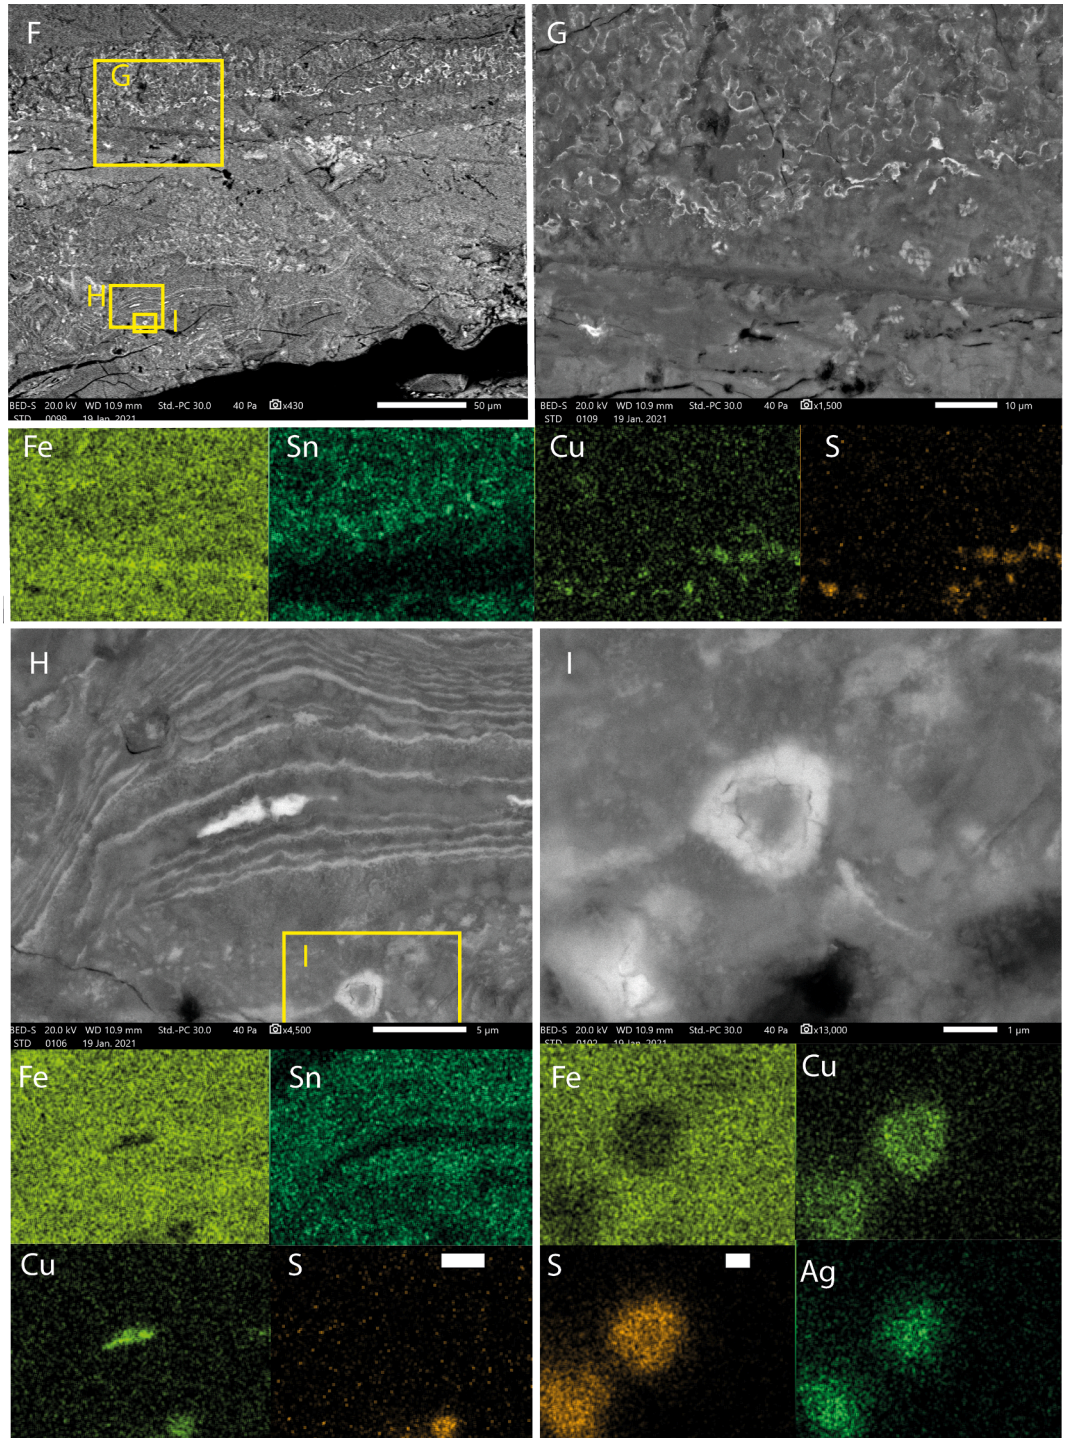
In incident light (Fig. 8A,B), the cross-section of the Berlicum concretion clearly shows an uncorroded core of the coin. The surrounding corrosion layer is massive, but has heterogeneous colours ranging from red and orange to black. Black material seems to be more prominent near the coin's surface. The distribution of the colours especially in the rim-area, suggests that the original surface of the coin was in what is now the concretion. It seems that the coin used to extend several mm from the present rim of the uncorroded core, a part that now seems to be replaced by the concretion material. Apparently, the corrosion happened anisotropically: little corrosion from the surface, but strong from the rim of the coin inwards. Sand grains are embedded in the concretion material, but this is not apparent everywhere.

Fig. 8. Berlicum coin cross-section analyses. A: Cross-section through the concretion, seen with incident light. The uncorroded core of the coin is clearly visible. The yellow-lined square indicates the area in B. B: Detail of coin core in concretion, showing the colour-variation in the concretion. The arrows indicate the original surface of the coin. C: Microscope image (transmitted plane polarized light) from the thin section with root tissue in the concretion. D: Backscatter (BE) image of the contact between the core (light grey) and the surrounding concretion (darker grey), showing a sharp, irregular boundary. The concretion is banded and shows fissures and cavities (black). Close to the coin, the concretion is massive and homogeneous, but the outer regions are more irregular with embedded sediment grains. The yellow-lined square indicates the area in E. E: Idem, detail of the core-concretion contact with element mappings. Cu and Zn are mostly restricted to the uncorroded metallic core, whereas the concretion is dominated by Fe and O. Note that the distribution of Sn is similar in the core and the concretion, as is the presence of minor amounts of Pb. F: BE image of another part of the concretion within the original coin volume, showcasing the distribution of Sn and other components. Note in F the pattern of light grey-white convoluted bands in the top, and parallel bands in the lower part of the image. Yellow-lined squares indicate the areas in G, H, I. G: BE images and element mappings of G; the light-grey features in the top of the image are sn-rich, whereas the white–grey clusters in the lower half contain Cu and S. H: Idem, showing thin parallel sn-rich bands, enveloping an elongated Cu-dominated feature. I: Spherical features dominated by S, with Cu in the core and an outer skin with Ag.

Backscattered electron (BE) images (Fig. 8D,E) show a sharp, irregular boundary between the uncorroded core and the iron oxide-dominated concretion. Element mappings confirm the metallic nature of the core (no O), which consists of a leaded Cu-Sn-Zn alloy. In the Fe,O dominated concretion, Cu and Zn concentrations are very low/absent, but the distribution of Sn and Pb seems unaffected. In more detail, however, as in Fig. 8F-I, it becomes clear that the Sn compounds in the concretion within the original coin volume are distributed in thin parallel or convoluted bands – probably as SnO_2 – embedded in the Fe(III) oxide groundmass. Apart from the tin oxides, small (micron to sub-micron scale) inclusions can be observed of remnant metallic Cu (Fig. 8H), Cu,S compounds (Fig. 8G) and – in one case – a combination of Cu,S and Ag,S compounds (Fig. 8I). The concretion outside the original coin volume does not contain Sn, but Cu-rich bands are embedded in the iron oxides (Supplementary Information).

The presence of some Cu and Ag sulphide species in a specific part of the corrosion layer (Fig. 8H,I) indicates that in Berlicum, some sulphur species have become available during the corrosion process. It is most likely that the sulphide species were already present in the coin when it was manufactured. It is unlikely, however, that these sulphidic compounds have had much influence on the overall progress of the corrosion processes.

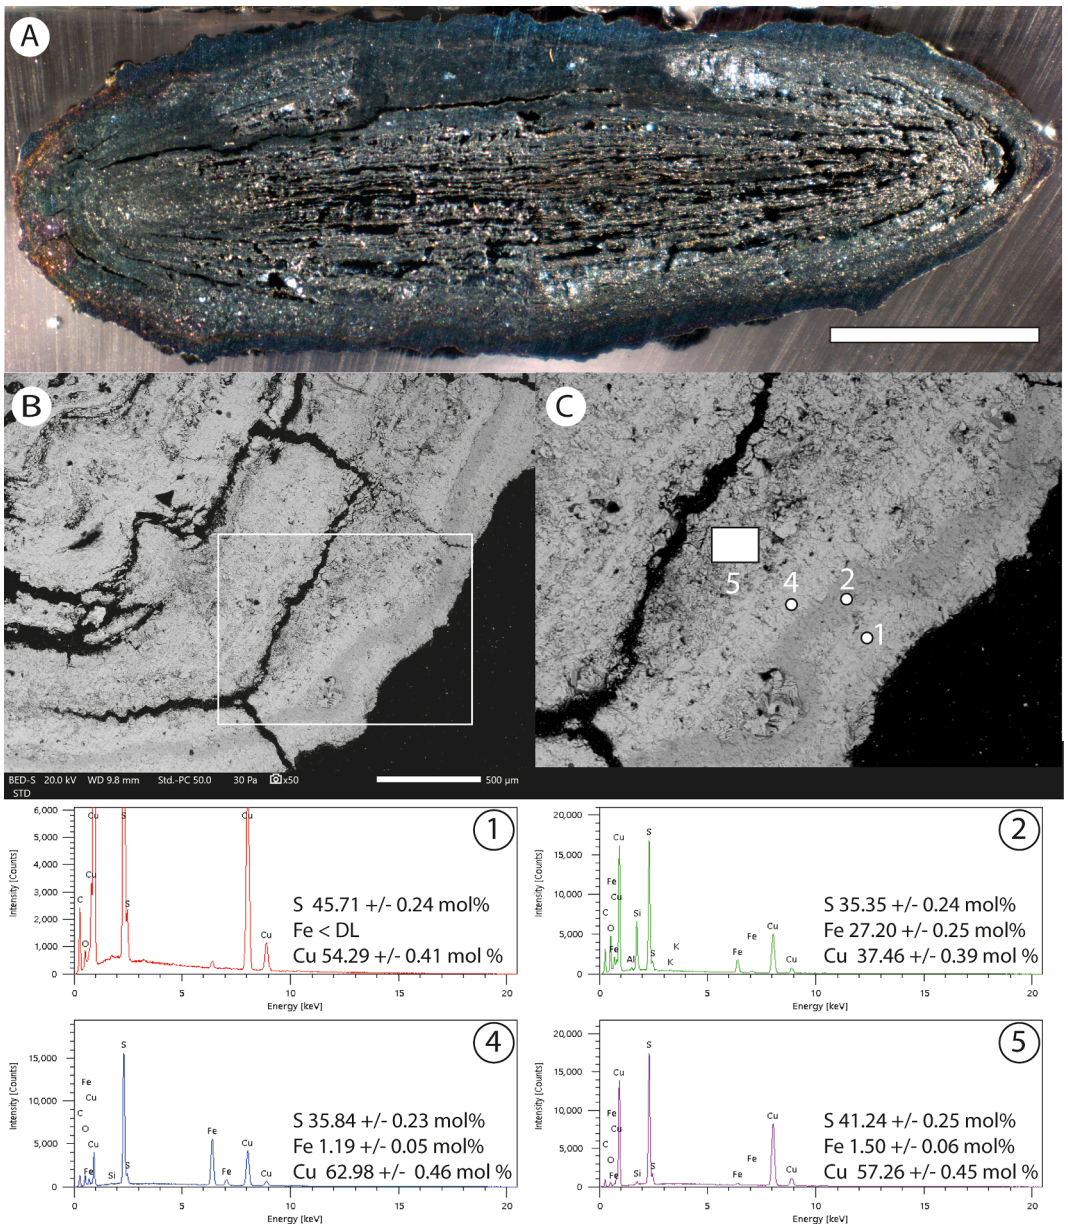
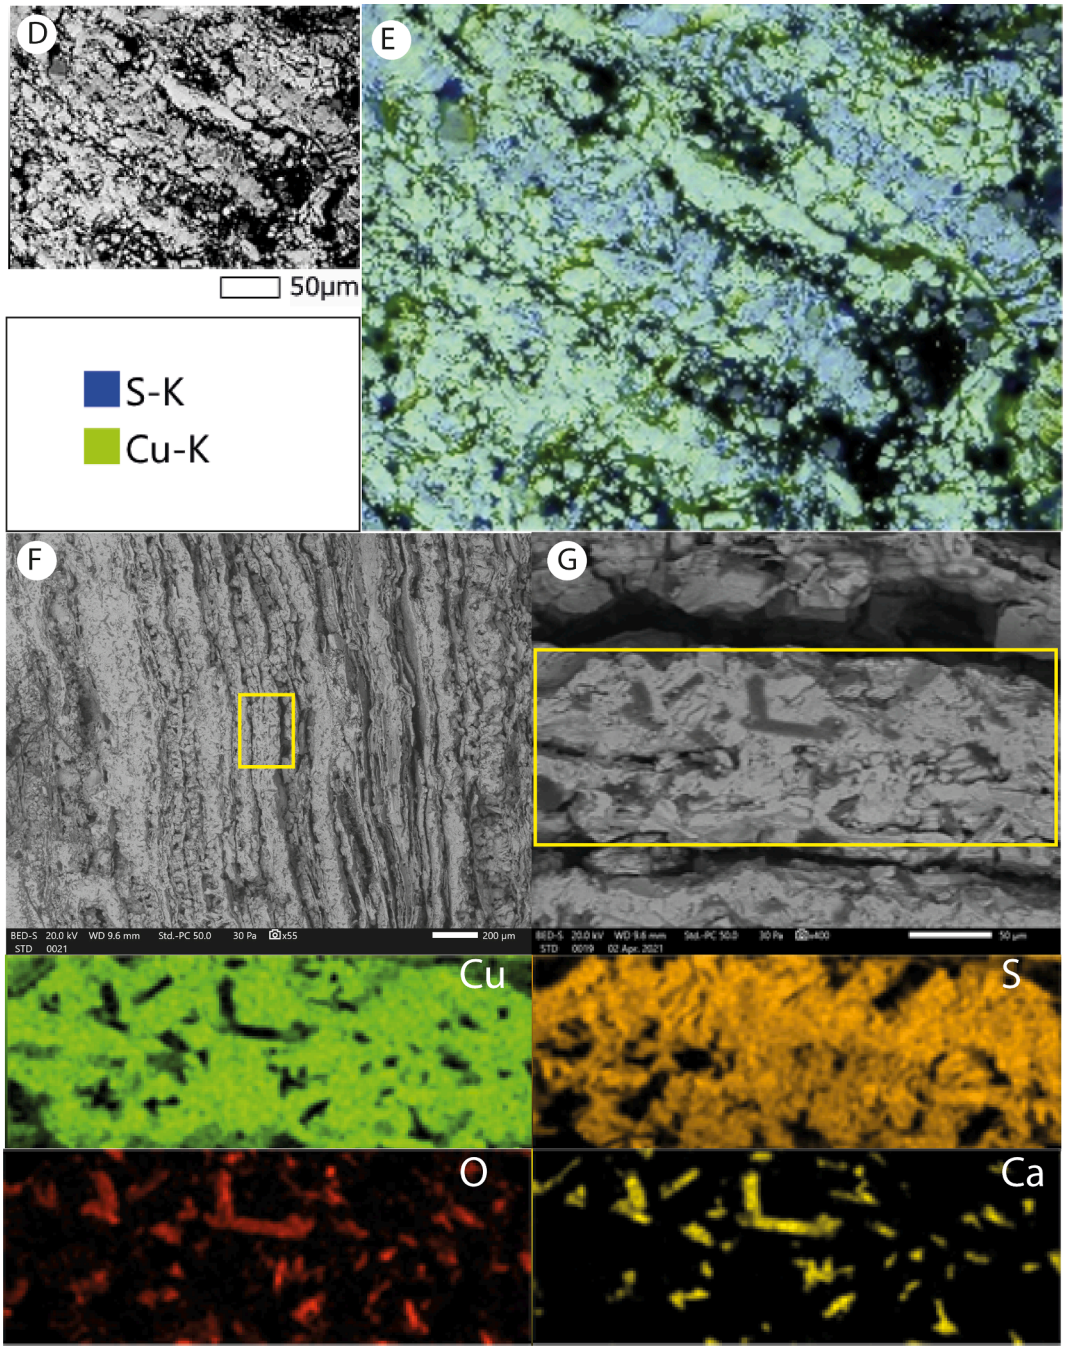
Fig. 9. Krommenie coin concretion cross-section analyses. A: Cross section of the Krommenie coin with incident light. The thin separate laminae in the core with a grey-metallic colour are clearly visible. The massive outer crust includes a blueish band. (Scale bar = 5 mm) B: BE image of the concretions' surface. Note the banded, massive nature of this part of the concretion. The square indicates the area of C. C: Detail of B and accompanying EDX-spectra. Spectrum positions are indicated with dots (spot measurement) and a square (area measurement). The groundmass consists of copper sulphides (probably a mix of CuS and Cu_2S; covellite and chalcocite) with traces of iron (<2 wt% Fe), but the dark band parallel to the surface (measurement 2) contains much more iron. D: BE image from the transition of the solid surface to the laminated core of the coin. E: As D, overlain with S and Cu element mappings. Banding with higher and lower S contents are apparent. F: Core of the coin, showing the stacking of very thin (<10 – 100 µm) lamellae. The area of G is indicated. G: Detail of F (turned 90°) with associated element mapping. The area that is mapped is indicated by the yellow square. Dark grey lath-shaped minerals are embedded like phenocrysts in the light-grey massive groundmass, forming a porphyric structure. The element maps show that these minerals are calcium sulphates, i.e. gypsum or isomorphs embedded in copper sulphides. In addition, the map of S shows banding at this level as well.

In cross-section, the Krommenie coin is dark grey to metallic in colour. The outer shell of the concretion is massive, but – as was already demonstrated by the mCT scans –- the coins' core consists of a series of

thin parallel lamellae, separated by elongate cavities, giving it an overall appearance of a stack of thin slivers of dark material. A metallic blueish band is visible in the outer shell. It is not clear from the cross-section whether the original surface of the coin is still present in the concretion (Fig. 9A).

It is remarkable that the whole coin of Krommenie has been transformed into corrosion products, with no original uncorroded core left: The coin proper has been transformed into laminae of Cu sulphides in which gypsum crystals are embedded. An outer corrosion crust has formed of Cu sulphides in which some iron is incorporated, and which contains one iron-rich band. The most puzzling feature in the Krommenie coin is the abovementioned embedding of sulphate (gypsum) crystals in the Cu sulphide lamellae in the core of the coin: The co-existence of sulphates and sulphides is already unexpected, as they are stable at different redox conditions. The origin of the Ca is maybe even more puzzling: It must have come from outside the coin, i.e. the burial environment or groundwater, at a moment that corrosion had already caused such a degree of damage to the coin that fissures or cavities had formed. Given the bulk of the evidence, it is likely that the coin's corrosion was the result of either fluctuating or changing burial conditions in a sulphide/sulphate-rich environment:

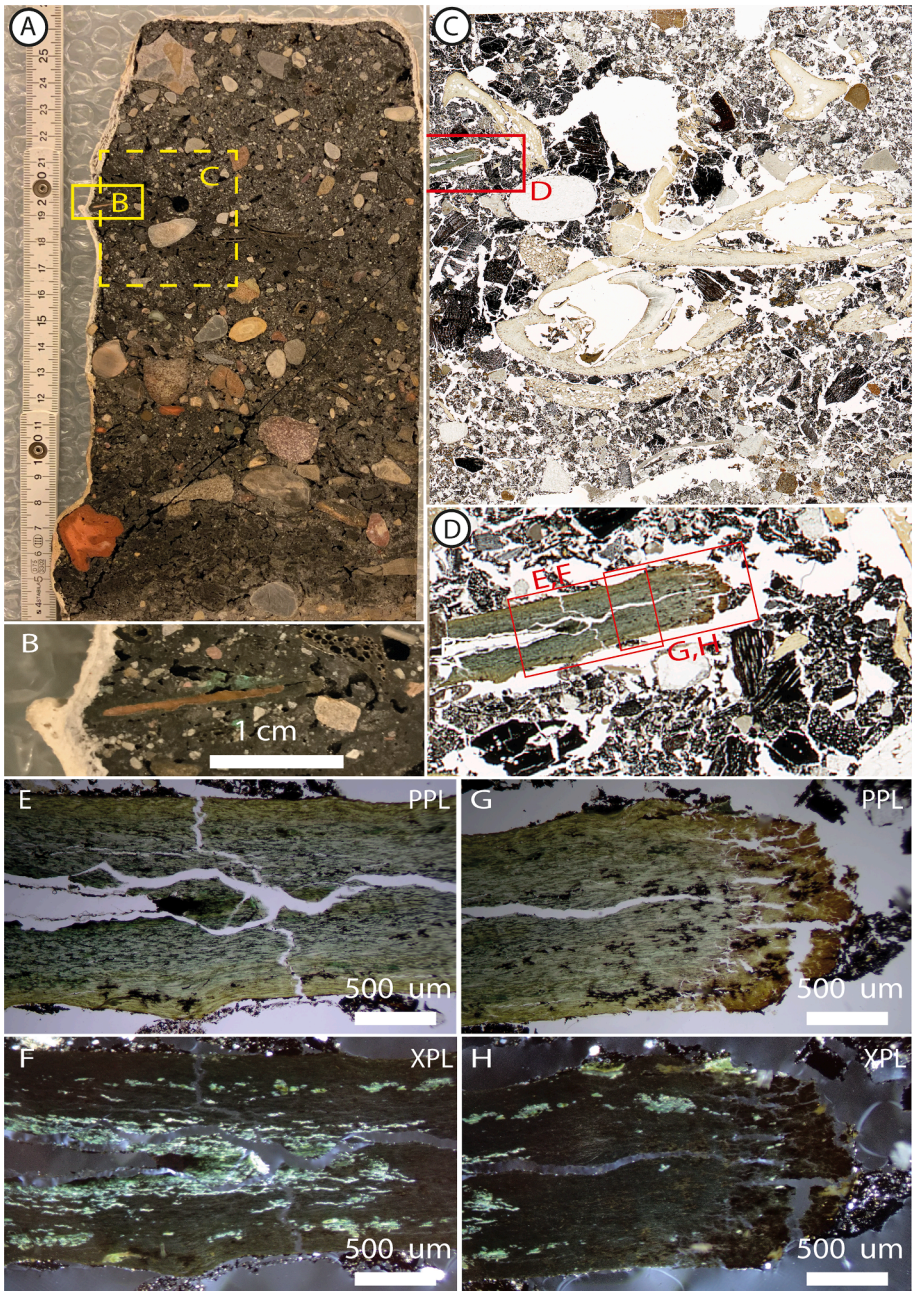
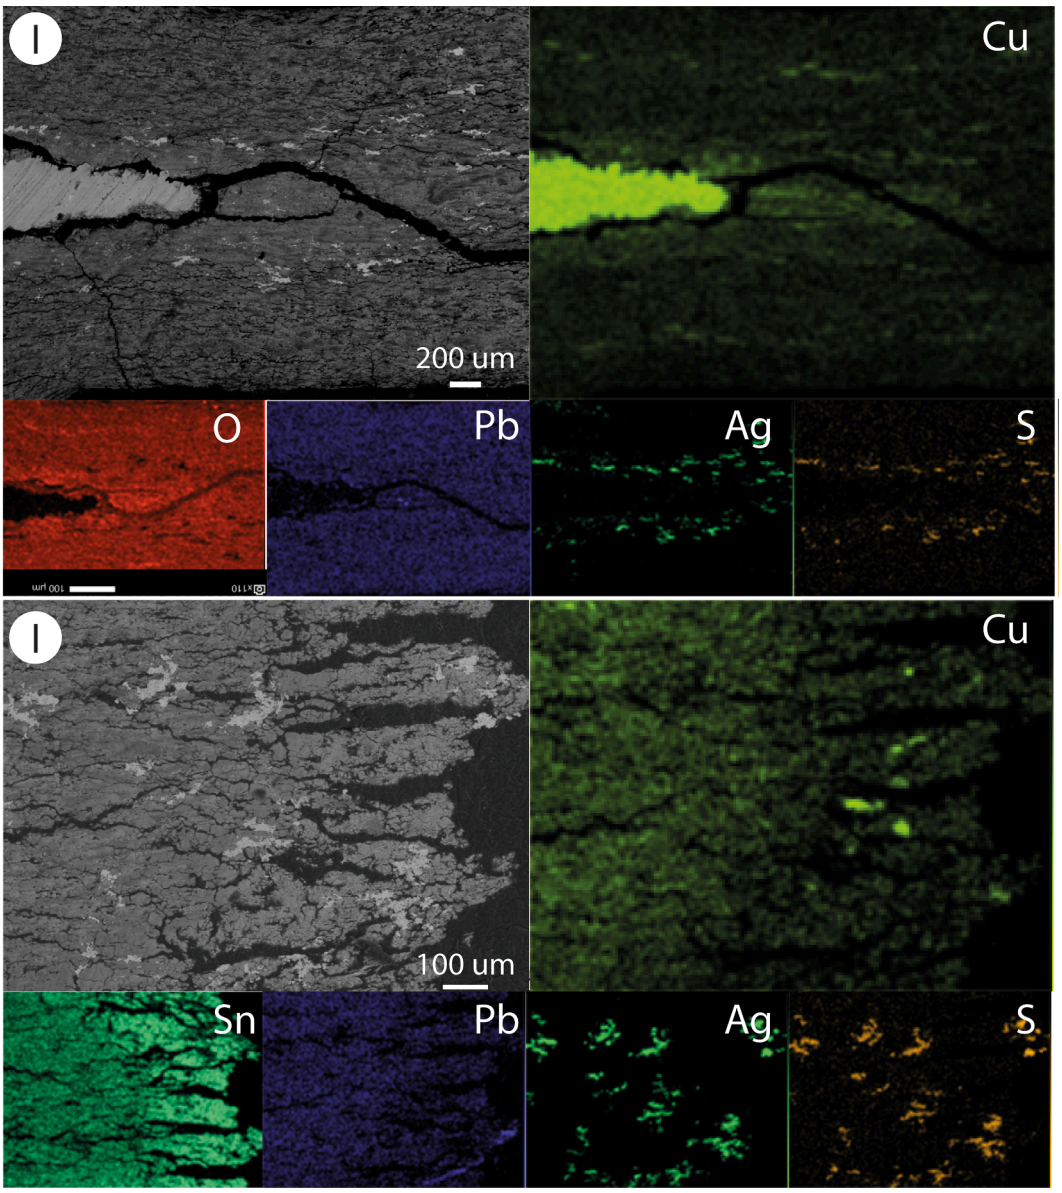
The incident light observations on the block (Fig. 10A,B) show how the coin is embedded in an anthropogenic deposit with ample debris and charred material. A remaining metallic core of the coin can still be seen, as well as some remnants of green corrosion products (probably malachite; $Cu_2CO_3(OH)_2$) in the surrounding soil. In the thin section (Fig. 10C,D) ample charcoal as well as large bone fragments can be

Fig. 10. Observations of cross-sections through the Kempraten coin. A: Photograph of the impregnated block in which the coin was embedded. Yellow boxes show the positions of B and C. B: Enlargement of A, showing the coin embedded in the block. The uncorroded metallic core is apparent, as are some remnants of green corrosion products in the soil surrounding the coin. C: Scan of the thin section with embedded coin, with visible bone fragments and charcoal. The box indicates D. D: Enlargement of C, showing the coin in the thin section. Note that the metallic uncorroded core is missing in this sample. Boxes indicate E-H. E: Plane Polarized Light (PPL) micrograph of the centre of the coin, surrounding the cavity where the uncorroded core was. The groundmass of the coins is banded green with some irregular black-opaque inclusions. Near the surface of the coin, the colour is more yellow. F: Idem, with crossed polarizers (XPL). Most of the groundmass shows very little birefringence, apart from the zone immediately surrounding the core, and smaller elongated domains throughout the groundmass. G, H: PPL and XPL micrographs of the edge of the coin. Although similar to E and F, the very edge of the coin shows considerable fissuring, and colours that go from yellowish to brown. I: BE image and mappings of the uncorroded core and surrounding area. The corroded area is strongly depleted in Cu, but Cu values are a bit higher in the zone immediately next to the core. The edge of this zone is formed by light irregular domains that are rich in Ag and S. Pb occurs throughout the groundmass – its apparent lower concentrations in the core is an artefact of the higher Cu concentrations there. Thin bands parallel to the coin's surface show elevated Cu and O. J: BE image and mappings of the edge of the coin, showing clearly the wider fissures at the coins' edge. This zone is richer in Sn, but the mapping shows some small domains richer in Cu (and O; not shown) as well. The Pb mapping shows a thin band in the lower right corner.

The micrographs in PPL (Fig. 10E,G) show that the green banded groundmass in the coin changes to more yellow colours at the edge, and even towards brown at the rim of the coin. Embedded in this groundmass are opaque irregular mineral features. They seem to occur preferentially in bands. The rim of the coin is strongly fissured, with V-shaped voids, as was already indicated based on the mCT scans. XPL micrographs (Fig. 10F,H) show in general that the groundmass of the coin is hardly birefringent, except for (1) the material immediately next to the uncorroded core and (2) isolated elongated domains parallel to the coins' surface. The green PPL colour and – in XPL - strong birefringence identify these as domains of malachite. There are no indications of the occurrence of tenorite. This mineral has a distinct light to dark brown colour, a strong blue to grey anisotropism and is weakly pleochroic (mindat.org).

SEM-EDX analyses show that, compared to the uncorroded core, the green banded groundmass is strongly depleted in Cu (Fig. 10I, 11). The malachite-zones identified in thin sections seem to appear in the SEM-mappings as zones with slightly higher Cu and O concentrations in the Cu-depleted groundmass. The opaque irregular mineral features spotted in the thin section appear in the SEM images (Fig. 10I,J) as light grey irregular Ag,S inclusions. It is remarkable that there seems to be a concentration of Ag,S inclusions at the outer edge of the malachite-dominated zone (Fig. 10I). At the coins' rim, the fissure-rich zone has even higher Sn-concentrations than the rest of the Cu-depleted mass. Fig. 11 shows that whereas the uncorroded core has Sn concentrations around 5 %, they rise to ca. 20 % near the core and approach 40 % close to the rim of the coin, while Cu concentrations drop from ca. 95 %, to ca. 20 % near the core and < 10 % close to the rim. The lead mapping (Fig. 10J) makes a faint band of increased lead concentrations visible on the outside of the coin near the rim. Point measurements in this band confirmed increased lead concentrations on the corroded coin, but a pure lead phase could not be discerned.

It is remarkable that the degree of Cu leached is not homogeneous. Most striking is that the outer rim of the coin has been leached to such a degree that the remaining corroded mass has shrunk, resulting in a pattern of parallel V-shaped fissures. Here, the coin also obtained a more yellow-orange than green-grey colour. It is unclear why this colour change occurred.

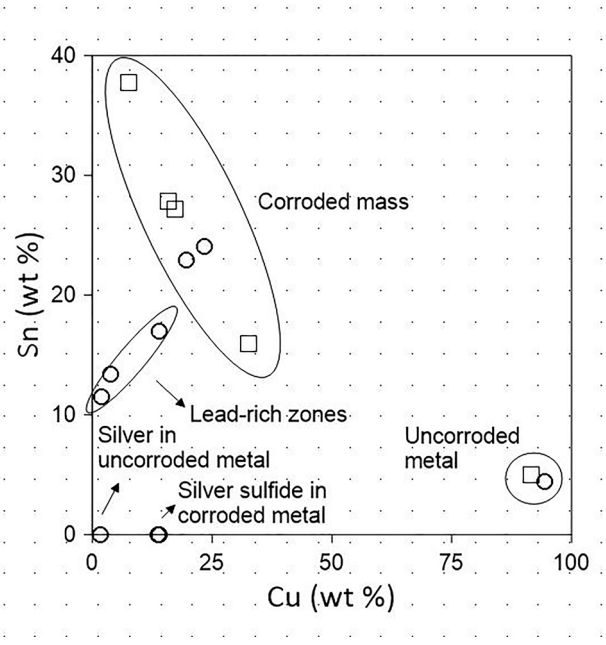
Fig. 11. Cu, Sn concentrations from spot- and area measurements on the Kempraten coin. Indicated are measurements from the uncorroded core, corroded material, Pb-rich material and Ag-rich inclusions on both the uncorroded core and the corroded material. Circles are spot measurements; squares are area measurements.
