Lessons for Remote Post-earthquake Reconnaissance from the 14 August 2021 Haiti Earthquake

Published in
Frontiers in Built Environment

ORIGINAL RESEARCH
published: 29 April 2022
doi: 10.3389/fbuil.2022.873212

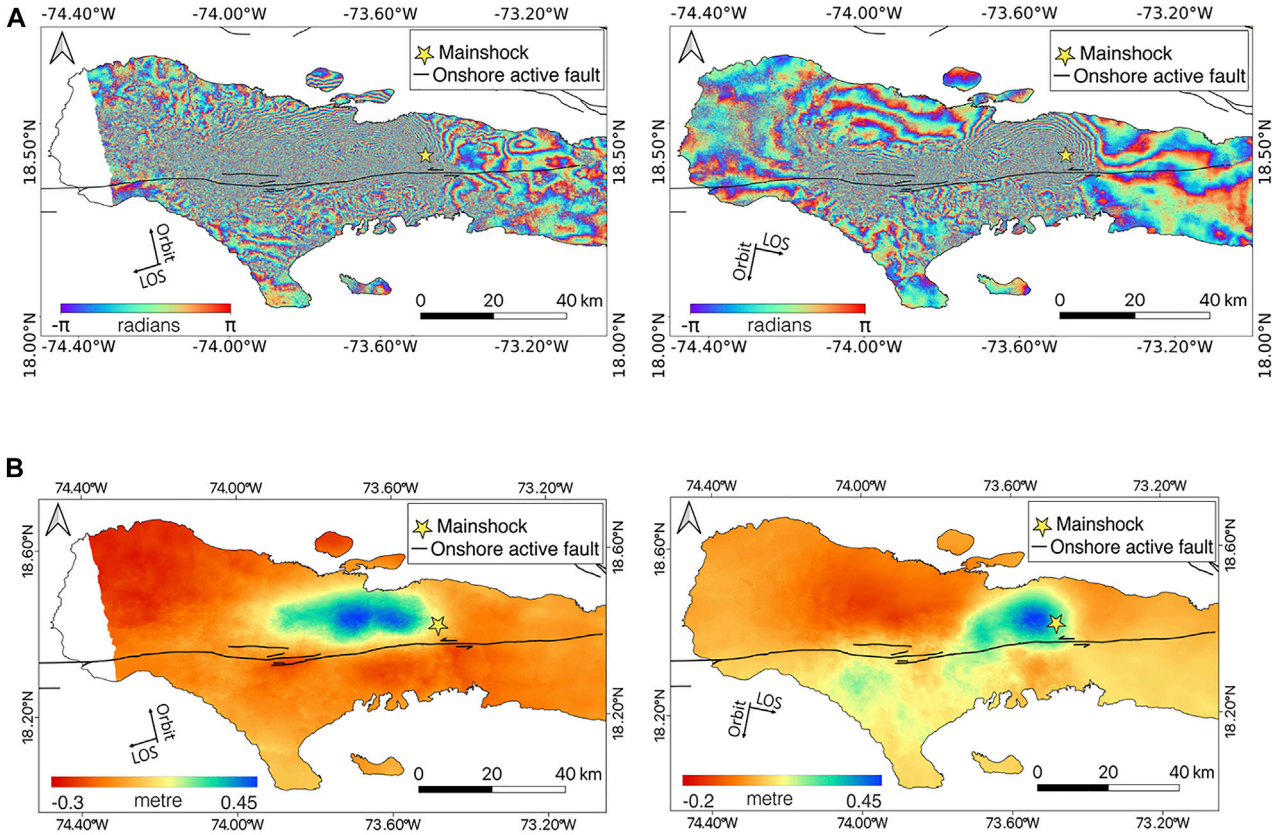
Two pairs of pre- and post-event images were processed to derive the co-seismic deformations caused by the 14th August 2021 earthquake (**Figure 7**). The images were acquired before and after the event by the Sentinel-1A/B satellites, which operate at C-band, i.e. with a signal wavelength of 5.6 cm, and acquire interferometric images every 6-days using both satellites. The images were processed using the topsApp.py processor of the InSAR Scientific Computing Environment (ISCE) v.2, an open-source software developed and released by the NASA Jet Propulsion Laboratory (Rosen et al., 2012). **Figure 7A** shows the resulting interferogram maps for the ascending (i.e. satellite travelling from south to north) and descending (i.e. satellite travelling from north to south) geometry. Each contour indicates a movement in the LOS direction equal to half of the sensor wavelength. Thus, those areas with more closely spaced contours, around and west of the epicentre, exhibit a greater amount of deformation in the LOS direction.

The differential phase values contained in the interferograms were later converted into actual displacement units (metre). **Figure 7B** shows the map of surface displacements for ascending and descending geometries. Each pixel indicates a change in distance along the satellite LOS between pre- and post-event acquisitions. Positive and negative values correspond to LOS displacements toward and away from the satellite, respectively. Results indicate that the blue area close to the epicentre moved toward the satellite by up to 0.5 m.

FIGURE 7 | (A) Co-seismic interferograms and **(B)** surface displacement maps obtained by processing (left) a pair of Sentinel-1 SAR images acquired on 05 August and 17 August 2021 from ascending acquisition geometry, and (right) a pair of Sentinel-1 SAR images acquired on 03 August and 15 August 2021 from descending acquisition geometry. The yellow star indicates the earthquake epicentre. Black lines are onshore active faults from Saint-Fleur et al., 2020.

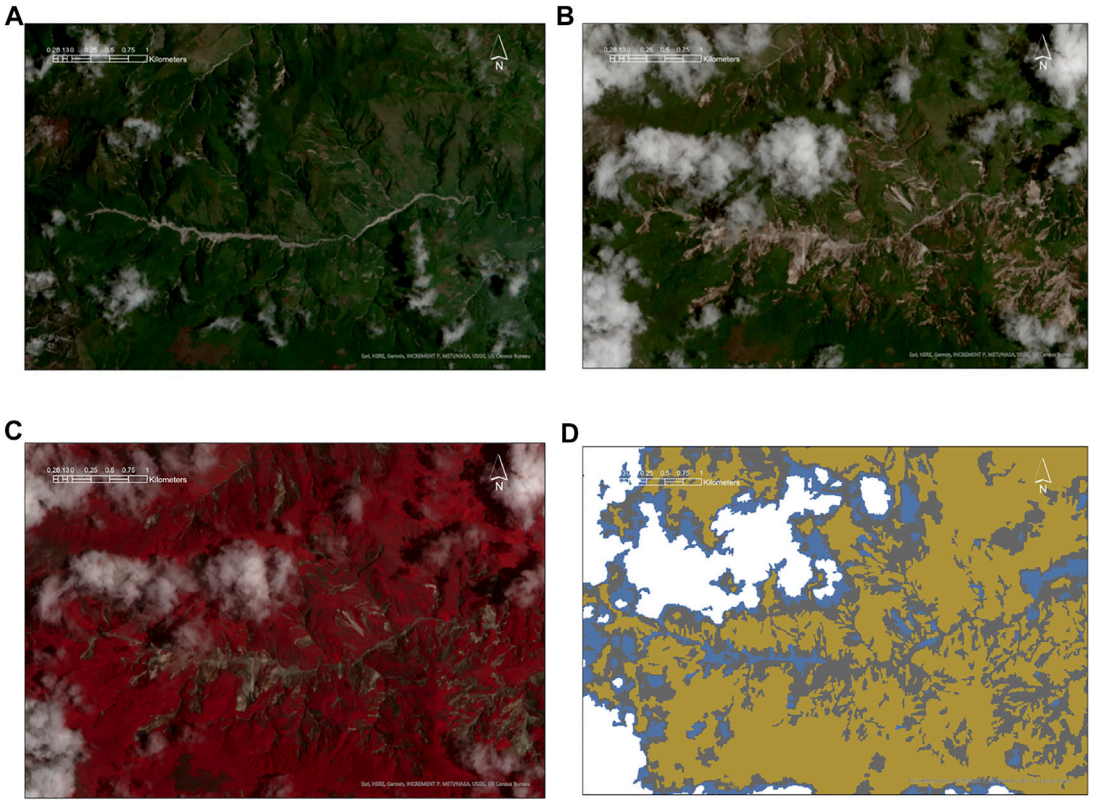
Figures 8C,D show some example outputs from the analysis. However, we found that these automated approaches could not adequately distinguish between landslides and cloud cover, despite training the system to classify landslides and clouds separately. Therefore, we mapped the landslides manually in the post-earthquake true-colour Sentinel-2 imagery.

FIGURE 8 | Sentinel-2 true colour Imagery **(A)** before and **(B)** after the earthquake. **(C,D)** processed multi-spectral Sentinel-2 imagery change detection images.

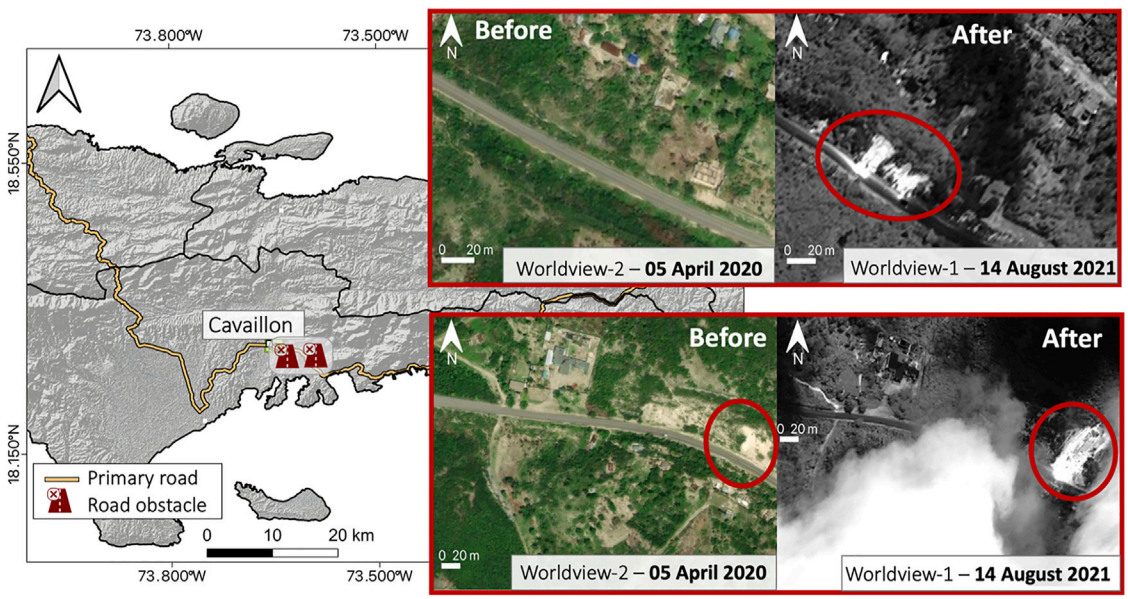
To evaluate the impact of landslides on transport infrastructure, we used higher resolution Worldview-1 and Worldview-2 imagery, in combination with an OpenStreetMap (OSM, 2021) database of roadways in Haiti. The employed optical data consisted of pre- and post-event Worldview-1, Worldview-2 and Worldview-3 images released by MAXAR (Maxar, 2021) 2 days after the earthquake, as part of the MAXAR Open Data Program. Such images have a resolution between 30 and 90 cm. The OSM road database contains vector data of road centrelines in the Tiburon Peninsula and includes information on the road length, road name, and road type, e.g., primary and secondary. We observed that some of the detected landslides had had a direct impact on adjacent infrastructure, causing damage and blocking roads. For example, **Figure 9** shows two landslides blocking a primary road a few kilometres outside Cavaillon, in the South Department of Haiti. The affected infrastructure is the National Road 2, which is a key route linking the South and Nippes Departments. A visual comparison between pre- and post-earthquake optical images shows that in the first location the earthquake likely activated a new sliding body, while for the second road obstacle, the presence of an existing sliding body was already visible in April 2020, i.e. the landslide hazard could potentially have been recognised in advance.

FIGURE 9 | Worldview 1 and 2 imagery used to evaluate impact of landslides on infrastructure. Optical imagery are from the MAXAR Open Data Program.

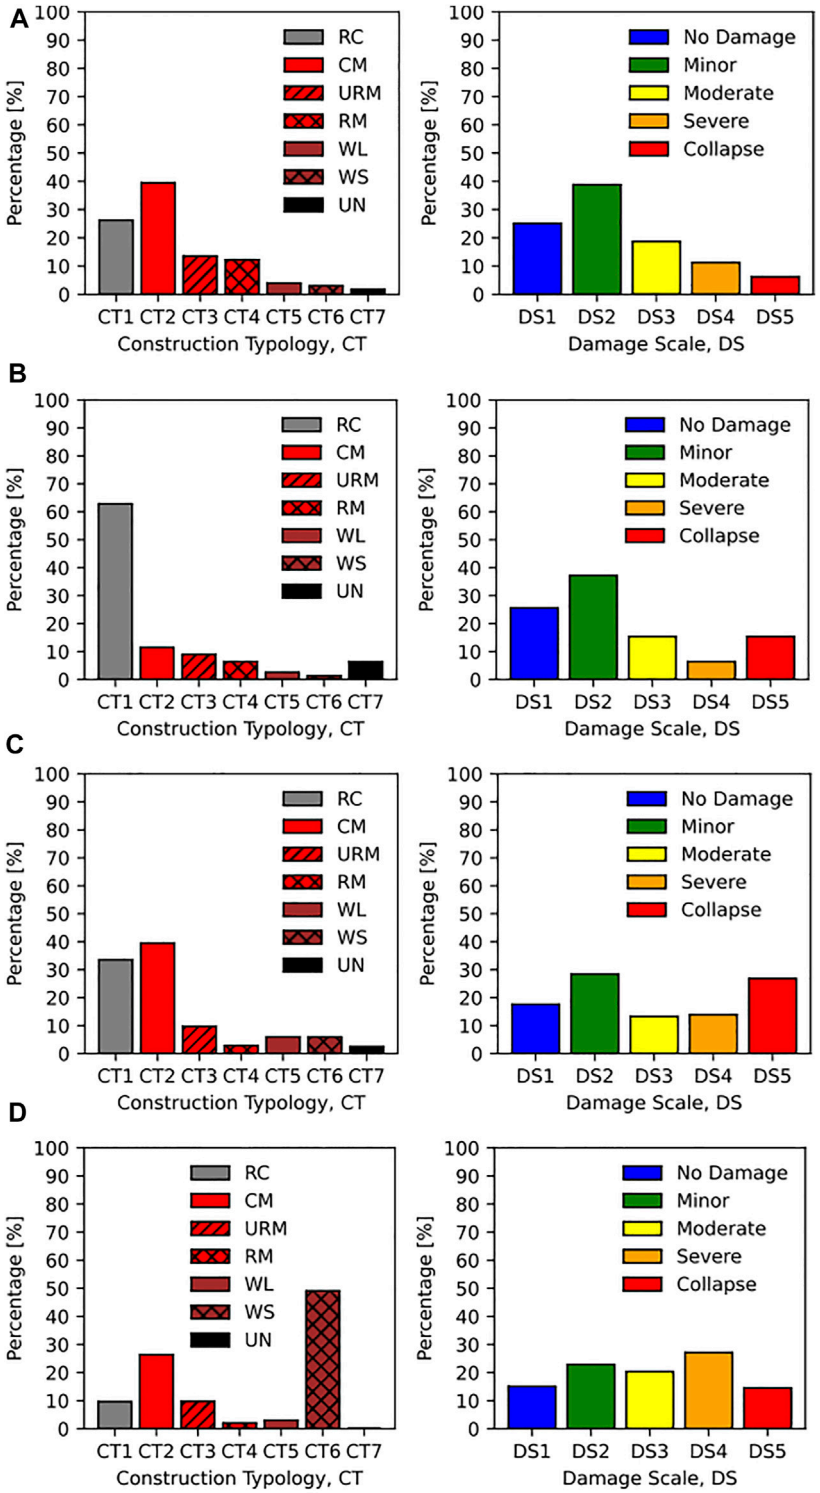
Among all surveyed schools, 39.5% (330 out of 836) and 26.2% (219) were constructed out of confined masonry and concrete frame with masonry walls, respectively (**Figure 11A**, left). In terms of damage level, 24.9 and 38.4% of the assessed schools experienced no or minor damage, respectively (**Figure 11A**, right). However, a significant proportion of schools demonstrated severe damage (11.1%), or partial or total collapse (6.1%). For most building typologies, the greatest percentage of buildings experienced only minor damage. However, the most common damage level for schools made of wood light frames (WL) was no damage, and that for wooden frames with stone infill (WS) was severe damage. Damage levels by building typology are presented in **Figure 12**.

FIGURE 11 | (Left column) construction typology and (right column) overall damage distribution for **(A)** school, **(B)** hospitals, **(C)** churches and **(D)** residential buildings.

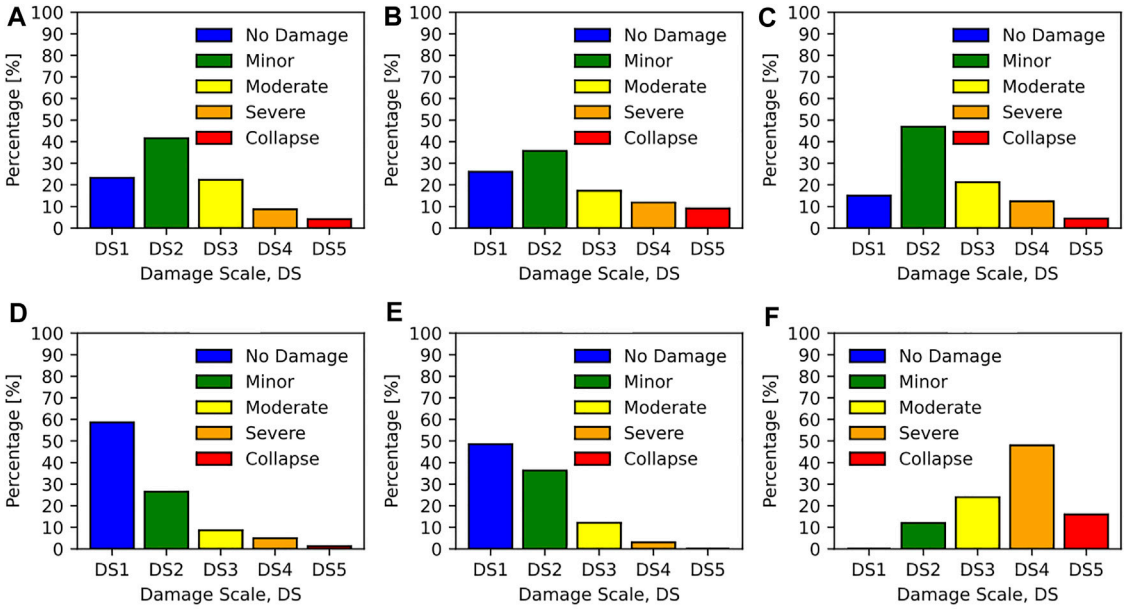
FIGURE 12 | Distribution of damage grades for **(A)** reinforced concrete, **(B)** confined masonry, **(C)** unreinforced masonry, **(D)** reinforced masonry, **(E)** wood light frame and **(F)** wood schools with stone infill.

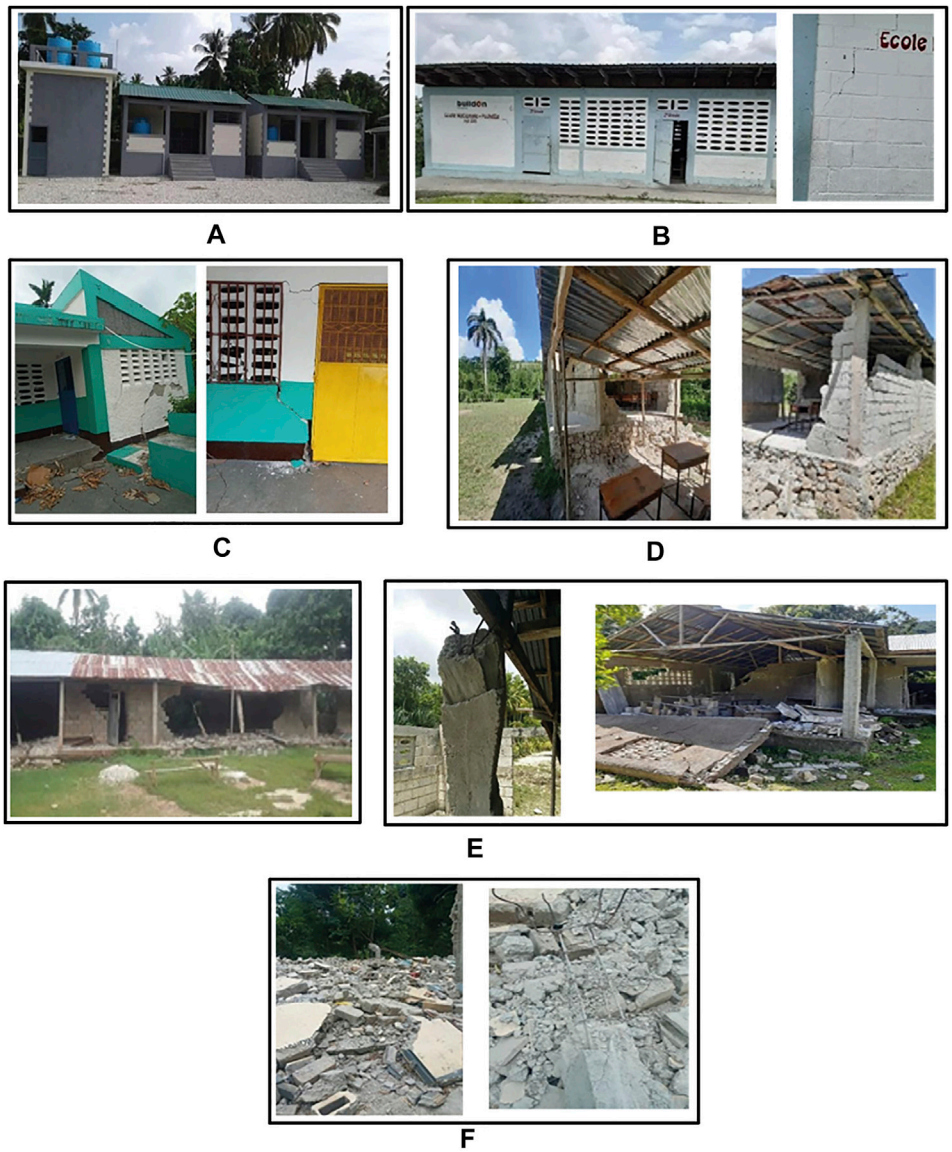
In-plane and out-of-plane masonry failure were the most common failure mechanisms for the damaged schools. Vertical cracks were evident along the corners and walls of the buildings, indicating out-of-plane material failure. Horizontal and diagonal "x" shaped cracks were also present, typically around openings and along walls in-plane with the earthquake slip direction. Whilst these failure mechanisms were primarily evident in the masonry and concrete structures, failure of the connections, either from poor material strength, detailing or workmanship was evident in all building typologies. On many occasions, openings along the perimeter walls provided areas of high stress concentration where the seismic load had no clear load path to the wall and ground below. **Figures 13C–F** show the typical damage mechanisms experienced by the schools graded from moderate to total collapse.

Schools which performed well had regular plans and provided adequate strength and ductility. Light timber roof structures performed particularly well, experiencing little or no damage. Strong foundations and sufficient connections between the shear walls and supporting corner columns acted to dissipate the seismic forces effectively and thus reduced the damage experienced by these schools. Evidence of this is presented in **Figures 13A–B**.

FIGURE 13 | Examples of the damage grades **(A)** no damage, **(B)** minor damage, **(C)** moderate damage, **(D)** severe damage, **(E)** partial collapse, **(F)** total collapse.
