The Restoration of the Exterior

Colour, Form and Space

1 / THE RESTORATION OF THE EXTERIOR

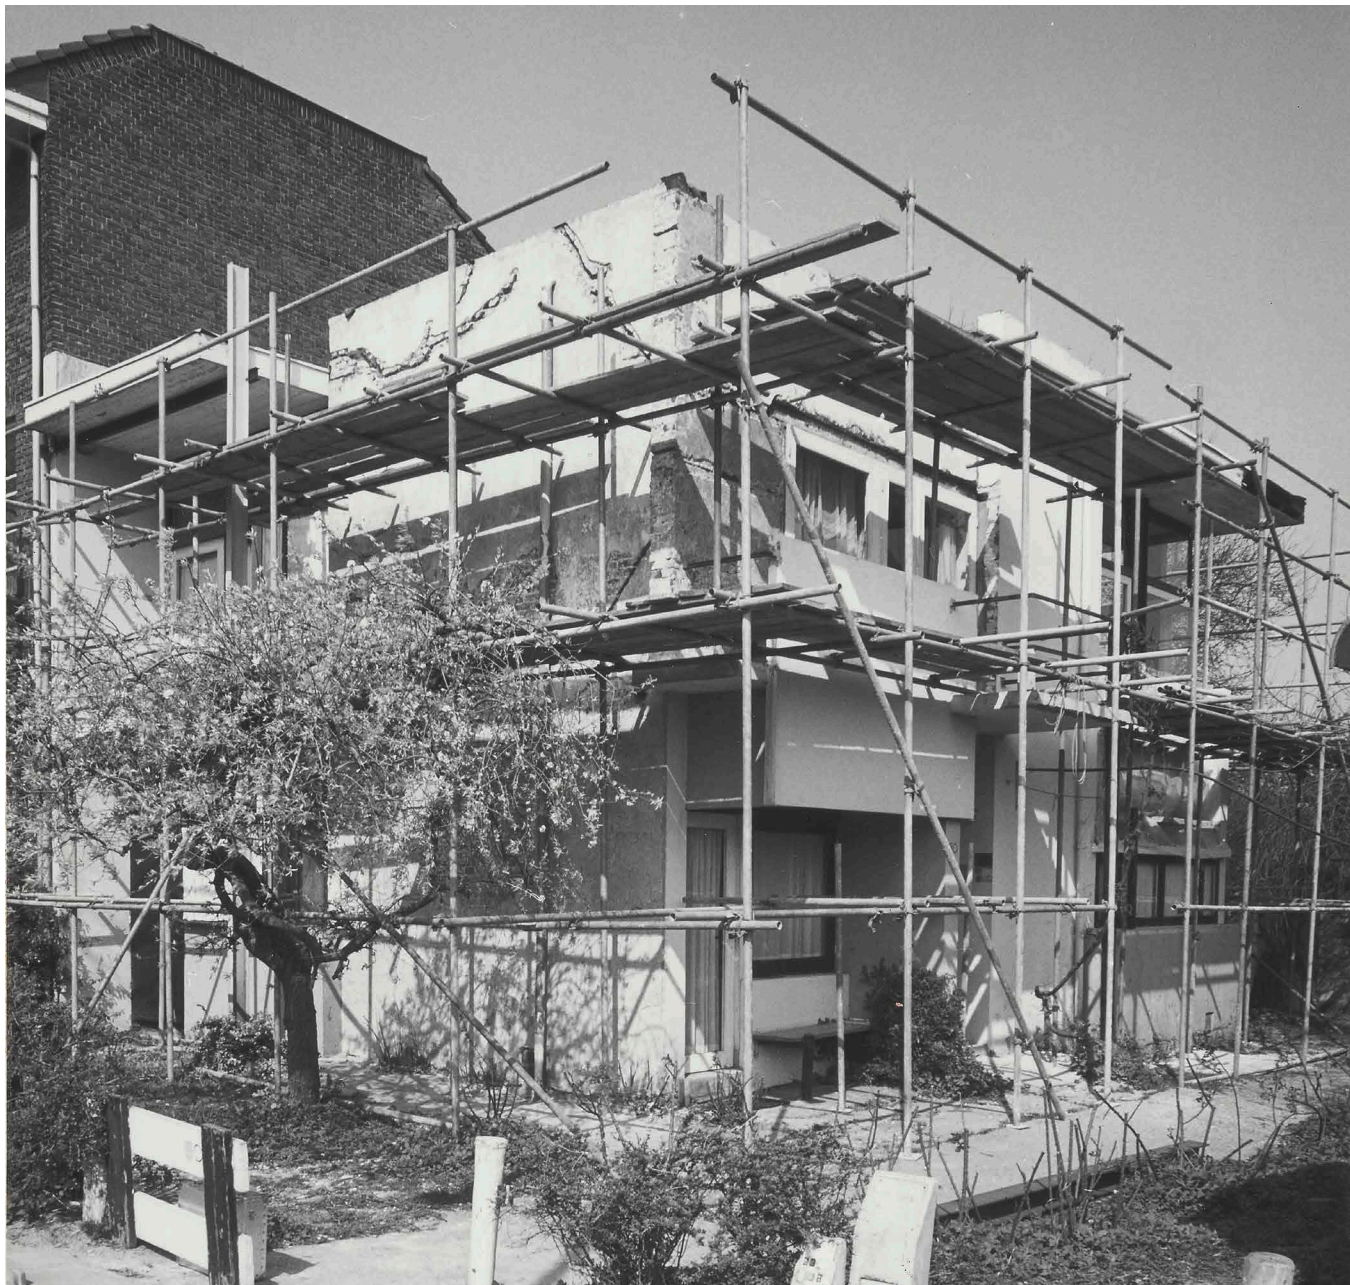
Once the house was surrounded with scaffolding, work could begin on the necessary repairs and replacements [FIG. 1.6]. The house had numerous defects and was not very stable.

FIG. 1.6 Scaffolded Rietveld Schröder House at the start of the restoration of the exterior, 1974

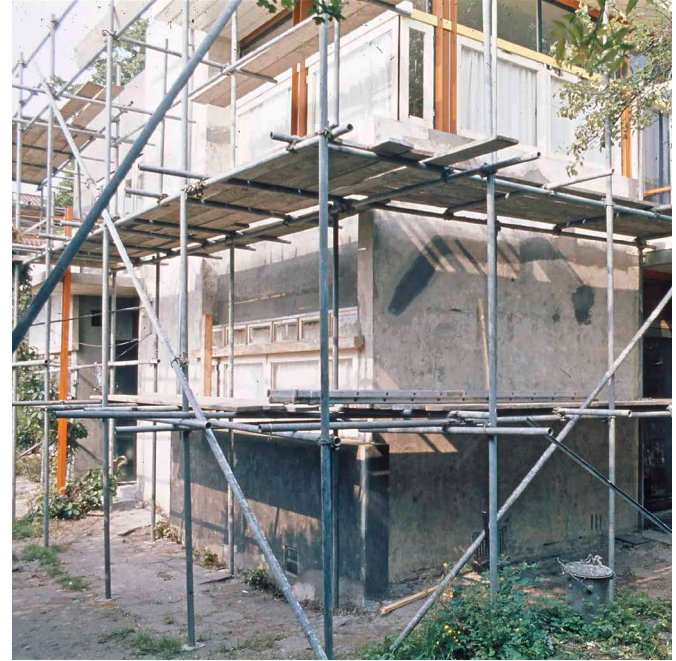
FIG. 1.8 Although the house was surrounded by scaffolding, Truus Schröder continued to live in it during the restoration of the exterior
