### **A case study**

Materials

# Wear Induced Failure of Automotive Disc Brakes—A Case Study

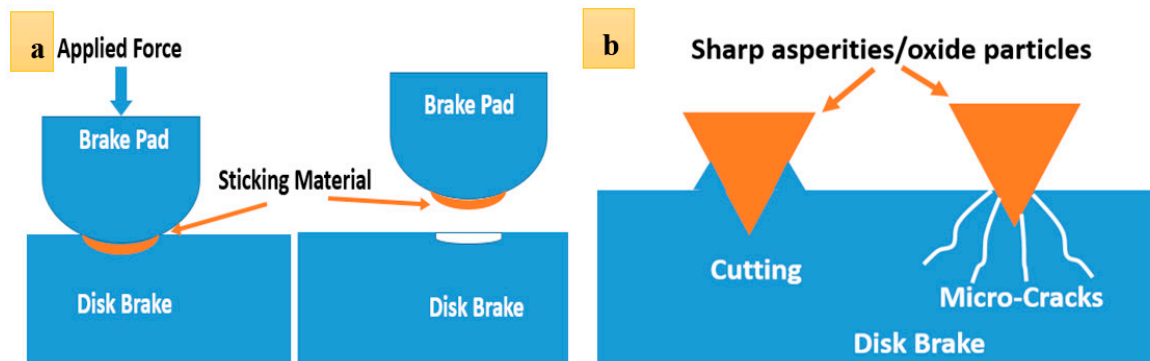
While plastic deformation and spallation are indications of an adhesive wear mechanism, plowing and cutting can be linked to the abrasive wear, inferring that both adhesive and abrasive wear mechanisms contribute to weight loss during wear test. The former wear mechanism has a relatively higher kinetics of weight loss. In severe conditions, contact points in-between sliding bodies can be severely damaged by adhesive wear. In case the surface has some minimum roughness and the applied load is high enough, metal-metal sticking on contact spots becomes inevitable. In case the so-called sticking layer is weakly bonded to the disc, it will eventually be detached from the surface. This is schematically shown in Figure 10a. In comparison to the adhesive wear, abrasive wear takes place when a hard particle/asperity is sliding over a surface. Hard particles/asperities can cause abrasion without having to induce any major plastic deformation on the surface. In case particles/asperities are sharp enough, they create surface cutting. However, their attributions are not limited to cutting, as they could also cause surface micro-fractures and grain pull-outs (see Figure 10b) [23]. Cutting and micro-cracks are essentially more dominant features on the fracture surface. Surface cutting results in the detachment of wear debris. Where the wear debris is hard and fragile, they will be fragmented and entrapped in between sliding bodies and inside surface grooves, and, in turn, contribute to the abrasion of the surface. The attribution of wear debris to the wear rate depends on the relative hardness of wear particles to that of the worn surface. Fast abrasion is expected to take place when the hardness of the matrix is less than 80% of the hardness of particles [23]. If the load at the contact points is high enough, the temperature at the contact points increases, and therefore, oxidation of the wear debris is also likely to take place. This appears to be the case in this failure (see Figure 7). Oxide particles are clearly hard and are expected to cause further abrasion. Both cutting and micro-cracks are less probable when the worn surface is ductile in nature. Results show that in this case, both adhesive wear and abrasion control the wear of the disc brake during service. Figure 11 shows the SEM images of debris after wear tests. Debris can primarily be categorized into large plate-like chips, with their sizes being in the range of a few ten micrometers, and fine agglomerated particles. EDS analysis shows that

**Figure 10.** Schematics of (a) adhesive wear and (b) abrasive wear mechanisms.
