Some learning cases in the Port of Rotterdam

De Gijt, J. G.; Brassinga, H. E.; Roubos, A. A.

IOP Conference Series: Materials Science and Engineering

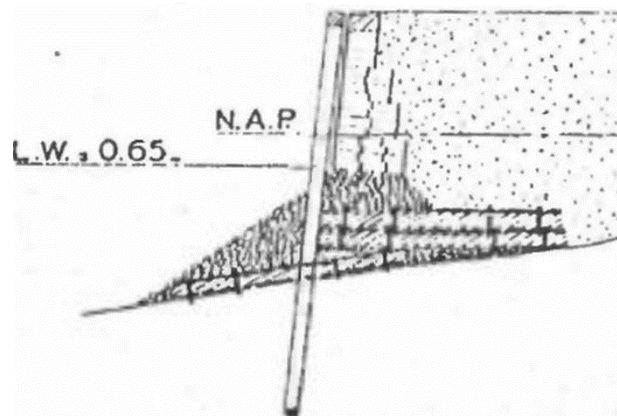
Figure 1. Quay wall along the Boompjes, Rotterdam.
