Corrosion-fatigue damage identification in submerged mooring chain links using remote acoustic emission monitoring

Marine Structures

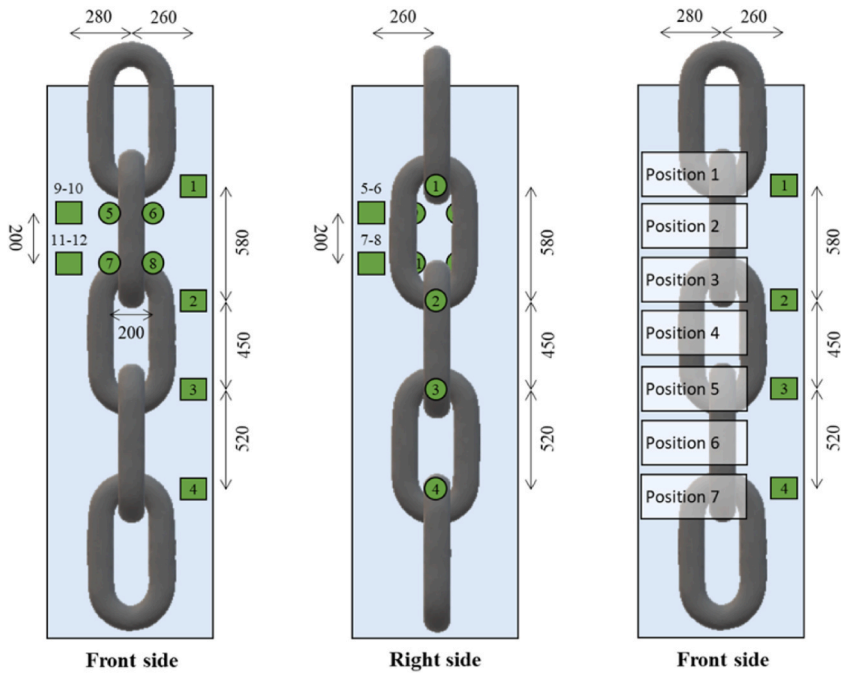
Fig. 5. Schematic illustration of the AE sensors layout and positions of movable arrays. Dimensions in mm.

The total number of AE signals indicates sensor 1 as the most active in the vertical array pointing out Link 1–2 as the most active area in the test rig. This can be due to the combination of main damage-induced ultrasound signals with noise signals from the upper clamp of the test rig. On the other hand, the latter is expected to be limited by the SNR-based filter used in the pre-processing of the data. The acoustic activity decays toward the bottom of the test rig. However, sensor 4 shows increased activity compared to sensor 3 possibly due to noise generated by the clamp and the water inlet at the bottom of the test rig.

The cumulative number of AE signals shows a clear distinction between the activity in the top part of the chain segment and the mid-lower one. The slope of the cumulative trend is represented by the AE hit rate (in Fig. 7). Note that in previous research, the correlation between crack growth and AE hit rate has been demonstrated [51,52] and the slope of cumulative AE parameters has been used to identify different crack growth stages [21,26]. Sensor 1 displays a relatively steep curve throughout the experiment. In particular, two slopes can be observed. First from 0 % to 35 %, and second from 45 % to 85 % of the test duration. This could indicate a corrosion-fatigue damage growth at two different rates between 0–35 % and 45–85 %, respectively. During the latest stage of the test, a characteristic AE quiescence is observed. Besides that, sensors 2–4 show relatively similar trends that differ from the one followed by sensor 1. The cumulative number of signals measured by sensors 2–4 undergoes a steep increase between 0 and 15 % of the test duration while it has a very low slope during the remaining part of the experiment. The AE activity at the initial part of the test could be related to crack formation. There seems to be a correlation between the local jumps in the elongation curve and changes in the slope of the cumulative number of AE signals in different channels. A more detailed assessment of the correlation however would require the selection of the AE events per damage location, hence not discussed further in this section.

Fig. 6. (a) Total number of AE signals and (b) cumulative number of AE signals measured by the vertical arrays of transducers and normalised vertical displacement throughout the test. (c) Layout of the vertical array of transducers.

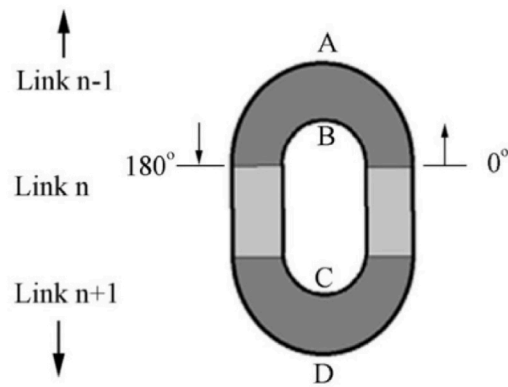
The condition of the chain segment was assessed at the end of the experiment through visual inspection and magnetic particle (MP) testing. All the links of the chain segment were tested. The positions in each link are labelled A, B, C, and D as shown in Fig. 10. The reported observations are located in the crown area of the chain links. The results of the post-failure inspection are shown in Fig. 11. The main fracture (Fig. 11a) was observed in Link 1 towards Link 2. The results of the post-failure inspection are summarised in Table 3.

Fig. 10. Positions in each link. Dark grey areas in the sketch were tested.
