Monitoring Pilot Study of Temporary Permeable Structures for Mangrove Restoration

Keywords: mangrove restoration; brushwood structures; temporary permeable structures; nature-based solutions; building with nature

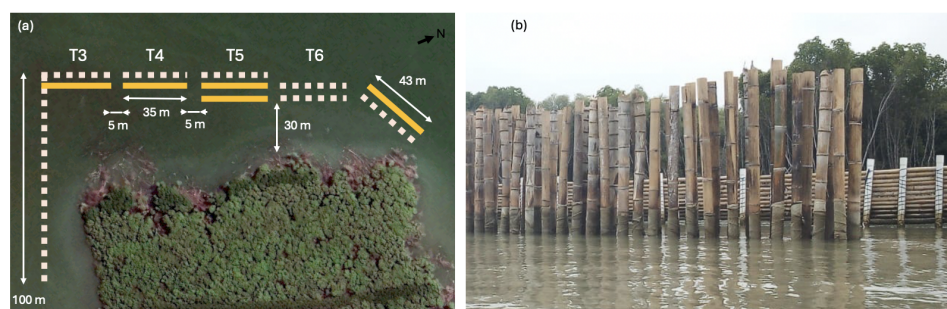
Figure 2. Layout of the structures built in the pilot project. (a) Overview of the arrangement of structures consisting of rows of vertical bamboo poles (white dotted lines), and horizontal bamboo beams attached to PVC poles filled with concrete (yellow lines). (b) Close-up details of a row of vertical bamboo poles (front) and row of horizontal bamboo beams attached to vertical PVC pipes (back).

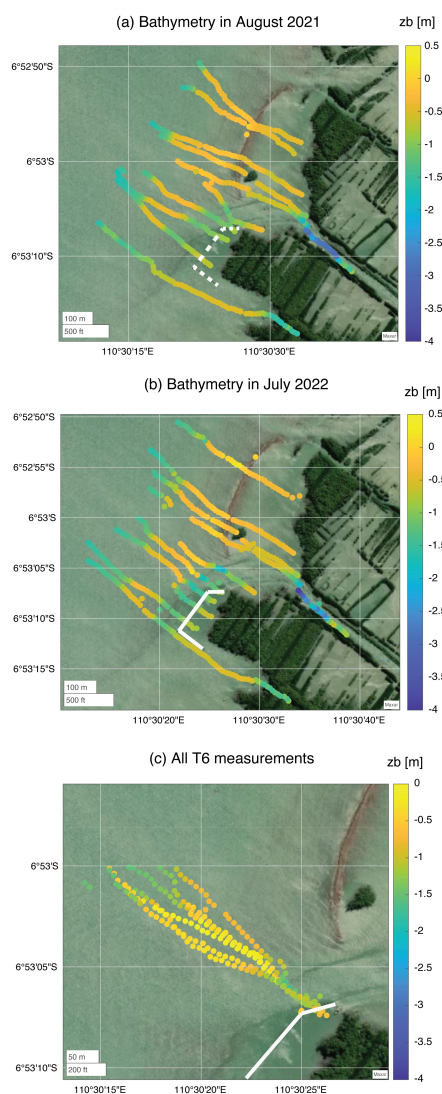
The bathymetry reveals two prominent features: a submerged chenier, represented by shallow (yellow) areas in Figure 4, and the drainage creeks extending from the mangrove stands, shown by blue-green dots. Between August 2021 (Figure 4a) and July 2022 (Figure 4b), the most significant large-scale changes include the deepening of several drainage channels and an increase in the crest height of the chenier, which rose above mean sea level, as it migrated onshore. The progression of these features over time is further illustrated in Figure 5, which provides a detailed view of the profile evolution over 10 months after structure construction. The bathymetry also shows that the structures aligned with the edge of an already present drainage channel, which deepened between August 2021 and July 2022 (Figure 4a,b).

Figure 4. Bathymetric profiles along monitoring transects, where z_b represents the seabed elevation relative to mean sea level (MSL) in meters. (a) Bathymetric profiles in August 2021, before the construction of the structures. (b) Bathymetric profiles from July 2022, showing the seabed elevation 10 months after structure construction. (c) Bathymetric profiles from all time measurements at transect T6, highlighting lateral variability and misalignment among measurements due to spatial differences in transect positioning. The location of the structures is indicated by white lines. In plot (a), a dashed white line is used to indicate that the structure had not yet been constructed at that time.

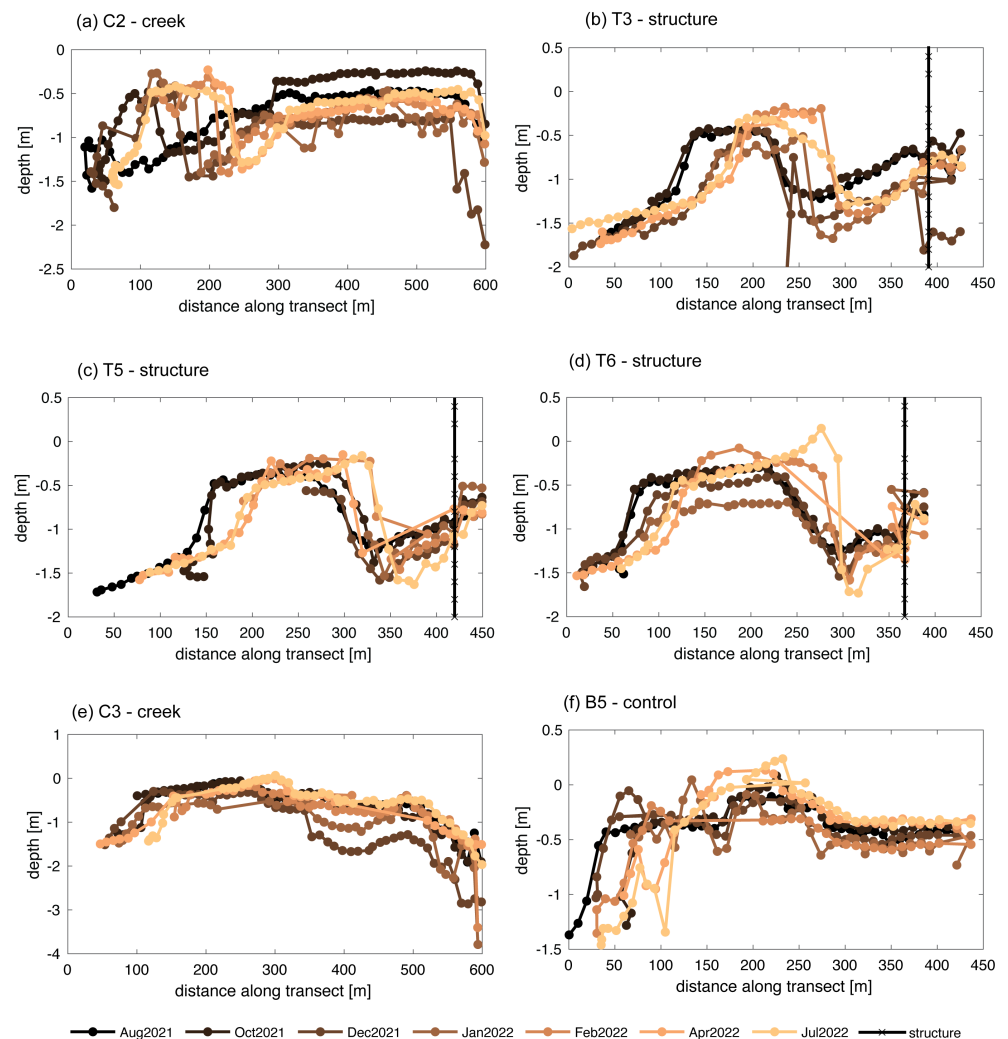
Cross-shore bathymetric profiles show that the chenier was highest in the control transect (Figure 5f), with an initial elevation of -0.1 m with respect to mean sea level, and grew in height over time until reaching a maximum crest elevation of 0.23 m. Bed levels increased behind the chenier up to ~ 0.1 m. Despite these accretive effects, the bed level remained at -0.3 m with respect to MSL at the most landward bathymetry measurements, which is below the bed level required for mangrove establishment. Satellite imagery also reveals that both the coastline and the mangrove edge continued to retreat over time (Figure 6). Behind the structures, the bed level response varied, as illustrated in the plots of different structure transects (Figure 5b–d). It is important to note that maintaining exact alignment when walking transects across different measurement periods was challenging (see Figure 4c). Therefore, the bathymetric data offers a broader overview of the site's dynamics, while the monitoring pole data delivers more precise information on vertical bed level changes at specific locations.

Figure 5. Bathymetric profiles across several transects, representing the water depth relative to mean sea level (MSL) in meters. (a) C2, (b) T3, (c) T5, (d) T6, (e) C3, (f) B5. The most seaward points are shown on the left, and the most landward at the right. Transects T3, T5 and T6 are located across structures, while B5 is situated without a structure. T3 partly collapsed during a storm in January 2022, whereas T5 and T6 remained intact. C2 and C3 are located along creeks. Different lines represent bathymetry data collected at various times between December 2021 and July 2022, illustrating the migration of a chenier across the transects over time.

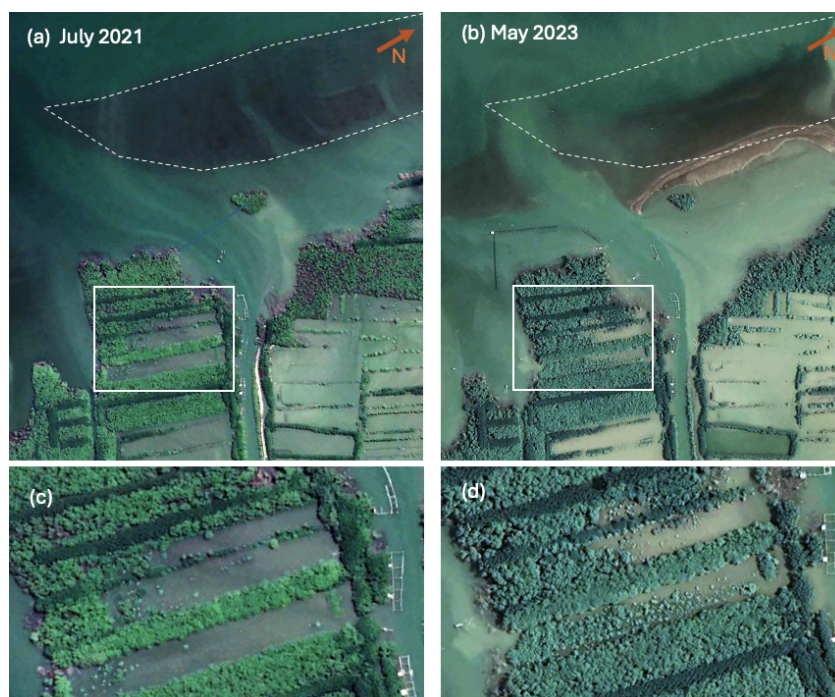
Figure 6. Satellite imagery from Google Earth depicting the study area in (a) July 2021, and (b) May 2023. The chenier outline from (a) is overlaid as a white dashed line in (b) for comparison. The landward migration of the chenier can be observed between (a,b). The white rectangles enclose areas with increase in mangrove cover between 2021–2023, with close ups for (c) July 2021 and (d) May 2023.

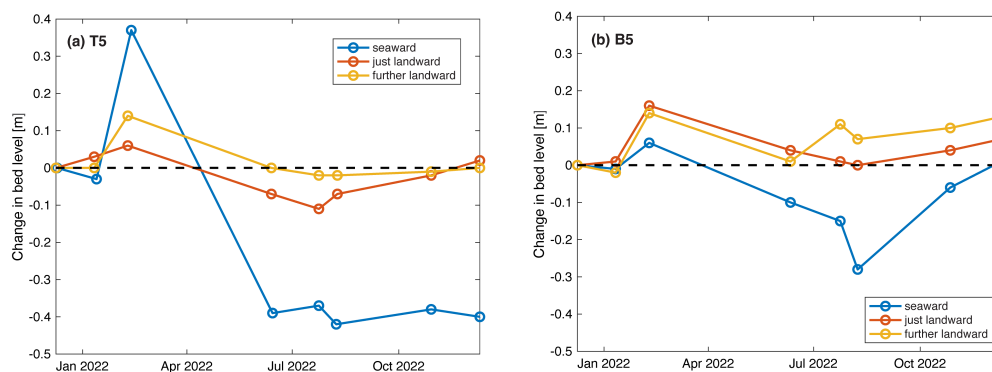
The time series of bed level changes for the structure transect T5 and the control transect B5 are shown in Figure A1.

Figure A1. Time series of bed level changes from monitoring poles at T5 (a) and B5 (b). Each subplot shows three lines representing measurements taken at different locations: seaward, landward, and further landward.
