Journal of Archaeological Science: Reports

A case study for scientific research prior to conservation of marine metal artefacts

A rare find of a high-status 17th century oval box, retrieved from a shipwreck, provided a unique opportunity to research the construction and finishing layers of an object that is untouched for 350 years. This case study was used to demonstrate the extent of data that can be gained from analytical techniques prior to conservation. The amalgam-gilt brass object was studied by optical and electron microscopy, X-radiography, micro-computed X-ray tomography, neutron tomography, X-ray fluorescence, X-ray diffraction, Rutherford backscattering spectrometry, proton-induced X-ray emission and gas chromatography. The results have led to a characterisation of the manufacturing methods used on the box and to a better understanding of the practicality of modern analytical methods and techniques in (maritime) archaeological research.

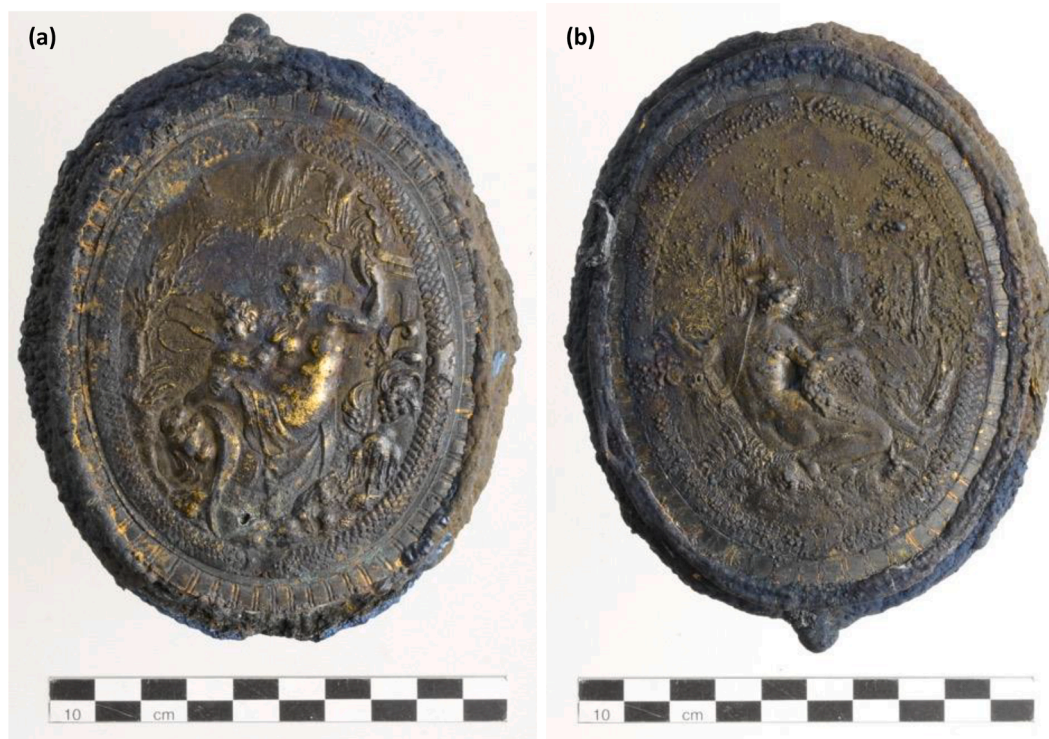
The metal box from BZN17 (inventory number 5372-007) is oval in shape (length ~13 cm, width ~10 cm, height ~4 cm) with a small protrusion on one of the short sides, see Fig. 1. A D-shaped feature is positioned at the side of the box along the entire perimeter. The box has two faces which are decorated with intricate designs and positioned in the box by a rotation along the horizontal axis. Both faces, or plaquettes, portray a female figure in different postures. One side shows the female figure of Venus with a winged cherub on her knees holding up a mirror to look at herself (Fig. 1a). The other side depicts the Greek mythological story of Leda and the Swan (Fig. 1b). Two (nearly) identical copper-alloy plaquettes with the Venus-cherub depiction are known to the authors (Metropolitan Museum of Art (accession no. 1975.1.1357); National Gallery of Art (accession no. 1957.14.587), both circumspectly ascribed to sculptor Paul Hübner, active 1582–1614, Augsburg), yet no identical constructed object was discovered to date. The construction of the box, its opening and closing mechanisms and its internal structure are difficult to identify, as it is too corroded to open. Unfortunately, the exact find location of the box within the shipwreck and its contextual relation to the other finds is unknown.

Fig. 1. Oval metal box from shipwreck BZN17. Both decorated faces are pictured, with an additional rotation of 180° for enhanced visibility: (a) Venus and Amor; (b) Leda and the swan. Images: Archeologie West-Friesland.

Previous to or during its recovery from the seabed the object was badly damaged in especially one area (Fig. 2; bottom area in Fig. 1a).
