## Restoration of the Interior

van Thoor, M.-T. (2019). Restoration of the Interior. In M.-T. van Thoor (Ed.), *Colour, Form and Space: Rietveld Schröder House Challenging the Future* (pp. 34-53). Delft University of Technology.

# 3 / RESTORATION OF THE INTERIOR

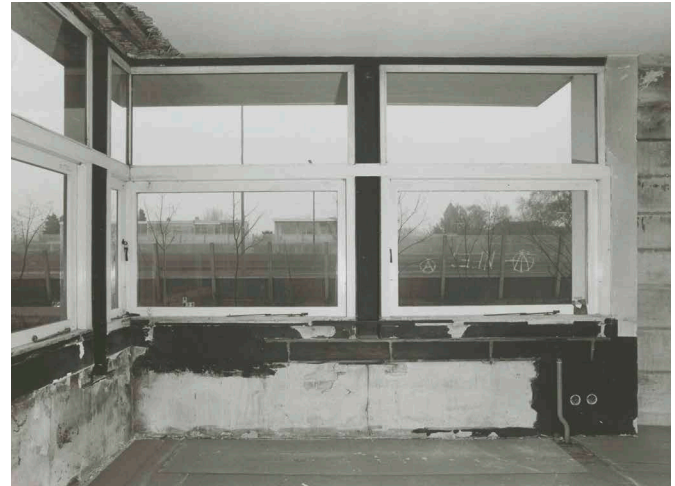
FIG. 3.4 The corner window during the restoration, with a view of the viaduct and the houses on Erasmuslaan

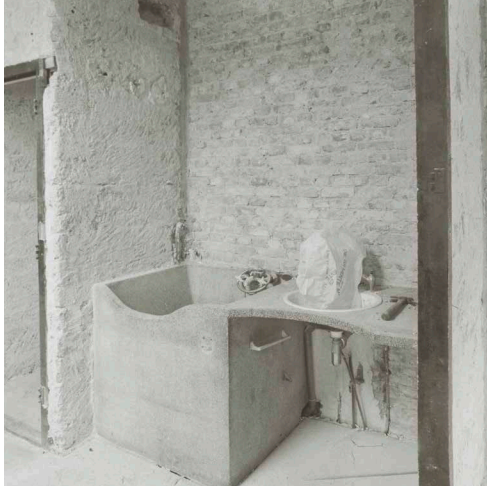
FIG. 3.7 Stripped bathroom with 'lavette'

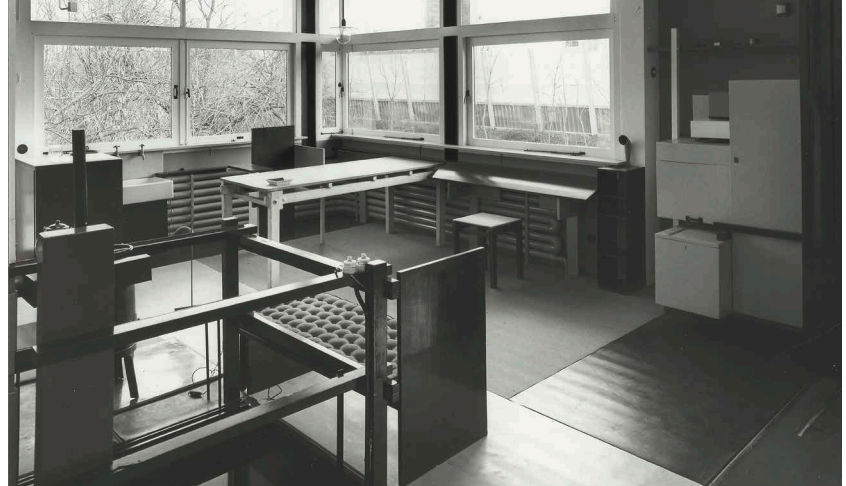
FIG. 3.8 A black-and-white photograph of the upper floor after the restoration shows the new spatial composition and colour scheme

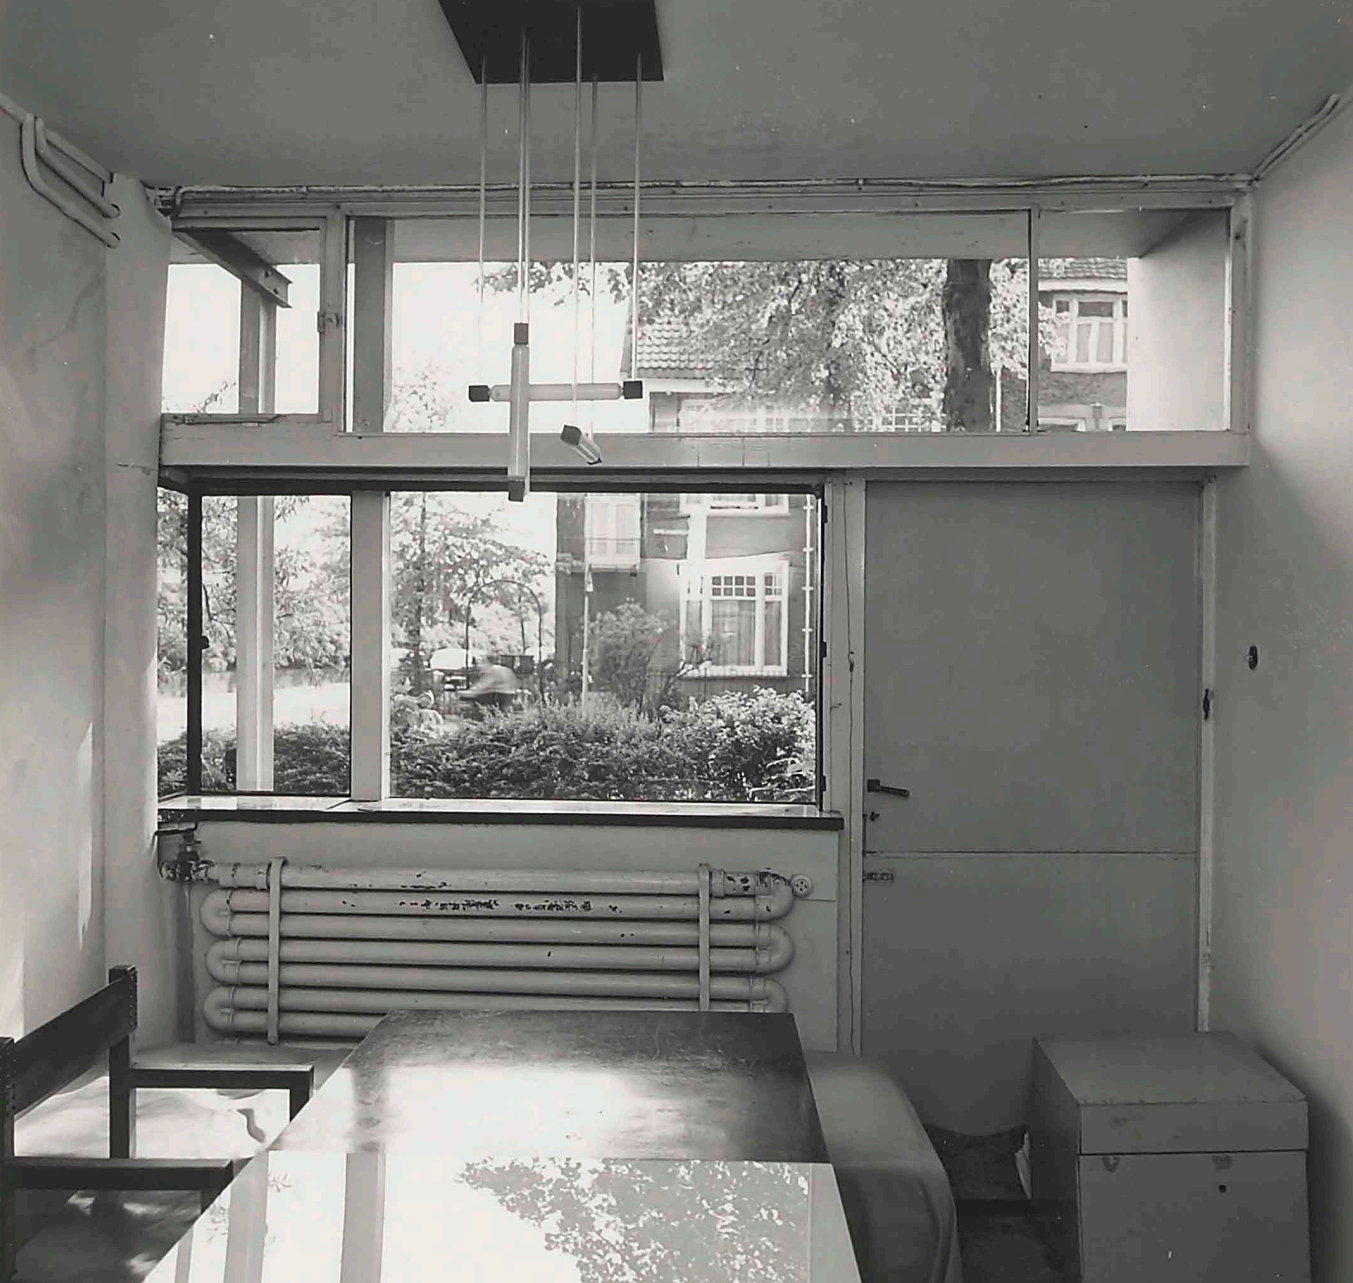
Armed with this information, we spoke again with the architect and took another look at the archival documents. We also obtained access to previously unavailable documents and photographs.<sup>39</sup> Given that the kitchen and adjoining daily help's room had been radically renovated, we focused on the study, next to the entrance, and on Rietveld's former studio, on the Prins Hendriklaan side. The latter was conceived as a garage, but was first used as studio and later served a number of different purposes. Various colour schemes can be gleaned from the historical photographs, all with an emphasis on white [FIG. 3.14].

FIG. 3.14 Undated photograph of the studio with view of Prins Hendriklaan; predominantly white colour scheme

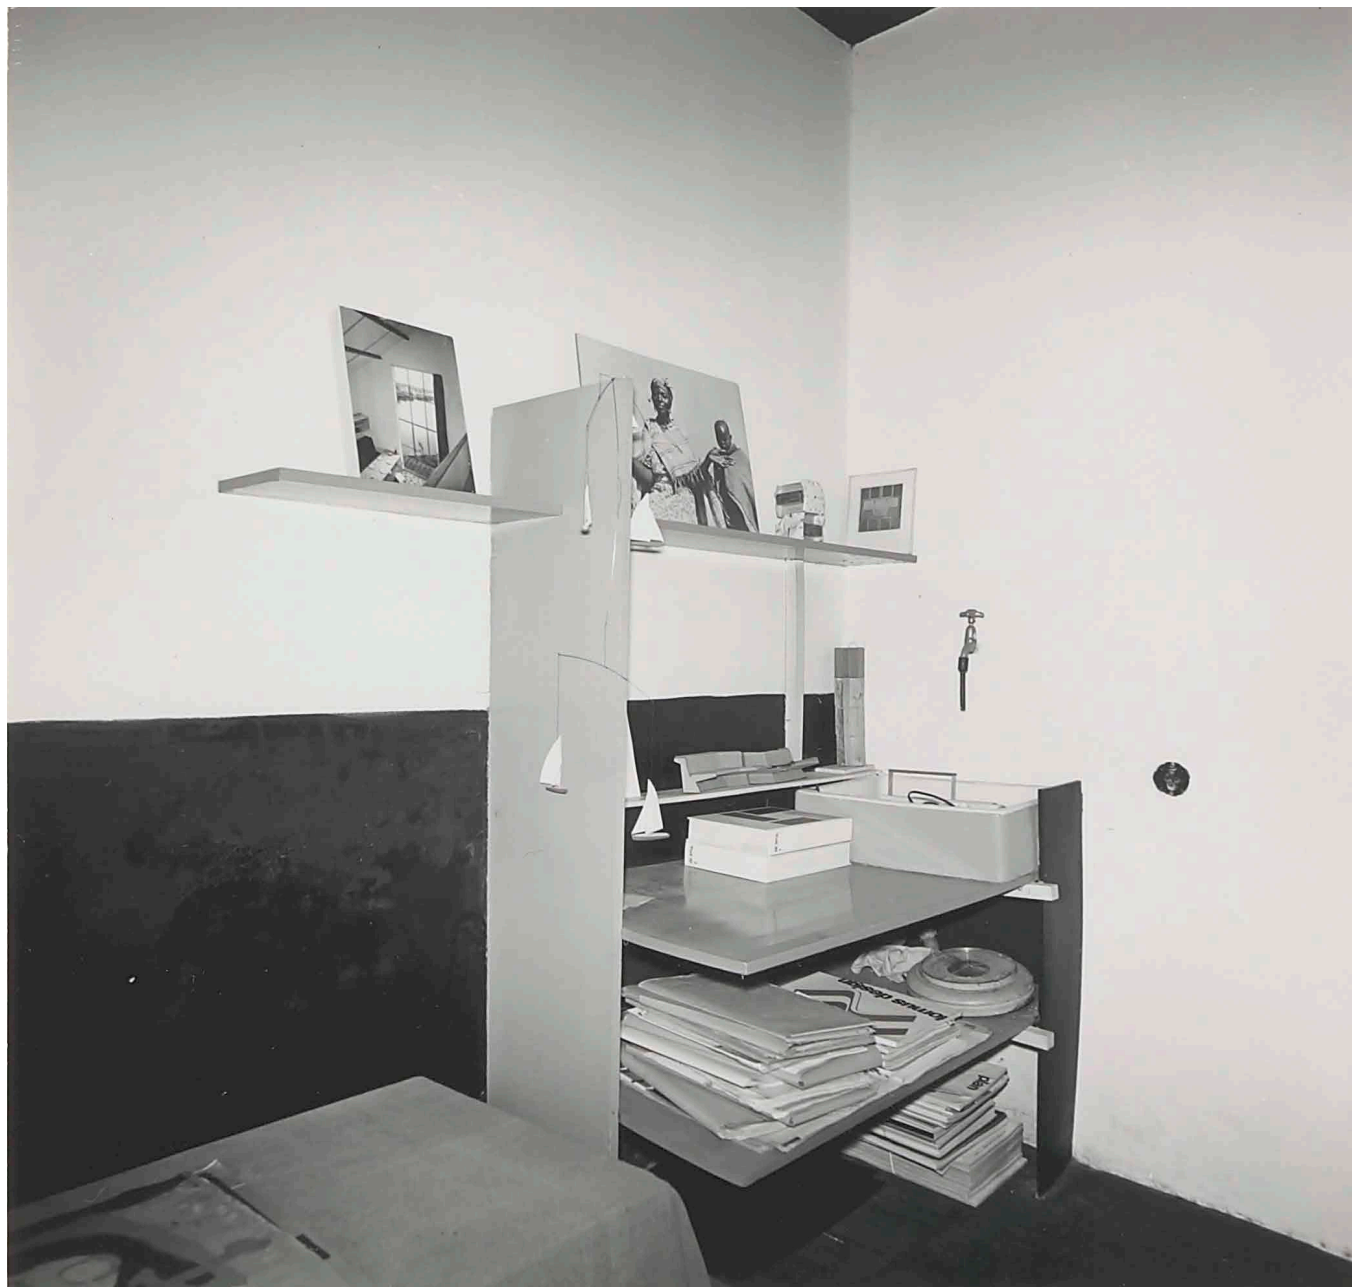
stripping away the plaster. The colour scheme of the adjoining study, in particular the greys, appeared to have changed little over the course of time, to the extent that this could be established based on historical photographs [FIG. 3.16/3.17]. Mulder recalled that the black ceiling in this room had looked pockmarked and had to be repainted. He had the other surfaces in this room repainted in the existing colours as well.

FIG. 3.16 The study painted in white, black and shades of grey, c. 1974
