Collapse of the Grimburgwal, a historic quay in Amsterdam, the Netherlands

A quay wall directly next to a building, both dating from around 1870, collapsed along the Grimburgwal in Amsterdam, the Netherlands, on 1 September 2020. The historic quay wall consisted of a masonry wall, built of a timber deck supported by several rows of timber piles of about 12 m long. As over 200 km of such quays exists in Amsterdam and streets are usually very busy, the collapse triggered the question of the safety of the remaining quay walls in the city. A forensic investigation was carried out to determine the failure mechanisms and factors that contributed to the collapse. The investigation aimed to learn from this event and to prevent similar failures in the future. The main failure mechanisms and contributing factors were identified and confirmed using an integrated model of the quay, which is both simple and robust. The model was used to perform a sensitivity study taking all relevant uncertain factors into account. This work provided valuable insight into the main collapse mechanisms of the wall. Based on the results of this forensic study, it is possible to assess other historic quays.

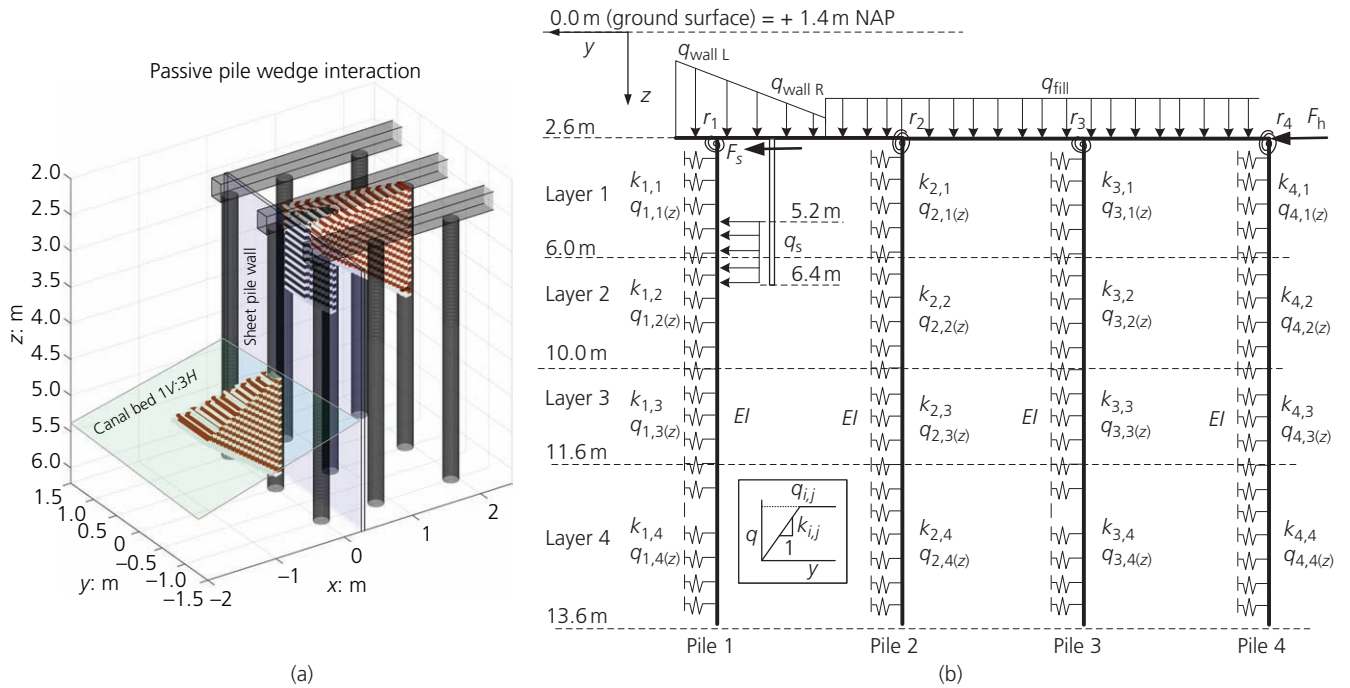
Some of the most important mechanisms are shown in Figure 9 and can be found in general sense in, for example, the handbook *Quay Walls* (De Gijt and Broeken, 2013) or the Dutch handbook of inner-city quay walls (Roubos and Grotegoed, 2014). From left to right, Figure 9 shows the horizontal bending of the piles and local geotechnical failure of soil around the piles, the overturning

The main failure mechanism was the horizontal bending of the piles as a result of a local deepening of the canal followed by breaking of the quay piles. This explanation assumes that only two rows of piles were present or functioned effectively over at least part of the quay. This is in accordance with the historic evidence and the underwater inspection and is also the most likely given the very short distance from the quay to the building behind it, where there is not enough space for a system with three piles. The long-existing cracks in the masonry wall reduced the possibility of redistribution of forces in the quay in the longitudinal direction, so that the loads could no longer be transferred to the stronger parts (with three rows of piles). The analyses were carried out with the assumption that the timber was not degraded, which to date needs to be confirmed. The presence

Figure 9. Most relevant failure mechanisms for the quay wall from left to right: horizontal bending of the piles and local geotechnical failure of soil around the piles, overturning of the masonry wall, cross-beam failure and horizontal sliding of the masonry from the deck
