Extensive testing on PVC sewer pipes towards identifying the factors that affect their operational lifetime

Konstantinos F. Makris, Jeroen G. Langeveld & François H. L. R. Clemens

ABSTRACT

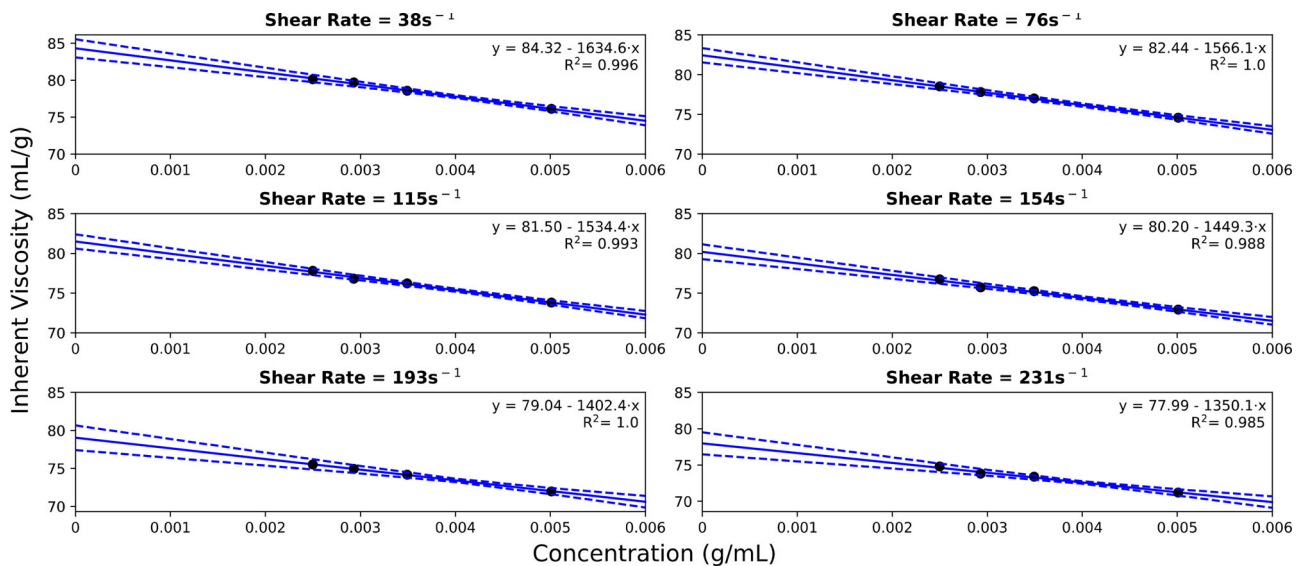
The process followed in order to estimate the intrinsic viscosity is illustrated in Figures 2 and 3. The relationship between inherent viscosities and solution concentrations is fitted using linear regression (Figure 2). Linear extrapolation to zero concentration provides the intrinsic viscosity for each tested shear rate. This procedure was repeated for the considered shear rates, whose selection has been derived by the conducted uncertainty analysis for rheometric measurements with Anton-Paar 302 (Appendix). Additionally, the shear-dependent intrinsic viscosities can be also described by a linear fit (Figure 3), which allows the extrapolation to the zero-shear rate and the estimation of the respective intrinsic viscosity.

Figure 2. Inherent viscosity with respect to solution concentrations of pipe B-4 for shear rates of lowest uncertainties. The value of the intrinsic viscosity for each shear rate is obtained by extrapolation of the linear regression fit to zero concentration (e.g., 84.32 mL/g for shear rate 38 s^{-1}).

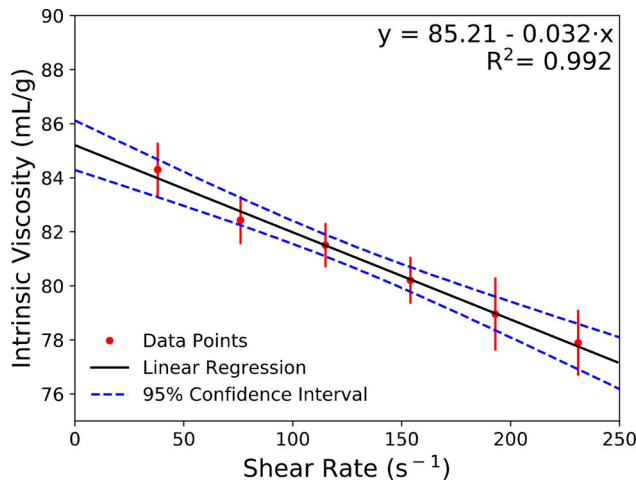
Figure 3. Intrinsic viscosity with respect to shear rates of lowest uncertainties for pipe B-4. The values of the intrinsic viscosity are obtained by Figure 1. The zero-shear intrinsic viscosity is estimated by extrapolation of the linear regression fit to zero shear rate (i.e., 85.21 mL/g).

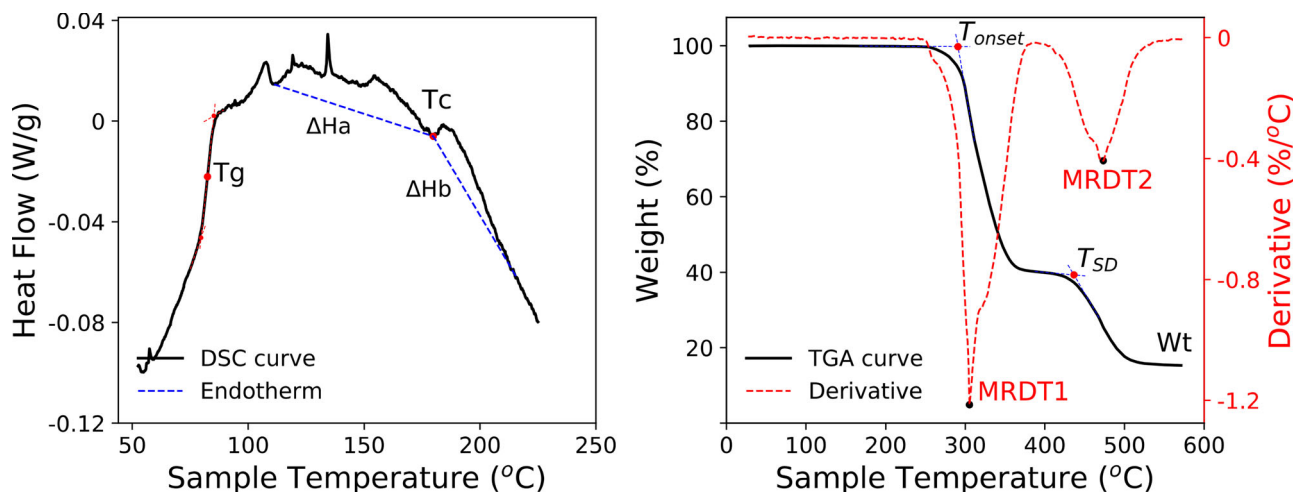
The results obtained from the thermal analyses are presented in Table 3. The glass transition temperature (T_g) is obtained by the DSC curve as shown in Figure 4 (left). All pipe samples demonstrate a glass transition temperature within the range of 81.6–83.7 °C with onset temperature values of the rubbery state within 79.2–81.4 °C (Table 3). The point between the two endotherms (ΔH_a & ΔH_b) reveals the production process temperature (T_c). ΔH_a and ΔH_b signify the melting of secondary and primary crystallites respectively. Processing temperature varied between 169.3–179.9 °C for pipes manufactured before 1980, whereas newer PVC pipes (after 1995) were processed at a temperature range of 185.7–192.4 °C.

The curves derived by TGA (Figure 4, right) indicate two characteristic decomposition temperature points [Primary (T_{onset}) and Secondary (T_{SD}) Decomposition Temperature]. T_{onset} denotes commencement of dehydrochlorination and volatile components loss, and T_{SD} reveals the starting point of scission of the main polymer chains back-bone. The plateau formed at the end of the analysis represents the amount of inorganic elements in the PVC matrix, which required additional thermal energy to decompose. The characterization of the thermal stability of the investigated samples was finalized by detecting the points of Maximum Rate of Decomposition Temperature (MRDT) on the weight curve (inflection points in the respective first derivative). All pipe samples show values of T_{onset} , T_{SD} and MRDT in close proximity, while the concentration of residual content of non-volatile inorganic elements differs (15.3–26.6%).

Figure 4. Left: Curve obtained via Differential Scanning Calorimetry on pipe B-2 including indication of glass transition (T_g), processing temperature (T_c) and endotherms ΔH_a and ΔH_b . Right: Curve obtained via Thermo-Gravimetric Analysis on Pipe 5 and the respective derivative (dashed line) including indication of temperature of thermal degradation onset (T_{onset}), of maximum degradation rates (MRDT1 & MRDT2), and residual inorganic elements (Wt).

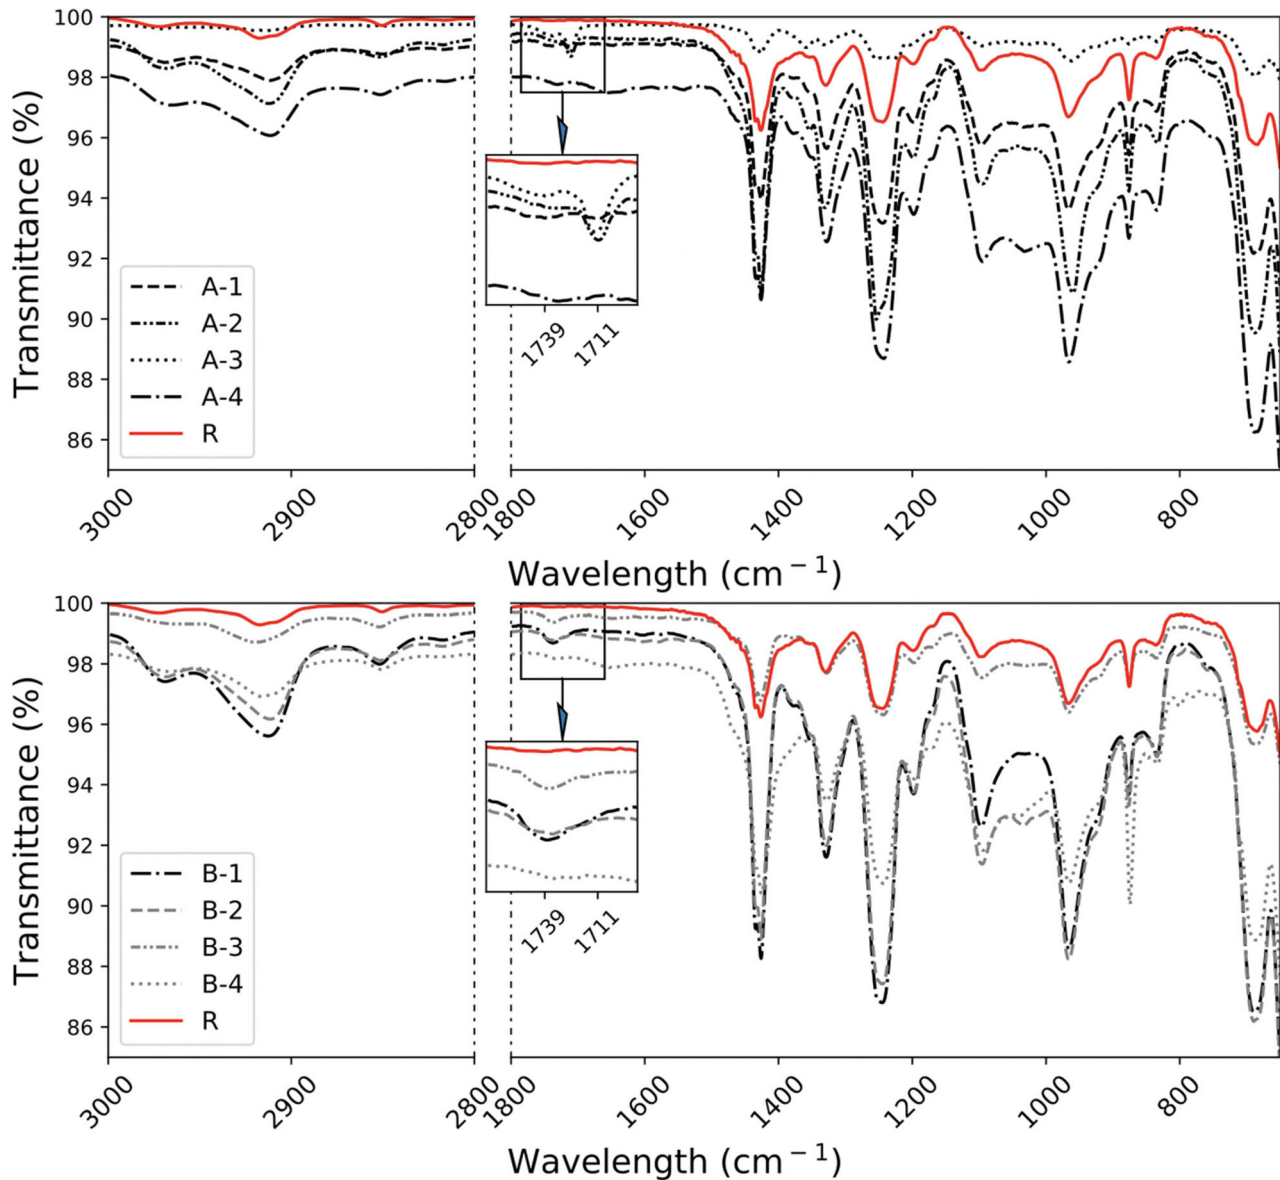
Figure 5 presents the results from FT-IR analysis. Peaks of considerable intensity level within the investigated spectrum were found and could be interpreted according to known molecular motions (Jakubowicz & Möller, 1992; Noda, Dowrey, Haynes, & Marcott, 2007; Wypych, 2015). The examined reference pipe demonstrated peaks at the same wavelengths as the old ones. In detail, these peaks appeared at circa 2970 cm^{-1} (CH stretch next to Cl), 2913 cm^{-1} (CH_2 asymmetric stretch), 1427 cm^{-1} (CH_2 wag), 1354 cm^{-1} (CH_2 wag), 1255 cm^{-1} (CH bend), 1100 cm^{-1} (C-C stretch), 960 cm^{-1} (CH_2 rock), 876 cm^{-1} ($CaCO_3$), and 687 cm^{-1} (C-Cl stretch).

(Matuana, Kamdem, & Zhang, 2001; Wypych, 2015). Depending on the installation area, the pipes demonstrated different peaks at 1711 cm^{-1} (Figure 5, upper) and 1739 cm^{-1} (Figure 5, lower).

Figure 5. FTIR-ATR transmittance spectra of the exterior of examined pipes from Almere (upper graph) and Breda (lower graph). Only wavelengths with peaks are displayed. The wavelengths that denote carbonyl groups are magnified in built-in graphs.

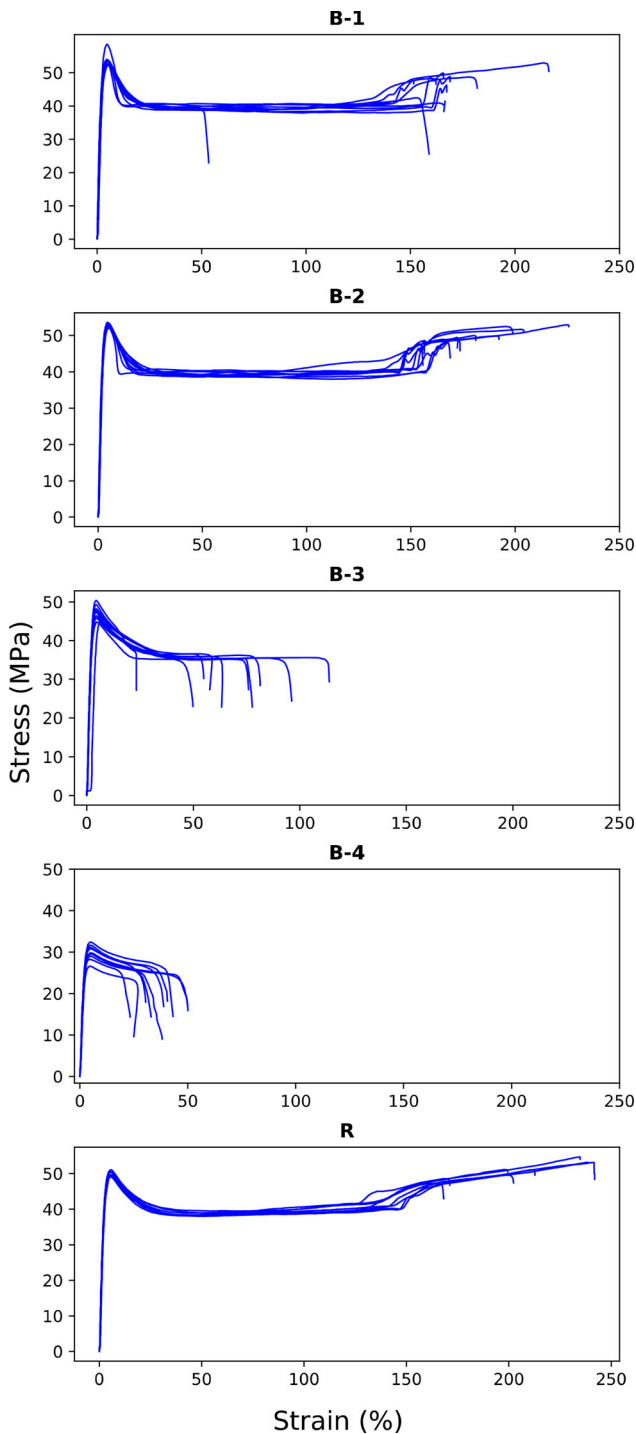
Tensile testing indicated high variability among different pipes (Figure 6). Concerning single layer PVC pipes (B-1 & B-2), a translation was observed towards higher ultimate

Furthermore, tensile tests showed a variability between pipes, as a consequence of the pipes' age and the construction materials. There was an evident indication of physical ageing regarding single layer pipes, as a transition was observed towards higher ultimate stress and modulus values, followed by lower strains at break. These values were of

Figure 6. Stress – Strain curves derived by uniaxial tensile testing on five specimens of pipes: B-1 (41 years, DN 250), B-2 (39 years, DN 250), B-3 (23 years, DN 200 with a recycled core), B-4 (16 years, DN 160 with a foamed core), and R (new pipe). Displacement rate = 5 mm/min. Testing temperature = $24 \pm 2^\circ\text{C}$.

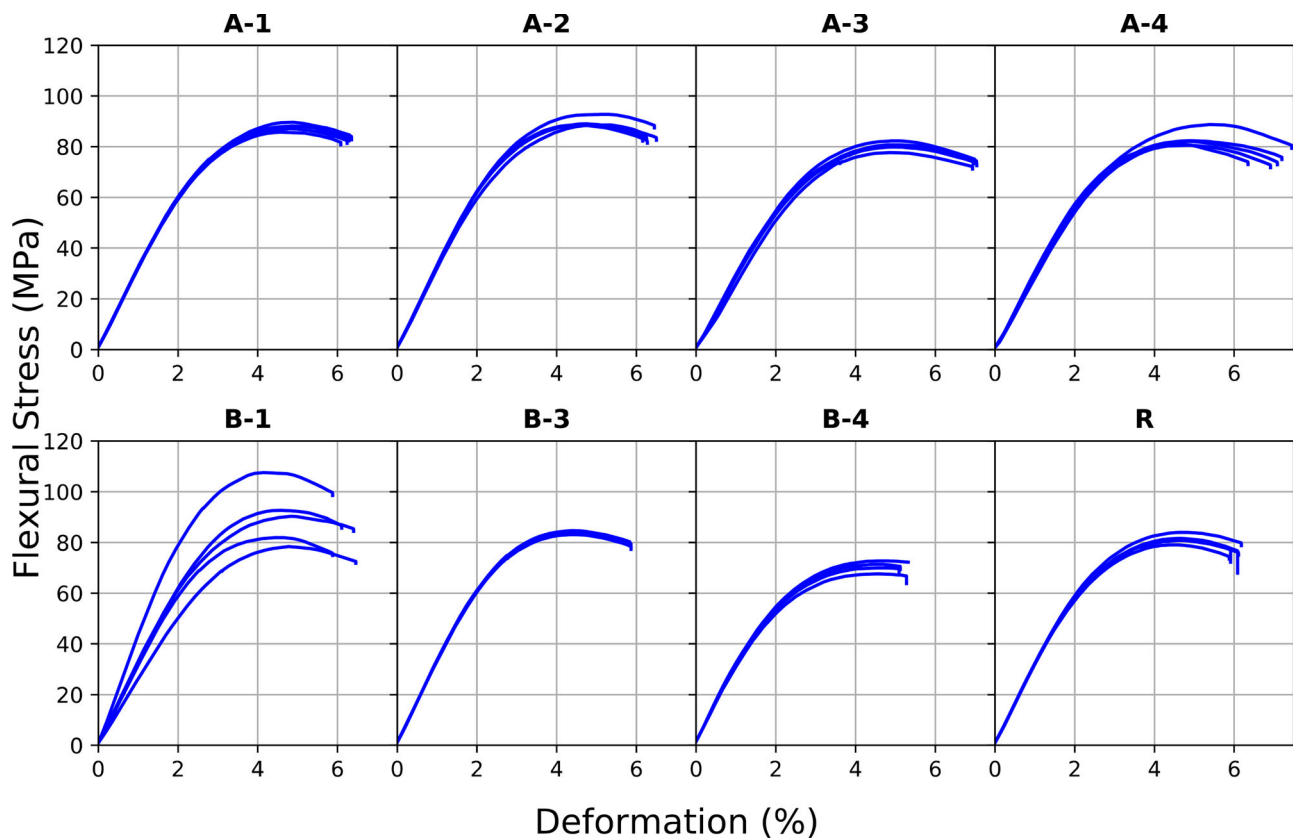
and flexural modulus compared to the reference pipe (Figure 8). However, high variability was noticed in some cases among samples coming from the same pipe, especially regarding pipe B-1. Further, pipe B-4 showed relatively low values in terms of flexural stress but similar to single layer pipes in terms of flexural modulus. On the contrary, pipes with a void core (A-3 & A-4) exhibited the lowest flexural modulus values. Pipe B-2 was not tested due to insufficient material. The average values of the tensile and flexural properties for each pipe are presented in Table A1 in the Appendix.

Results from flexural tests revealed that a foamed or recycled core did not affect the performance against bending, yielding similar results with single layer pipes. However, pipes with a void core (A-3 and A-4) demonstrated lower flexural modulus values. While several factors may have led to this outcome (for instance soil composition, backfill quality, traffic load), samples from these pipes performed at the same level in a series of tests (density, intrinsic viscosity, thermal analyses) as single layer pipes subject to similar conditions (A-1, A-2). Therefore, the presence of the void core is considered as the main parameter for lower flexural properties. It should also be emphasized that both tensile and flexural testing on different samples of single layer pipe B-1 showed high variability, denoting high heterogeneity levels within the pipe.

Figure 8. Flexural Stress – Deformation curves derived by repeated 4-point flexural testing on five different specimens per pipe. Displacement rate = 15 mm/min (B-3: displacement rate = 14 mm/min, B-4: displacement rate = 11 mm/min). Testing temperature = $20 \pm 0.2^\circ\text{C}$.

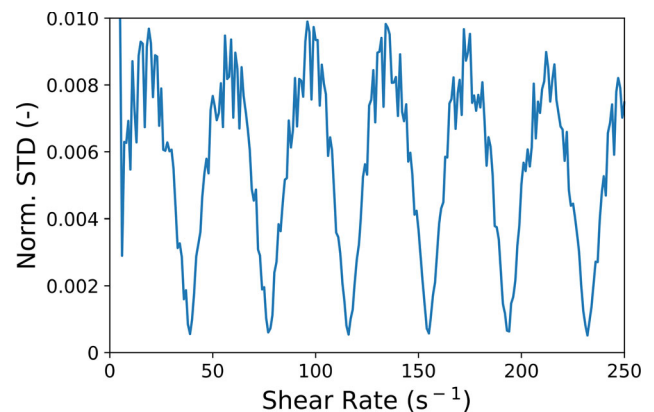
Figure A1. Normalized Standard Deviation (STD) with respect to shear rate obtained by 10 consecutive measurements on cyclohexanone at 20 °C with Anton-Paar 302. The same method utilized for viscosity measurements of the investigated polymer solutions was applied.
