Safety and Health Concerns for the Users of a Playground, Built with Reused Rotor Blades from a Dismantled Wind Turbine

Abstract: This paper analyses the user safety of a playground built out of reused blades from a dismantled wind turbine. Located in Rotterdam and designed by the Netherlands architecture firm Superuse Studios, the playground, called “Wikado”, represents an example of the circular economy applied to the built environment. With reused materials, Wikado represents a saving in resources and energy, when compared to a standard playground built with primary materials. Furthermore, the playground creates a unique design experience for its users, who can still recognise the original rotor blades following their transformation into slides, platforms, and tunnels. However, the safety of the playground could be questioned. This paper will analyse the materials and products used in the playground and their condition some years after opening. The analysis focuses on the risks of human health during the use of the playground. It considers the shape and the sharpness of the rotor blades, its components such as glass fibres and epoxy resin. As a result of the analysis, two risk

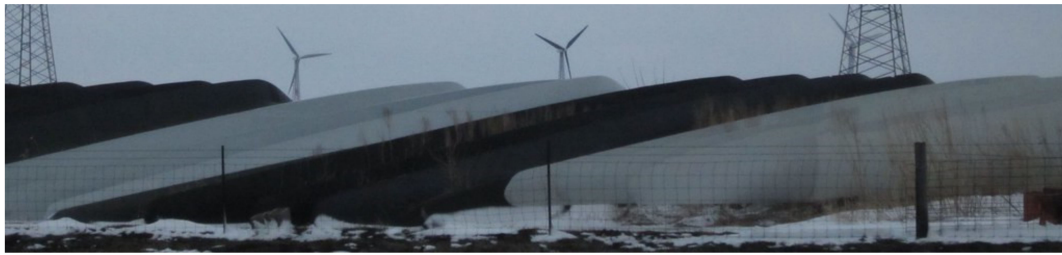
Figure 1. Rotor blades stored on a field before being transformed in components for the playground ('03.02.12-Wind Turbine Blades' by 'kristinefull' is licensed under CC BY-SA 2.0).

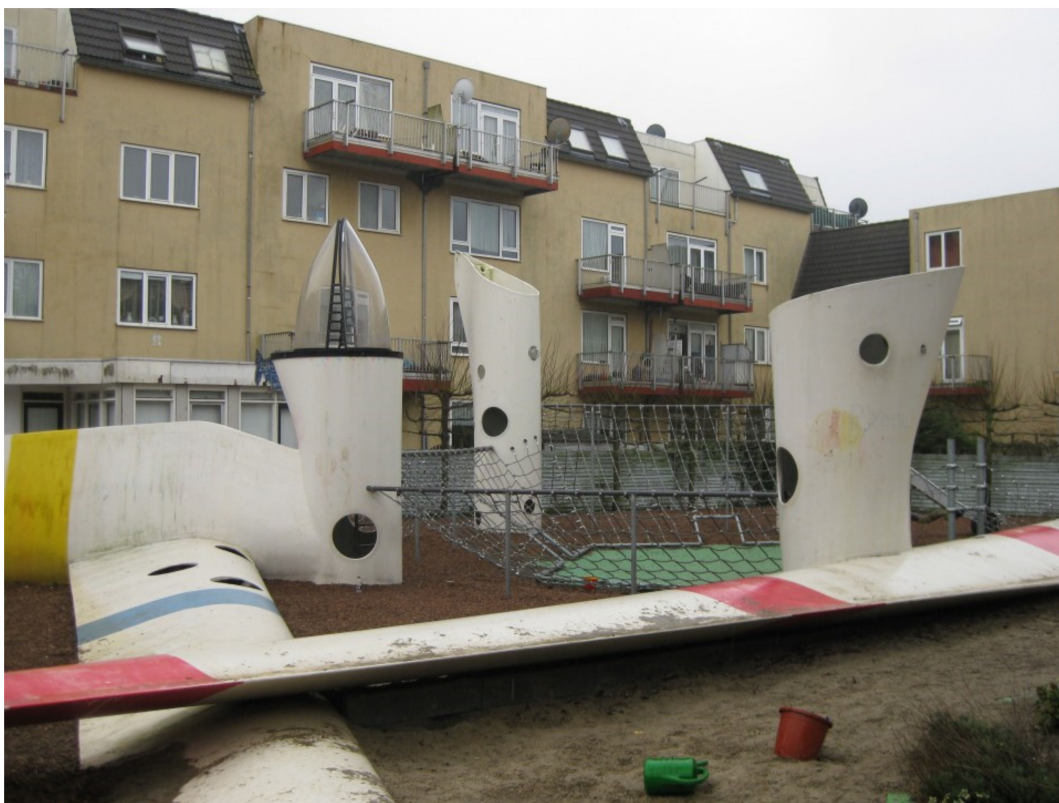
Figure 2. The “Wikado” playground, composed of rotor blades painted in white with coloured stripes (Photo by Carolyn Butterworth, 2011).

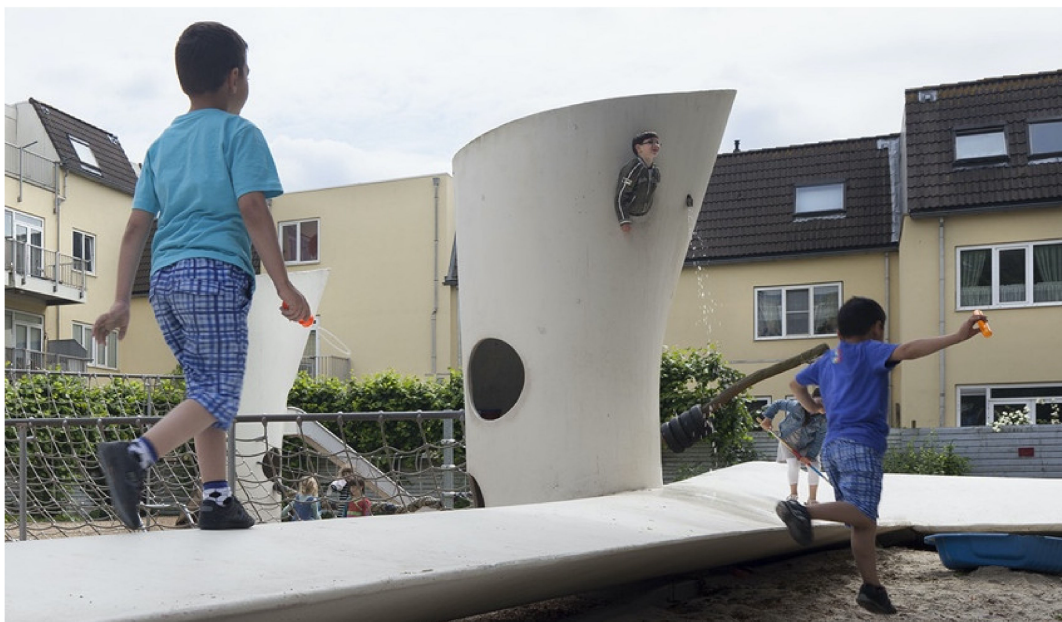
Figure 21. Water flowing on the blade, from the fountain located on top of the tower (Photo by Dennis Guzzo, 2014).

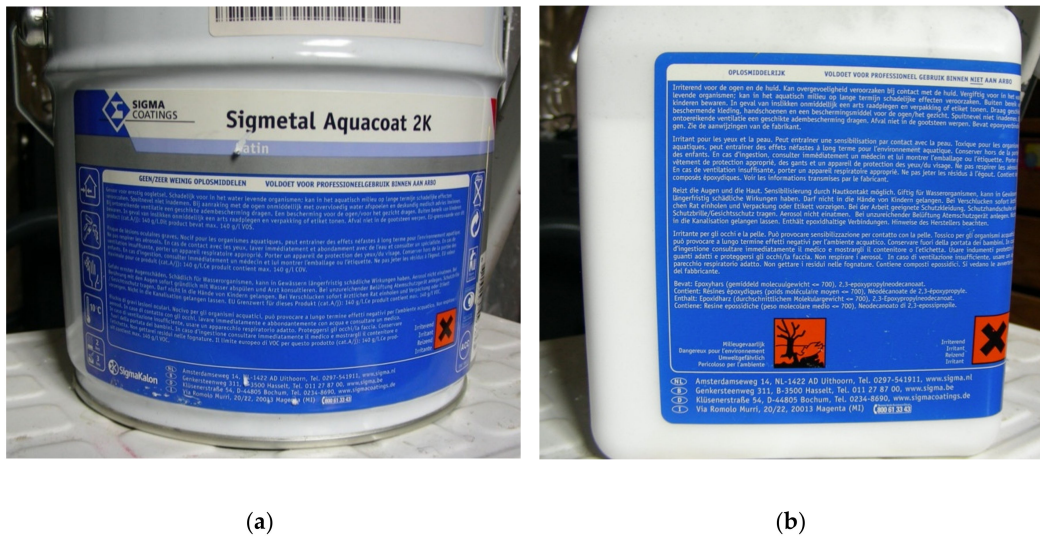
Regarding the possible human health concerns for the users, the yellow drops of Wikado could contain epoxy resin. This is because the epoxy resin was present in the original rotor blades by NGUP, in the finitude made by Maropol (type THV 500 and 600), and in the hardener of the painting applied

by the caretaker. He used three quarters paint and a quarter hardener composed of epoxy resin and 2,3-epoxypropyl neodecanoate (Figure 28a,b).

Figure 28. (a) Paint used by the caretaker; (b) hardener applied by the caretaker (Photos by Piero Medici, 2011).
