Health Condition Monitoring of Insulated Joints based on Axle Box Acceleration Measurements

Maria Molodova, Maider Oregui, Alfredo Núñez, Zili Li*, and Rolf Dollevoet

Section of Railway Engineering, Faculty of Civil Engineering and Geosciences, Delft University of Technology, Stevinweg 1, 2628 CN Delft, The Netherlands

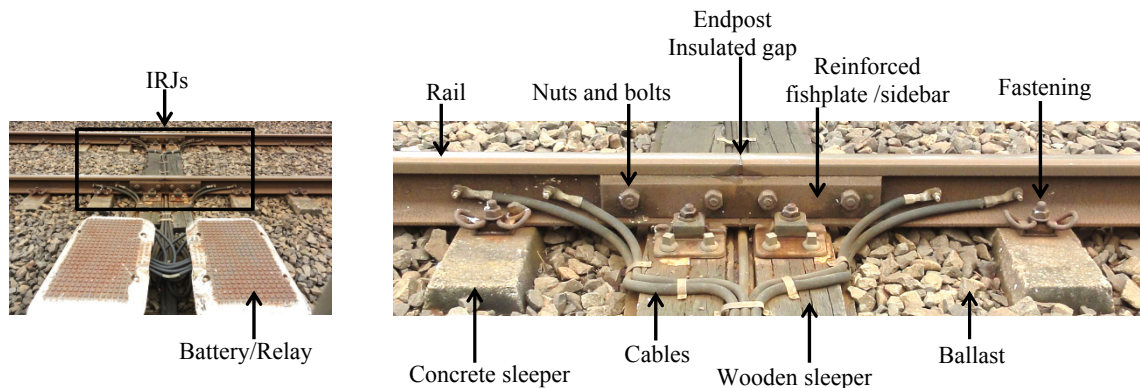
Figure 1: Picture of an IRJ and its main components.

An IRJ constitutes a discontinuity to the track, see Figure 1. The rail ends are connected with two joint bars, placed on both sides of the rail web, and the gap between the rail ends is filled with an isolating component called endpost. The joint bars are attached to the rails by bolts and epoxy adhesive. The IRJs are characterized by high impact dynamic forces at the wheel/rail interface (Wen et al., 2005), caused by the combination of two factors: lower bending stiffness of the joint bars comparing to that of the rail, leading to larger deflection (Jenkins et al., 1974; Kerr and Cox, 1999); and lower values of the Young's modulus of the endpost comparing to the one of the steel (Chen and Kuang, 2002). The impact dynamic forces may have several consequences on the state of an IRJ, such as the resulting high stress concentration producing plastic deformation of the rail surface (Kabo et al., 2006); "cavity-like" damage appearing in the rail head after the gap (Sandstrom et al., 2012); the high maximum shear stress leading to the partial loss of the bond between the joint bars and the rail (Himebaugh et al., 2008), and the contribution to the growth of cracks starting from the holes in the rail (Mayville and Stringfellow, 1995).

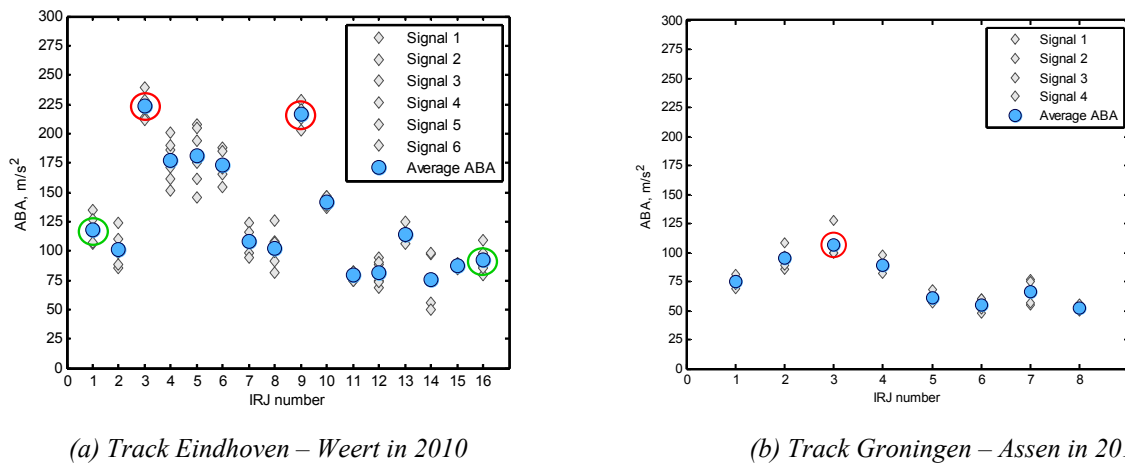
Figure 4: Local maxima of ABA at IRJs. Blue circles indicate average local maxima, grey diamonds denotes the maximum of each ABA measurement.

The IRJs are usually characterized by high values of ABA. In Figure 4, we relate the local maximum ABA to the state of the IRJ from the two tracks. The photos of some of the IRJs of Figure 4 are presented in Figure 5. The ABA signals from repeated measurement runs were low-pass filtered with the cut-off frequency of 2 kHz, to include the frequency range typically excited at short wave track defects (Molodova et al. 2014b). The blue circles in Figure 4 are the average local maximum of six repeated signals on the track Eindhoven – Weert (Figure 4a), and four repeated signals on the track Groningen – Assen (Figure 4b); the range of ABA maximum values was indicated by the grey diamonds.

To study the relationships between the state of IRJs and ABA values we compared two IRJ with high ABA magnitude (IRJs number 3 and number 9 indicated with red circles in Figure 4a) and two IRJs with comparatively low ABA magnitude (IRJs number 1 and number 16 indicated with green circles in Figure 4a). As it appeared from the visual inspection of the IRJs, the two IRJs with high ABA magnitudes (above 200 m/s^2) were indeed in a deteriorated condition: the IRJ number 3 had plastic deformation D_1 on the rail surface caused by the impact at the endpost (Figure 5c) and the IRJ number 9 had a crack in the fastener D_2 (Figure 5g-h). As for the IRJs with comparatively low ABA magnitude (below 150 m/s^2), the IRJ number 1 may be considered as in a good condition (Figure 5a), since only light deformation of the rail surface is visible. While the IRJ number 16 had a significant gap between the two pieces of the rail, as a result of the loss of insulation material D_3 (Figure 5j). Thus, the ABA magnitude at IRJs cannot be an indication of D_3 . Therefore, further investigation of the frequency content of ABA is presented in the next section.

In Figure 4b the ABA on the track Groningen – Assen has less variation in values, than on the track Eindhoven – Weert, with the average local maxima ranging between 50 to 100 m/s². The IRJ with the highest ABA value is number 3, which has moderate degradation of the rail surface D_I (Figure 5l).

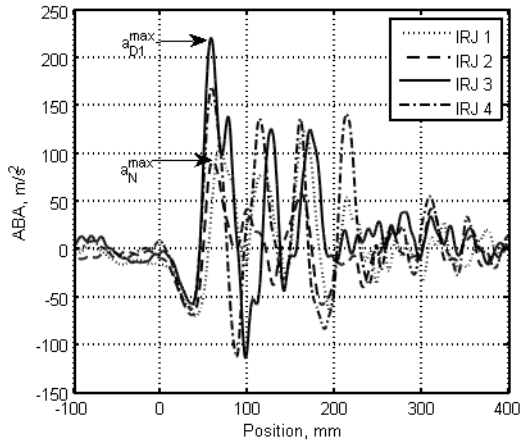
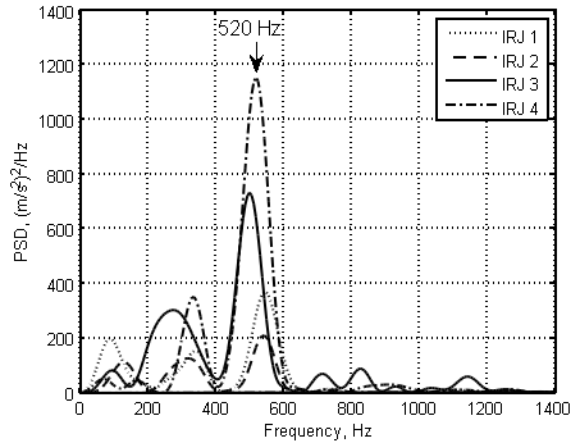
Figure 6: ABA and PSD at various IRJs, October 2010

The ABA measured at these four IRJs are shown in Figure 6a. The ABA signals for each IRJ in this section and the next sections are the average signals out of four repetitive ABA signals, filtered with the low-pass Butterworth filter with a cut-off frequency of 2 kHz. The averaging and the filtering were done in order to reduce the noise in the measured signals. The ABA signals at these IRJs had a wavelength of about 50 mm. The local maximum ABA was the highest for IRJ number 3 ($a_{D_I}^{max} = 220 \text{ m/s}^2$) and about 2.4 times higher than ABA at the IRJ number 2 in normal condition ($a_N^{max} = 91 \text{ m/s}^2$). The plastic deformation at IRJ number 3 has the longest wavelength among these four IRJ's, 50 mm (Figure 5c).

The PSD at these IRJs is shown in Figure 6b. The major peaks for the IRJs fall into the following frequency ranges: 70 – 170 Hz, 270 – 350 Hz and 500 – 550 Hz. The largest peak is at 520 Hz for IRJ number 4 with severe rail surface plastic deformation. The peak that appears in each ABA signal in the frequency range between 500 Hz and 550 Hz might be related to the plastic deformation of the rail surface. As the train speed was 100 km/h the vibrations in the range of 500 – 550 Hz are related to the wavelength of the wave pattern of 50 – 55 mm of the rail surface. When the wave pattern on the rail surface starts to develop, the vibrations in the range of 500 – 550 Hz work as a positive feedback mechanism. That is, the wave pattern of 50 – 55 mm increases the vibrations at 500 – 550 Hz, and higher level of vibrations at this frequency causes further plastic deformation with a wavelength of 50 – 55 mm.

IRJ number 3 has the longest wavelength of plastic deformation (50 mm) and the highest local maximum ABA compared to the other three IRJs in Figure 6a. However, the PSD at 500-550 Hz for IRJ number 3 was not the highest among these IRJs, because the energy was distributed over a range of frequencies (270 Hz, 730 Hz, 830 Hz, 1150 Hz, see Figure 6b). This can indicate that there is damage in other components of IRJ number 3 besides plastic deformation of the rail surface (sleeper, fastener, etc.) Thus, there is no direct correlation between degree of plastic deformation of the rail surface and PSD at 500-550 Hz. However, the combination of high ABA magnitudes and high values of PSD at 500-550 Hz can

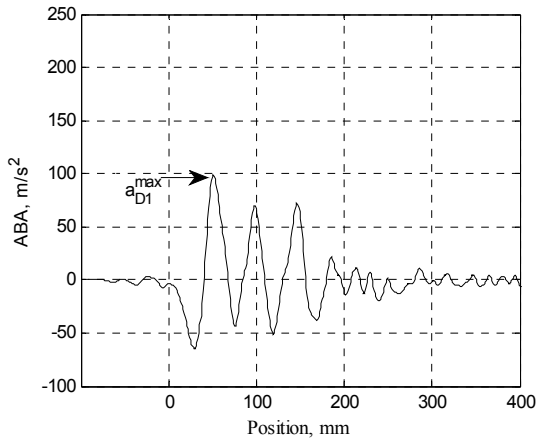
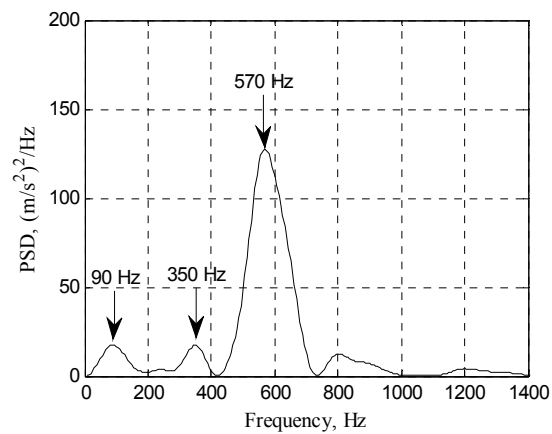
Figure 6c presents the ABA measured at IRJs 3 from the track Groningen – Assen (G-A), see photo in Figure 5l. The ABA signal at this IRJs had a wavelength of about 50 mm. The local maximum ABA was $a_{D1}^{max} = 100 \text{ m/s}^2$, which is quite close to the normal condition ($a_N^{max} = 91 \text{ m/s}^2$). The PSD at these IRJs is shown in Figure 6d. There major peaks for this IRJ are 90 Hz, 350 Hz and 570 Hz, which is consistent with the frequencies in Figure 6b.

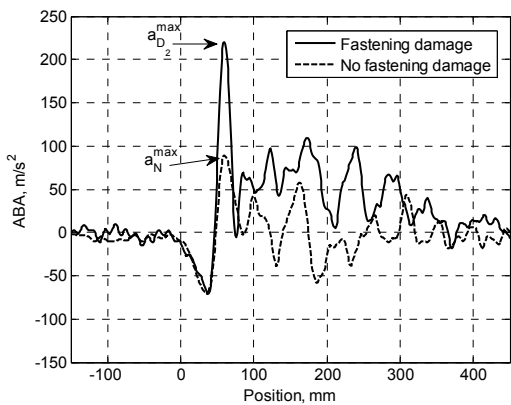
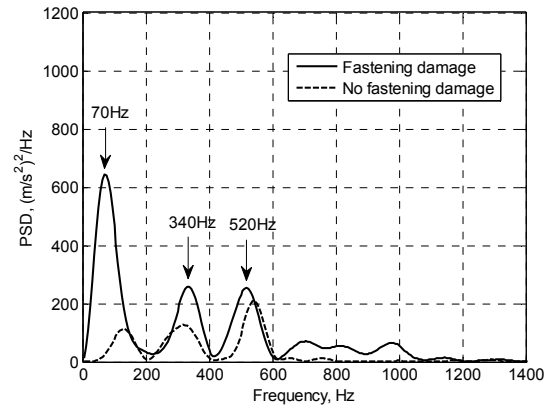
In this section the IRJ with a crack in the fastener was investigated (D_2). That is IRJ number 9 in Figure 5g-h. The dynamic responses at this IRJ were compared to the reference IRJ without visible damage in the fastener (Figure 5b).

The ABA at the IRJ with a crack in the fastener is shown in Figure 6e (solid line) together with the reference IRJ (dashed line). The ABA signal at this IRJ has a high peak of about $a_{D_2}^{max}=220 \text{ m/s}^2$. This peak is also related to high contact force, which caused the deformation of the rail surface, visible in Figure 5g as a broadened shiny wavy running band after the gap. It can also be observed in Figure 6e that the ABA magnitude of the IRJ number 9 is elevated compared to the reference one.

The PSD at the IRJ with a crack in the fastener is presented in Figure 6f. The major peak for an IRJ with a crack in the fastener is at 70 Hz, and the other two peaks at 340 Hz and 520 Hz are similar to the peaks of the reference IRJ. The frequency at 70 Hz is probably related to the change in the stiffness of the fastening caused by the crack. This frequency might be responsible for the higher level of vibration after the gap.

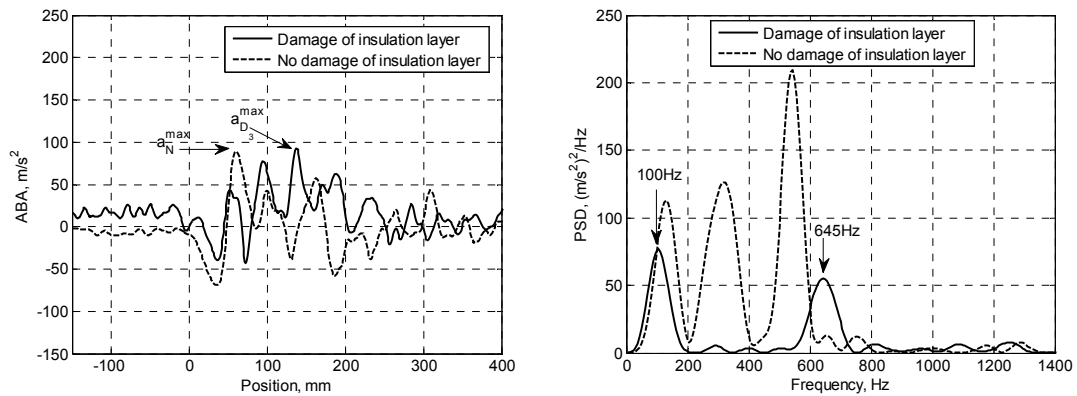
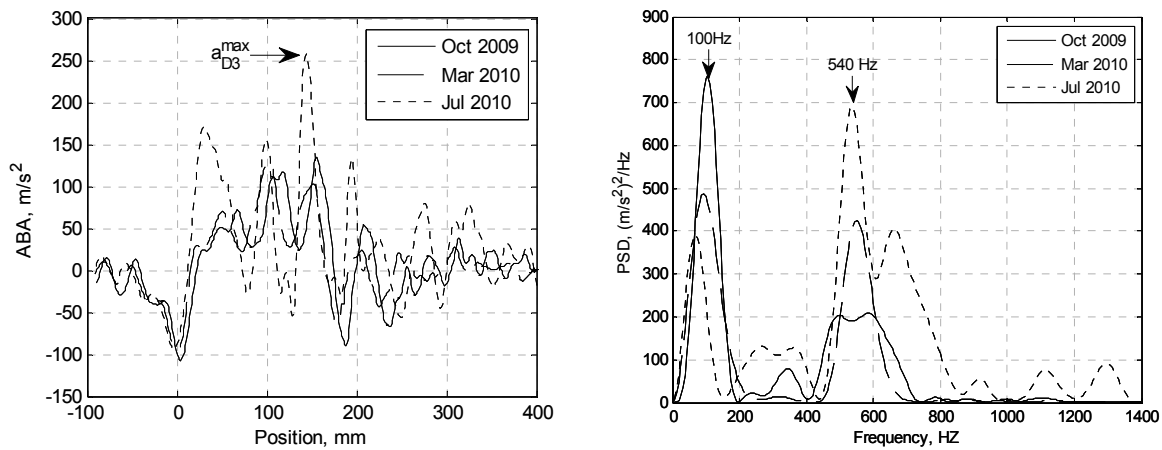
Figure 7: ABA and PSD at an IRJ with damaged insulation layer, track Eindhoven - Weert.

In this section, an IRJ number 16 with two types of damage was investigated: with damaged insulation layer (Figure 5j) and the crack in the fastener (Figure 5k). The damage of the fastener for this IRJ was similar to the one of IRJ number 9 in Figure 5h.

The ABA at this IRJ is shown in Figure 7a with a solid line. The ABA magnitude at this IRJ is comparable to the reference IRJ ($a_{D_3}^{max}=86 \text{ m/s}^2$), but the wavelength is shorter than that of the reference signal. The PSD at the IRJ with the damaged insulation layer is shown in Figure 7b. The major two frequencies for this IRJ are 100 Hz and 645 Hz.

From these data it is impossible to extract the information about the health state of the IRJ due to low ABA magnitude and PSD. Thus, the retrospective analysis of the ABA measurements was performed to obtain more information. Figure 7c presents the ABA signals measured in October 2009 – July 2010. The ABA magnitude at this IRJ in October 2009 was $a_{D_3}^{max}=134 \text{ m/s}^2$, in March 2010 was $a_{D_3}^{max}=129 \text{ m/s}^2$, and in July 2010 was $a_{D_3}^{max}=257 \text{ m/s}^2$.

The major two frequencies in the PSD for this IRJ are 100 Hz and 540 Hz (Figure 7d). The frequency of 100 Hz is close to the frequency of 70 Hz obtained by the analysis of Figure 6f and must be related to the crack in the fastener. As for the damage of the insulation layer, it was difficult to see in these data any specific features related to this phenomenon.

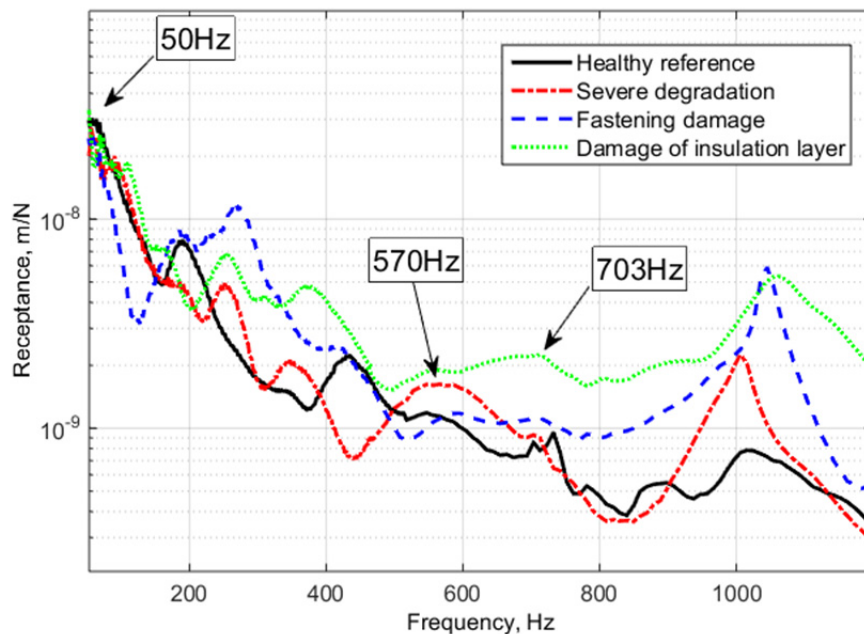
Figure 9: Receptance functions at the investigated IRJs.

Figure 9 presents the calculated receptance functions of the nominal and damaged IRJs studied in Section 4.2. For the IRJ with light surface deformation the following peaks were observed: 190 Hz, 350, 430 Hz, 560 Hz, 730 Hz, 900 Hz and 1006 Hz. Some of them (190 Hz, 350 Hz, and 560 Hz) agree with the results from the ABA analysis. For the IRJ with severe plastic deformation, there are peaks at 80 Hz, 190, 250 and 570 Hz that agree well with the results from the ABA measurements. The other two peaks, at 350 Hz and 1006 were not clearly observed in the ABA measurements. For the IRJ with a crack in the fastener the peaks in the receptance function were at about 50 Hz, 190 Hz, 270 Hz, 420 Hz, 580 Hz and 1045 Hz. The peak at about 50 Hz agrees with the major peak at 70 Hz from the ABA analysis; the peaks at about 270 Hz and about 580 Hz correspond more or less to the peaks observed in the ABA at 340 Hz and 520 Hz. The major peaks observed in the receptance function for the IRJ with a damaged insulation layer were at 107 Hz, 250 Hz, 370 Hz, 703 Hz and 1055 Hz. The

peaks at 107 Hz and 703 Hz agree with those at 100 Hz and 645 Hz observed in the ABA analysis.

In conclusion, most of the frequency characteristics found from ABA analysis were also observed in the hammer test (with some deviation, due to the different loading conditions and some random factors). The hammer test revealed some frequency characteristics that were not measured using ABA. These were probably filtered out by the wheel.

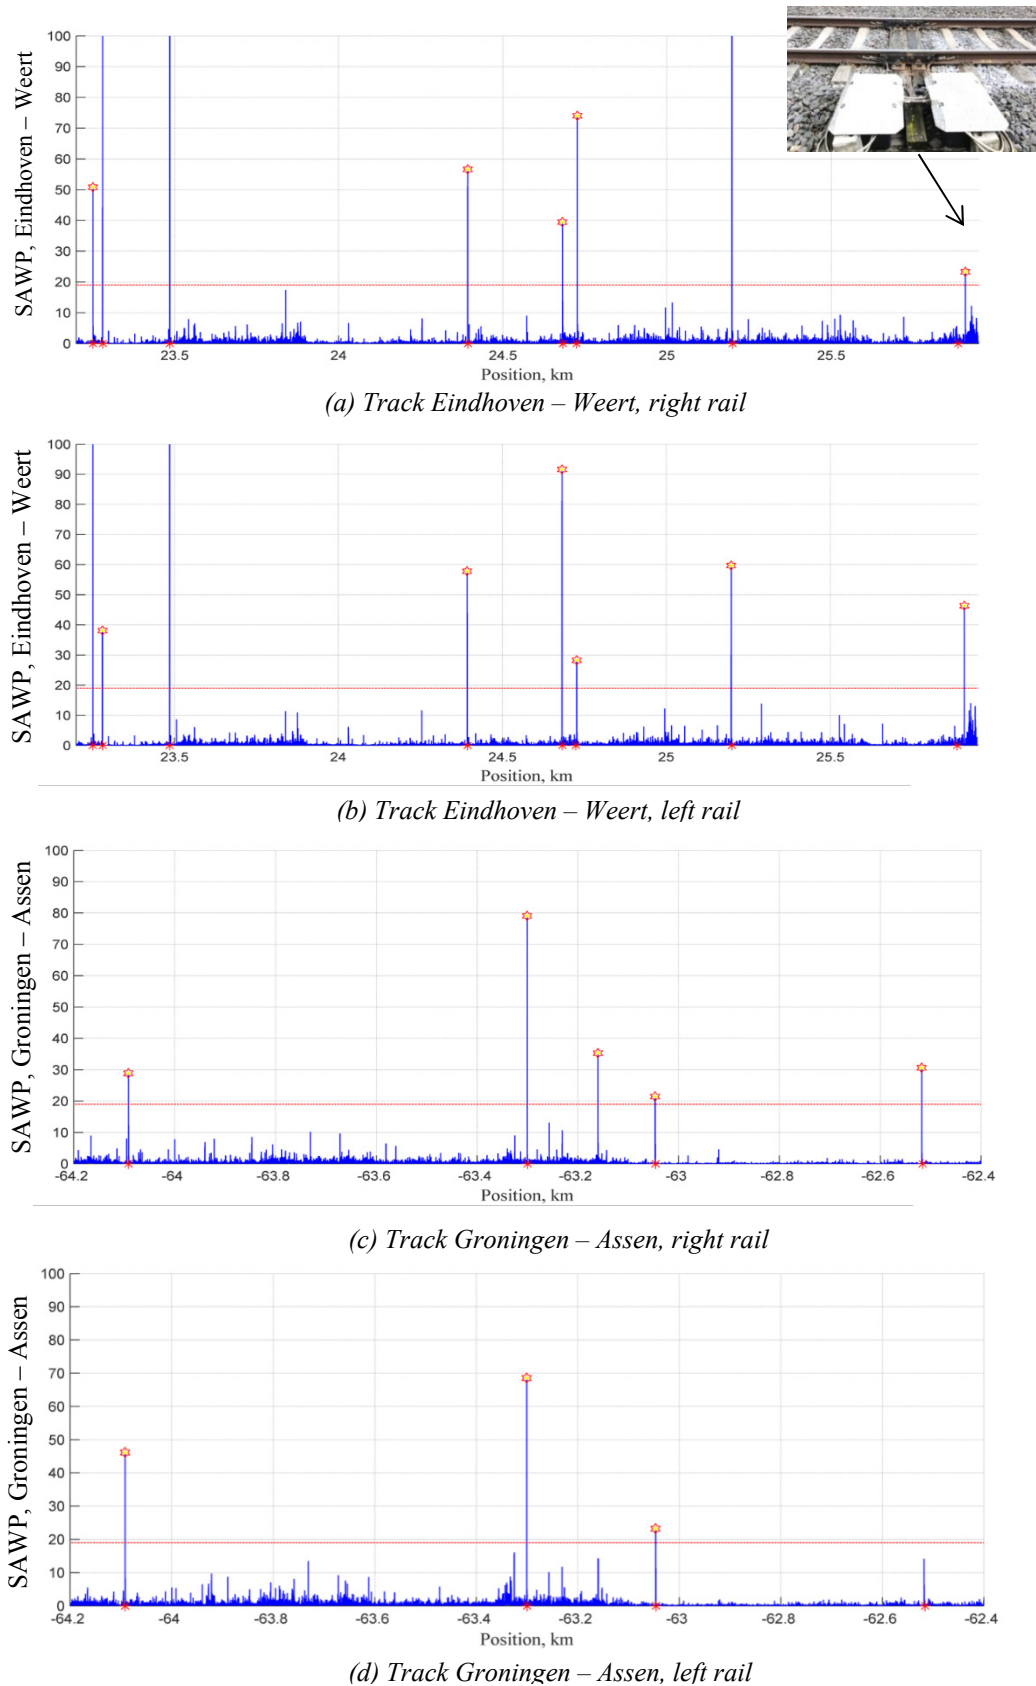
Figure 10: Detection of IRJs.

Figure 10a-b shows the calculated SAWP functions for right and left rails on a section of this track with 8 IRJ's locations, marked with red asterisks. The detection resulted in 77 predicted locations, with 62 of them being correct; 13 locations have been missed and 15 locations were falsely predicted. The hit rate of this detection is 83% and the false alarm rate is 19%.

Figure 10c-d presents the prediction for another track, Groningen – Assen. The length of the investigated track was 2.2 km with 4 IRJ's locations in total. One of the IRJs at position - 62.5km on the left rail was missed by the automatic detection. However, this location was detected from the signal on the other rail, and thus, by combination of the signals from both rails all the IRJs can be detected. In Figure 10c there is also one rail defect at -63.160 km.

which was falsely detected as an IRJ. This is an artificial rail surface defect, which was made for another research (Molodova et al., 2014b) by removing a thin layer of the material on the rail head. Since this artificial defect is an unusual situation on the rail, it can be excluded from our investigation, and we can conclude that the false alarm rate is zero for this track. The combined hit rate of detection from the two tracks is 84% with the false alarm rate 19%.

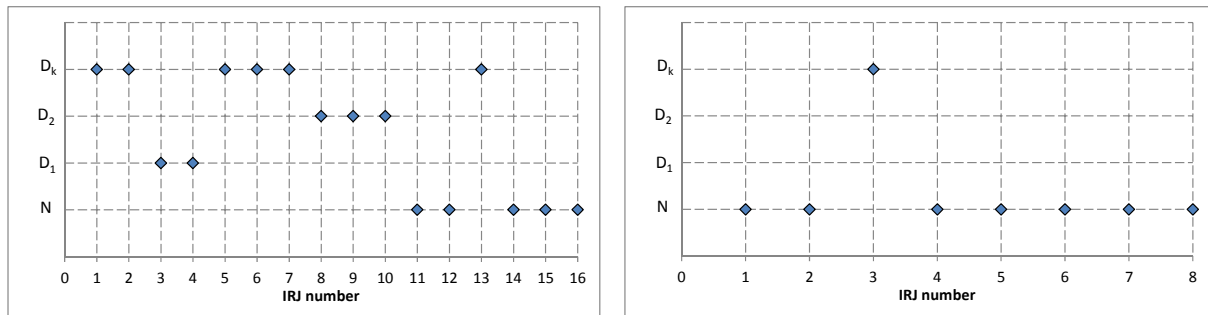
When the locations of the IRJs are detected, the assessment of the IRJs health condition can be performed based on the damage-IRJ analysis presented in section 4. The normal health condition is characterized by low ABA magnitude ($a_N^{max} < 100 \text{ m/s}^2$) and low PSD values ($P_{a_N a_N}([70;100]) < 200 \text{ (m/s}^2\text{)}^2/\text{Hz}$, $P_{a_N a_N}([520;570]) < 400 \text{ (m/s}^2\text{)}^2/\text{Hz}$). The IRJs with sever plastic deformation of the rail surface are characterized by high ABA values ($a_{D_1}^{max} > 100 \text{ m/s}^2$), and high PSD values around 520 – 570 Hz ($P_{a_{D_1} a_{D_1}}([520;570]) > 400 \text{ (m/s}^2\text{)}^2/\text{Hz}$). The IRJs with fastener damage are characterized by high ABA values ($a_{D_2}^{max} > 100 \text{ m/s}^2$), and high PSD values around 70 – 100 Hz ($P_{a_{D_2} a_{D_2}}([70;100]) > 200 \text{ (m/s}^2\text{)}^2/\text{Hz}$).

Figure 11 presents the assessment of IRJs health condition for the two tracks. The normal health condition is denoted by N , the plastic deformation of the rail surface after the gap is denoted by D_1 , the fastener damage is denoted by D_2 , and the uncertain health condition is denoted by D_k . The results presented in Figure 11 agree with the observation of the IRJs health conditions in Figure 5. Further investigation of various health conditions of IRJs is needed in order to improve these results and assess the IRJ with uncertain health conditions. The health conditions D_1 , D_2 and D_k indicate that deterioration of the IRJ has started and it is recommended to the inframanager to increase the frequency of inspections to prevent the failure of the IRJ. The proposed assessment can be used as performance indicator (Stenström et al., 2015), in order to simplify the overall analysis. The methodology can facilitate the maintenance operations providing crucial information that can be used to optimally design a condition based inspection plan strategy (Uzarski and Grussing, 2013) and maintenance decision making under risk averse situations (Rockafellar and Royset, 2015).
