# FIELDWORK 2017

CIE5318 Fieldwork Hydraulic Engineering

December 2017

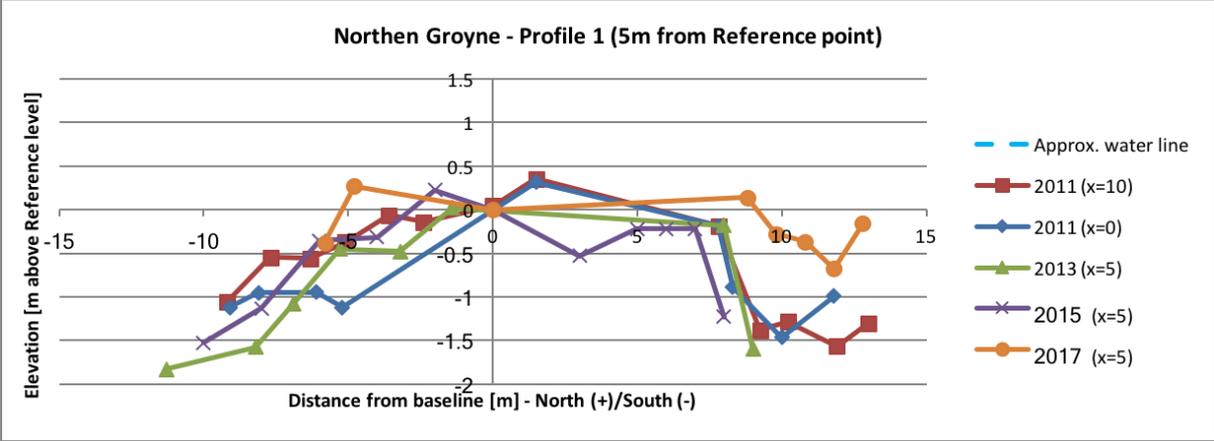
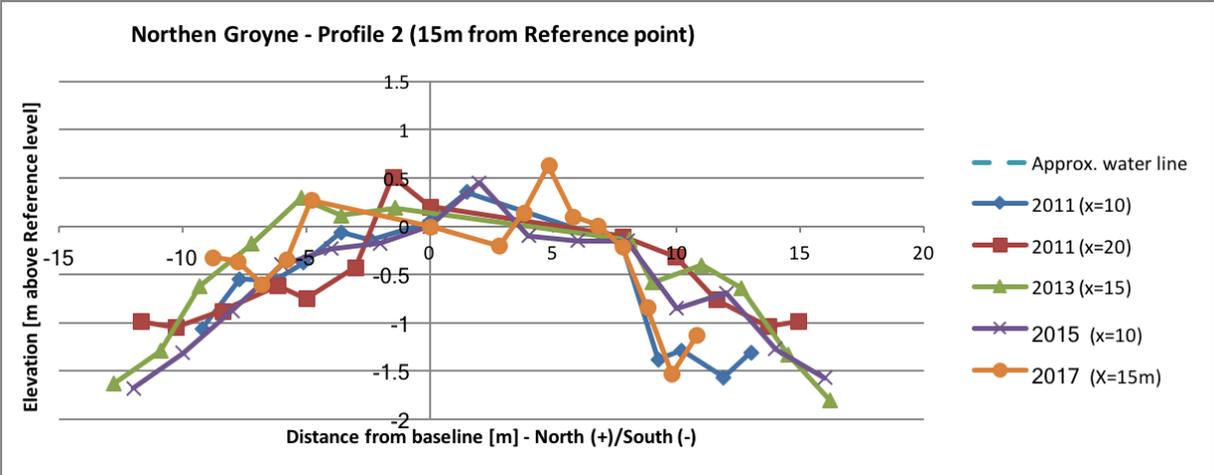
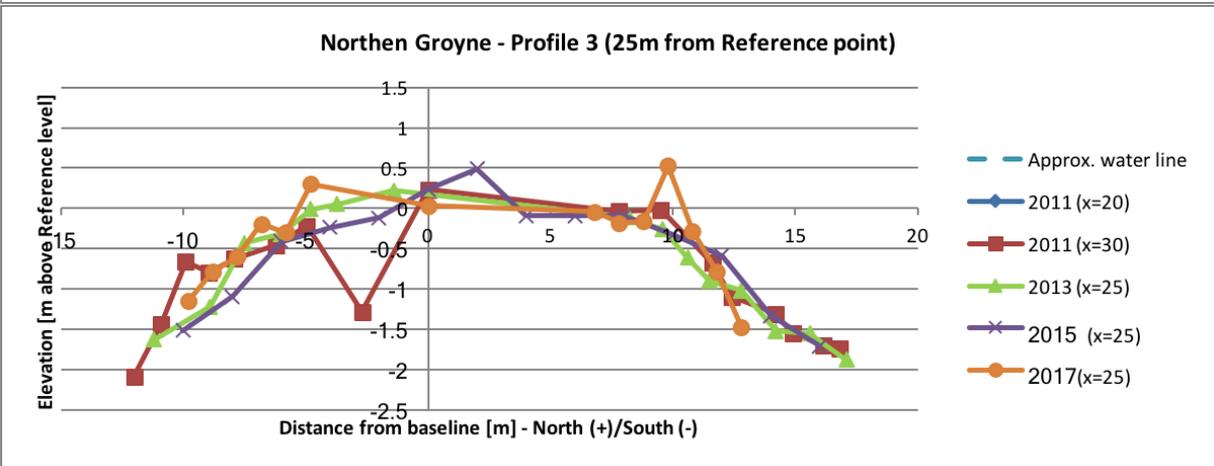
Figure 75: Measured groyne profiles of 2017 and earlier

In the pictures below the graphical results of the groyne can be found. It can be obtained that overall the results are approximately the same as previous years. In the following paragraphs the changes are mentioned.

Fifthly at  $x=45\text{m}$ , no noticeable changes are measured in this line.

Sixthly at  $x=55\text{m}$ , line is similar.

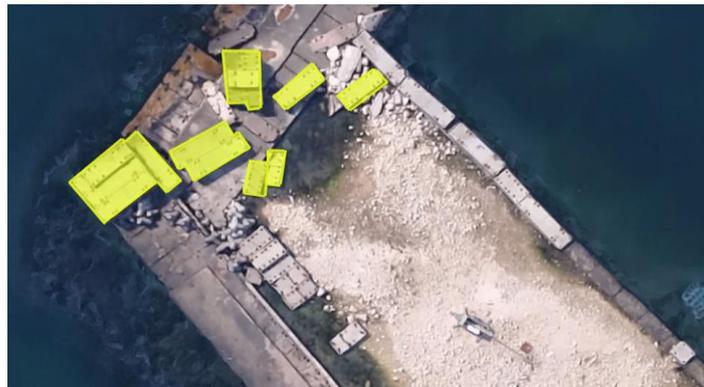
Figure 84: Overview of concrete blocks on the breakwater

The concrete blocks were obtained from visual observations can be seen with yellow colour in Figure 84 below. Furthermore, their dimensions and associated volumes were calculated as can be seen in Table 25 below.

The concrete blocks were damaged (some, cut in half) and with insufficient concrete cover. The rebars could be seen and were corroded. The amount of usable material was estimated up to 550m<sup>3</sup> (12237.5 tn) which represents the visible and counted concrete blocks while a percentage of about 40% is assumed to be the losses of materials.
