Performance of flood defences in the Netherlands during the 2021 Summer floods

André Koelewijn¹, Joost Pol² and Malou van Schaijk³

Abstract

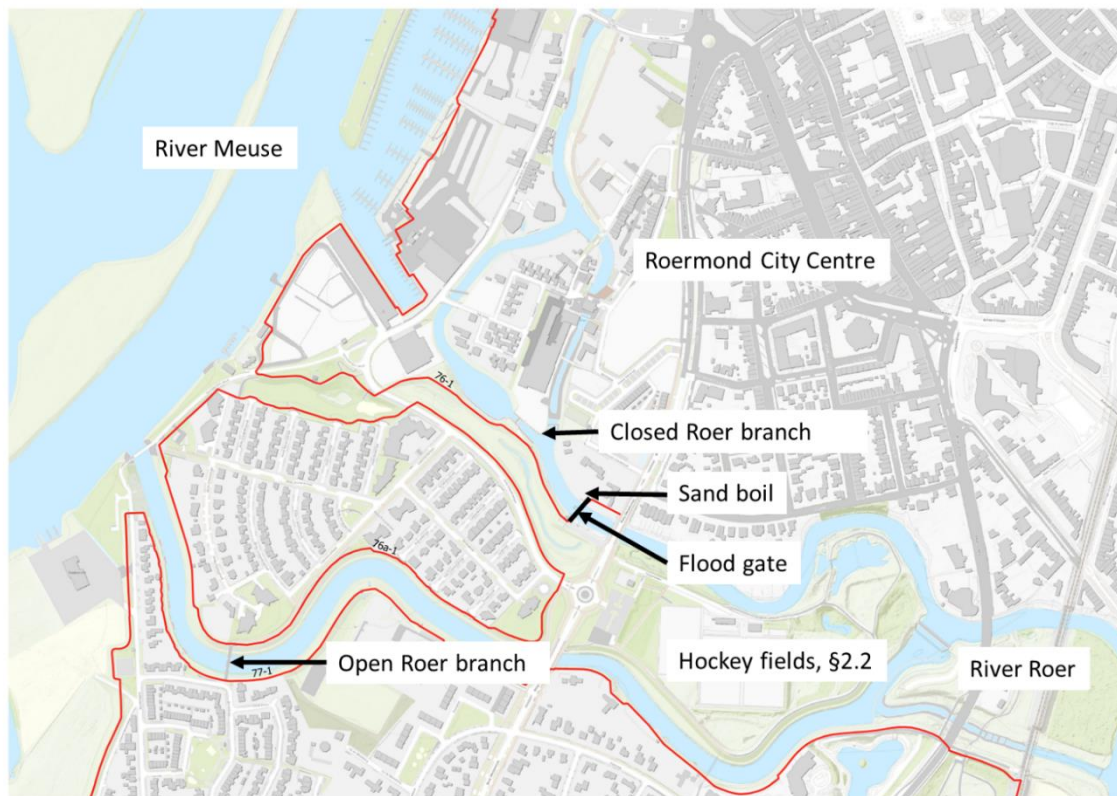
Another incident with internal erosion occurred at a floodgate in the city of Roermond (Figure 8). This floodgate in the Roer river, which is a tributary of the Meuse river, was closed in order to protect the city centre from flooding. At this location, excessive seepage and erosion in the corner of the L-shaped wall on the downstream side was reported on Saturday 17 July at 03:15 AM. The sand boil was bringing up coarse sand and gravel. Half an hour later, the first ring of sandbags was put down (see Figure 9ab) which was eventually built 3 to 4 layers high (Figure 9c). This stopped the erosion process. In the afternoon, again outflow of water and sand was reported, and the ring of sandbags was heightened to a height of 60 to 80 cm which turned out to be sufficient to stop the erosion for the maximum water level drop of more than 1.6 m that was present over the structure. To be sure to stop further erosion, the area near the corner was completely filled with sandbags [Figure 9c].

After the floods, a poor connection was found between the sheet pile and concrete cover on the high-water side (Figure 9d). This opening may have enabled the water to flow through the opening, and down behind the sheet pile, resulting in the formation of the sand boil.

Figure 8: Overview of the area around the Roer flood gate in Roermond.

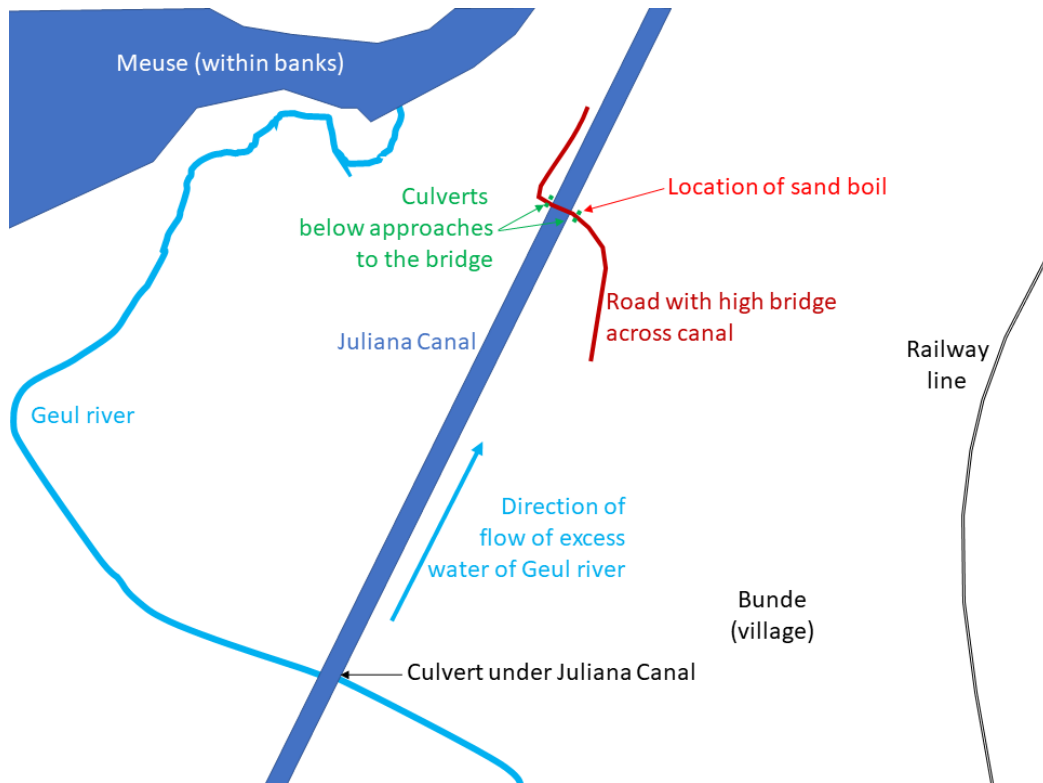
On the afternoon of Friday 16 July, various media reported that a dike had breached near the village of Meerssen or Bunde (1Limburg, 2021b) - (RTL News, 2021) - (De Telegraaf, 2021). On closer inspection, it was found to be a substantial sediment-carrying flow of water which also washed out gravel, just to the north of the approach road leading to the bridge over the Juliana Canal near Bunde, see Figure 14 and Figure 15. As a matter of urgency, this water flow – that was mistaken for a large sand boil– was handled by installing a coffer dam more than a metre high consisting of around 3000 sandbags which stabilised the situation. It was initially thought that the dike along the Juliana Canal which is elevated here was on the verge of failing due to a leak from the canal or from the Meuse. However, it was water from the Geul that was the problem, see Figure 15. Because not all of it could flow through the culvert under the Juliana Canal, it flowed along the eastern side of the Juliana Canal to the north. At the approach roads leading to the bridges near Bunde and Geulle, water then flowed around the road and through the originally constructed culverts. However, near Bunde the culvert had become covered and was not included in asset databases so that the flow of water from this culvert was initially misinterpreted as coming from the subsoil (“sand boiling”). It was discovered that there was a culvert here a week later when further investigation of this location was carried out. This last example clearly shows how the capacity of emergency services can be absorbed to a significant extent by issues that appear to be irrelevant at hindsight – or with sufficiently

Figure 15: Situation plan around Bunde bridge.
