## Investigation of the formation of corrugation-induced rail squats based on extensive field monitoring

2018

International Journal of Fatigue

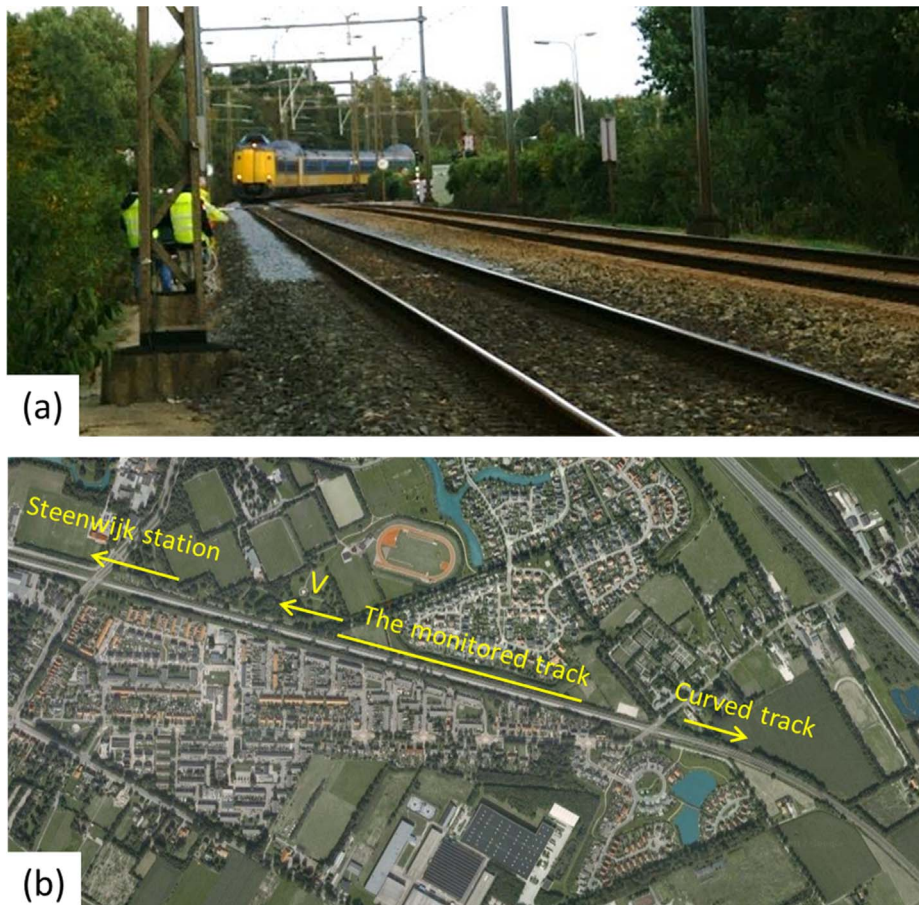
Fig. 2. Overview of the monitored straight track: (a) Monitored track looking in the direction of the curve against the traffic; (b) Google satellite view of the site.

A straight section of the Dutch railway network was selected for a five-year continual field monitoring of squat initiation and evolution. The monitored track was located in Steenwijk in the Netherlands, as shown in Fig. 2. During the period from 2007 to 2012, ten field observations were conducted at intervals of approximately 6 months. Two times of grinding were performed on the monitored track during the period of the monitoring. The first one was performed between the fifth monitoring observation (November 2009) and the sixth observation (June 2010) with a material removal of 1.1 mm (including natural wear by traffic because these 1.1 mm were derived from the profiles measured during the fifth and sixth observations); the second one was performed between the seventh observation (April 2010) and the eighth observation (August 2010) with a material removal of 0.3 mm (including natural wear). There was no grinding before the start of the monitoring. One-directional traffic ran on the track at a frequency of approximately 20 min per train during the day and no trains during the night. The majority of the traffic consisted of passenger trains. The maximum axle load of the trains was approximately 22 tons [19], and the annual traffic load was about 3.4 MGT. When trains were running on the straight section, they had just exited a curved track. The speed of the trains was 130 km/h and some traction was needed to maintain this speed. The rails were of the R260Mn grade with UIC54E1 as the nominal profile with a weight of 54 kg/m. They were installed in the track in 1989.

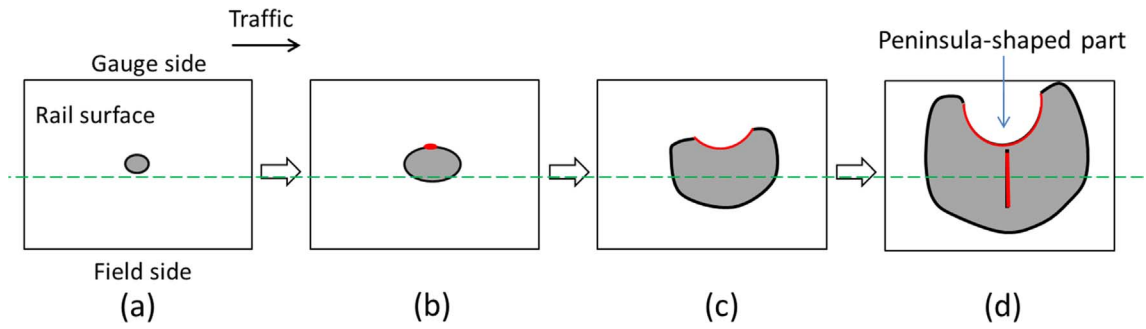
**Fig. 11.** Schematic diagram of the squat development process, including crack initiation and growth. The green line represents the rail centerline, the red line represents the cracks, and the gray area represents the squat/black depression with the black curved line representing its edge: (a) Elliptical small black depression; (b) crack initiation point, usually on the gauge side edge of the black depression; (c) U crack starts to form, causing the elliptical depression to become kidney shaped; crack propagates slightly more rapidly in the traffic direction due to traction force; (d) two-lung-shaped mature squat with a Y-shaped crack. (For interpretation of the references to color in this figure legend, the reader is referred to the web version of this article.)

Based on the observations and analyses described above, a squat development process is proposed. A schematic diagram of the process is shown in Fig. 11 to describe the squat evolution and cracking processes.

Initially, a small black depression is generated at a corrugation (Fig. 11(a)). The black depression results from microcracks due to plastic deformation and work hardening in the surface layer of the rail material, typically up to a depth of 1.1 mm, and it is caused by the cyclic wheel-rail impact forces excited by the corrugation. The black depression grows roughly in the shape of a complete ellipse until it reaches a critical size, and a primary macrocrack is initiated in/near the rail surface on the gauge side edge of the depression (Fig. 11(b)). Then, the shape of the black depression starts to change and follows the propagation of the crack, while the uncracking part remains elliptical. The surface crack propagates in a U shape toward the gauge side in both the traffic direction and the opposite-traffic direction (Fig. 11(c)). This process forms a U-shaped crack with the bottom point of the U being the initiation point of the primary crack. In this stage, the squat becomes a kidney-like shape with a concave part in the middle region bordered by the U-shaped crack. Moreover, the squat grows more rapidly in the traffic direction if the longitudinal contact force is tractive. It also propagates into the rail toward the field side at an angle of approximately 20°. When the squat grows to a certain stage, a ridge is

formed in the middle of the black depression, and an I-shaped crack can occur at this ridge. The combination of the U-shaped crack and I-shaped crack forms a Y-shaped crack (Fig. 11(d)). In this process, the U-shaped part grows into a peninsula-like shape around the time of the formation of the I-shaped crack. Eventually, this evolution process leads to a mature two-lung-shaped squat with a Y-shaped crack. The proposed development process is derived from and is valid for corrugation-induced squats, and it is elaborated in the next section.

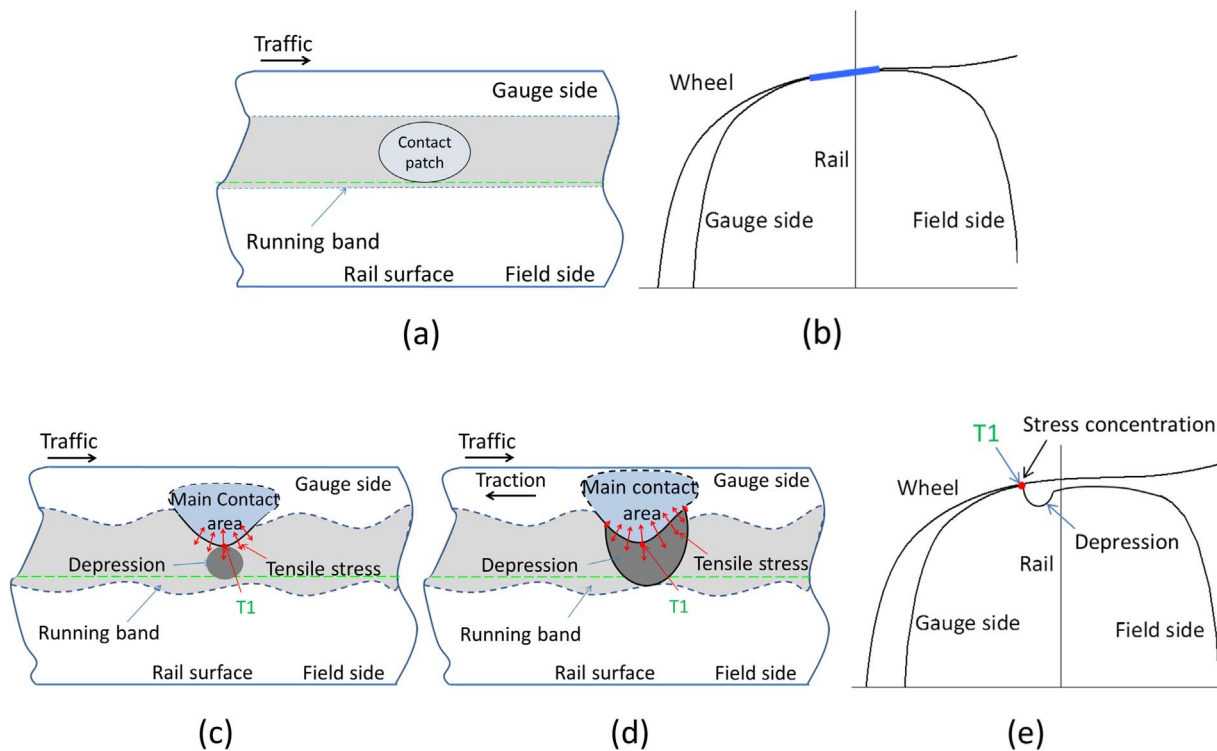
**Fig. 12.** Wheel-rail contact patch. The green line represents the rail centerline; the blue dashed lines mark the running band and corrugation; and the blue solid line indicates the main contact area: (a) and (b) When the rail is smooth; (c) and (e) when corrugation and a small black depression exist. The red arrows indicate tensile stress along the border of the main contact area; the length of the arrows is schematically proportional to the magnitude of the tensile stress. (c) corresponds to Fig. 11(b), and (d) corresponds to Fig. 11(c) and (d). (For interpretation of the references to color in this figure legend, the reader is referred to the web version of this article.)

When a small black depression grows to a certain size, it significantly changes the effective contact patch at the wheel-rail interface, as illustrated in Fig. 12. The contact patch can be approximated as elliptical when the rail surface is smooth, as shown in Figs. 12(a) and 10(b). However, its location and shape are different in the region when a small black depression exists. The main contact patch at the depression shifts to the gauge side, as shown in Fig. 12(c) and (d). The border of the main contact area at the edge of the depression exhibits a U shape with the opening of the U facing toward the gauge side. The U shape comes from the intersection of the wheel and the rail surfaces as a wheel is loaded onto a rail. This change in the contact patch is generalized and marked in Fig. 12(c) and (d). This main contact area is most clearly indicated by the brighter contact area bordered by the U-shaped crack at the monitored squats, such as those seen in Figs. 1, 4(d) and (e), 5, 6(d) and (e), 7, 9, 10, 15 and 17.

The region at the black depression sustains the impact from the wheels; the dynamic force is large. At the same time, the depression causes stress concentration at edge T1, as seen in Fig. 12(c), (d) and (e). The large contact force and stress concentration lead to stress that is much larger than elsewhere on the rail surface. According to the Hertz theory [25], tensile stress is present immediately outside the contact patch, and its value is maximal at the border of the contact. In the case of corrugation with surface depression, a tensile stress distribution arises along the border of the main contact area in a U shape, as indicated by the red arrows in Fig. 12(c). The tensile stress is the greatest at T1. Since the material at the depression is brittle, this greatest tensile stress results in a macrocrack at T1 by mode I fracture. This crack initiation phenomenon is analogous to the ring/cone crack formation of brittle materials under sphere contact [26] and the formation of crack

Once this primary crack is present, the tensile stress drives it to propagate along the border (the solid black line in Fig. 12(c) and (d)) of the main contact area in a U shape by stress concentration and mode I fracture toward the gauge side in both directions of the U-shaped crack. This fracture mode was observed in [8]. It forms the U-shaped primary cracks.

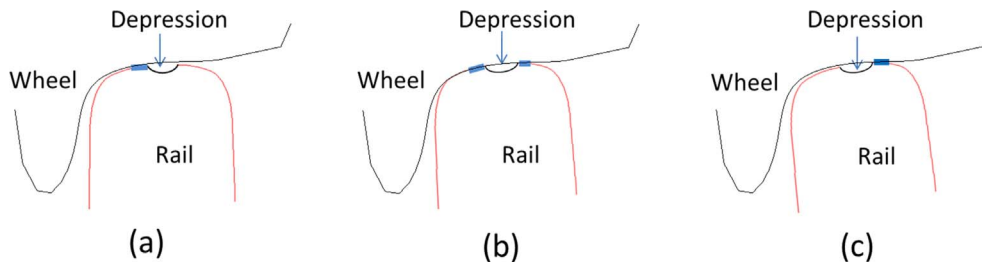
Fig. 13. Positions of the main contact areas (indicated by the blue line) that determine the locations of the primary cracks: (a) Rail inclination of 1/40; (b) a slight increase in the rail inclination; (c) a larger increase in the rail inclination. (For interpretation of the references to color in this figure legend, the reader is referred to the web version of this article.)

The case between the situations Fig. 13(a) and (c) is a slight increase in the rail inclination that slightly shifts the contact to the field side.
