Investigation of the formation of corrugation-induced rail squats based on extensive field monitoring

Deng, Xiangyun; Qian, Zhiwei; Li, Zili; Dollevoet, Rolf

International Journal of Fatigue

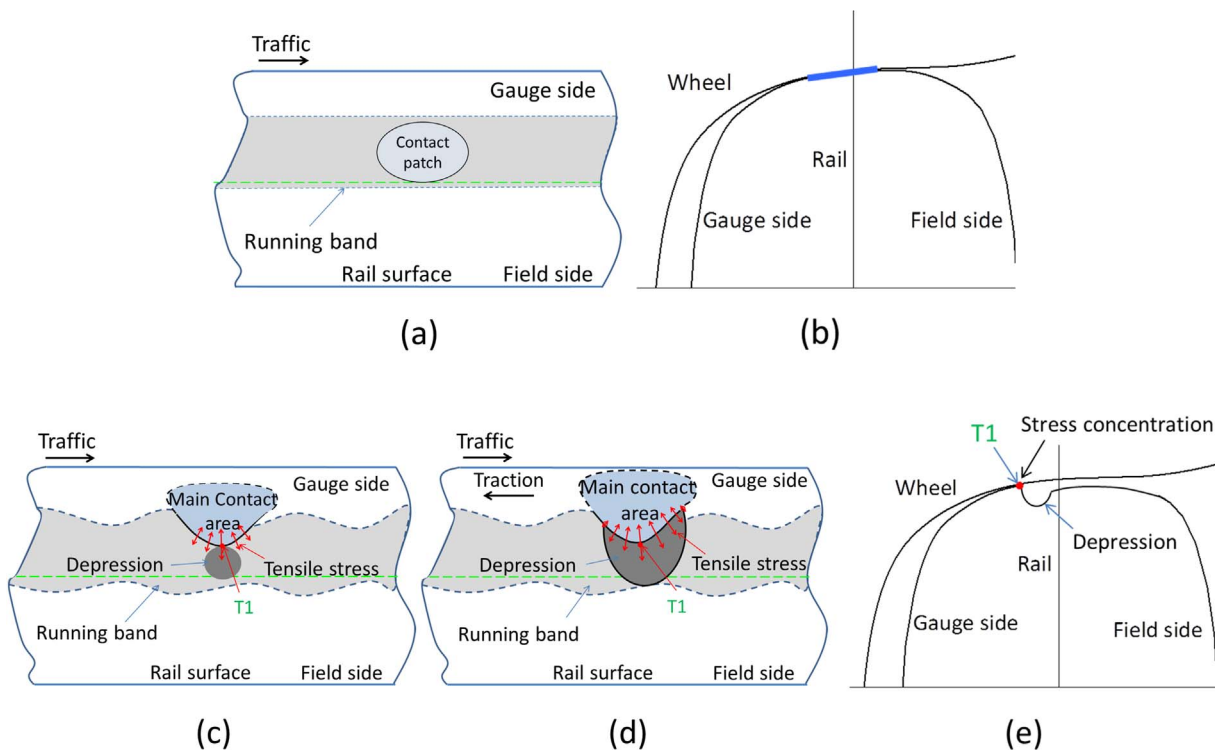
Fig. 12. Wheel-rail contact patch. The green line represents the rail centerline; the blue dashed lines mark the running band and corrugation; and the blue solid line indicates the main contact area: (a) and (b) When the rail is smooth; (c) and (e) when corrugation and a small black depression exist. The red arrows indicate tensile stress along the border of the main contact area; the length of the arrows is schematically proportional to the magnitude of the tensile stress. (c) corresponds to Fig. 11(b), and (d) corresponds to Fig. 11(c) and (d). (For interpretation of the references to color in this figure legend, the reader is referred to the web version of this article.)

When a small black depression grows to a certain size, it significantly changes the effective contact patch at the wheel-rail interface, as illustrated in Fig. 12. The contact patch can be approximated as elliptical when the rail surface is smooth, as shown in Figs. 12(a) and 10(b). However, its location and shape are different in the region when a small black depression exists. The main contact patch at the depression shifts to the gauge side, as shown in Fig. 12(c) and (d). The border of the main contact area at the edge of the depression exhibits a U shape with the opening of the U facing toward the gauge side. The U shape comes from the intersection of the wheel and the rail surfaces as a wheel is loaded onto a rail. This change in the contact patch is generalized and marked in Fig. 12(c) and (d). This main contact area is most clearly indicated by the brighter contact area bordered by the U-shaped crack at the monitored squats, such as those seen in Figs. 1, 4(d) and (e), 5, 6(d) and (e), 7, 9, 10, 15 and 17.

The region at the black depression sustains the impact from the wheels; the dynamic force is large. At the same time, the depression causes stress concentration at edge T1, as seen in Fig. 12(c), (d) and (e). The large contact force and stress concentration lead to stress that is much larger than elsewhere on the rail surface. According to the Hertz theory [25], tensile stress is present immediately outside the contact patch, and its value is maximal at the border of the contact. In the case of corrugation with surface depression, a tensile stress distribution arises along the border of the main contact area in a U shape, as indicated by the red arrows in Fig. 12(c). The tensile stress is the greatest at T1. Since the material at the depression is brittle, this greatest tensile stress results in a macrocrack at T1 by mode I fracture. This crack initiation phenomenon is analogous to the ring/cone crack formation of brittle materials under sphere contact [26] and the formation of crack

Once this primary crack is present, the tensile stress drives it to propagate along the border (the solid black line in Fig. 12(c) and (d)) of the main contact area in a U shape by stress concentration and mode I fracture toward the gauge side in both directions of the U-shaped crack. This fracture mode was observed in [8]. It forms the U-shaped primary cracks.
