2024

Journal of Flood Risk Management

Field survey assessment of flood loads and related building damage from the July 2021 event in the Ahr Valley (Germany)

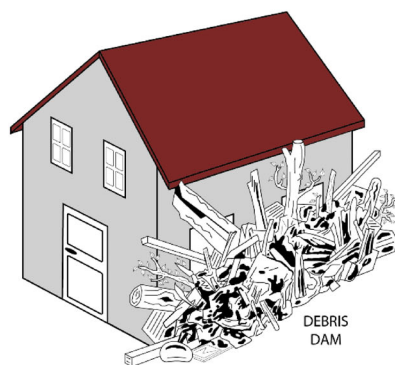
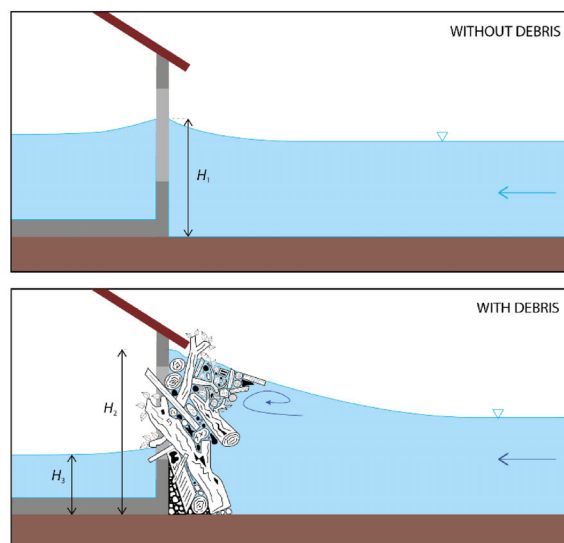
As an overly simplified example, Figure 16 shows the sketch of a house with its upstream side completely covered by debris, similar to those observed during the survey. Assume that the wall is 3 m tall, 6 m wide and that two windows of $1.5 \text{ m} \times 2 \text{ m}$ are present at a height of 0.75 m. If the flood depth is 2 m and water flows through the openings, the area exposed to the flood is 8.25 m^2 , which corresponds to a resultant hydrostatic pressure of 10γ (where γ is the specific weight of the water in N/m^3 ; Kelman & Spence, 2004). If the flow velocity is 1 m/s, the resultant hydrodynamic pressure, assuming a uniform

distribution over the depth and a drag coefficient of 1.0 (Jansen et al., 2020), would be 8.25γ . When a debris dam builds up against the house, water can no longer flow freely through the openings, increasing the area exposed to the flow (Wüthrich et al., 2018). Moreover, the dam may also span out on the sides of the building, which further increases the obstructed area and therefore the loads. Besides, the reduced flow area may lead to a constriction of the flow depending on the neighbouring buildings and obstructions. This may lead to an increased water level in front of the house. For this example, the increase in water level is considered 10% and the additional area covered by the debris-dam on the sides of the building is assumed as 10% in total. This is an optimistic assumption since experiments have shown increases in water depth of up to 20%–25% depending on the flow

FIGURE 16 Sketch of 'debris-dam' resting on a building. Comparison of water levels with and without the dam.

conditions (Wüthrich, Ylla Arbós, et al., 2020). Ten percent increase means that the exposed area becomes 14 m^2 and corresponds to a resultant hydrostatic pressure of 16γ . If the flow velocity and drag coefficient remain unchanged, the hydrodynamic drag would amount to 14.5γ . Consequently, in this simple example, the debris dam leads to a 75% increase in the resultant hydrodynamic force exerted by the flood. Furthermore, the hydrostatic pressure is often equalised on both sides of the wall if water can enter the structure (Figure 16); but in the case of a debris dam, the water level inside could be lower than outside, which would add a hydrostatic component to this value.
