CHAPTER 4

STRUCTURAL DAMAGE BY TSUNAMIS

Orville T. Magoon
Navigation and Shoreline Planning Section
Engineering Division
U. S. Army Engineer District, San Francisco
100 McAllister Street
San Francisco, California

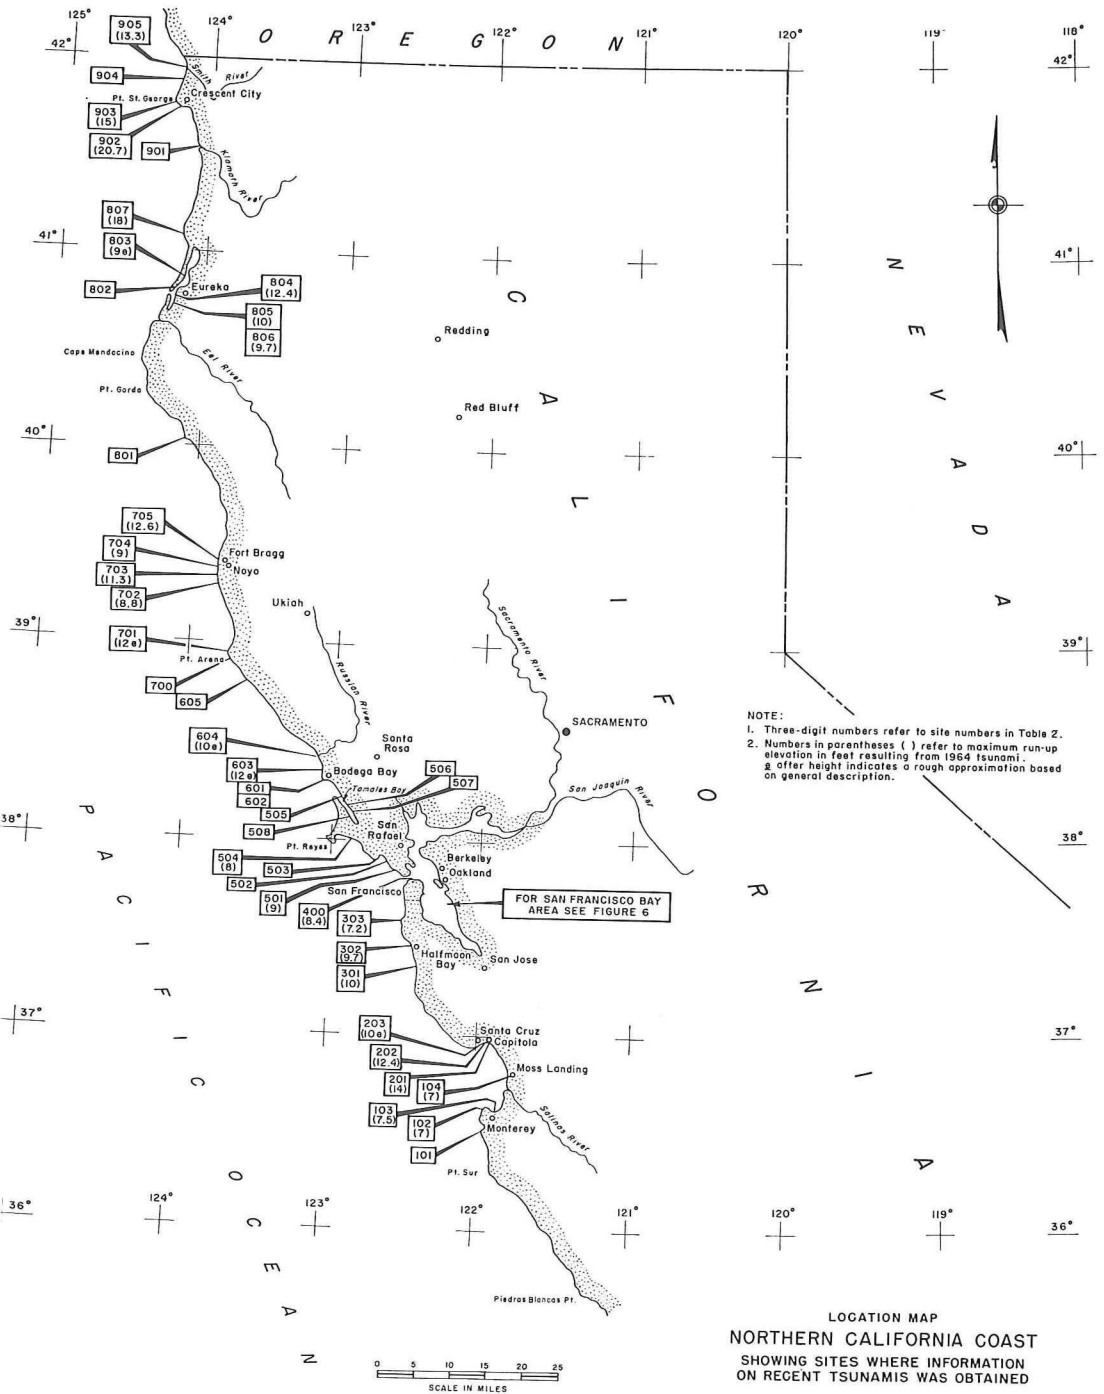
Figure 1

The characteristics of the three tsunamis mentioned as they affected the northern California coast are given in Table 2. The site numbers referred to in Table 2 are located on Figure 1. The effects of the March 1964 tsunami inside of San Francisco Bay are given in Table 3. The site numbers referred to in Table 3 are shown on Figure 2.
