## Confirming Debonding of Non-Metallic Inclusions as an Important Factor in Damage Initiation in Bearing Steel

Nikolic, Ksenija; De Wispelaere, Jelle; Ravi, Gopalakrishnan; Hertelé, Stijn; Depover, Tom; Verbeken, Kim; Petrov, Roumen H.

Metals

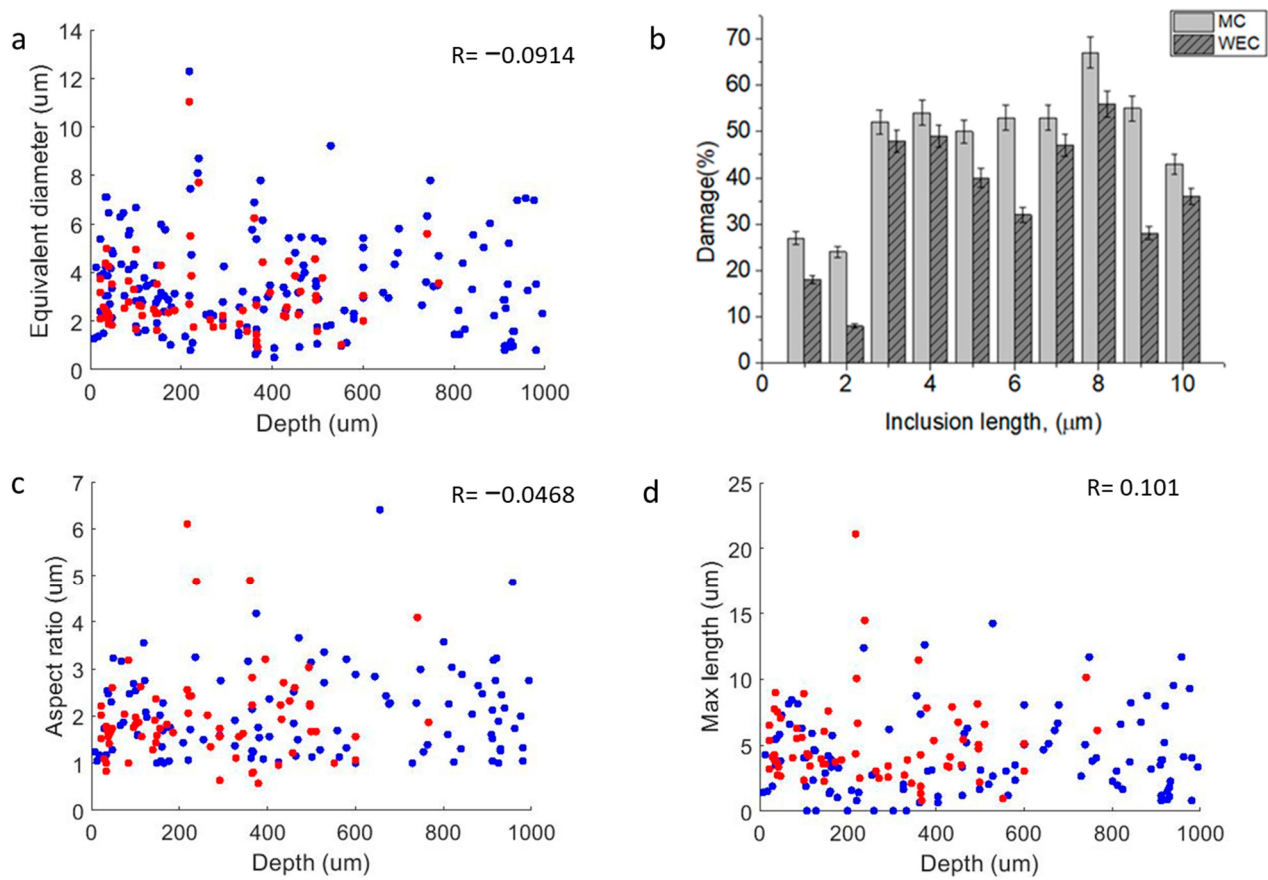
with the observations in [24,26]. Figure 8 shows the depth versus size, aspect ratios, and max length of the inclusions; red dots are the inclusions that initiated damage, and blue inclusions are without damage. The equivalent diameter of the inclusions across depth suggests that they are randomly distributed throughout the sample (cf. Figure 8a). In Figure 8b, we observe the relationship between inclusion length and the percentage of initiated MCs and WECs. The damage percentage was determined by categorizing all non-metallic inclusions in the loaded zone based on their size per 1 micron, such as 0–1 micron intervals, 1–2 microns, 2–3 microns, and so on. Subsequently, the total number of non-metallic inclusions in the specific zone and the count of damage initiated by these inclusions were established. Inclusions measuring up to 2  $\mu\text{m}$  exhibit a low probability of damage, less than 30%. However, as the inclusion length reaches 3  $\mu\text{m}$  and beyond, there is a significant rise in damage initiation. The greatest percentages of damage occur at inclusion lengths of 8  $\mu\text{m}$ , with 66% for MC and 56% for WEC. A similar observation as in Figure 8a is valid for the aspect ratio, maximum length of the inclusions (cf. Figure 8c), and maximum length across the depth of the sample (cf. Figure 8d).

**Figure 8.** (a) Distribution of inclusion size across depth. (b) Percentage of initiated MCs/WECs in correspondence with inclusion length. (c) Maximum length of inclusions across depth. (d) Aspect ratio across the depth. Red represents inclusions that initiated damage, and blue indicates inclusions without damage.

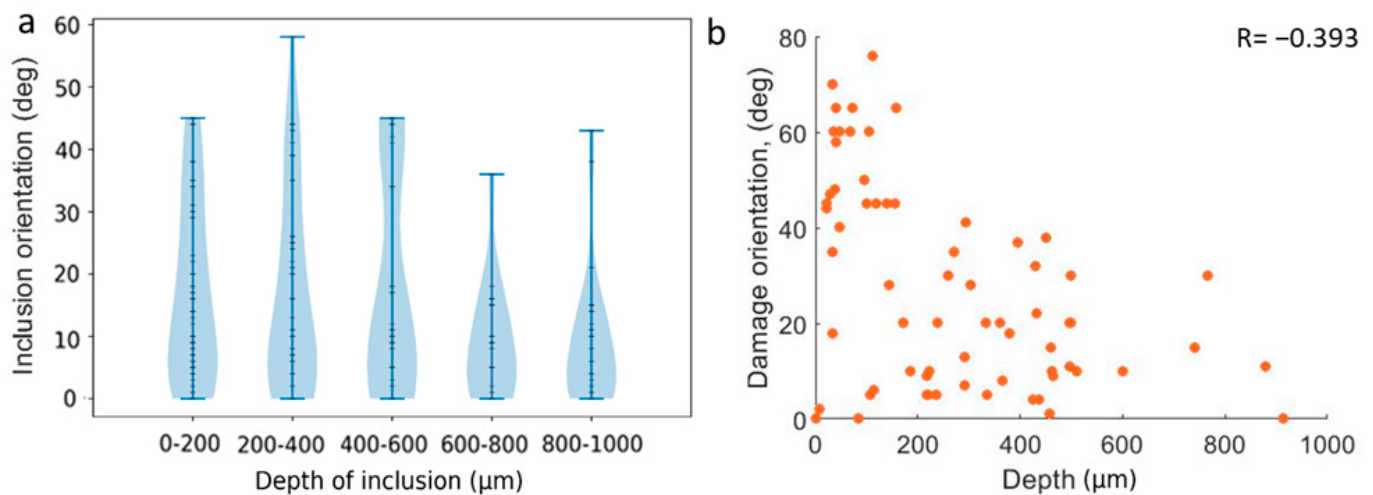
In this section, the microstructural features of butterfly wings and white etching cracks were evaluated. Some authors referred to both as a non-linked phenomenon [23], while others see the BWs as a precursor for WECs [26,35,47,48]. It is reported that WECs appear to develop in parallel or branching patterns without following any particular maximum shear stress directions [49]. In this study, BWs were found down to 200  $\mu\text{m}$  below the surface, with the majority of them being closer than 100  $\mu\text{m}$  to the surface. The inclusions leading to WECs were located within a band of 200–500  $\mu\text{m}$  below the surface, which is assumed to be the zone that experienced high rolling contact stresses. It is widely accepted that BWs initiate within the angle of 45 degrees with respect to the over-rolling surface. Moreover, given the depth below the surface, WECs cannot initiate at these angles as the shear stresses are not the same as in the zone up to 200  $\mu\text{m}$ . Of course, these numbers correspond to this particular bearing, given its particular loading history. The orientation of the inclusions in relation to the distance below the surface is presented in Figure 9a. Inclusions tend to have a lower orientation angle smaller than 30 degrees. The orientations of microstructural alterations across the depth of the sample are presented in Figure 9b. Most of the alterations up to 200  $\mu\text{m}$  are oriented close to 45 degrees, and the angles become shallower as the inclusion depth increases.

**Figure 9.** (a) Inclusion orientation across the depth. (b) Average angle of damage in relation to depth.

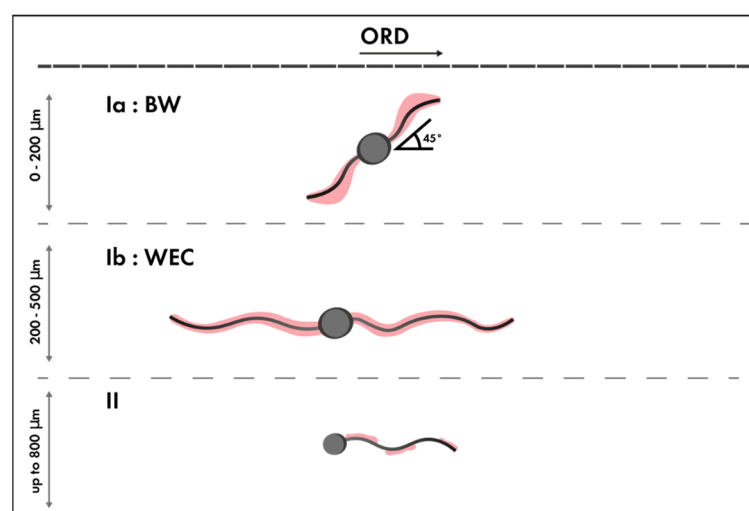
Comparing the microstructural alterations in different zones, earlier postulated mechanisms about crack rubbing and severe plastic deformation can be confirmed. A graphical representation of the proposed hypothesis is shown in Figure 14. In zone Ia, only individually present BWs were observed, which had a typical 45-degree propagation on either side of the non-metallic inclusion. In zone Ib of Figure 14, most of the WECs consisted of cracks propagating left and right from the non-metallic inclusions with a significantly thick WEA developed in the vicinity of the WEC. In zone II, most cracks appear only on one side of the non-metallic inclusions and the accompanying WEA was thinner than in zone Ib. These findings are in line with the previously proposed mechanism [35,52]. Indications of severe plastic deformation can be derived by comparing zones Ib and II. Zone II (where the stresses due to over-rolling contact are less pronounced) had a less deformed area around the WEC. Lower stresses mean that crack face rubbing is less intense; consequently, less WEAs are formed.

**Figure 14.** Schematic representation of the appearance of microstructural alteration with respect to the angle of initiation and depth below the raceway surface.
