Damage behavior of ground pearlitic railway steel

Schotsman, B.

Dissertation

for the purpose of obtaining the degree of doctor
at Delft University of Technology

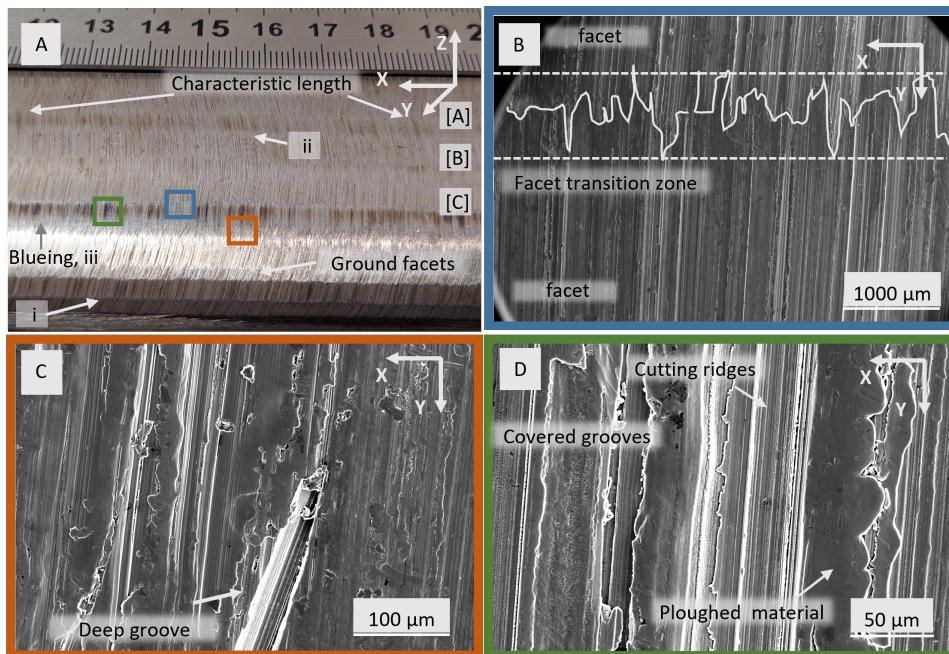
Figure 2.4A shows an optical micrograph of the rail surface of RS0 for detailed analysis. The grinding grooves are parallel and typical for vertical-axis grinding, formed transverse to the grinding direction. The average roughness is $R_a = 5.5 \pm 0.2 \mu\text{m}$. The pattern of repeated deeper grinding grooves evidences the characteristic length of the grinding process, which is $\sim 67 \text{ mm}$.

Facets are smaller in the smaller-radius sections of the transverse rail head profile and wider in the larger-radius sections. The average width of the facets is 5 ± 2 mm. Temper colors are an important quality indicator [32]. Blueing of individual grinding grooves is observed in facet 3, indicated with *i* in Figure 2.4A, whereas in facet 12, see *ii*, groups of colored grooves are present. The purple to black surface oxidation in facet 7, see *iii*, is associated with temperatures above 735°C , indicated as metallographic burn [33]. This burn is accompanied by WEL formation and these temperatures may even result in damage formation due to thermal stress [16, 33, 34].

Figure 2.4B shows a SEM image of the blue-framed area in Figure 2.4A, enclosing the facet transition zone. The width of the zone is $\sim 800\text{ }\mu\text{m}$ and is defined by the variation in grinding groove lengths, as highlighted in the figure.

The deepest grinding grooves cross the transition zone and are often characterized by a different orientation. One such groove is indicated in Figure 2.4C which corresponds to the area enclosed by the red frame in Figure 2.4A.

Figure 2.4: Representative micrographs of the ground rail surface of sample RS0. A) Optical micrograph of the ground surface. The measurement positions A-C, the characteristic length of the grinding process, and the various degrees of blueing, see *i-iii*, are indicated. B) Facet transition zone. The extremities of the grinding grooves that define the transition zone are highlighted. C) A grinding groove crossing the facet transition. D) The characteristic grinding groove. Cutting ridges are present in the grinding grooves. At both sides of the groove ploughed material is observed.

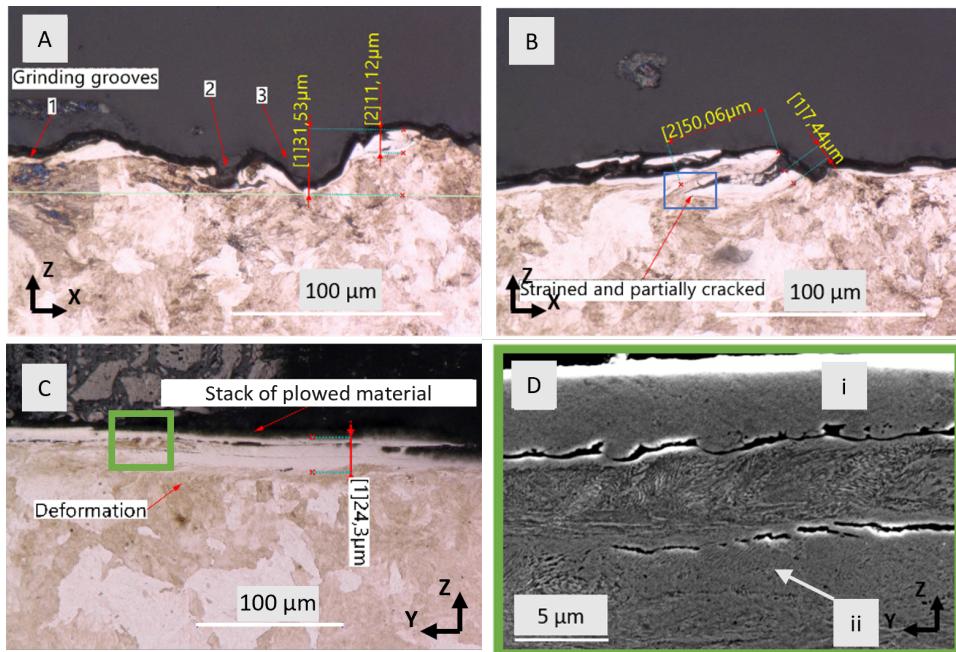
Figure 2.5 shows representative micrographs of RS0 to study the freshly ground surface in more detail. The micrograph in Figure 2.5A is observed transverse to the running direction. It displays the variety of grinding groove profiles resulting from the abrasive particle size variation. The presence and orientation of extruded material in the parallel grinding grooves show a cutting sequence, although the grooves were cut in the same grinding pass.

Figure 2.5B shows another consequence of the cutting depth variation between abrasive particles. Material is strained instead of cut and removed, and is covering the freshly ground surface.

The observation direction in Figures 2.5C and 2.5D is parallel to the running direction and perpendicular to the grinding grooves. Figure 2.5C shows a material pile-up that results from subsequent passages of different abrasive particles ploughing material to the side. The layers are shifted relative to each other due to different abrasive particle trajectories. The limited deformation below the pile-up, in the $-Y$ -direction, evidences their direction of movement. In addition, some layers show evidence of WEL while other layers have remained pearlitic.

Figure 2.5D presents a detailed SEM image taken within the green framed area of Figure 2.5C. The strained pearlite of the middle layer has a $\sim 1 \mu\text{m}$ thick WEL on both sides which is also present at the interface, see *i*. The surface layer, see *ii*, consists of WEL and the interface between the top layer and the pearlite middle layer is frayed. The protrusions seem to have deformed the pearlite microstructure.

Figure 2.5: The freshly ground rail surface observed in cross-section on metallographic specimens from rail sample RS0. A) Grinding grooves with various shapes, widths, and depths. Grinding groove 1 is shallow and wider compared to grinding groove 2, which is deeper and covered with extruded material. Groove 3 is narrow and the distance to the ridge at the side is $R_t \sim 31 \mu\text{m}$. B) Strained and partially cracked material that was not removed and covers the WEL-coated surface. C) A stack of ploughed material. The layers have a total thickness of $\sim 24 \mu\text{m}$. Below the layers, the deformation orientation is in the $-Y$ -direction. D) The SEM micrograph shows the green framed area in Figure 2.5c in detail. The top layer is phase transformed, see *ii*. At the bottom, see *i*, a $\sim 2 \mu\text{m}$ WEL is observed while the middle layer consists of strained pearlite with a small WEL at both sides.

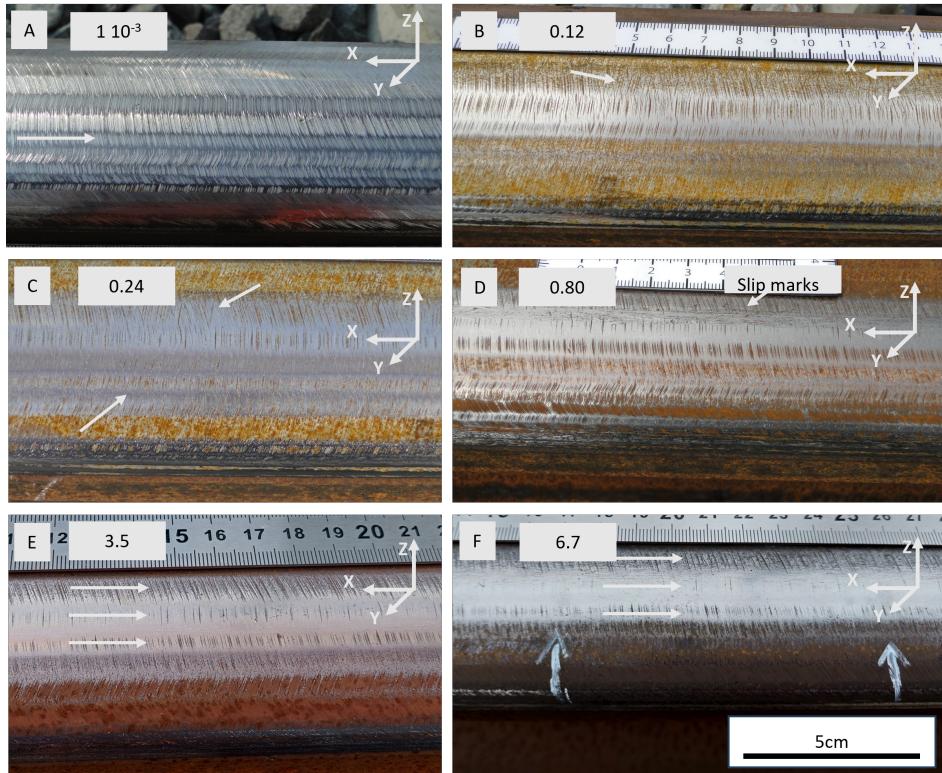
Figure 2.6A shows the rail surface after $1 \times 10^{-3} \text{ Mt}$ of load. The contact surface is narrow and facet transitions of facet 8, indicated by the arrow, are widening, evidencing localized contact.

In Figure 2.6B the contact surface after 0.12 Mt is presented. The contact has widened and includes facet 9, which can be determined well by the surface corrosion that was worn away. In addition to the contact surfaces on the facet transitions, load-carrying surfaces develop on the facet surface, as evidenced by the surface widening between the brownish grinding grooves.

Figure 2.6: The contact-surface formation as a function of the cumulative load, based on rail surface inspections in daylight. The cumulative load in Mt is presented in each micrograph. A) 1×10^{-3} Mt. Contact-surface formation takes place at the facet transitions of facet 8, indicated by the arrow. Blueing is still present. B) 0.12 Mt. Surface corrosion has taken place. The contact surface widens and load-carrying surfaces start to develop between the grinding grooves at the face surface. Grinding grooves with diverging orientations appear. C) 0.24 Mt. The surface of the facet transitions is smooth on the gauge side of the contact zone. Surface corrosion is locally present at the facet surfaces and the grinding grooves with diverging orientation are still present. D) 0.80 Mt. The contact surface width is reached and the corrosion layer has thickened. The length of grinding grooves shortens, but deeper grooves remain. Slip marks at the surface are caused by track maintenance and are not investigated. E) 3.5 Mt. Three arrows are placed to observe the grinding groove lengths and the densities. F) 6.7 Mt. The surface condition just before the field test is completed.

Figure 2.6C shows that the contact width after 0.24 Mt of train load is wider than after 0.12 Mt. At the gauge side of the contact surface the wheel contact is concentrated at the facet transition zones, resulting in smooth and light gray surfaces.

The inspection results in Figures 2.6D-F cover a longer period of time because the development of the contact surface, after the initial stage, occurs more gradually. The figures present the rail surface at 0.80 Mt, 3.5 Mt, and 6.7 Mt of train load, respectively. The contact surface width in Figure 2.6D and in Figure 2.6C is the same from which it is deduced that the contact surface widening that took place during the initial stage of the contact surface formation stopped. The number of grinding grooves on the center of the contact surface decreases and the length shortens. Deep grooves are still present.

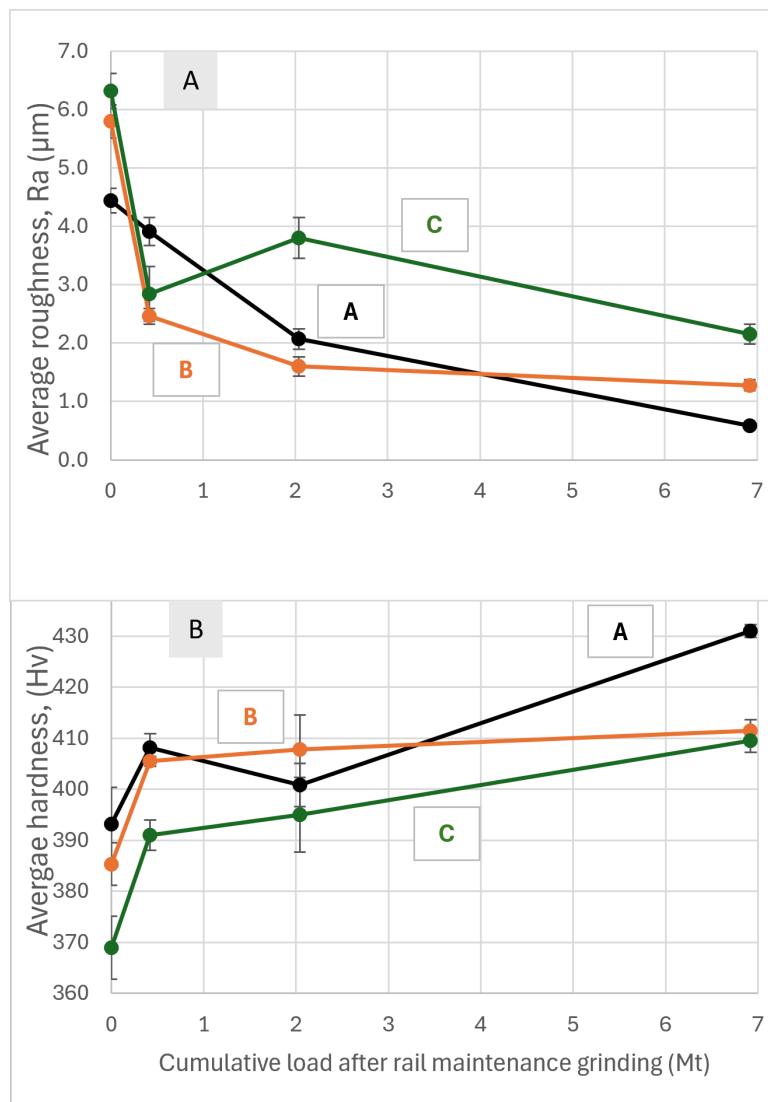
Figure 2.7: The evolution of surface roughness (A) and hardness (B) in positions A, B and C, during the field test. The measurements were made on the surfaces of the extracted rail samples. See Figure 2.3 for the reference of the measurement positions.

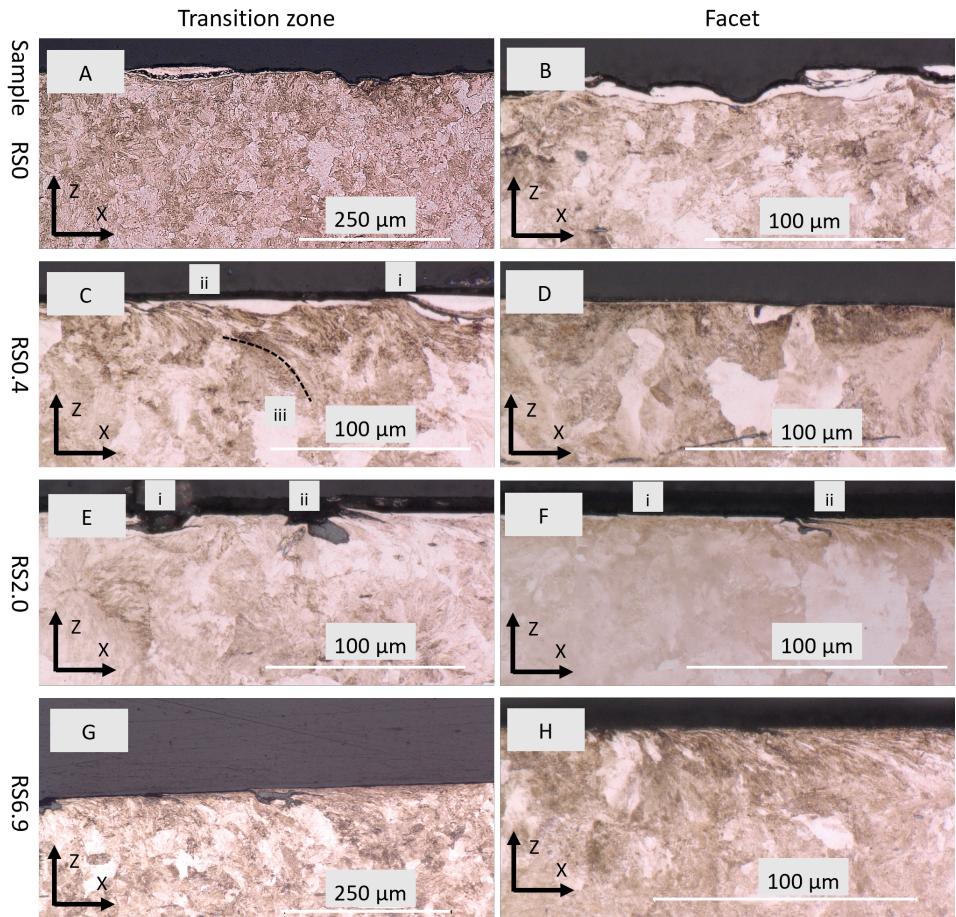
Figures 2.9C and 2.9D present the rail surfaces at RS0.4. In the transition zone, the mechanisms that contribute to the rapid formation of the contact surface are explained by three characteristic features. First, material extruded from the asperities covers grinding grooves, see *i*. Second, WEL formation takes place. The deformation and sharp transition between WEL and the pearlitic microstructure evidence the high temperatures that are reached during extrusion of asperities [36, 37]. WEL is formed on both the extruded slivers and on adjacent areas, see *ii*. Third, subsurface deformation aligns with the direction of the traction, as highlighted by the dotted line. The deformation reaches

Figure 2.9: The contact surface formation as observed on longitudinal sections. The rows of the array present the micrographs of sections from rail samples RS0 to RS6.9. The columns present the micrographs of sections from the transition zone position on the left and from the middle of the facet on the right. The microstructure details are described in the main text.

a depth of $\sim 60 \mu\text{m}$ and is only locally present, see *iii*. The facet surface is smooth and slightly wavy. At the facet no deformation or fresh WEL, associated with wheel load and slip, are observed.

Figures 2.9E and 2.9F present the surfaces at sample RS2.0. At the facet-transition zone, the WEL thickness is smaller than that of RS0.4. The residual grinding groove in Figure 2.9E, indicated with *i*, is partly covered with material from both sides. The second grinding groove, see *ii*, is filled with corroded material and damage initiates at the positive *X*-side. On the surface, next to the damage initiation, a fresh WEL has formed. The facet surface in Figure 2.9F shows damage initiation at the extreme of the WEL, indicated with *i*, but the feature of interest is the large damage, see *ii*. A crack starts at the grinding groove bottom, bending downwards, and a parallel crack has initiated. Deformation, both at the surface and also below the surface, is concentrated at the positive *X*-side of the grinding groove.

Figures 2.9G and 2.9H show the surface and deformation of rail sample RS6.9. The surface conditions at the facet and the transition zone are comparable and only the larger depth of deformation in the transition zone indicates a still slightly higher load.

Figures 2.8B and C present the surface of RS0.4 evidencing the ratchetting-based wear. The parallel extruded slivers exhibit small mutual distances corresponding with the distances of the grinding grooves shown in Figure 2.4D. Figure 2.9C shows a micrograph of a facet transition of RS0.4. The slivers that are formed by extrusion cover and fill valleys in the ground surface, accelerating the reduction of the roughness. The direction of extrusion is determined by the tractive shear stresses that point in the $-X$ -direction.

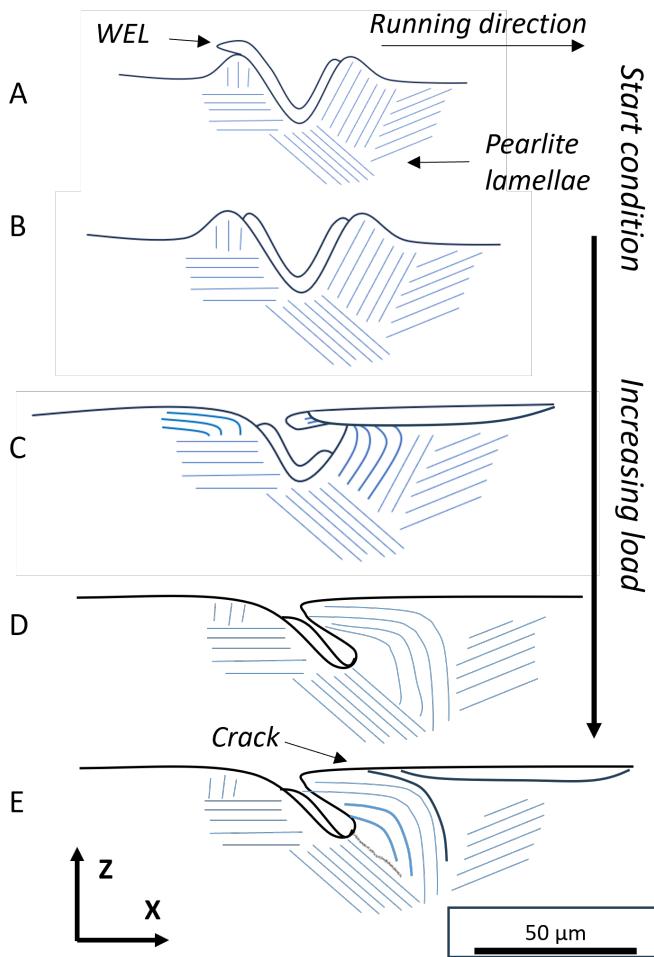
Figure 2.13 shows this schematic model for a simplified ground surface consisting of a representative single grinding groove and the adjacent surface. Figure 2.13A presents the freshly ground surface. Material removal caused a groove with ploughed ridges at both sides. The friction in the cutting zone caused heat generation resulting in a WEL at the bottom and at both sides, as well as the extrusion of material.

Figure 2.13B represents the second stage. The majority of extruded slivers and semi-detached WEL patches are fractured and removed from the surface.

In Figure 2.13C the load-carrying surface starts to form. Material is extruded, embedding ground surface features in the surface and the surface roughness is strongly reduced. The material extrusion causes strain concentration at one side of the grinding groove. At the extruded material fresh WEL is formed. WEL, present at the surface of the grinding groove, spalls off from the deformed side but stays attached on the opposite side. During this stage the grinding groove starts to align with the deformation orientation.

Figure 2.13D shows that, with the progress of the contact-surface formation, the reappeared WEL becomes thinner or is even worn off. The grinding groove, under ongoing deformation, is closed at this stage, resulting in flanks pressed together with the embedded WEL in between. Exposure to the elements causes the embedded WEL to corrode.

Figure 2.13E shows the last wear stage. Wear processes at the surface have reduced the number of submerged grinding grooves, but the deepest grinding grooves still remain. Thin WEL reappears at the surface and damage initiates at the bottom of the deformed grinding groove and in the deformed material next to it.

Figure 2.13: Schematic model describing roughness reduction and WEL removal, re-appearance and submerging of the freshly ground surface.

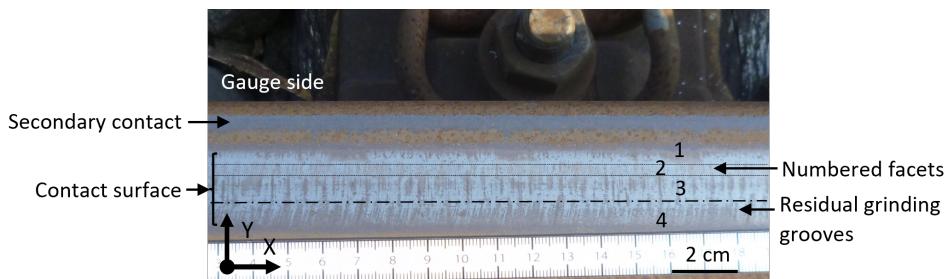
Figure 3.3 shows the ballasted railway track with wooden sleepers on which the rail is mounted with spring clips. The wheel-rail contact surface is light gray and contrasts with the corroded rail. The contact surface has a width of 22 ± 1 mm. At the gauge side of the rail a secondary contact is observed. The rail is lightly touched by the wheel flange, only removing the surface corrosion.

As a result of the preventive grinding maintenance in 2017, four facets are present, which are numbered 1 to 4 in this study. The facets are distinguished by the partly worn grinding grooves and the smooth transition zones separating them. Facets 1 and 2, close to the gauge side of the rail, where the rail head radius is small, have a width of 4 mm and

Figure 3.3: Railway track construction and characteristic contact surface, just before rail sample extraction in 2020. The numbers indicate the ground facets at the contact surface.

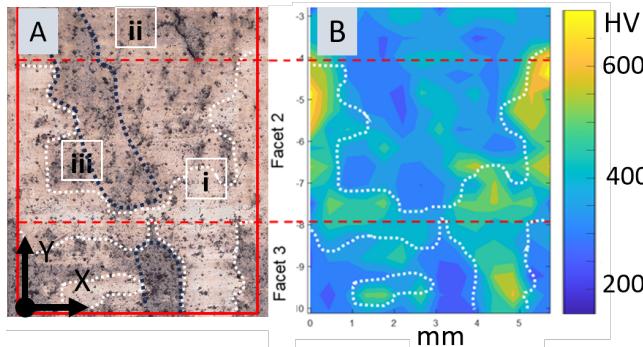
Figure 3.5 shows the surface characteristics at facet 2 and the facet transition zone. The figure presents the surface of the same extracted rail but is taken outside the area shown in Figure 3.4, focusing on wider residual grinding grooves in facet 2 and facet 3. Figure 3.5A presents the surface after cleaning and light etching and Figure 3.5B shows the hardness contour plot which is constructed from a grid of measurements. The grind-

Figure 3.5: Detail of the rail surface. A) load-carrying surfaces, on which WEL-stripes are present (see i), surround the residual grinding groove, highlighted with dotted lines. In the grinding groove damage initiations are present, see ii and iii. B) The hardness distribution of that rail surface, showing locations of lower hardness, the grinding groove (blue) and locations with higher hardness and WEL (yellow/green). The regions where WEL is observed are outlined by the white dotted lines.

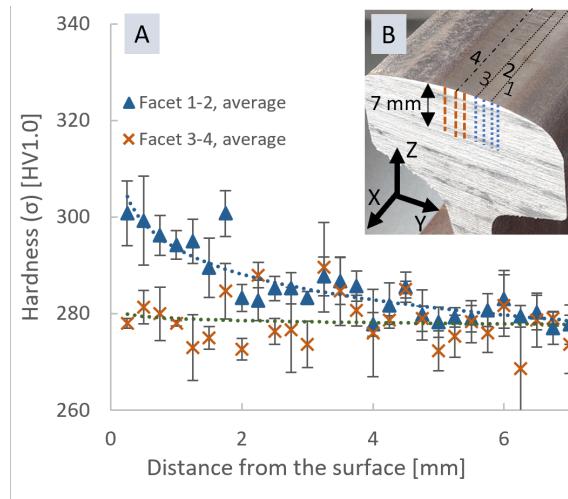
Pearlitic rail steels are known for their strain-hardening behavior and the exceedance of the yield limit results in an increase of the hardness and strength [41]. Figure 3.7 shows the hardness distribution of the contact surface with in Figure 3.7A the measured hardness profiles in blue for facets 1 and 2, and in red for facets 3 and 4. Figure 3.7B presents the corresponding measurement positions on the cross-section.

Figure 3.7: The hardness distribution below the running band. A) Graph presenting the hardness measured on the cross-section of facets 1 and 2 in blue and facets 3 and 4 in orange. The hardness is measured from a distance of 0.25 mm to the surface, until 7 mm distance. B) The location of the hardness indents on the cross-section. The colors correspond with the colors in the graph.

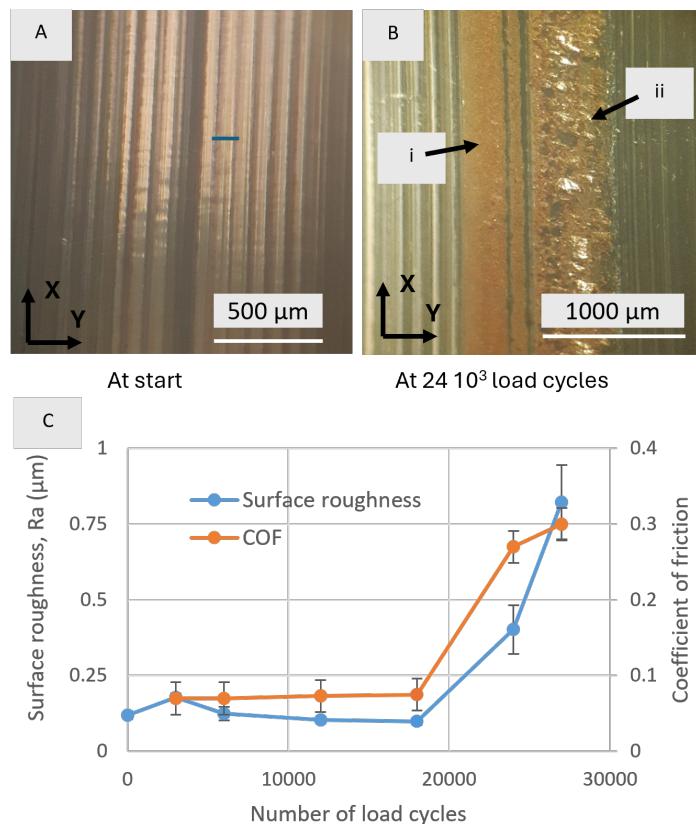
The graphs in Figure 4.5C present the evolution of surface roughness and coefficient of friction as a function of the number of load cycles. Each dot in the graph represents a stop between runs to characterize the transient surface condition. The surface roughness decreases slightly at first, as a result of contact surface formation, while the coefficient of friction is constant. The latter starts to rise at 18×10^3 load cycles and the increase continues into the next test run, but the rate of increase slows down. The surface roughness also increases, but unlike the coefficient of friction, the roughness increase accelerates.

Figure 4.5: The contact surface formation at the HT surface condition. A) The fresh HT surface with characteristic feed marks and ridges on both sides. B) The surface condition at 24×10^3 load cycles, consisting of a smooth band, see *i*, and a rough band, see *ii*. Both bands are separated by remaining feed mark valleys. C) The evolution of the surface roughness and the coefficient of friction as a function of the number of load cycles.

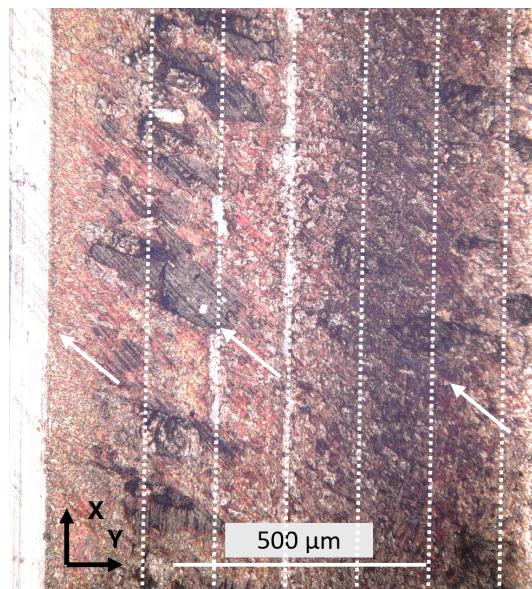
Figure 4.6 presents a micrograph of the HT contact surface condition for the detailed observation of the contact surface after the test. The test duration was kept short at 27×10^3 load cycles to avoid losing interesting features due to wear. The contact width is

~960 μm and divided into two bands. The –Y-side of the contact surface is characterized by a straight side, caused by the feed mark, a reddish surface, an indication of ferro-oxide presence, and spallation of material. The larger spallations have a ~30° angle to the Y-axis, and the smaller spallations align with the parallel wear scars having a ~48° angle to the Y-axis. The band at the right, the Y-side, the contact surface is darker, and material spallations are localized.

Figure 4.6: The contact surface, that was formed on the HT surface condition, after the test. The white arrows indicate the sharp edge of the contact surface and spallation of material. Spallation takes place at a $\sim 30^\circ$ angle and a $\sim 48^\circ$ angle. This second orientation coincides with the wear scratches at the surface. The ridges in the cavities, the result of material spallation, might be propagation marks. The dashed vertical lines indicate the former feed mark positions.
