Commision of the European Communities
Guyana Sea Defence Lome IV Project
Essequibo/West Demerara Locations

Investigation of slip failures at
Henrietta and Anna Regina

Delft Hydraulics
Delft Geotechnics

October 1996

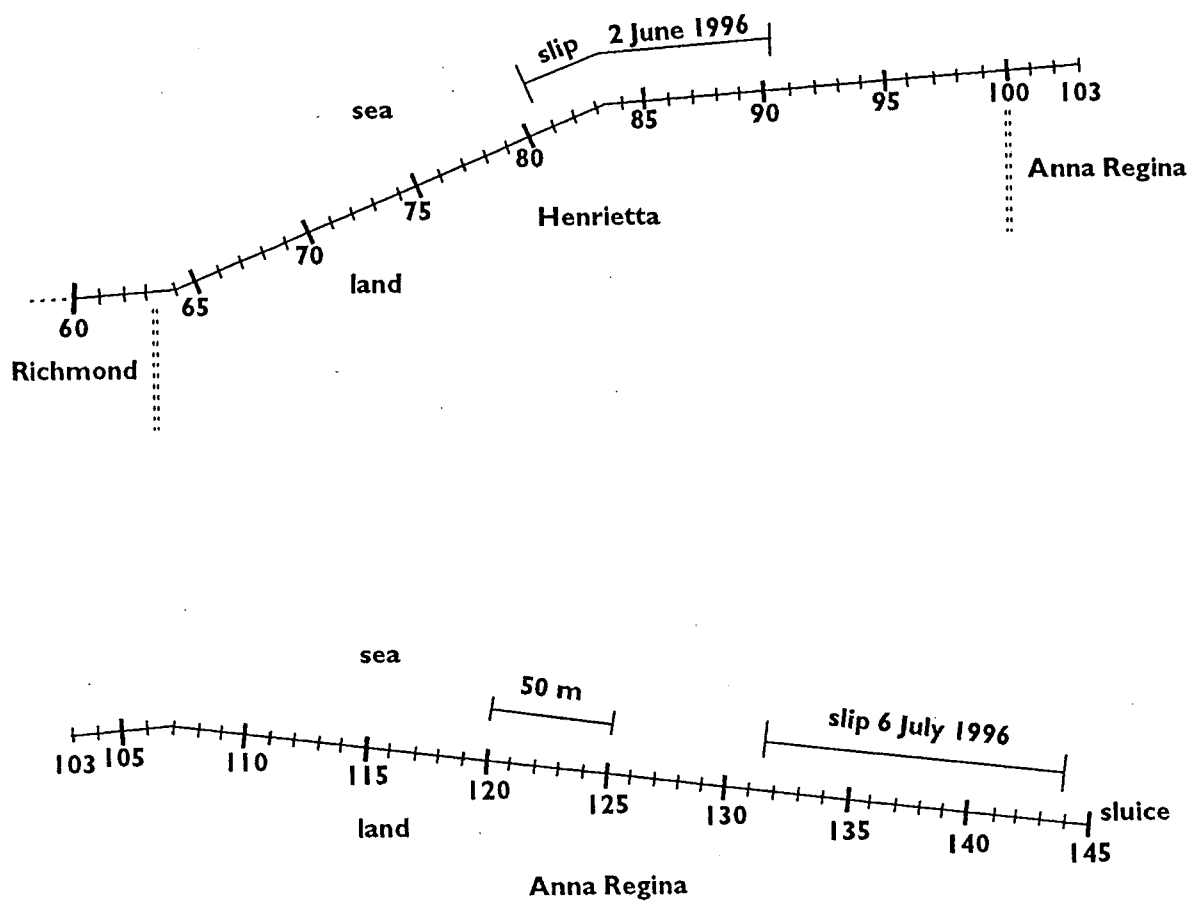
Plan view of area B from sections
60 - 145 with locations of slip failures

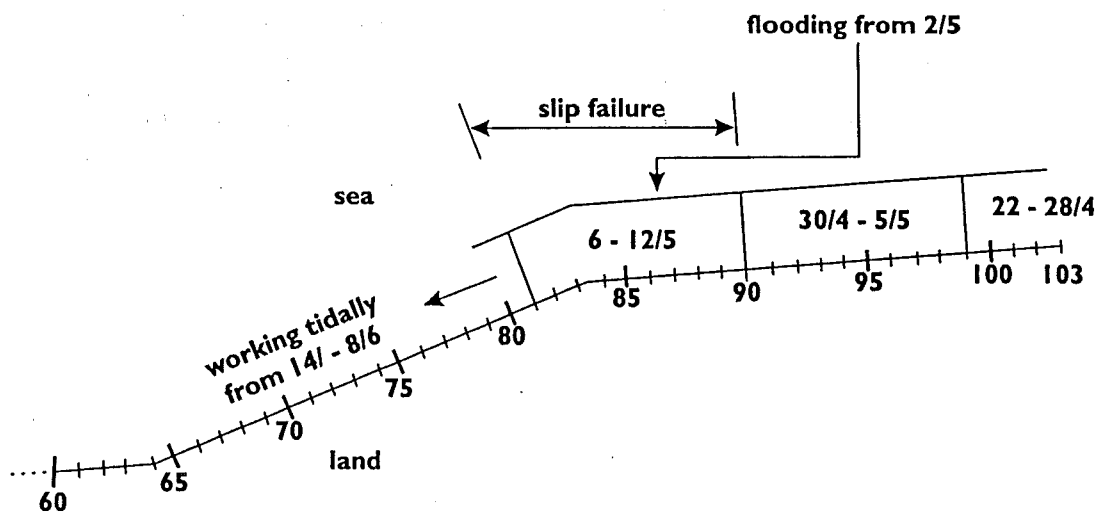
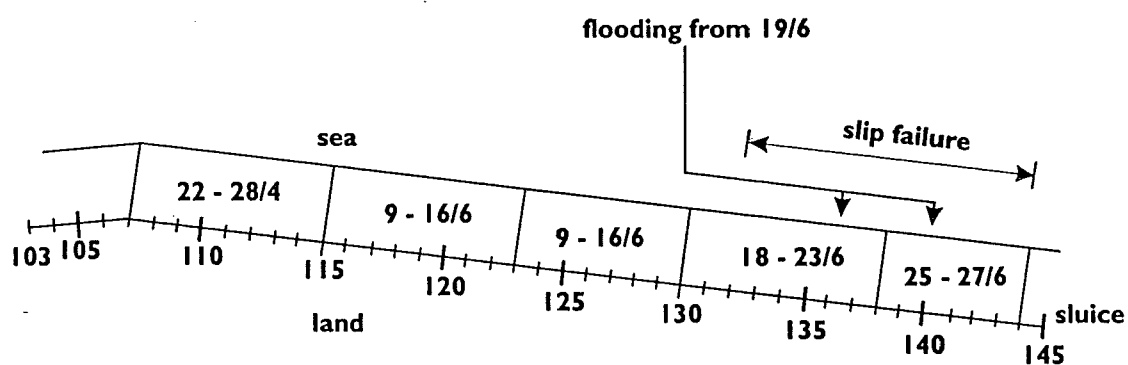
Location cofferdams and progress of work

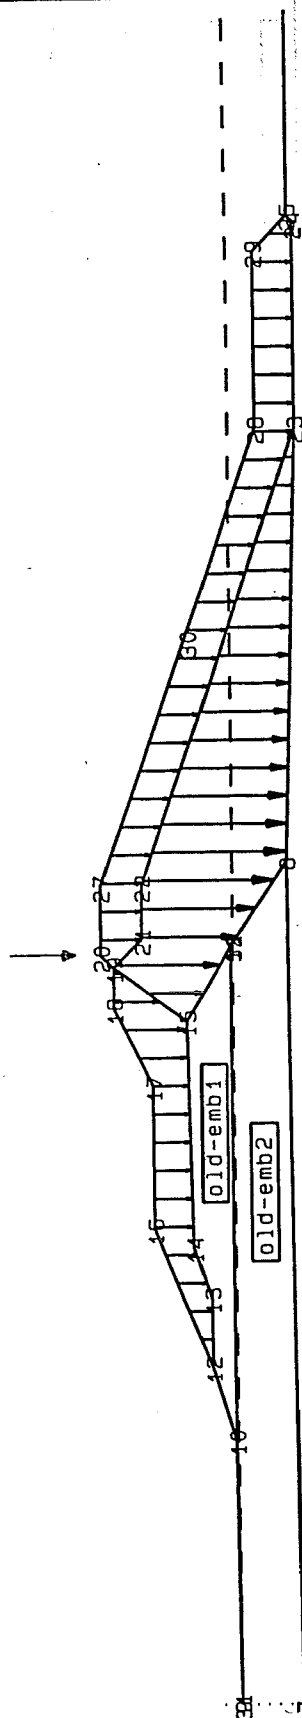
FIG. 2.5.4

The result of the effective stress stability analysis is presented on the Figure 2.5.4. The sliding plane is given. The calculated minimum stability factor $F_{min} = 0.95$. This stability factor indicates that at the 7th of July 1996 at low tide the sea defence at the Henrietta site was unstable.

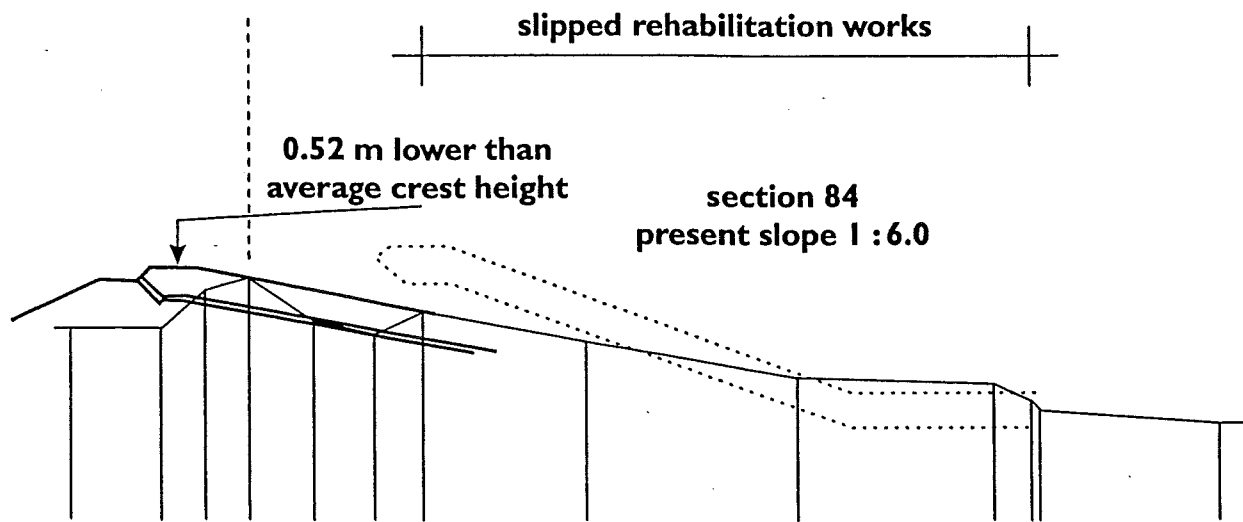
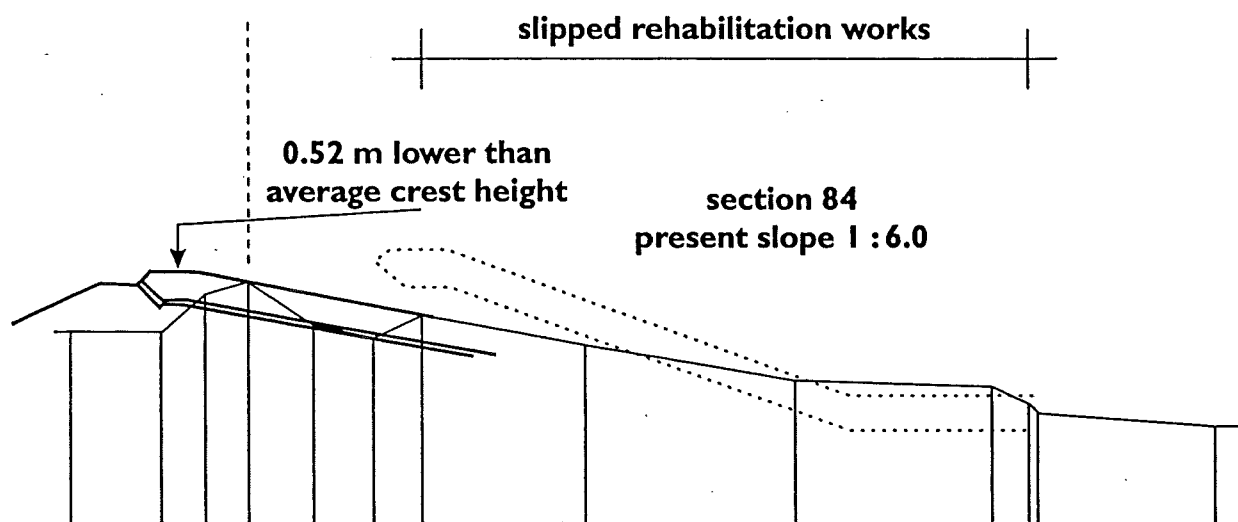
FIG. 4.1.2

Figure 4.1.1 gives the measured profiles of sections 84 and 89 (SRKN'gineering/DSCL, 21 June 1996). Section 84 is in the middle of the Henrietta slip failure and section 89 is close to the side. The average slope in section 84 is now 1:6.0 and in section 89 1:4.1. This is much more gentle than the original design of 1:3. A gentle slope gives less wave run-up than a steep slope. It is therefore possible to make a lower sea defence than in the original design.

Proposed permanent repair works at sections
84 and 89 Area B
