Failure of the breakwater
at port Sines,
Portugal

ASCE Port Sines Investigation Panel

1982

*This report is an investigation of the breakwater
failure that occurred on February 26, 1978,
and a compendium of data and reports relevant to this failure.*

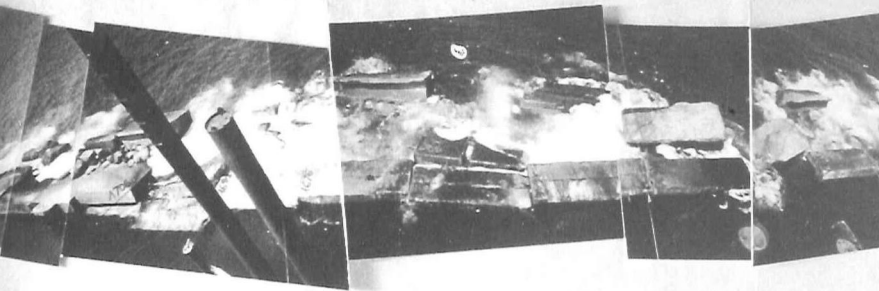
ESTADO ACTUAL DA SUPERESTRUTURA ORIGINAL
NA ZONA ONDE SERA' EXECUTADA A NOVA CABEÇA

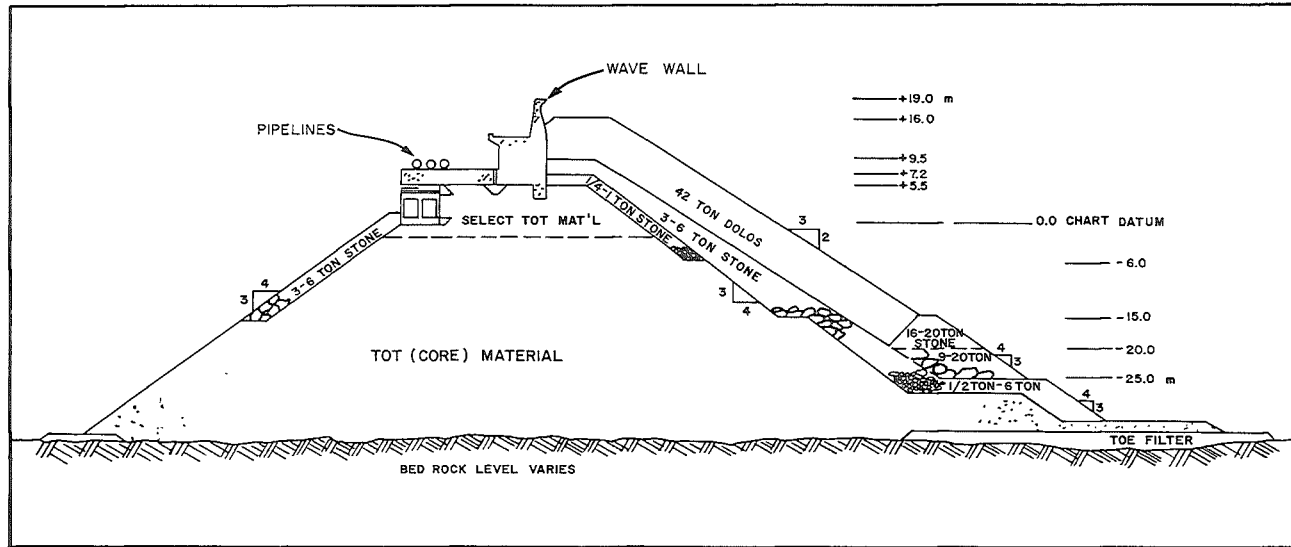
FIGURE 4.1 FINAL DESIGN CROSS-SECTION OF BREAKWATER

"At the toe of the dolos face irregular wave tests showed that draw down under severe wave attack caused damage with 6-t to 9-t rock as originally provided. Stone of 16-t to 20-t weight, supported on 9-t to 20-t rock proved sufficiently stable, but only with the revised shape shown in (Figure 4.1). The toe armor rests on 0.5-t to 6-t rock which also extends down the seaward face.

The exterior of the core* is protected by a first layer, with slopes of 4:5 and stones ranging from 250 to 1000 kg and by a second layer, slope 2:3, with stones from 3000 to 6000 kg resting on a toe composed of elements weighing 500 to 3000 kg. (The cross-section of the breakwater is presented in Figure 4.1).

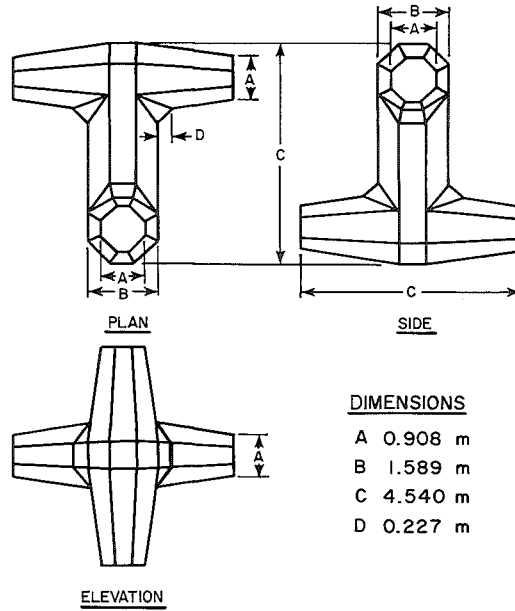
FIGURE 4.2 DIMENSIONS OF THE DOLOS UNITS

"The dimensions, provide a waist:leg ratio of 0.35. Fillets at the junction of the legs have dimensions of 5% of the leg length. [Figure 4.2 gives the dimensions of the dolos units.]

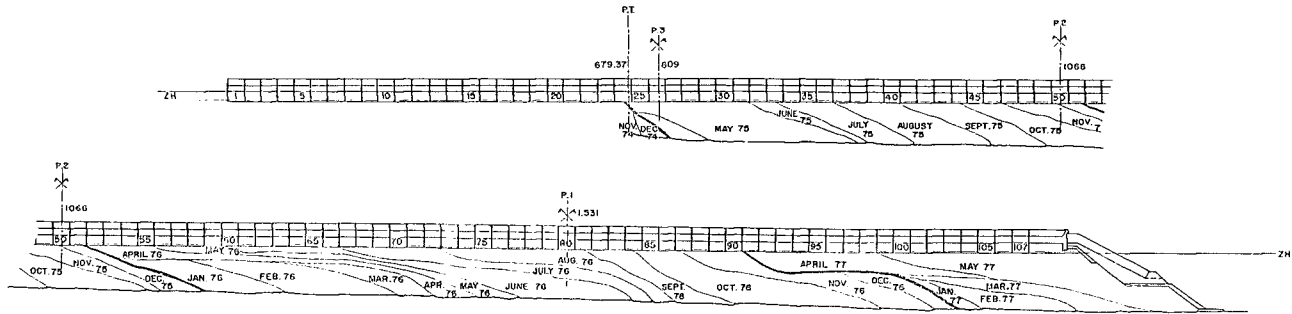
FIGURE 5.1 PROGRESS OF CORE CONSTRUCTION BY MONTH

Placement of the quarry-run material (TOT) in the core began in November 1974 and was completed during early summer of 1977. Figure 5.1 shows the progression of the core of the breakwater by month. (Inspection of the figure also shows the winter head of the breakwater). A temporary winter head was placed on the structure in 1974, 1976, and 1977. By the winter of

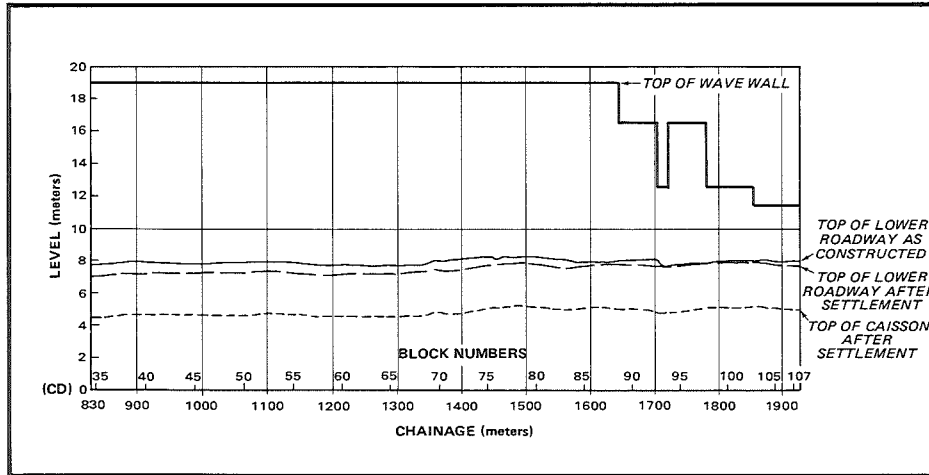
FIGURE 5.4 LONGITUDINAL PROFILE OF SUPERSTRUCTURE BEFORE STORM

Additionally, longitudinal surveys of the structure were made regularly to monitor settlement of the superstructure. Figure 5.4 gives a longitudinal profile of the structure before the storm. It is compared in Chapter 6 with the conditions immediately after the failure of February, 1978.

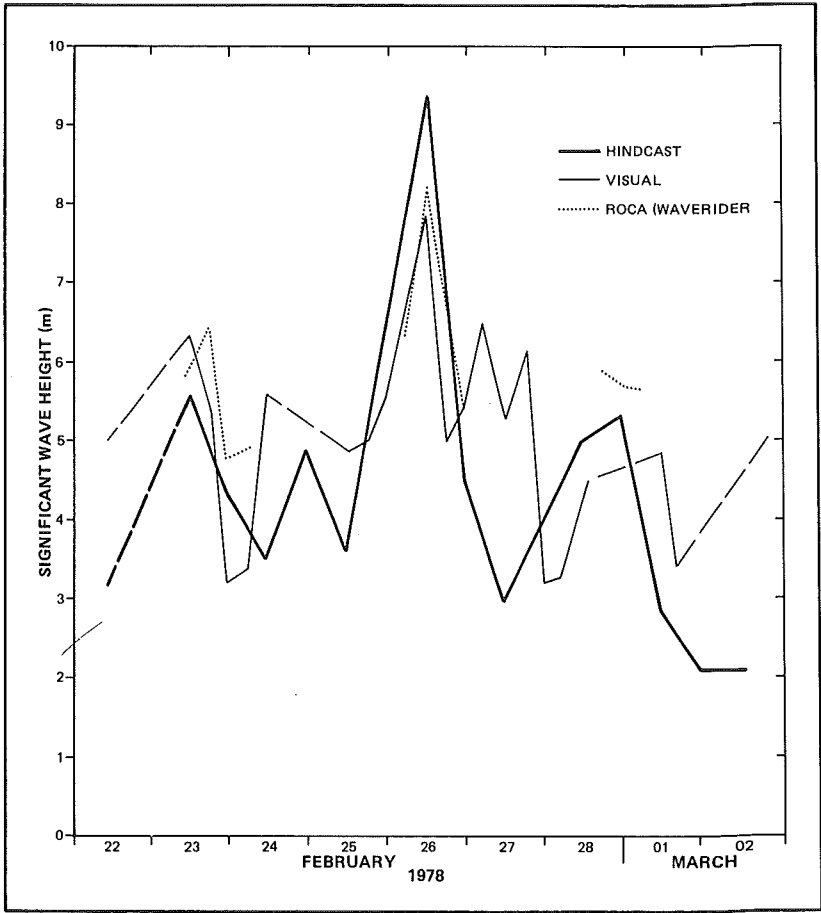
FIGURE 6.1 COMPARISON OF HINDCASTED WAVES WITH THOSE OBSERVED FROM PASSING SHIPS AND THOSE MEASURED AT CABO DA ROCA FROM FEBRUARY 22 TO MARCH 2, 1978

Results of these analyses are presented in Figure 6.1. This figure presents a comparison of visual observations of waves and wave recordings obtained at Cabo da Roca with the hindcasted values for Sines. The "broken" visual line is used to connect observations which were taken at intervals larger than six hours. The wave recordings at Roca are used for comparison, since the Datawell Waverider at Sines was not operating during the peak of the storm. (The details of the measured wave data from Cabo da Roca and Sines will be described below.) Comparison of the hindcast, visual, and waverider data show reasonable correlation for the maximum significant wave on February 26. Based on this correlation, the statistics of the wave data from the waverider at Roca are used to infer the wave statistics at Sines. From the figure, the storms preceding and following the peak on February 26 are very obvious. On both February 23 and 25 the waves had a significant height of 5 m and again on the 28th the significant wave exceeded 5 m. Based on this figure it can be assumed that the maximum significant wave height offshore of Sines was at least 8 m.

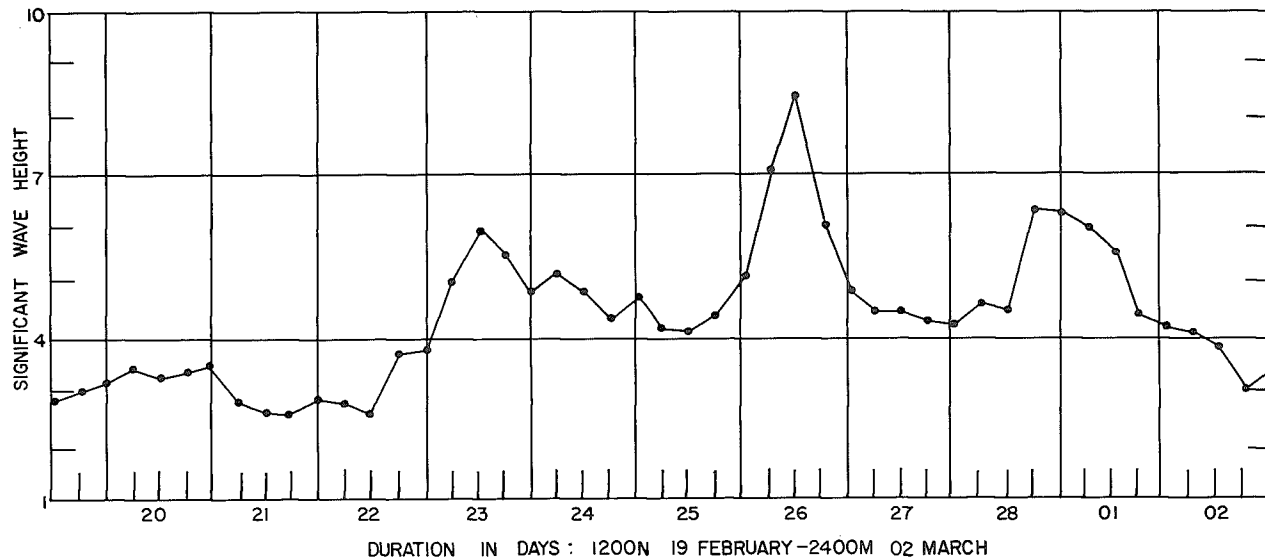
FIGURE 6.2 SYNTHESIS OF WAVE RECORD AT SINES FROM RECORDED
DATA AT CABO DA ROCA (MANSARD AND PLOEG, 1978)

A history of the wave heights during the storm was synthesized for Sines from the records at Cabo da Roca. This is shown in Figure 6.2. Note that all times given are local times. A sample of the wave record of

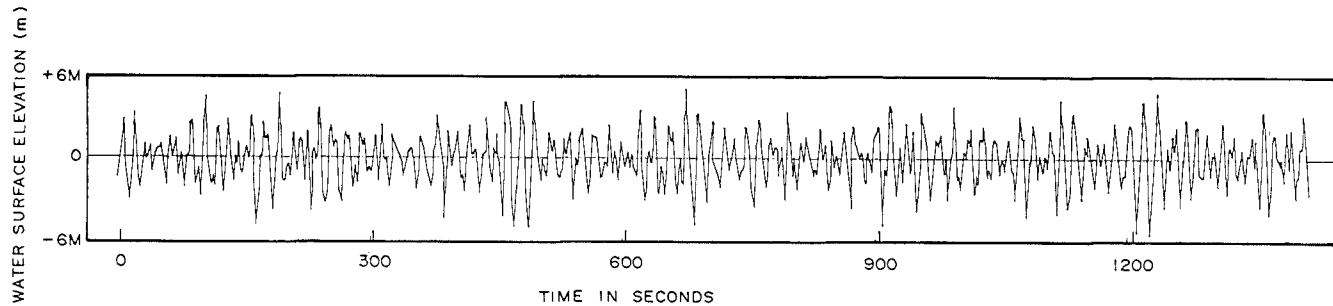
FIGURE 6.3 SAMPLE OF WAVE RECORD FROM CABO DA ROCA ON
FEBRUARY 26, 1978

Cabo da Roca is shown in Figure 6.3. The data of Cabo da Roca have not been treated to account for any refraction that may exist there. (LNEC had some refraction diagrams made for Cabo da Roca. The data from Cabo da Roca, unfortunately, did not by any means represent offshore conditions. November 1979 correspondence from LNEC.)

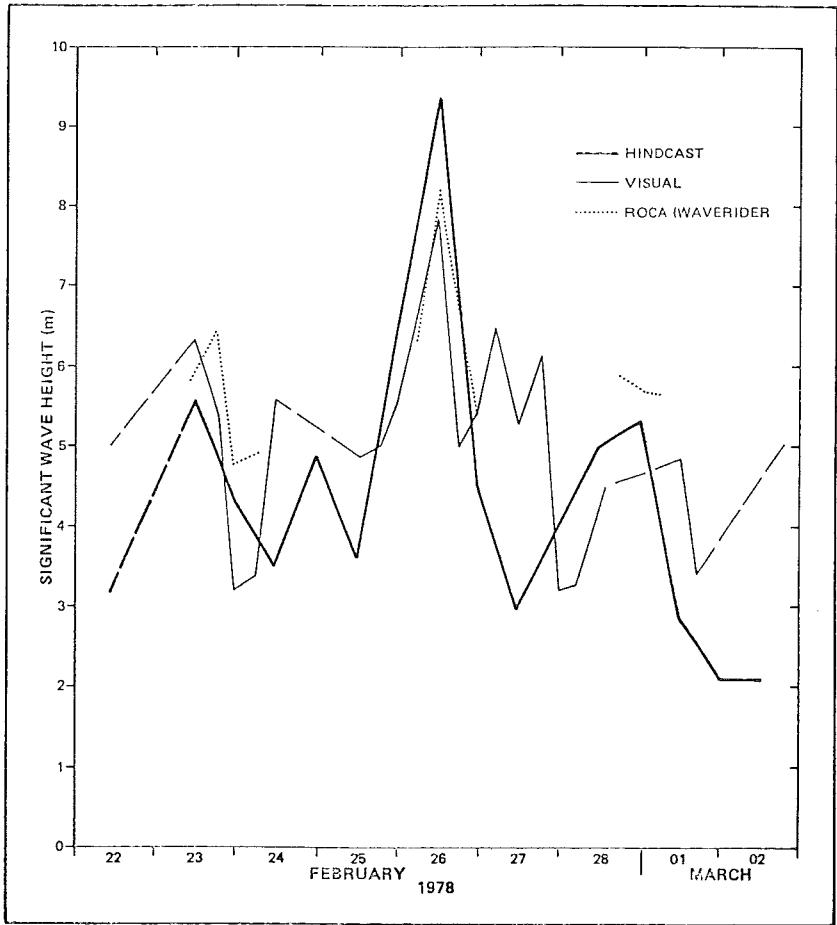
FIGURE D-1

COMPARISON OF WAVES HINDCASTED BY DRAPER
 WITH THE VISUAL SHIPBOARD OBSERVATIONS AND THE
 MEASURED WAVES AT CABO DA ROCA
