## Some learning cases in the Port of Rotterdam

J G de Gijt<sup>\*1,2</sup>, H E Brassinga<sup>2</sup> and A A Roubos<sup>1,3</sup>

**Abstract.** This paper present several cases in the Port of Rotterdam where both in the design and construction phase several different did not marched as expected. These cases are interesting for both the design as well the construction phase of a project. People will make mistakes however the mistakes describes in this paper have to be judged in time as not always everything was understood during the design and construction and the people of that time still these huge structures.

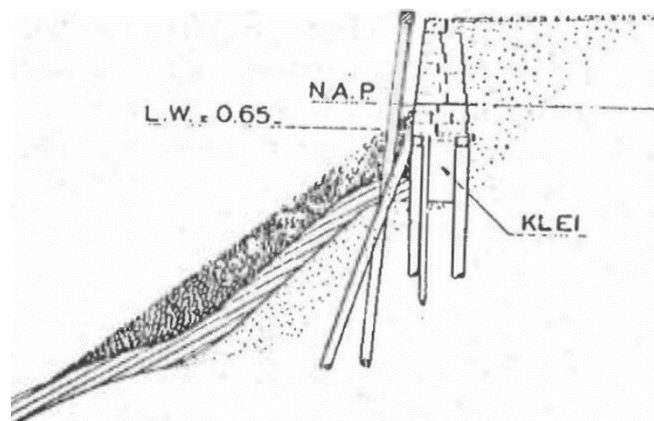
**Figure 2.** The reconstruction of the old Boompjes quay wall using batterpiles to increase horizontal stability.

As can be observed the retaining height is about 5 meters [7]. Since that time the port developed in western direction to the North Sea. The last extension was Maasvlakte 2, reclaimed from the sea. In figure 3 this development is indicated.
