ARCHITECTURAL ANALYSIS | STOOP - NEERLANDIA - PROZEE

TU Delft | RMIT | MSc 3 graduation studio
post-war areas Utrecht, 2011/2012

analyse : architectural & techical
subject : Stoop - Neerlandai - Prozee
area : Utrecht/South/Hoograven

*Verlengde Hooggravenseweg 71
3525 BB Utrecht*

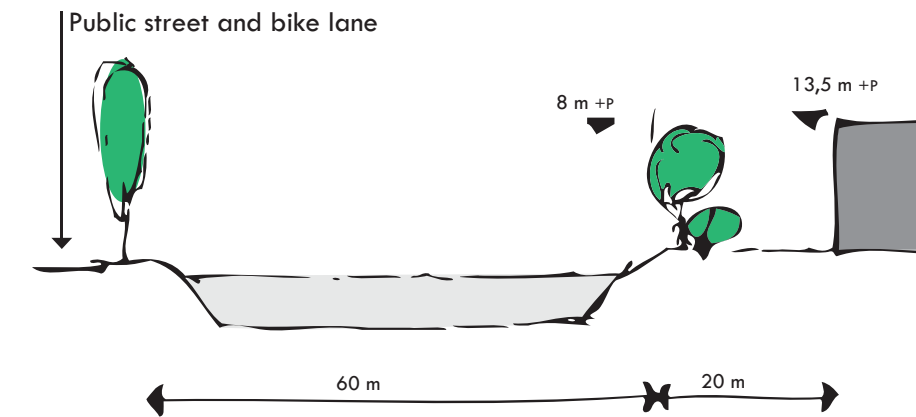
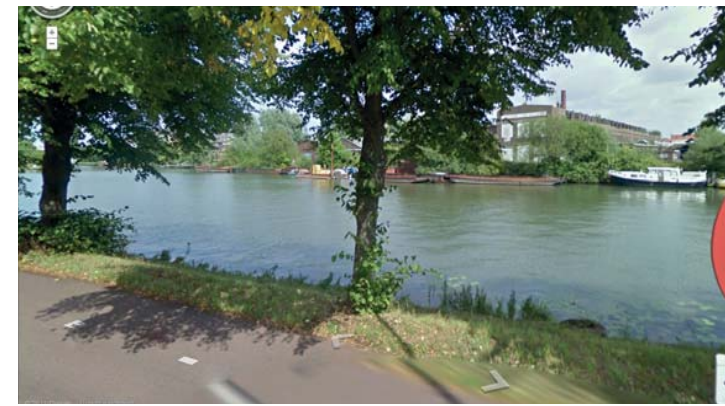
View towards Prozee from the west bank of Vaartse Rijn

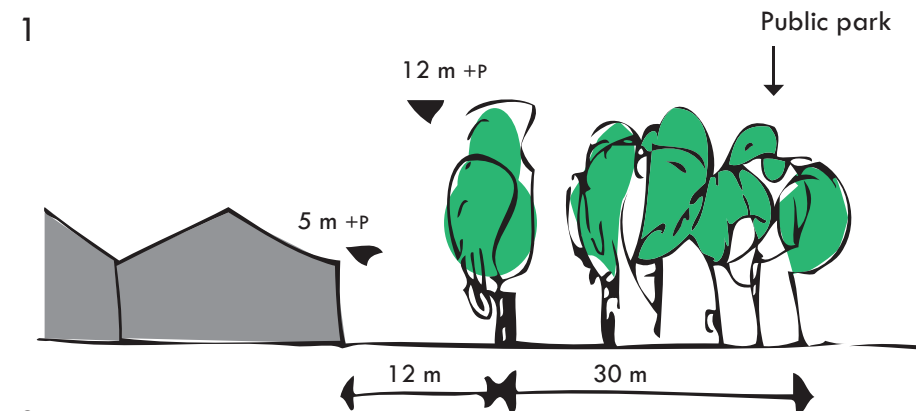
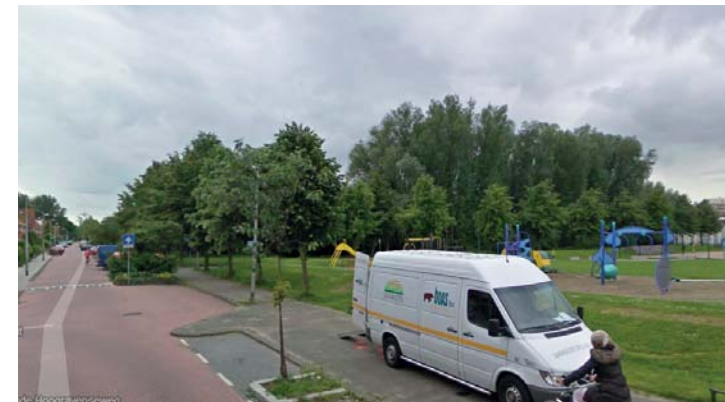
View towards Prozee from meester J.M.M. Hamersplantsoen

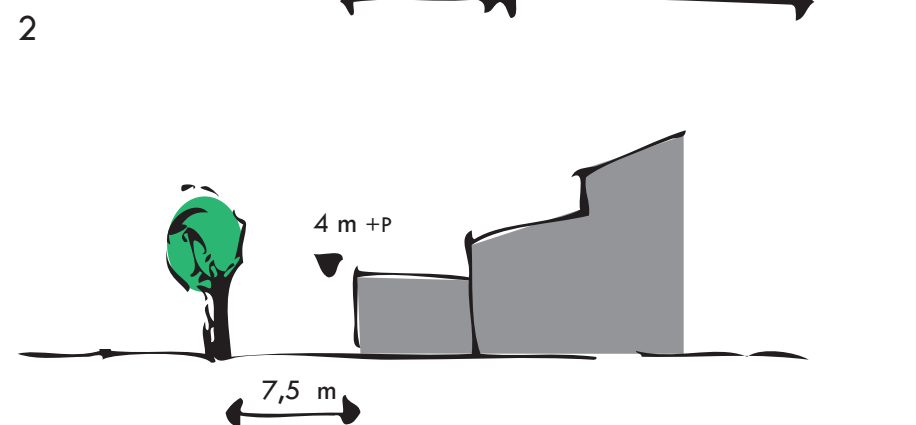
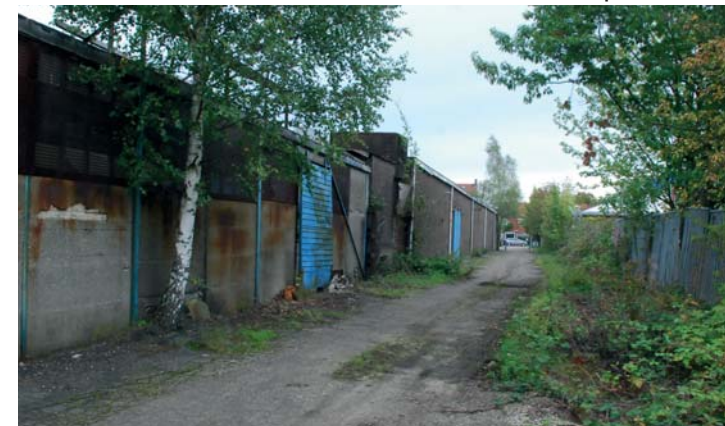
South side of the building, circulation between building and fence line

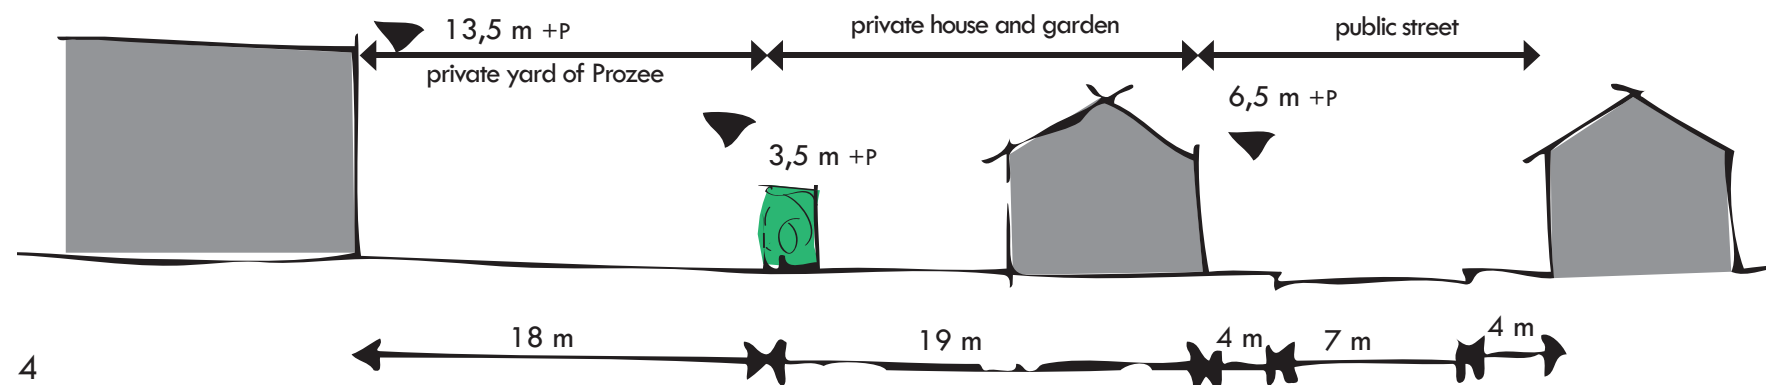
Dimensions - reference to plot borders

1. view from the canal is obstructed by a line of spontaneous vegetation on the bank which was formerly used for industrial activity (loading and unloading of materials and products - between buildings and the boats).
2. Space between the south annex building and the fence is narrow; the impression of a tight space is accentuated by the relatively tall spontaneous vegetation that grew along the fence; the tall mass of trees in the park (meester J.M.M. Hamersplantsoen) also obstructs the view to the building.
3. South part of the plot - space between halls and fence is relatively large but seems narrow because of the tall vegetation.
4. View from the street to the factory is obstructed by the row of houses; a green wall blocks the view from the houses back yards to the factory; large space between the factory building and the green wall; street has narrow profile - can't be enlarged.

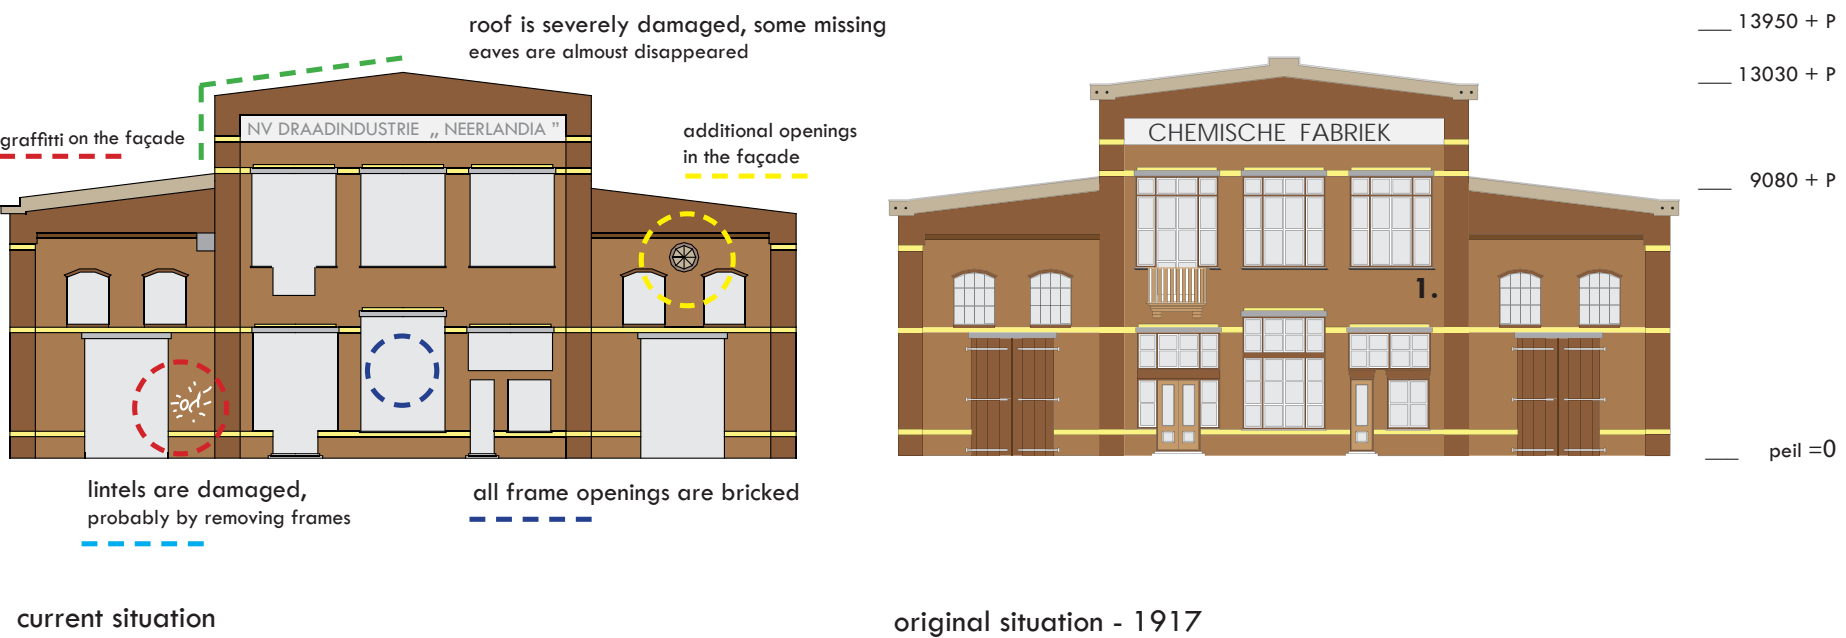
West Facade:

The west facade was originally the main facade of the building, as the main access was from the water front, therefore the access for raw material, products and the office area was on this side.

Today, this side is not used for access - the windows and doors had been closed (5) leaving no physical trace of the window design or elements. The lintels are mostly intact (some decay of the plaster and concrete) as well as the decorative yellow brick (6)

The facade doesn't show significant structural damage; however some installations have been placed on it - electrical panels, ventilation fan drilled in the facade (4,6) and there are some accidental plaster marks on it.

Most of the wooden frames on the south side of the building disappeared, except one (2). The wooden window frames on the north facade are still there but in a bad condition; rotten styles, glazing disappeared (3)

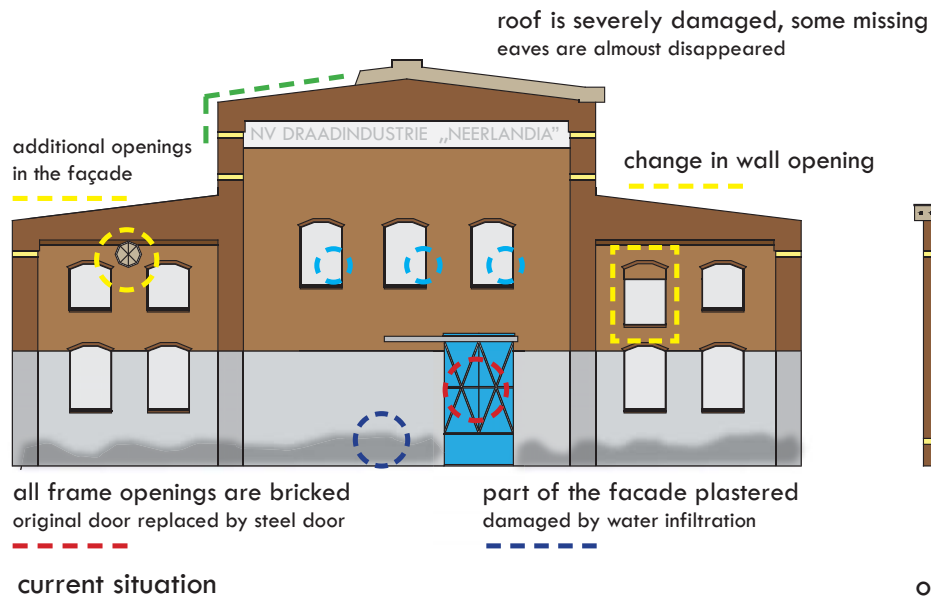
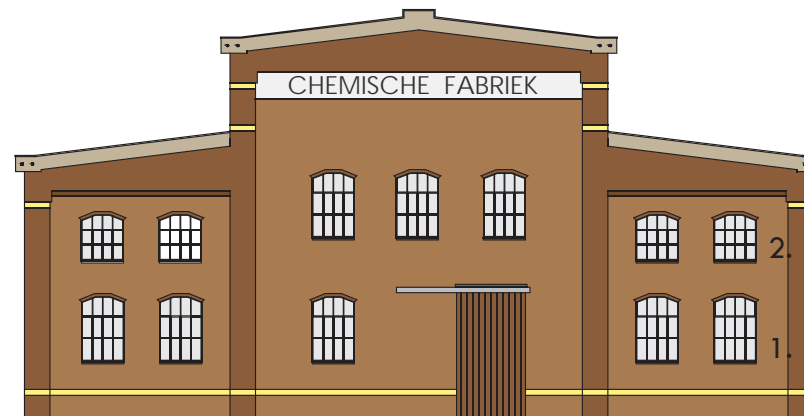
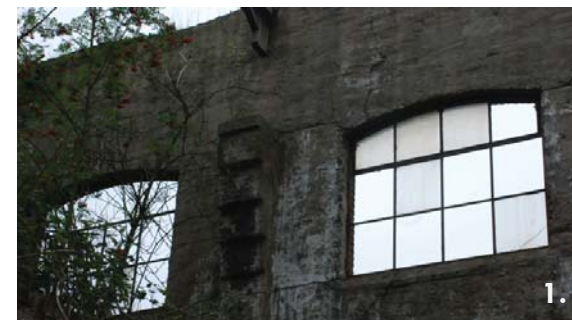
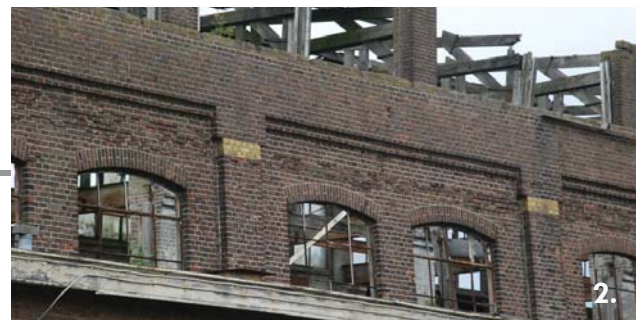
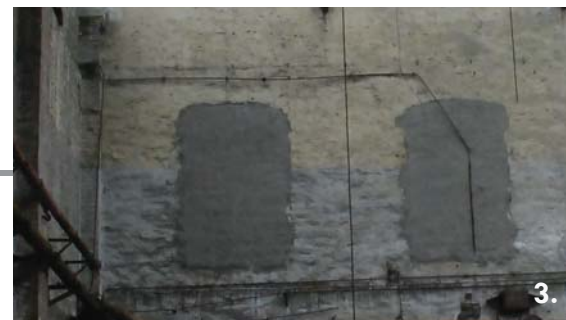
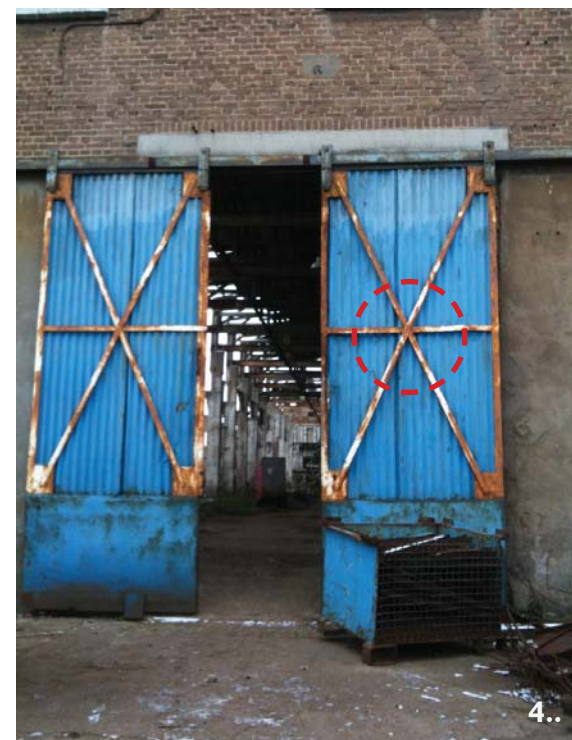
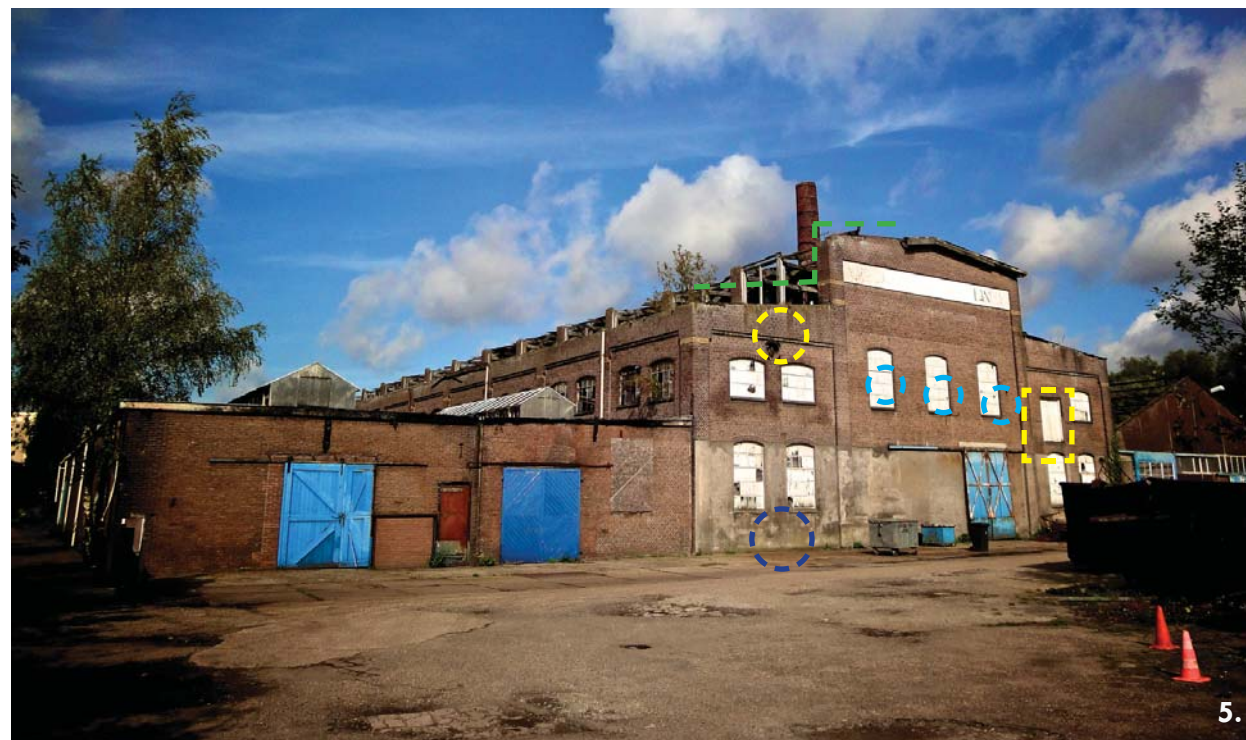
East Facade:

The East facade holds today the main access to the building.

The lower part of the facade had been plastered and shows moisture marks (water infiltration) at the base.

The roofline of the central nave is damaged towards the south side. (5)

the other cast iron frames at the north and south facade are still there but there are strongly corroded. The tipping area of the frame are missing in some parts even as the glass (2).

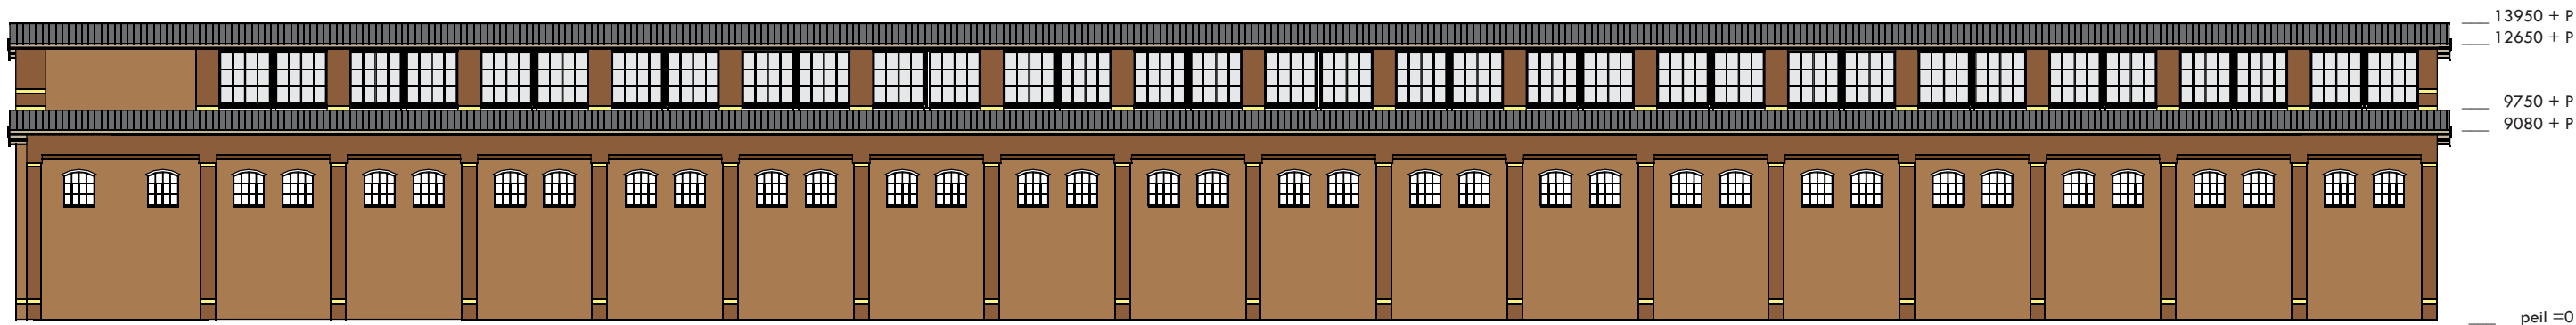
current situation

roof is severely damaged, most part is missing
eaves are almost disappeared

all cast iron frames are in poor condition
partly rotten, or missing

the side wall is along its entire length to a height of 2.5 meters hidden behind an expansion

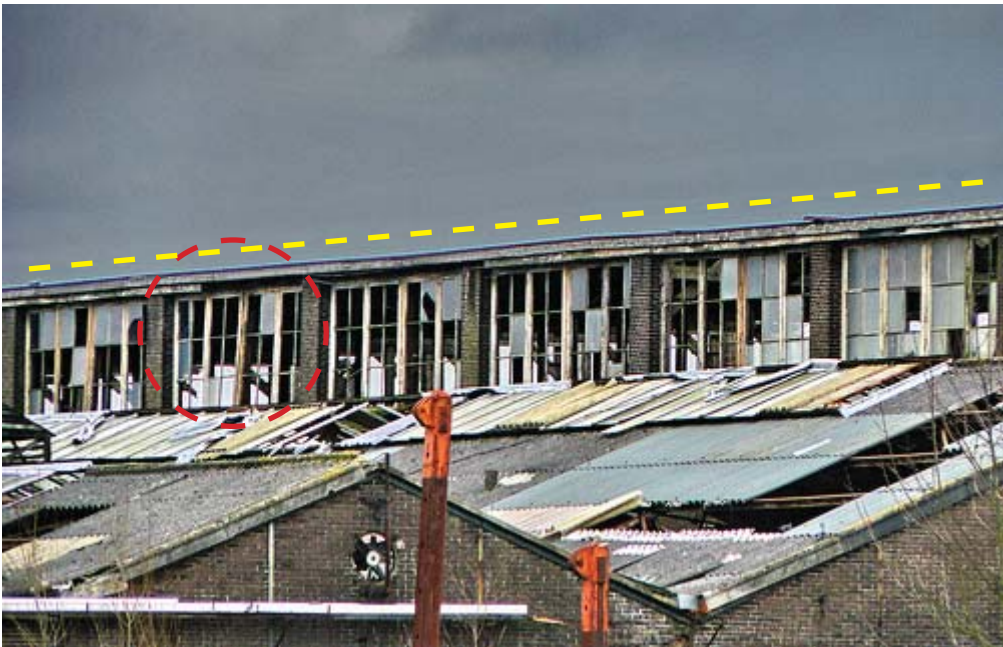
north facade - upper part - current situation

The top row of windows (central nave) are severely damaged but still bare physical proof of the design.(2)

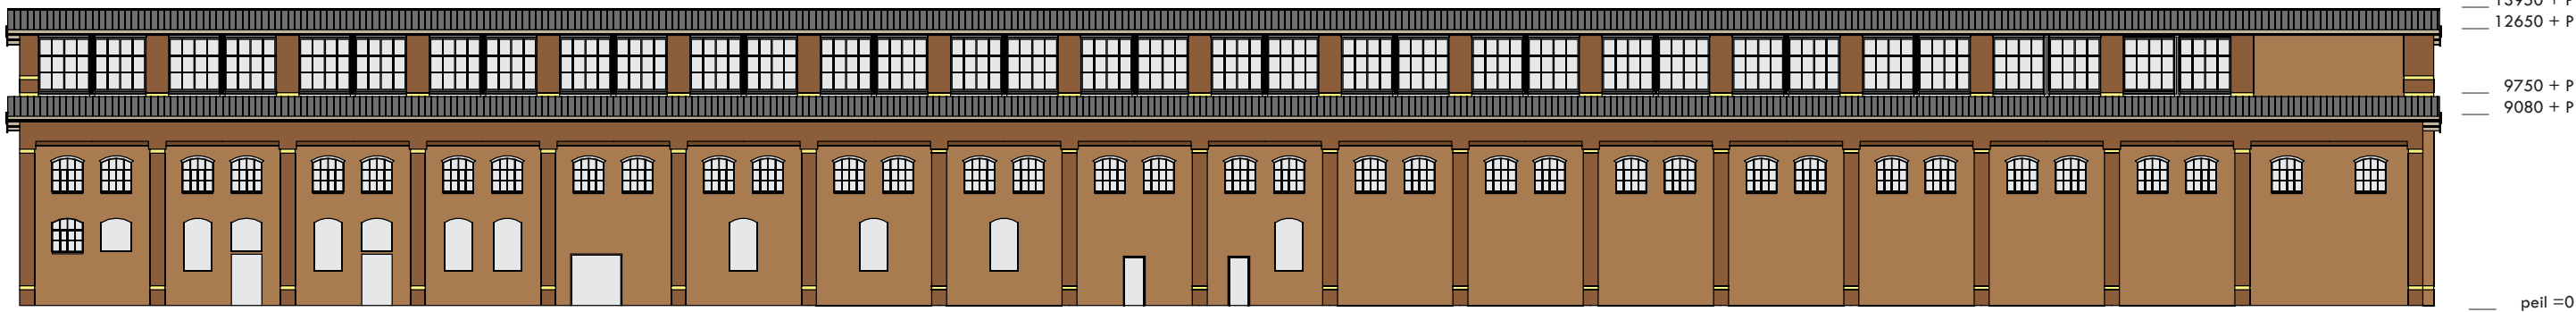
current situation

roof is severely damaged, some parts missing
eaves are almost disappeared

all wooden frames are still there
but in a poor condition, some glass parts missing

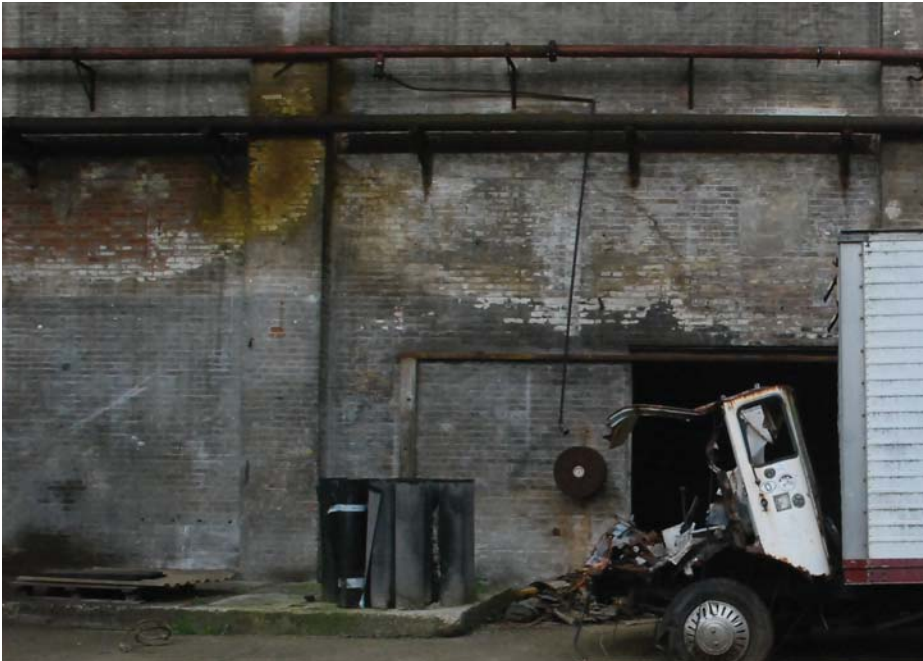
2

Due to water infiltrations or direct exposure to rain biological groth and calcium deposits developed on the wall's surface (1,2,3)

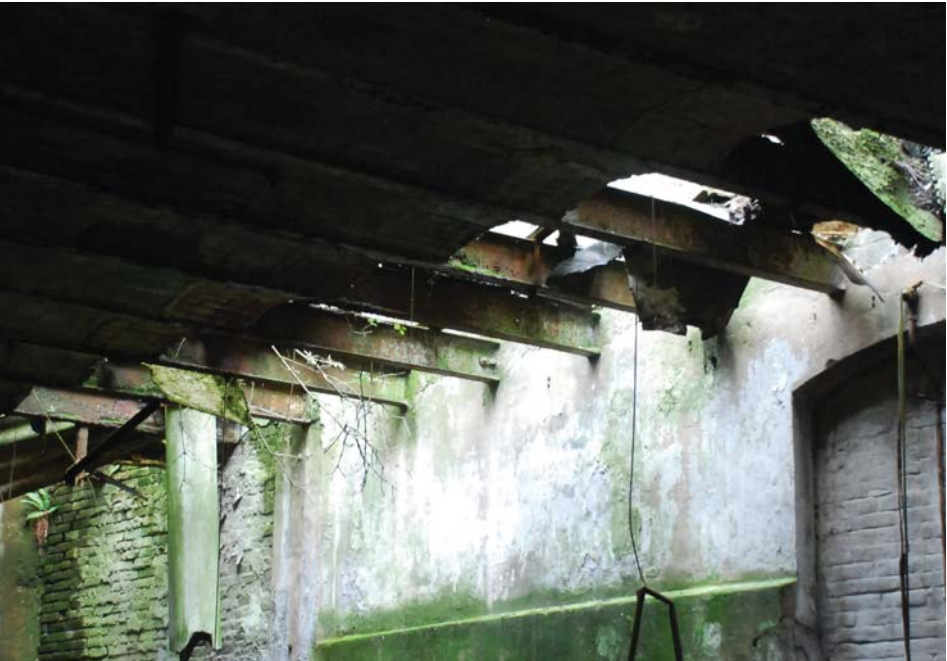
3

The wall of the central apsis doesn't show major traces of structural damage (1) The few cracks that are visible maybe caused by: instalation weight and un-strengthened openings in the wall (3) Also the mid-floor in the north apsis that is anchored by metal beams to the central apsis wall may be cause of structural failure (3)

The metal beams from the north apsis and their connection to the walls do not show high structural damage. However, the brick infill of the floor is damaged all along the north apsis wall. (3)

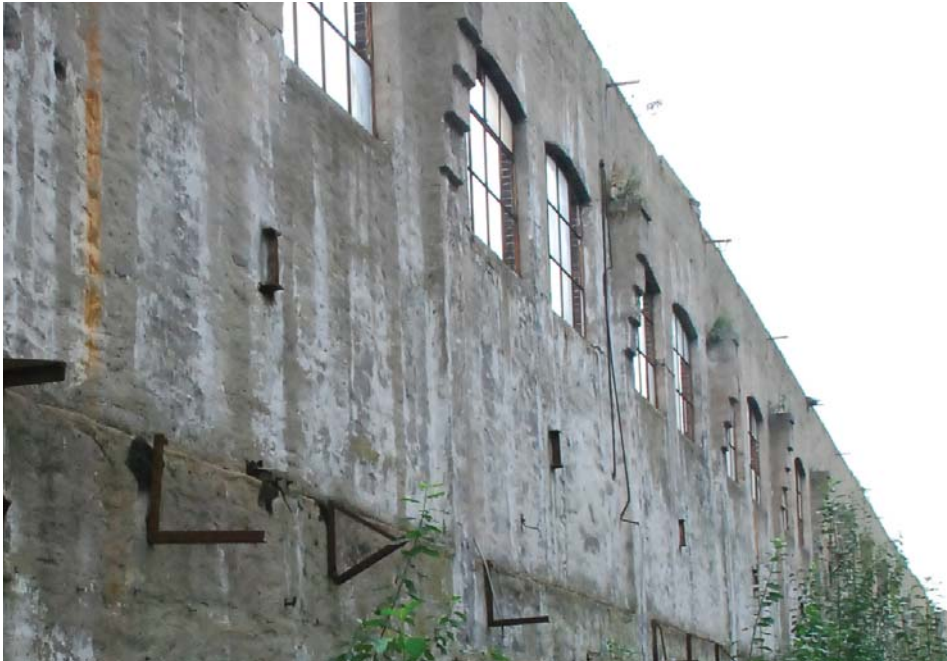
4

The I profile beams that form the roof structure of the building extension (south) are visible on the south apsis wall and are exposed to external factors, therefore they are rusted. Their exposure also determines a cold bridge in the annex building (4)

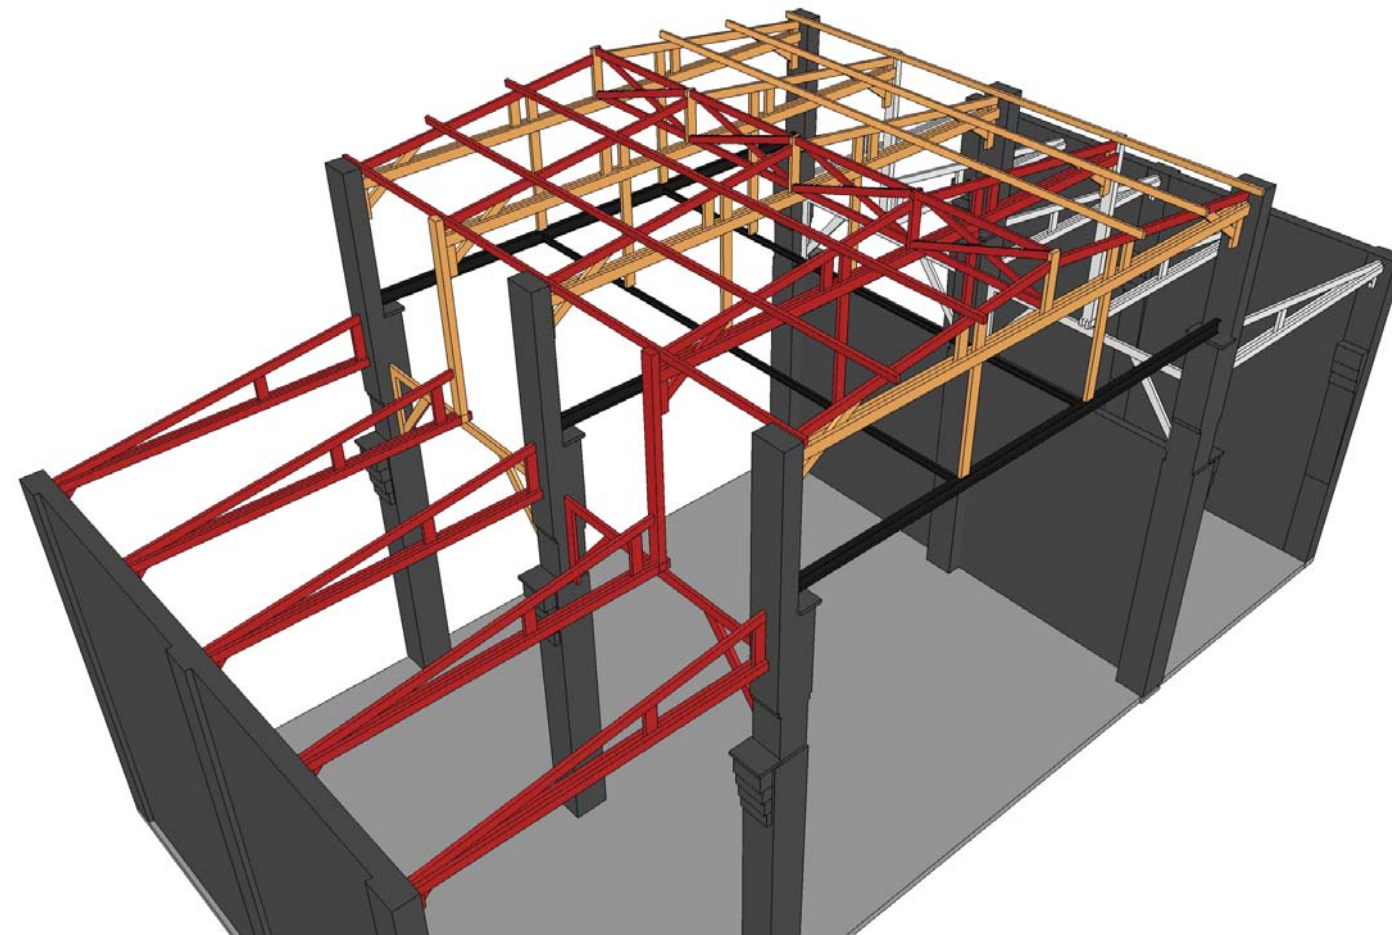
The wooden structure of the central nave suffered high damage due to exposure to external factors and lack of maintenance:

The truss edges are mostly damaged on the south side - due to the earlier destruction of the roof which now is almost completely gone on the south side. The trusses that do not rest on the central pillars are mostly gone, especially in the area where the roof has been completely damaged. The reason is most probably the failure of the whole wooden truss system that connects the central and the lateral trusses.

There are no trusses left on the south apsis; most of the purlins that rested on the central truss have disappeared; the struts between the south row of central pillars are heavily damaged or completely gone.

Structural cracks are visible around most of the windows of the south apsis - the lack of transversal structural connection made the wall of the south facade unstable and naturally cracks occurred around the openings.

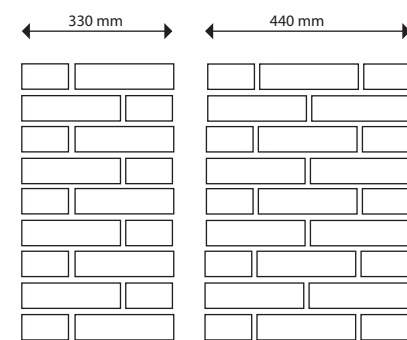
section outside wall + piers

The piers are situated on the same pattern as the columns. The dimensions of the piers are 440 x 660 mm. This amounts to a visible thickening on the outside facade of 110 mm. (440-330=110mm)

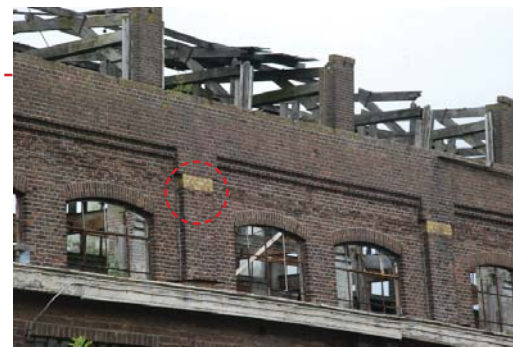
photo piers (steunberen)

The width of the piers are 660 mm. visible in the photograph as 6xhead. (6x100) + (5x12) = 660 mm

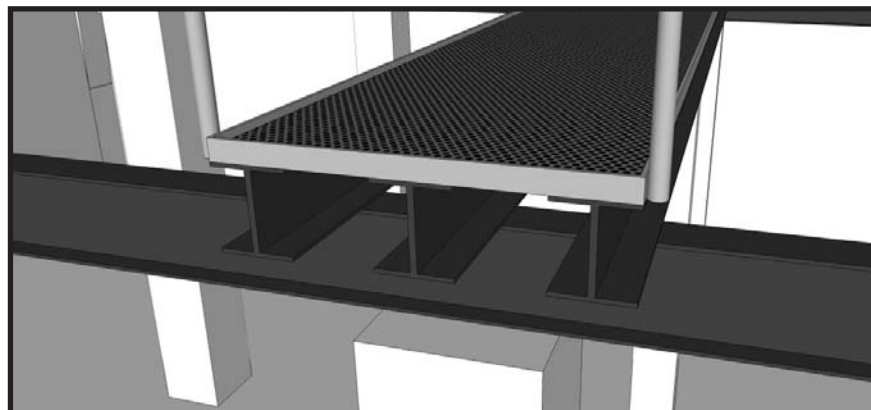
bridge structure made of I profile steel beams - 3 beams resting on a transversal steel beam.

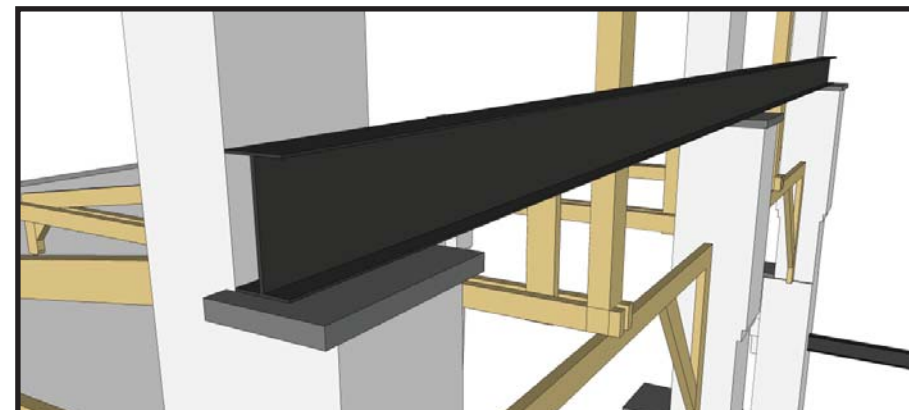
steel beam resting on the central pillars - probably used as crane lane

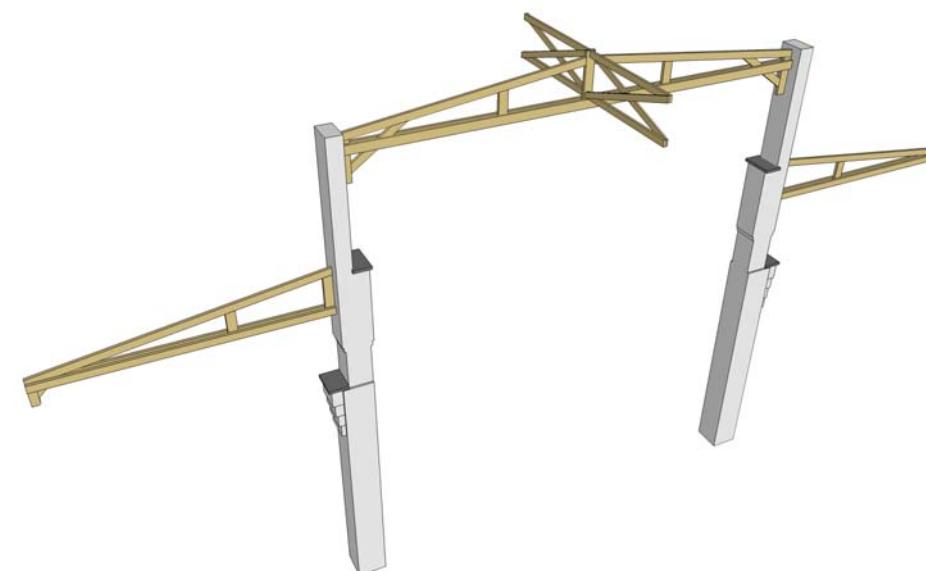
wooden truss systems - main nave and apsis are not directly connected, they rest individually on the central pillars.

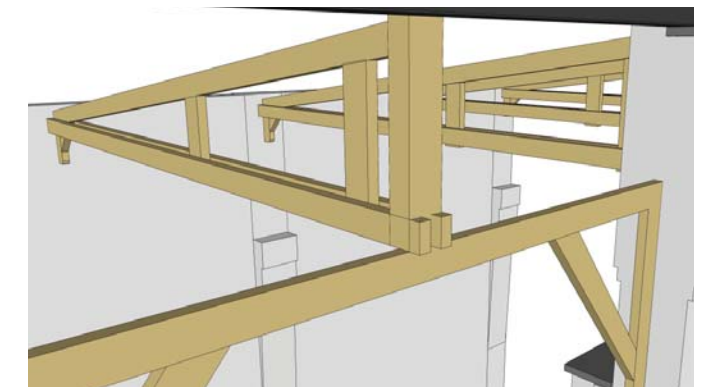
Wood truss of the apsis resting on the prop that rests on two central pillars

Also, the wooden truss presents additional elements to the original design - two props that rest on the transversal metal beam. It is highly probable that this structural solution was adopted even from the beginning because of the underdimensioned roof structure.
